The Rio dos Padres case study – Working in a dangerous area and minimizing the impact of clean-up activities on the environment.

Fernando Henrique Falkiewicz, Process Senior Engineer, Petrobras, President

Getúlio Vargas Refinery, Parana State, Brazil.

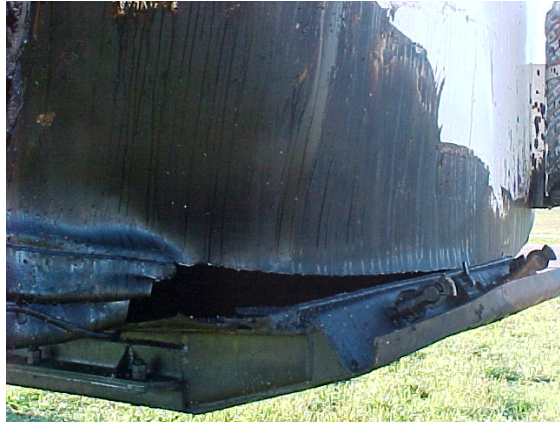
Fig 2 – Tank rupture detail.

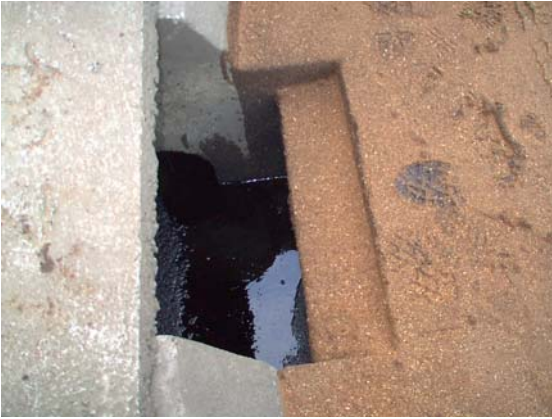
Fig. 7 – Rainwater sewer inlet.

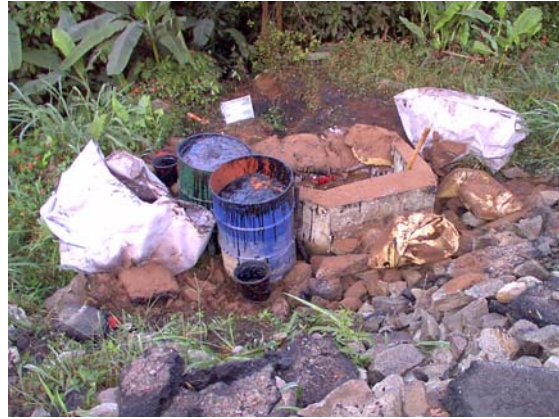
Fig. 8 – Sewer discharge to the forest.

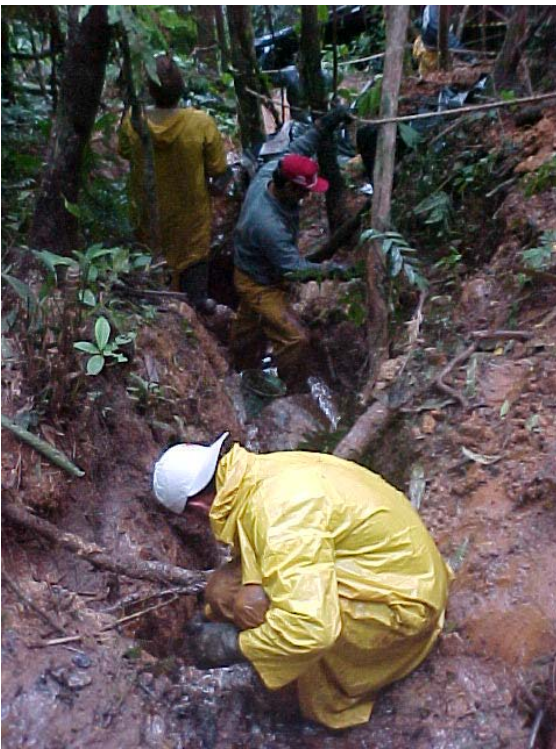
Fig. 17 – Workers cleaning one of the “tracks”.

In the “tracks”, the oil was absorbed with sawdust and/or peat powder, packed in plastic bags, and then carried manually up hill; most of the way with rows of men and passing the bags hand to hand up hill, once walking up the hill was very exhaustive. Some residue bags

were too fluid; these bags were packed into buckets to protect against rupture by impact on trees or rocks. At the first working base, at the roadside, the bags were packed in containers and removed for treatment and final disposal at a petroleum refinery. The equipment utilized in this site included shovels, backhoes, plastic bags, buckets, ropes and wood sticks as anchor points. Where possible, in the tracks, small dikes were built to contain the oil. All the hardware and material had to be small and light enough to be carried into the forest without damage to the environment. Although slow and difficult, these techniques were effective and had very good results, technically leaving no oil in this portion of the forest. The cleaning of this section finished in one week.

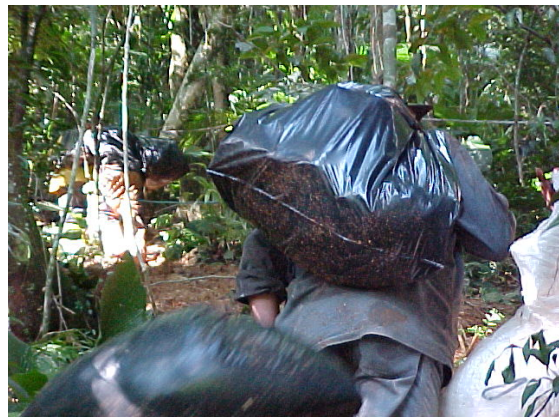
Fig. 18 – Worker carrying bag with oil recovering material up hill.

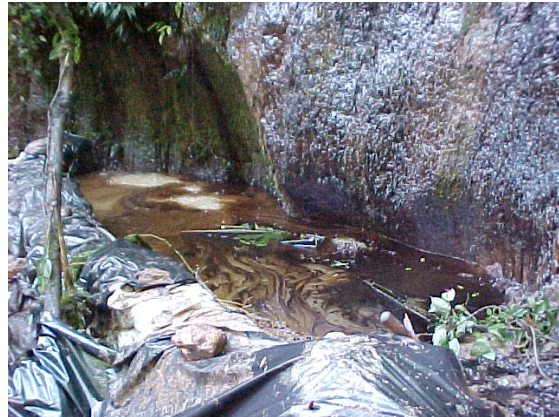
Fig. 20 – Pool for containment of the wall wash water.

The tracks finished at a vertical rock wall, around a hundred feet high. The wall was soaked with oil and workers were rock climbing to clean it using high-pressure water jets. At the bottom of this wall, the team built a pool to contain the wash water and recover the oil. The pool was made of sand bags, coated with plastic sheet and drained at the bottom. The oil could then be recovered from the surface of this pool with cans and absorbent material as booms and pads. The oil was conditioned in sealed light drums and carried up hill to the roadside base.

No chemical product was used to wash the rock wall, since it could contaminate the river. The pool water was drained at the bottom into portable oil-water separators and from them to the river.

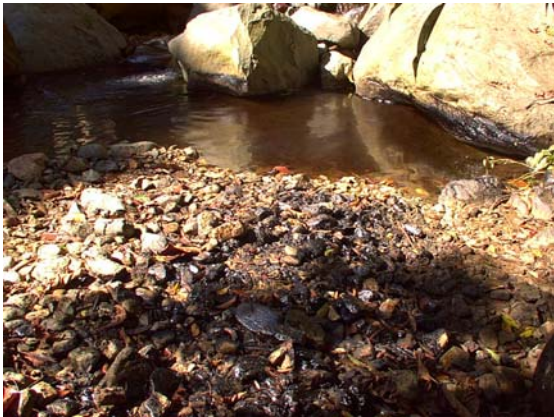
The most important contamination was in the river, the Rio dos Padres. This river set in the groove formed by the mountains, has an intense slope, runs between rocks, and, as the first “tracks”, had never known human presence before the accident. The oil reached the river and ran on its surface contaminating rocks, shores and vegetation. There was no injury to wildlife and fishes, the impact on the vegetation not significant. The rivers water was not used for human consumption.

Fig. 21 – Oil stained portion of Rio dos Padres.

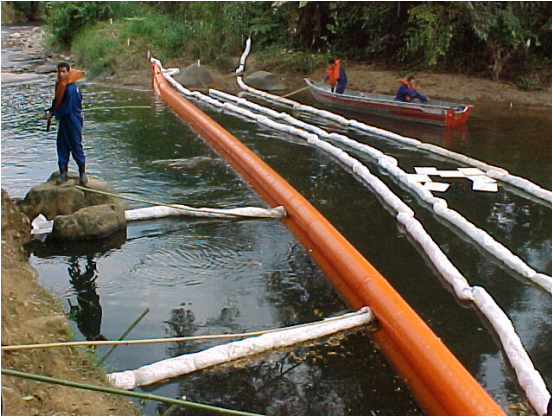
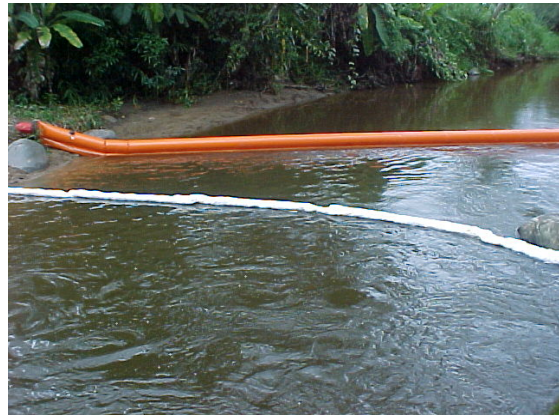
Fig. 27 – Rio dos Pintos containment point.

Fig. 28. – Booms on Rio dos Pintos.

This river had standard response techniques, with the use of containment and absorbent booms, absorbent pads, vacuum trucks for oil recovery. This response does not require any further comments or description.
