Inland Oil Spill – Well Blowout, 2004

Abstract

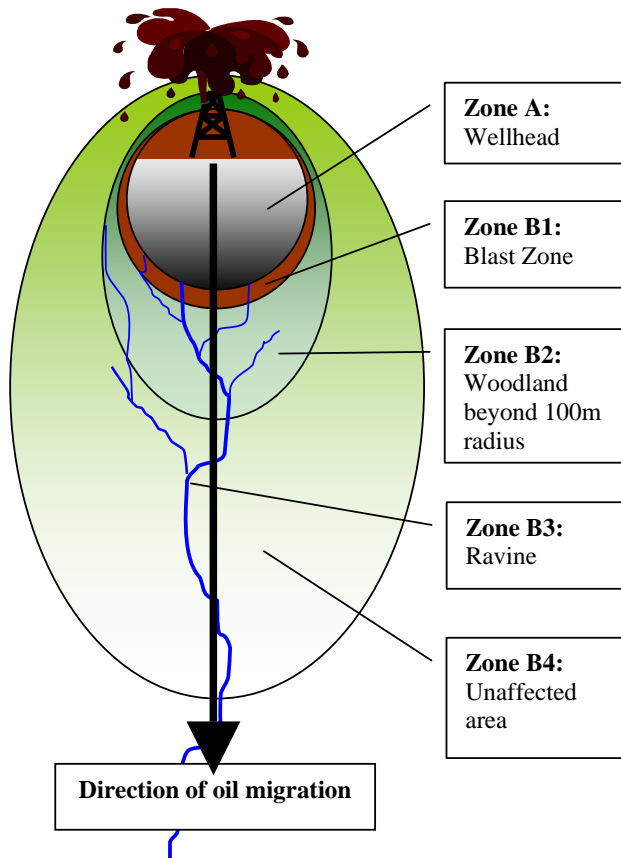
The only mitigating measure conducted in this area by the client was the building of storage pits and earthen bunds as mentioned above. The hillside is characterised by its dense mixed deciduous trees and shrubs which suffered different degrees of disturbance dependant on the distance from the wellhead. This zone was, therefore, sub-divided.

Trees at the edge of the wellhead clearing suffered the most direct damage, with leaves and branches being stripped from some. To the south of the well the topography slopes steeply toward the village. Both airborne and surface flowing oil migrated in this direction, funnelled and concentrated into the ravine. Here oil coverage was almost complete, from tree-top to leaf-litter layer. This highly polluted area extended south for about 100m from the tree line.

At approximately 100m from the tree-line the intensity of the pollution began to lessen, with trees and the leaf-litter layer suffering a less intense coverage. Coverage of the leaf litter layer was shallow, with only the top layer being affected.

The ravine cuts through the hillside in a southerly direction down to the village. Free flowing oil was present along the entire length of the ravine. The ravine’s clay substrate, acted to prevent infiltration of oil. At the time of the survey a small flow of water was present which mobilised the stranded oil.

Figure 2. Showing the subdivision of Zone B.

The felling of trees was considered a viable option in Zone B1 due to the number of trees condemned during the survey. Removal of these trees would reduce the threat of secondary contamination and chronic oiling from the remobilisation of oil and improved access to areas where bulk surface oil removal was required. The trees identified to be felled were clearly marked prior to felling, thus avoiding unnecessary removal and ultimately more waste.

Coppicing was recommended for trees within Zone B2 that were partly oiled and so presented a higher chance of recovery. This option resisted the removal of the entire tree, maintaining soil stability through root binding and allowing the ingress of opportunistic species through increased light fill. Following the coppicing, any remaining bulk oil was removed, followed by manual clean-up of residual oil on trees.

Leaf litter removal and manual clean-up was the preferred response option for this low-priority area. This zone covered a large area and represented low-level contamination levels when compared to Zones A & B, it was therefore suggested that this area be tackled as part of the final polish.

Due to the inaccessibility of this area it was recommended that low pressure / high volume flushing be used to drive the mobile oil down the ravine. This mobilised oil was captured in pits constructed on the outskirts of the village. It was deemed preferable to conduct this in a controlled fashion using recycled water from the flushing of the wellhead than wait until the rains of fall or the snowmelt of spring.

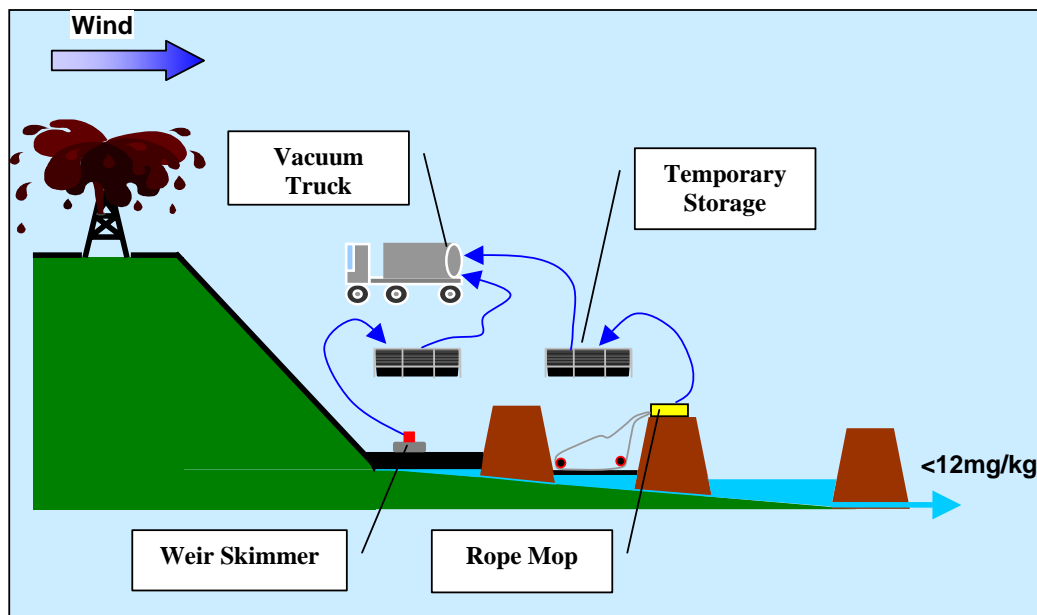
Figure 3. Diagrammatic representation of the oil / water separation pits.

In an attempt to reinstate the stream's flow, the pre-existing pit was split into three to produce a crude oil/water separation facility (Fig.3). The top pit was used to collect and concentrate oil mobilised from the ravine, while allowing the separation of water and oil. The bottom water level was then allowed to decant at a controlled rate to the next pit, which was again allowed to settle and allowed any oil to accumulate on the surface for removal. Again the water was decanted into the third and final pit where sorbants were used to remove any trace of sheen ready for release downstream once hydrocarbon levels of 12mg/l or lower were reached. This level was given as the acceptable limit after consultation with the Ministry of Environment and levels were monitored by an independent agency.

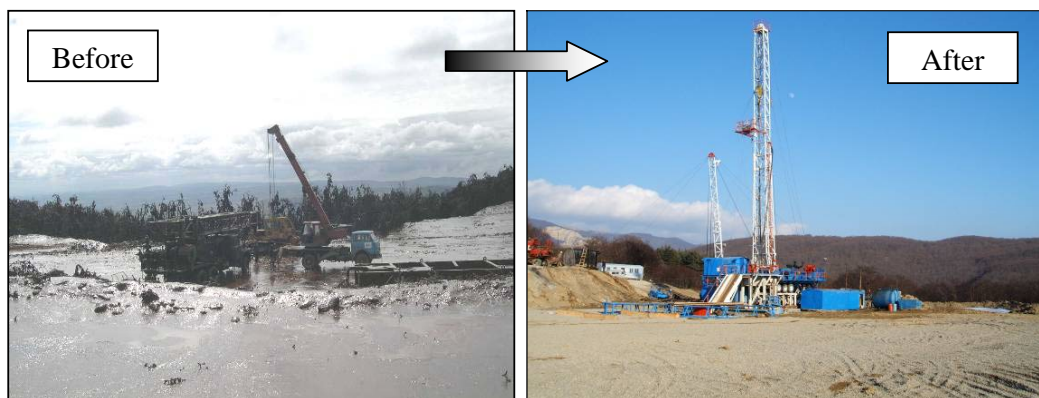
Figure 3. Showing the wellhead site immediately after the spill and four months after.

role in this structure, working intimately with the client. Of primary concern to the client was getting the wellhead site sufficiently clean to allow pumping operations to be resumed from the rejuvenated well (Fig. 3). Daily meetings allowed a constant information flow between the on scene commander and operations manager, ensuring logistical requirements for the following days operations were met.

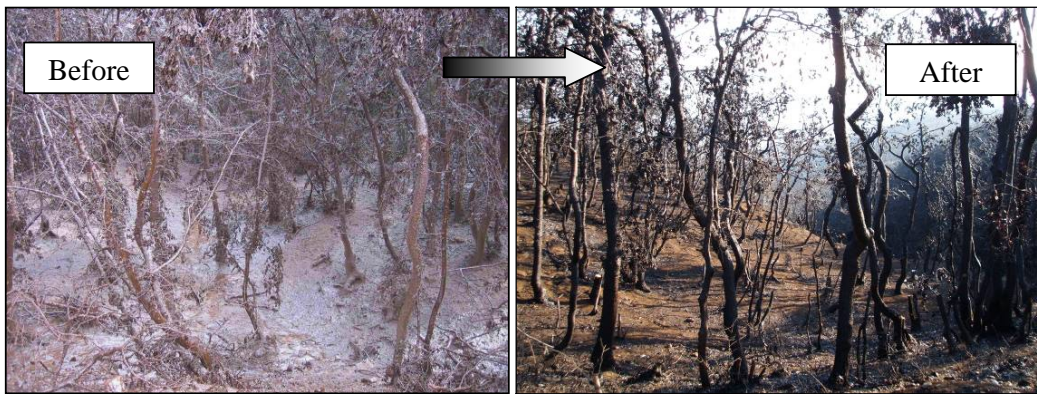
The environmental action plan written by OSRL had been closely followed. Selective felling and the removal of oiled leaf litter, fallen branches and badly damaged trees had been removed as prescribed in the action plan (Fig. 4). The remaining trees within this area still showed signs of surface oiling but the majority of oiled leaves had fallen and been removed, thereby reducing the risk of chronic re-oiling.

Figure 4. Showing the woodland site immediately after the spill and four months after.

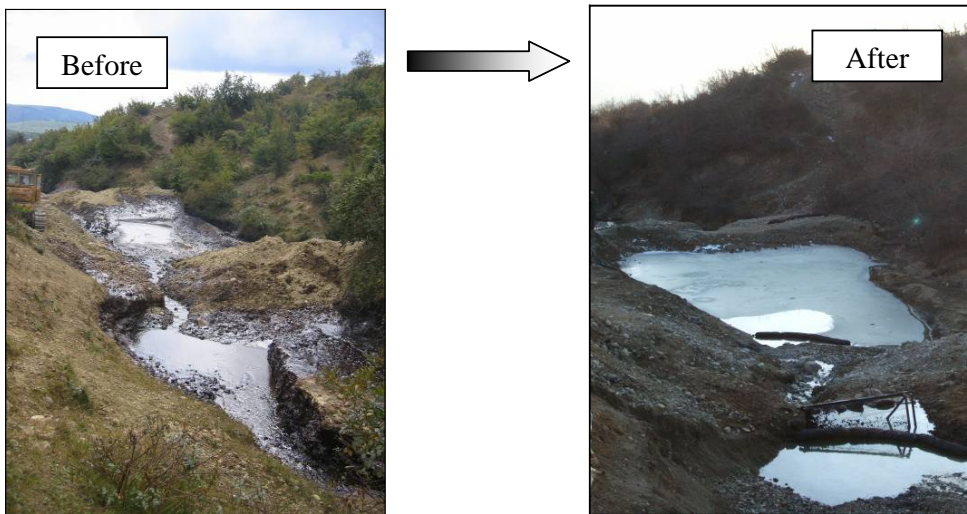
The pits remain in place and are manned in order to monitor the water flow and manually skim any sheen from the surface. The upper pits are still showing some surface sheen, though it is unclear whether this is as a result of oil mobilised from the ravine or chronic oiling from the pit itself. It is predicted that this sheen may increase during the wetter, warmer months as oil is remobilised and transported down the ravine.

Figure 4. Showing a separation pit during and after the response.

The client has also planned to landscape the pit area to create a permanent facility for the collection and separation of runoff for this watershed using concrete pits and larger sluice gates. An independent hydro-geologist has been consulted to design this facility in order to withstand a 1 in 100 year event.
