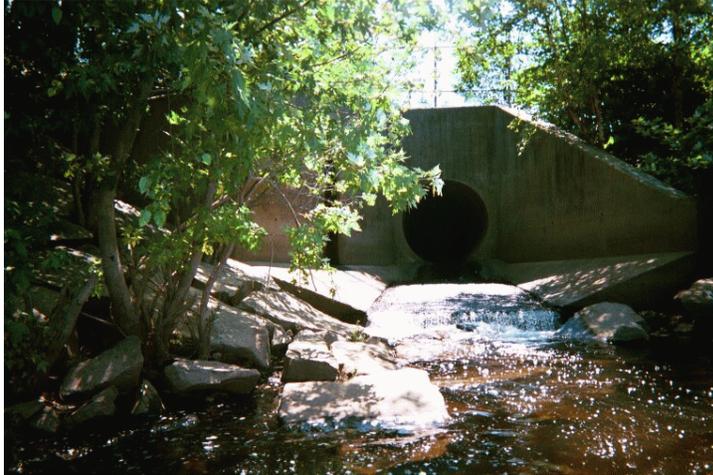
Pipe # 26:	Approximately 72" wide concrete culvert. <i>Flowing approximately 400 gpm. Discharge was clear with a slight foam and had no odor.</i> Located on the North Andover shore, near the Greater Lawrence Sanitary District Wastewater Treatment Facility.
-------------------	---

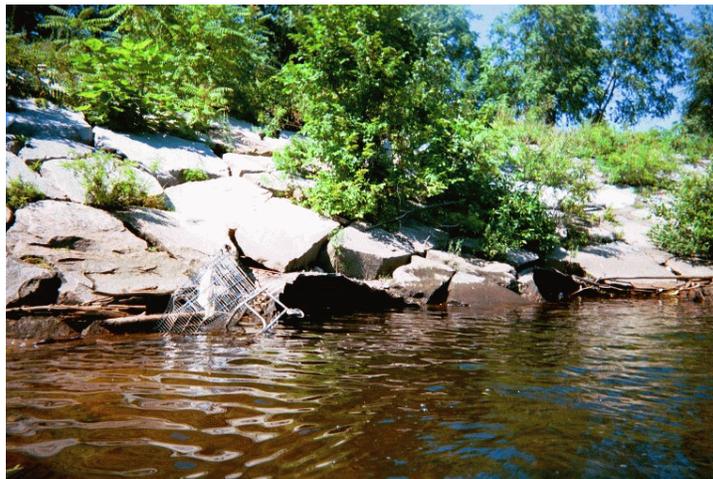
Pipe # 27:	Approximately 72" diameter corrugated metal culvert (left). Mostly submerged. No flow.
------------	--

Pipe # 28:	Approximately 48" diameter corrugated metal culvert (right). Mostly submerged. No flow.
------------	---

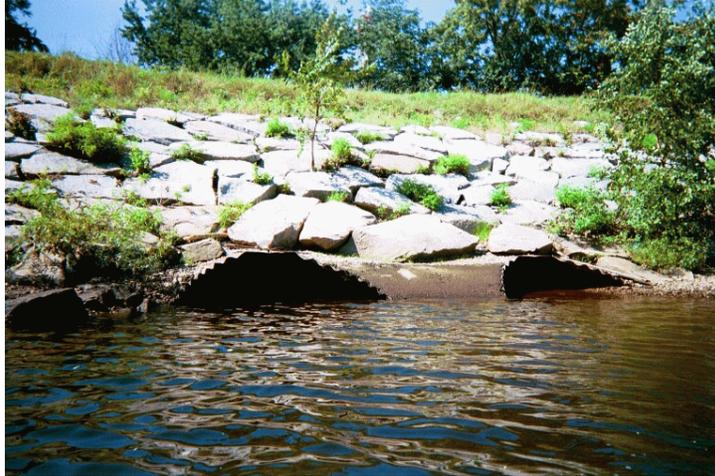
Pipe # 29:	Approximately 72" diameter corrugated metal culvert (left). Mostly submerged. No flow.
Pipe # 30:	Approximately 72" diameter corrugated metal culvert (right). Partially submerged and partially filled with sand. Located approximately 6' downstream of Pipe # 30. No flow.

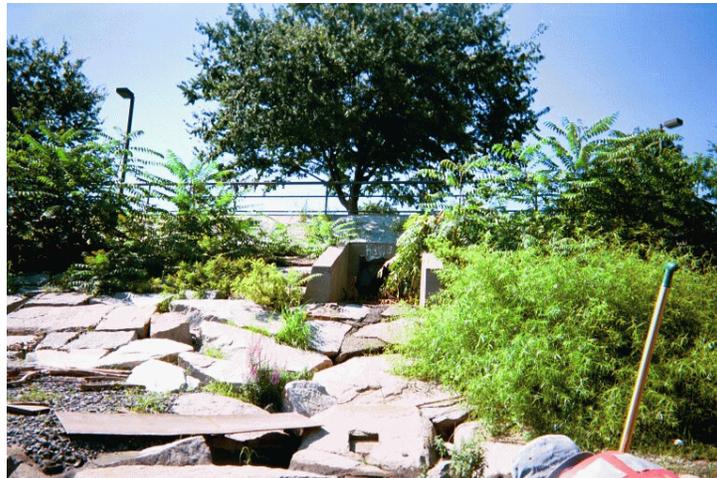
Pipe # 31:	Approximately 30" diameter iron pipe with broken flapper valve. Located approximately 25 feet from the river in an embankment adjacent to the Lawrence Riverfront Park parking lot. No flow.
------------	--

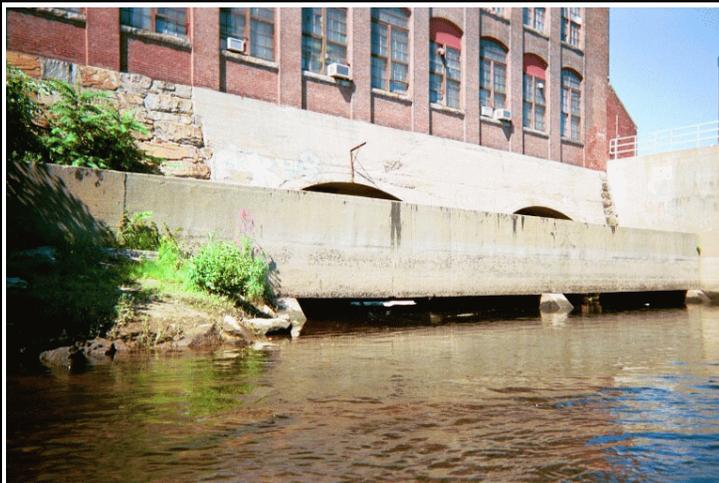
Picture A

Two approximately 20' wide concrete culverts (Picture A). Located under a 5-story brick building at 300 Canal Street (Pacific Mills Industrial Complex). Pipe #32 is the upstream culvert (left) and Pipe #33 is the downstream culvert (right). There were containment booms and absorbent booms in the upstream culvert (Picture B). The downstream culvert was partially filled in with soil. It did not appear that booms were located within the downstream culvert.

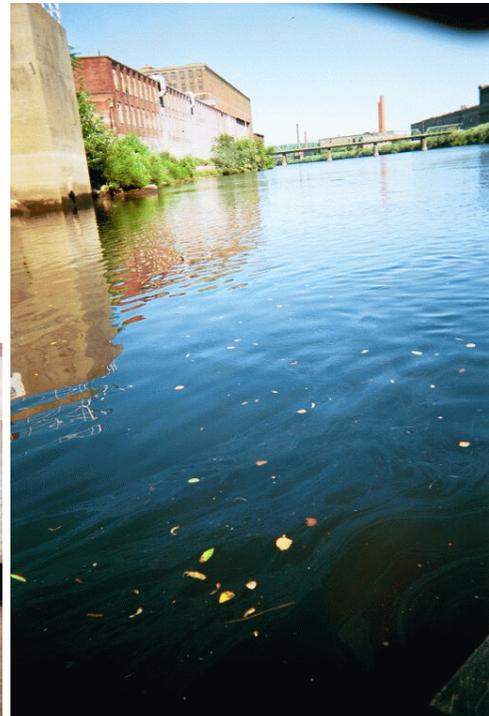
Picture C

There was a sheen extending from the upstream culvert containing the booms, into the Merrimack River (Picture C). There was a strong oil odor emanating from this culvert. Once the sheen reached the current of the river, it quickly dissipated.

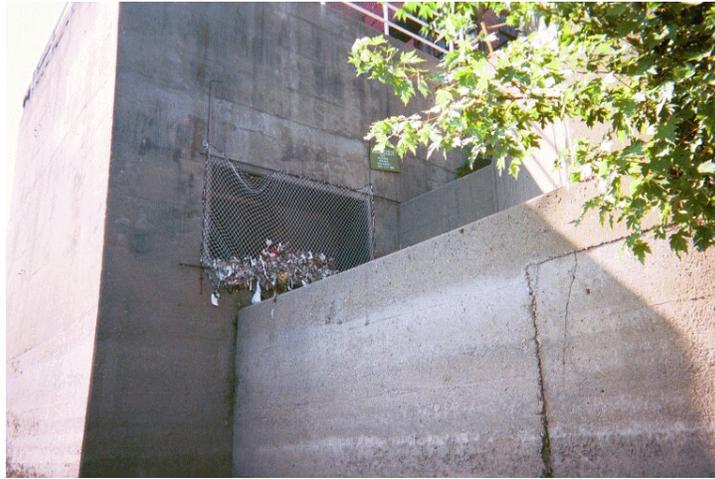
Pipe # 34: Approximately 10' wide rectangular concrete culvert covered with netting. Paper and plastic debris caught throughout netting. Sign states "Greater Lawrence Sanitary District Wet Weather Sewage Discharge Outfall 005." No flow.

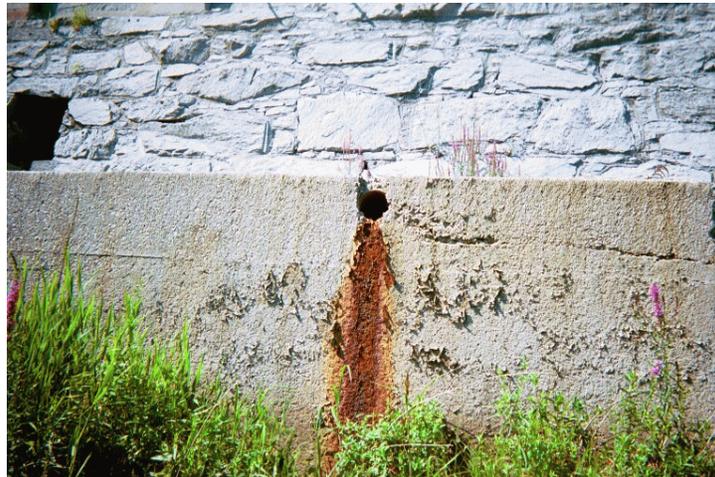
Pipe # 35: Approximately 4" diameter iron pipe. Located behind a brick building with a rock foundation at 300 Canal Street (Pacific Mills Industrial Complex). *Trickle flow*. The wall beneath the pipe was stained orange.

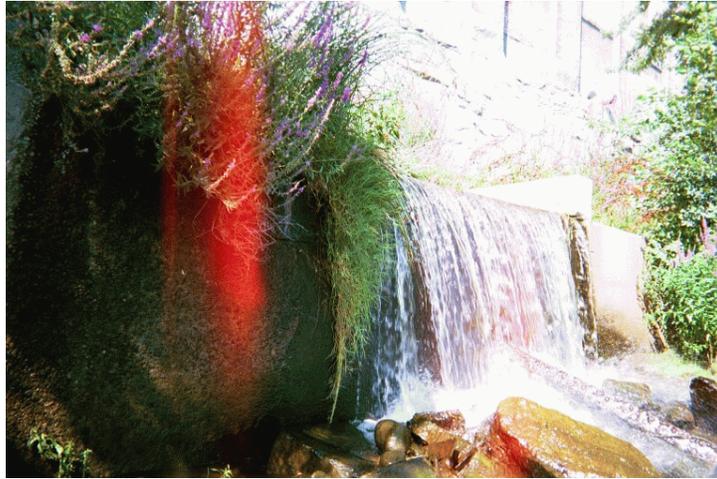
Pipe # 36: Approximately 10' wide concrete sluiceway. Located in same building foundation as Pipe # 35. *Flowing approximately 200 gpm. Discharge was clear with no odor.*

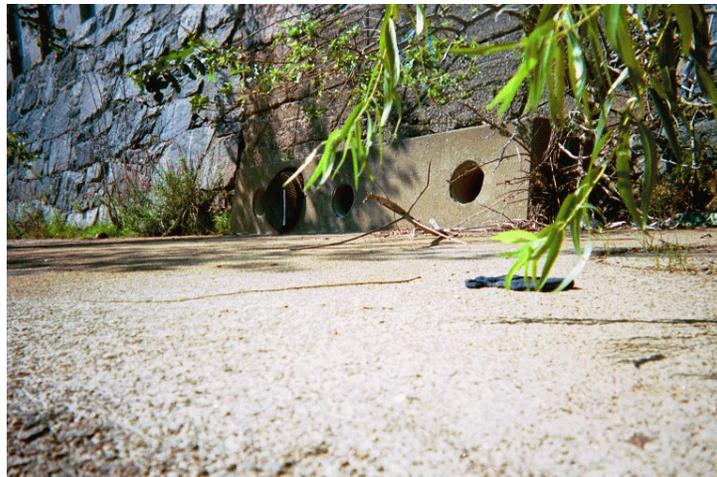
Pipe # 37: Approximately 12" diameter concrete pipe. Located in the same building foundation as Pipe # 35. No flow.
