**2004 Restoration Monitoring Report
1.5 Mile Reach Removal Action**

DCN: GE-033105-ACQO

March 2005

**Environmental Remediation Contract
General Electric (GE)/Housatonic River Project
Pittsfield, Massachusetts**

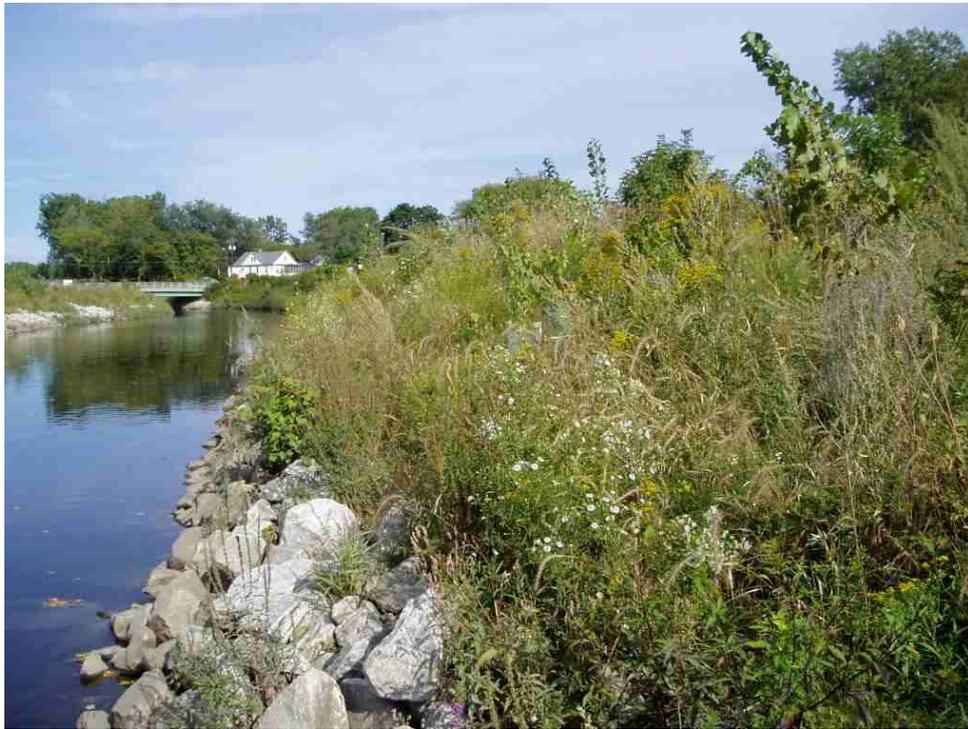
Photo 1. Typical riverbank herbaceous cover in Phase 1 is approximately 95% (looking downstream, east riverbank-STA 508+00) 9/15/04 Woodlot Alternatives, Inc.

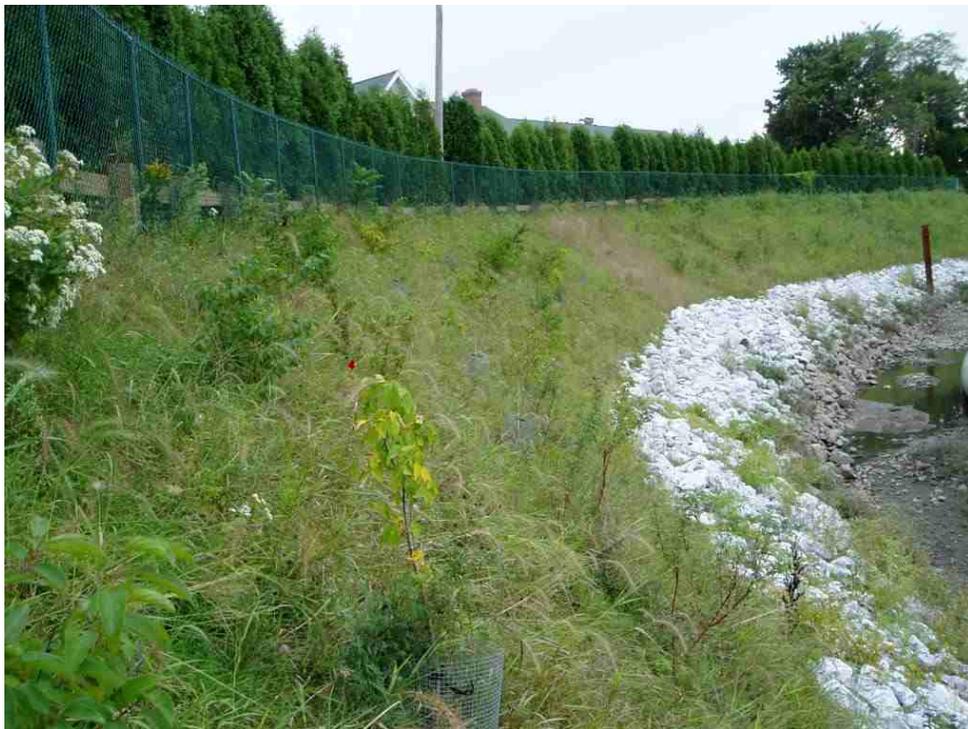
Photo 2. Typical riverbank herbaceous cover in Transition Phase with Geocell is approximately 90%. Vigor of planted stock is fair. (east riverbank, looking downstream- STA 515+00). 9/15/04 Woodlot Alternatives, Inc.

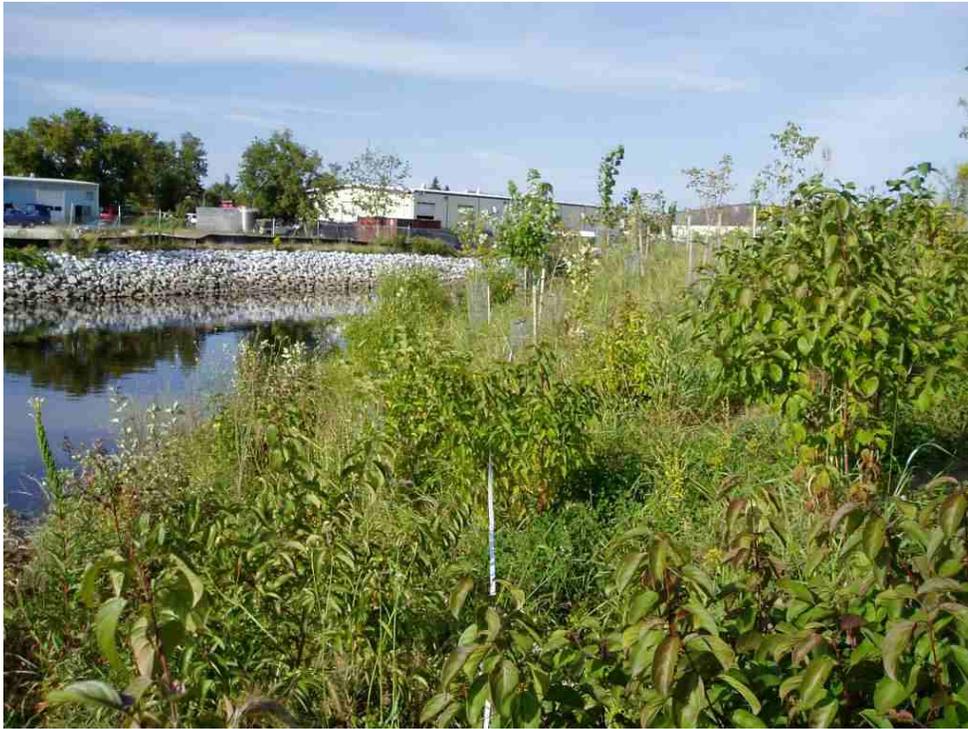
Photo 3. Shrub clumps appear healthy and vigorous in Phase 1 (looking upstream, east riverbank- STA 511+50) 9/15/04 Woodlot Alternatives, Inc.

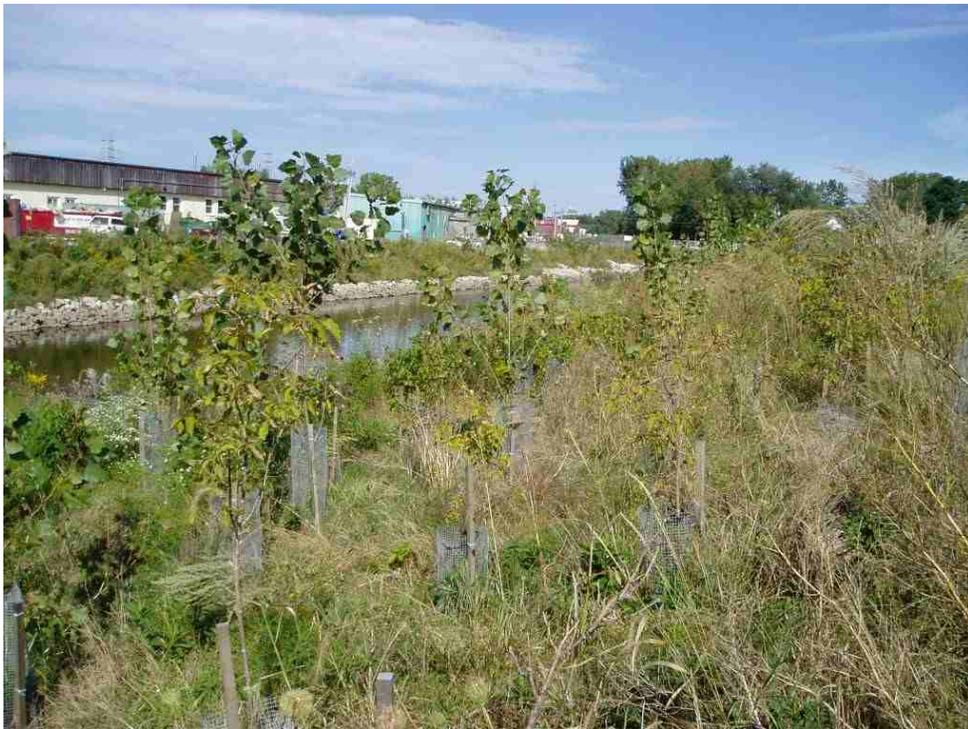
Photo 4. Planted trees had approximately 90-95% survivorship depending on species (looking upstream, east riverbank-STA 506+50) 9/15/04 Woodlot Alternatives, Inc.

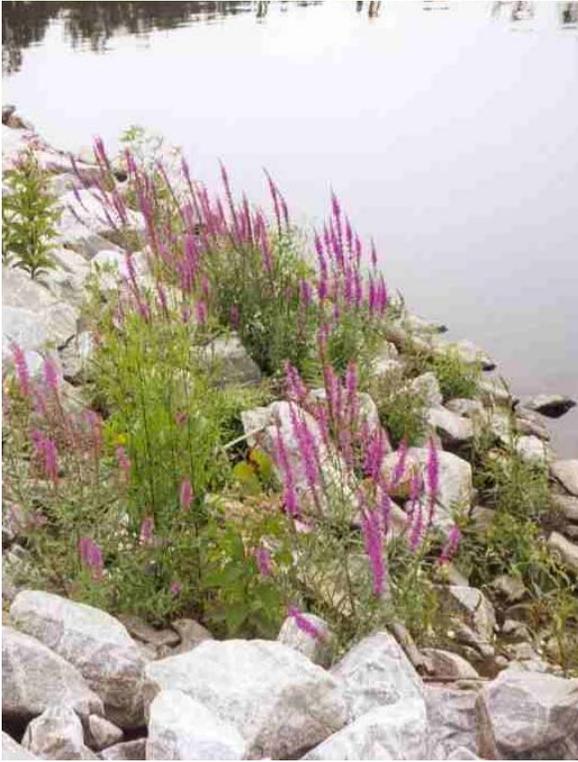
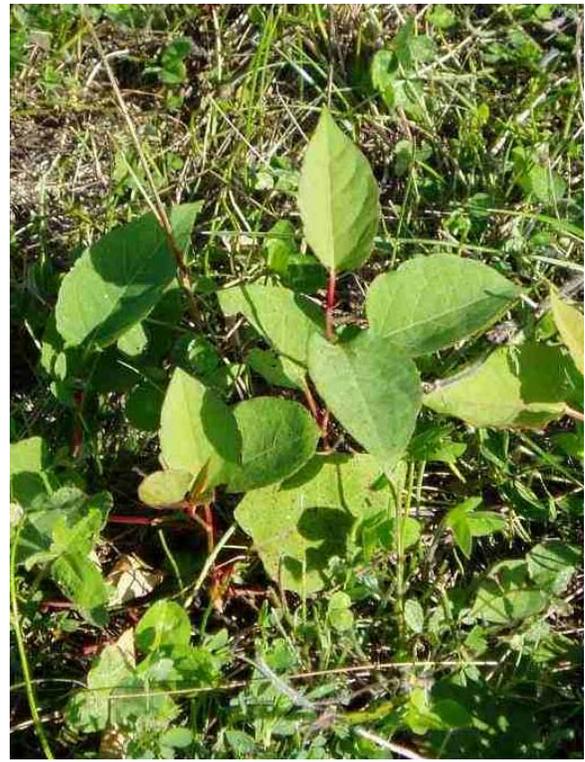
Purple loosestrife, which was a relatively minor invasive plant component in 2003, was observed in higher densities in 2004, particularly in the Phase 1 area within the riverbank rock armor. Here, estimated areal coverage was 5-10 percent in late August 2004. Recent colonization by this species is likely the result of seeds being transported by the river from upstream sources and deposited onto the fine sediments within the armor.

Photo 5a - 5b. Purple loosestrife (*Lythrum salicaria*) within the rock armor and Japanese knotweed (*Polygonum cuspidatum*) within some planting areas are the dominant invasive plant species in Phase 1. 9/15/04 Woodlot Alternatives, Inc.

Invasive plant control work began in the Phase 1 area during June 2003 and has continued through 2004 to facilitate meeting the invasive plant cover restoration performance standard. Invasive plant control work in Phase 1 and Transition Phase areas was performed four times during 2004, and has included both physical removal (e.g., hand pulling and cutting) and chemical removal (e.g., herbicide applications). Observed results suggest that the herbicide applications have been effective, as treated invasive plants have died back with no drift impacts on surrounding non-target vegetation. The estimated kill rate for all treated invasive plants was approximately 90 percent with the density and areal cover of invasive plants reduced following the initiation of the invasive plant control work. Appendix F includes two invasive plant control update memos that provide additional details of the invasive plant control work performed.

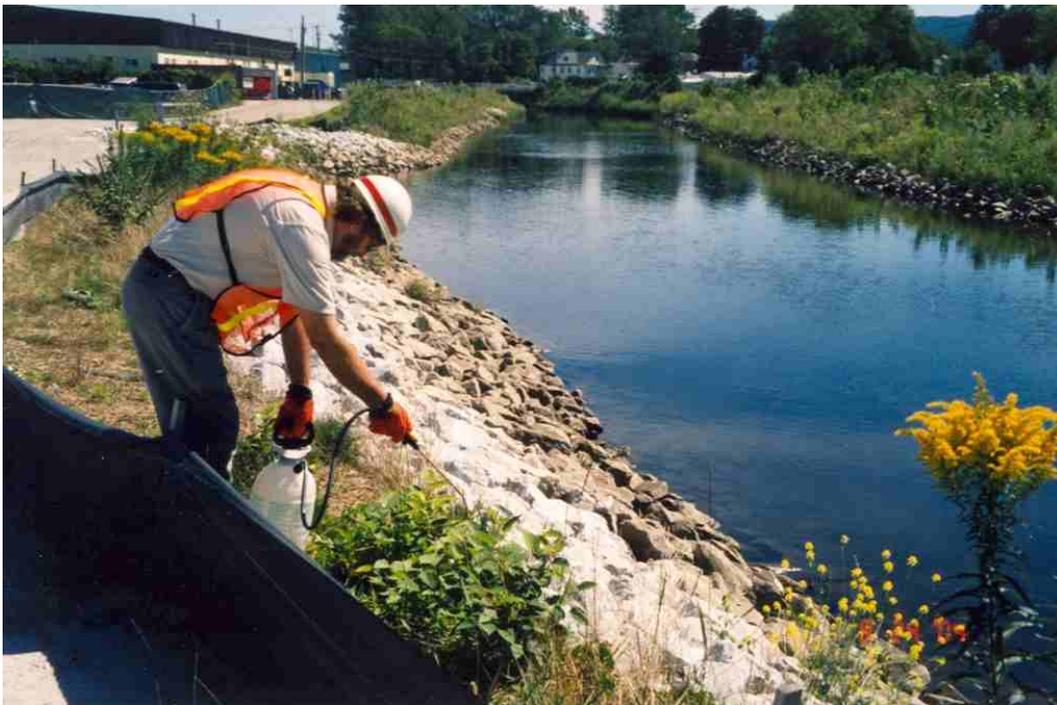
Photo 6. Invasive plant control treatments with herbicide applications have kept invasive plants from spreading and reduced areal cover to less than 5%. 8/24/04 Woodlot Alternatives, Inc.

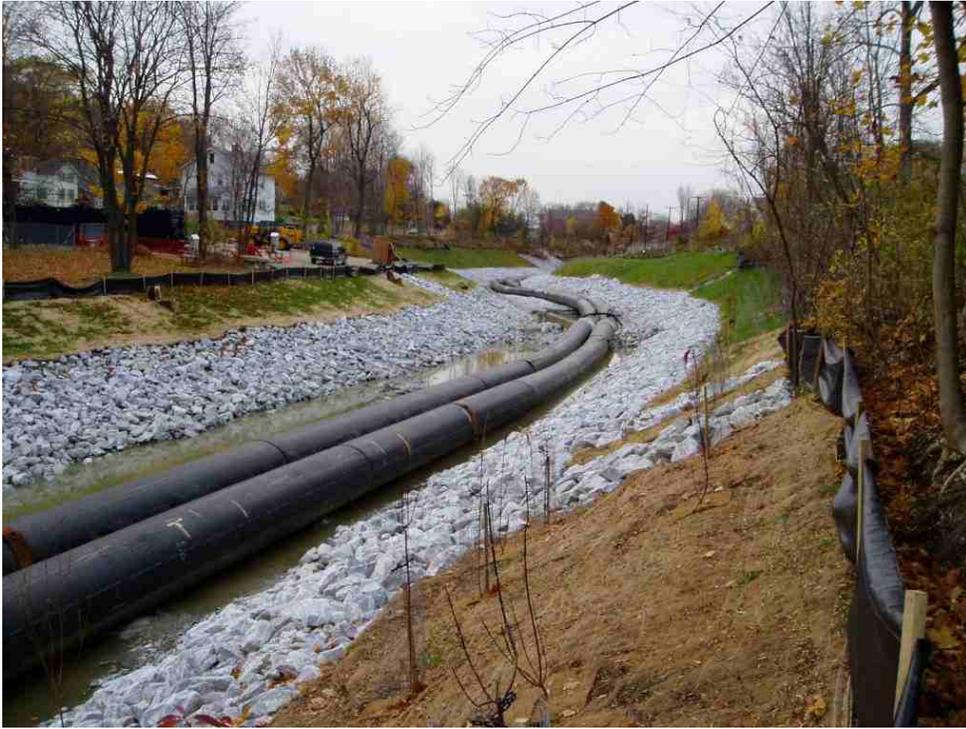
Photo 7. Planted red osier dogwood (*Cornus sericea*) in Phase 2 Area.
September 15, 2004. Woodlot Alternatives, Inc.

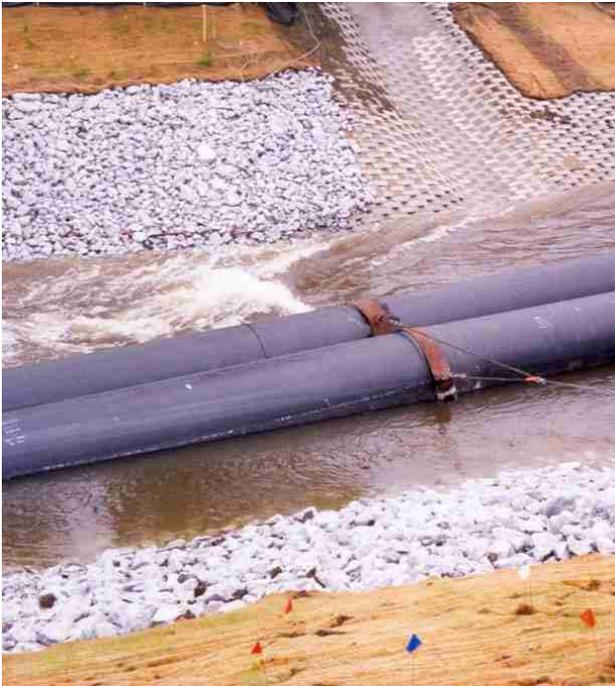
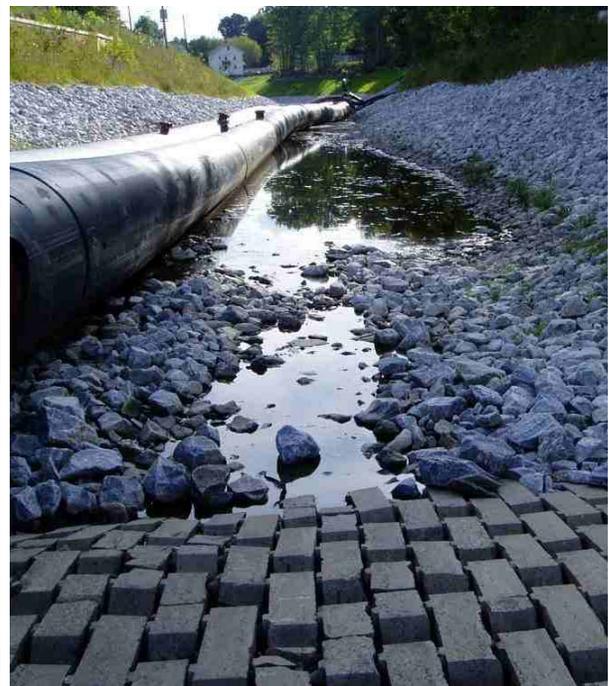
Some downstream displacement of the streambed riprap was observed in the riverbed at approximately STA 524+25. The riverbed grade and substrate transitions at this location from a relatively steep riverbed grade comprised of articulated concrete blocks (ACB) to a relatively flatter grade with riprap rock armor (see photographs in Appendix C). At this transition point, the movement of the riprap has exposed a portion of the downstream end of the ACB and the bedrock immediately downstream. The displacement of the riverbed riprap at this location is not unexpected, as a hydraulic jump has been observed at this location on a number of occasions during intermediate flow events (during high flow events the hydraulic jump appears to be “drowned”). While the ACB is anchored to the underlying bedrock and the presence of the bedrock immediately downstream of the ACB should preclude the mobilization of any adjacent underlying soils, this location should continue to be evaluated as part of the ongoing monitoring work.

Photo 8a - 8b. Hydraulic jump at downstream termination of ACM and associated riverbed scour.
July 7, 2004 / September 11 2004. Woodlot Alternatives, Inc.

Riverbed and Riverbank Riprap. The restoration performance standard for riverbank and riverbed riprap was achieved. Some movement of riprap was observed at a location on the riverbed in Phase 2 (STA 524+25). The riprap in this area should be monitored on an ongoing basis and after periods of high flow.

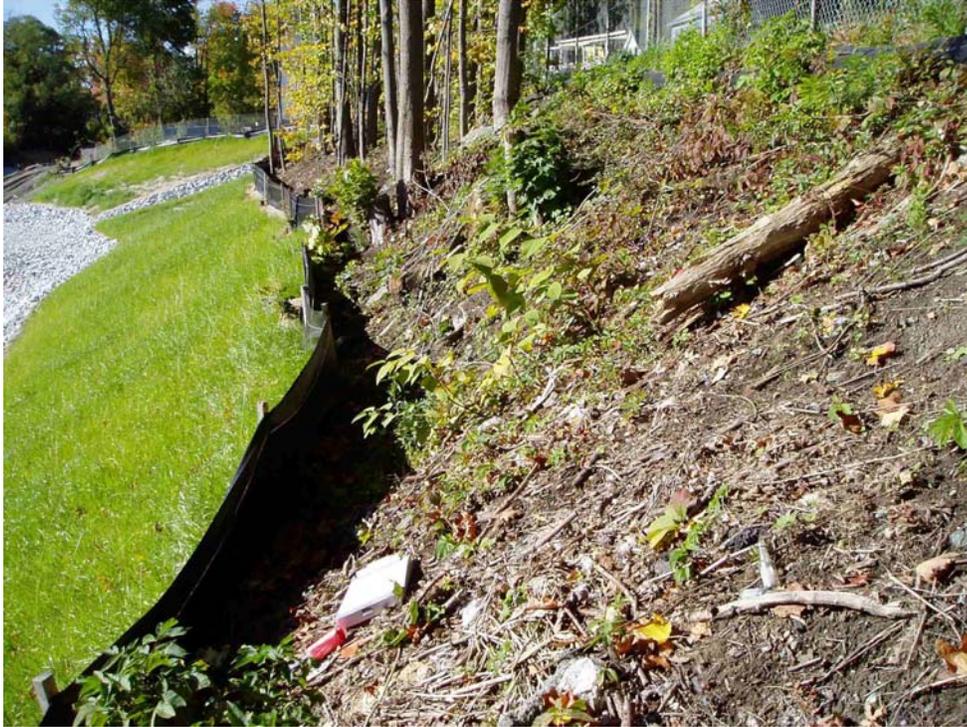
Photo 9. Existing slope above restored area, Phase 2 Area.
September 15, 2004. Woodlot Alternatives, Inc.
