Re: GE/Housatonic River Site
1.5 Mile Reach Removal Action
Monitoring of Aquatic Structures, Riprap, and Riverbank Soil
DCN: GE-110107-ADRK

Re: Monitoring of Aquatic Structures, Riprap, and Riverbank Soil, August 15, 2007 Site Visit,
1½-Mile Remedial Action of the General Electric-Pittsfield/Housatonic River Site in Pittsfield,
Massachusetts

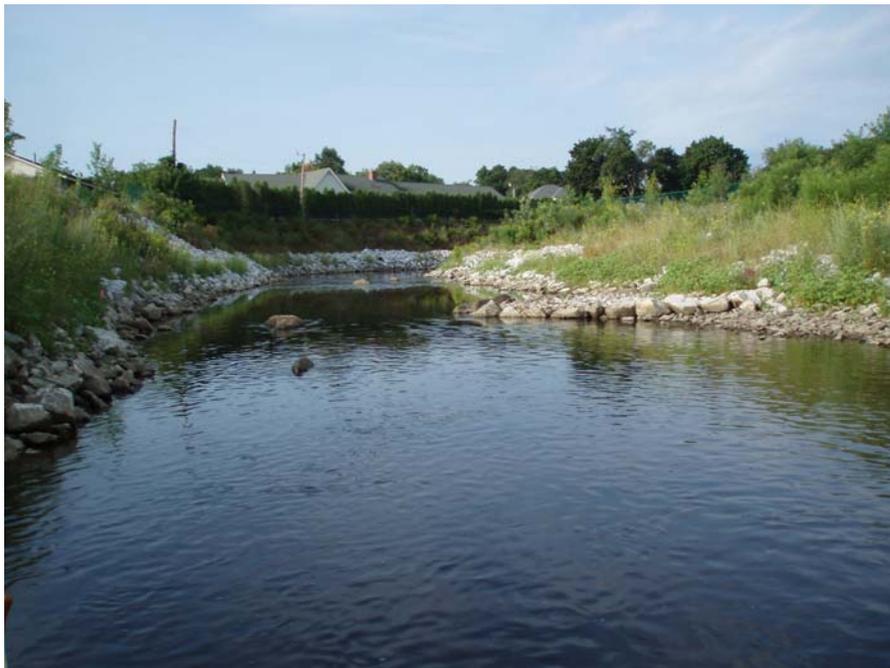
Aquatic Habitat Enhancement Structures – The aquatic habitat enhancement structures appear to be stable, as-built condition and performing as designed, as indicated by variations in current speed, turbulence, and sediment deposition adjacent to the structures (Photo 1). Scour of riverbed or riverbank riprap was not observed adjacent to any of the observed structures. Sediment deposition was observed adjacent to some of the aquatic habitat structures, further indicating that the presence of the structures is providing diversity of aquatic habitat.

Photo 1: Aquatic Habitat Structures, Monitoring Area 1

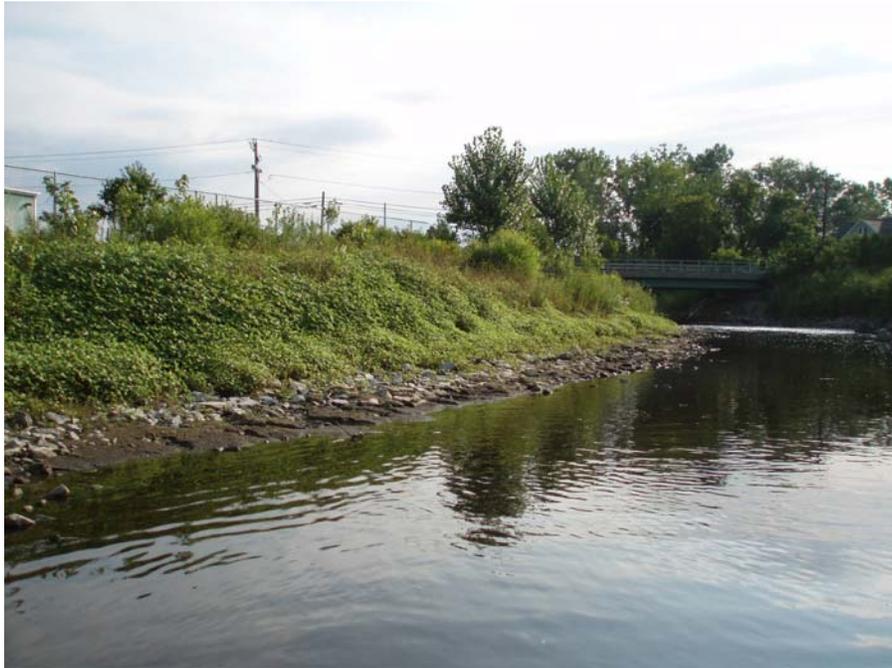
Riverbank Riprap – No deficiencies in the riverbank riprap were observed. The riverbank riprap was not observed in areas where sedimented material has accreted (Photo 2). Some exposure of the sheet pile retaining wall was observed along the left (facing downstream) streambank behind the carwash (Photo 3). The observed sheet pile exposure was less than six inches.

**Photo 2: Sediment Material, Monitoring Area 1
Right Bank Looking Upstream at Lyman Street Bridge**

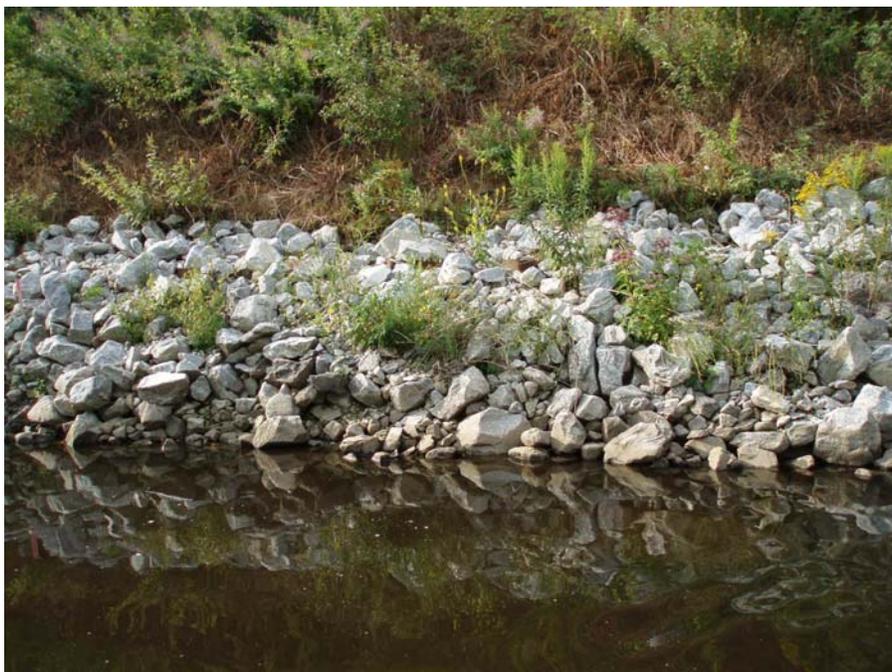
Photo 3: Area of Sheet Pile Exposure, Monitoring Area 1, Left Streambank

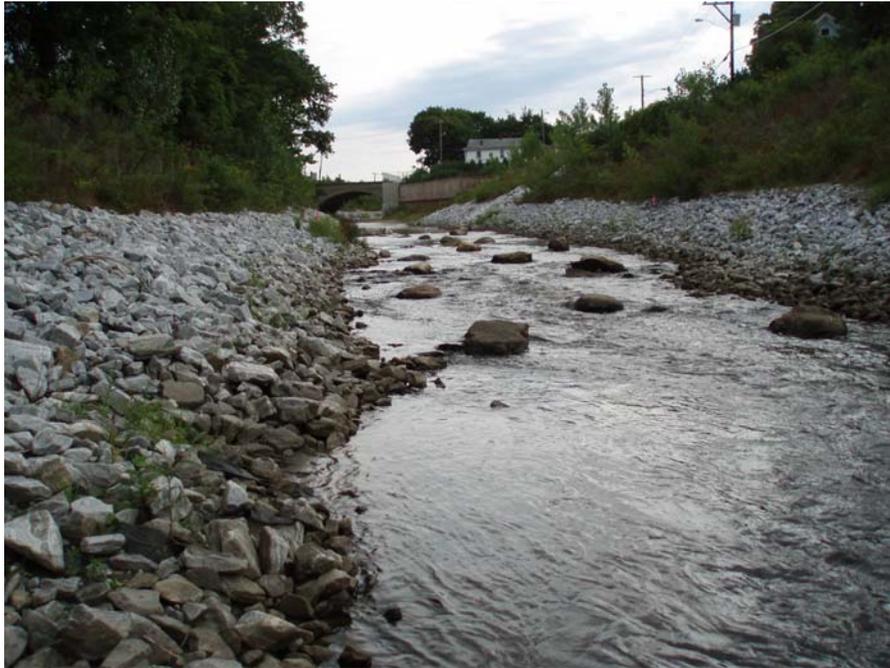
Aquatic Habitat Enhancement Structures – The aquatic habitat enhancement structures appear to be stable, as-built condition and performing as designed, as indicated by variations in current speed, turbulence, and sediment deposition adjacent to the structures (Photos 4 and 5). Scour of riverbed or riverbank riprap was not observed adjacent to any of the observed structures. Sediment deposition was observed adjacent to some of the aquatic habitat structures, further indicating that the presence of the structures is providing diversity of aquatic habitat.

**Photo 4: Aquatic Habitat Structures, Monitoring Area 2
Looking Upstream at Elm Street Bridge**

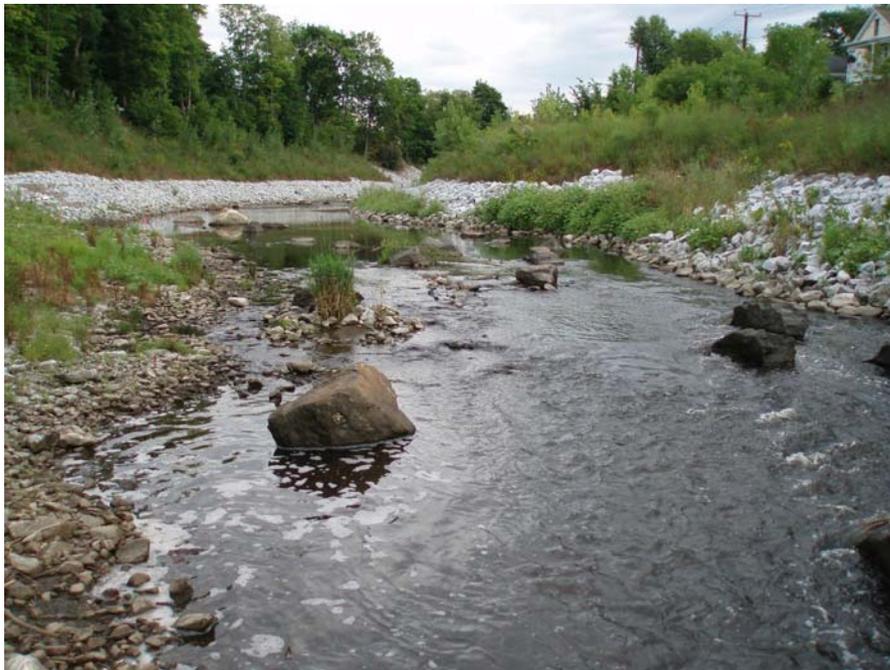
Photo 5: Riffle/Run Development, Monitoring Area 2

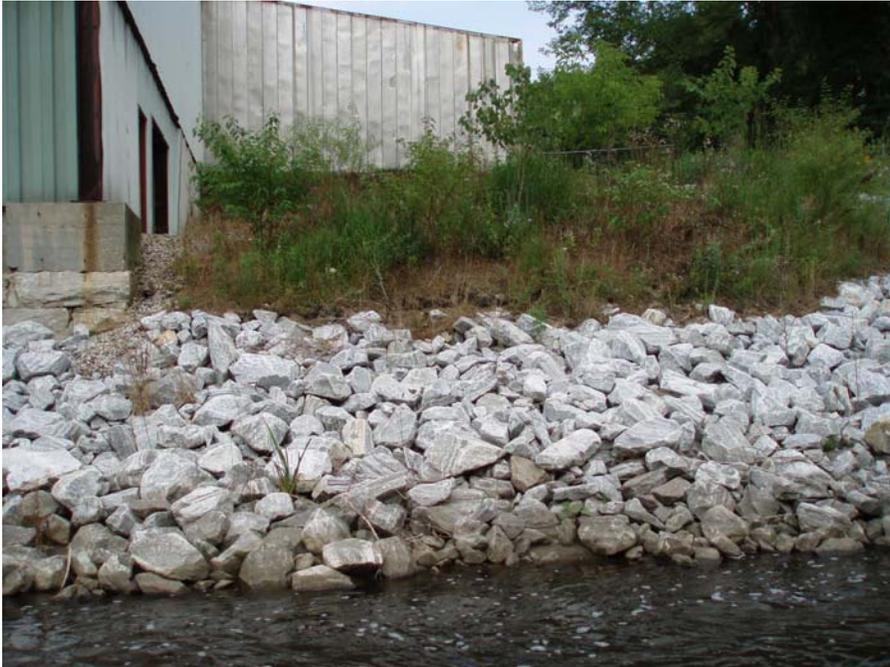
Riverbank Riprap – No substantial deficiencies in the riverbank riprap were observed. A small area of exposed geotextile fabric was observed at the base of a riprap swale adjacent to the former access road along the right streambank in the approximate middle of this monitoring area. Some exposure of Geoweb material was observed along the right streambank between the former dam foundation and the adjacent building (Photo 6).

**Photo 6: Area of GeoWeb Exposure, Monitoring Area 2
Right Streambank**

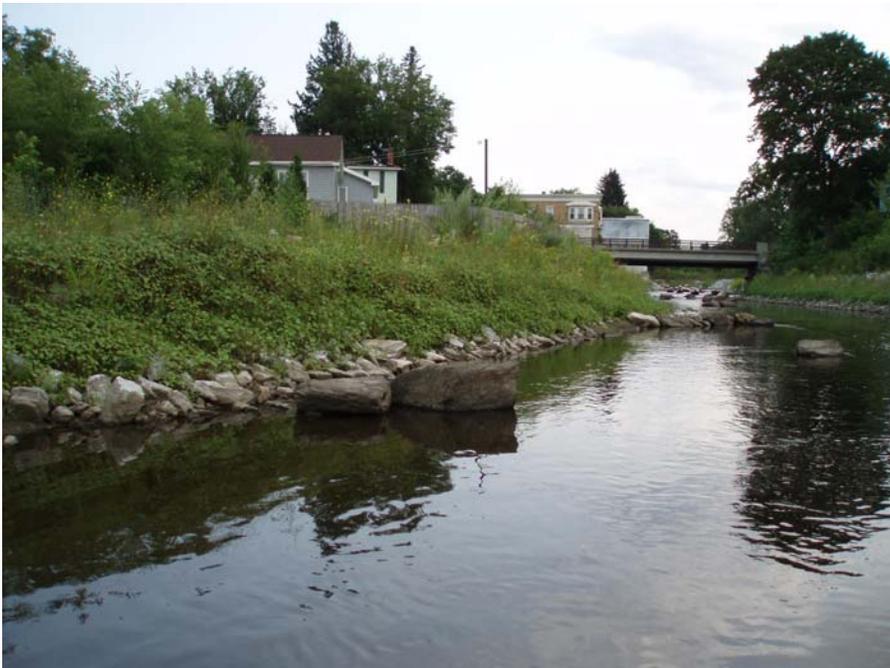
Riverbank Riprap – No deficiencies in the riverbank riprap were observed. The riverbank riprap was not observed in areas where sedimented material has accreted (Photos 7 and 8).

**Photo 7: Sediment Material, Monitoring Area 3
Right Bank Looking Upstream at Dawes Avenue Bridge**

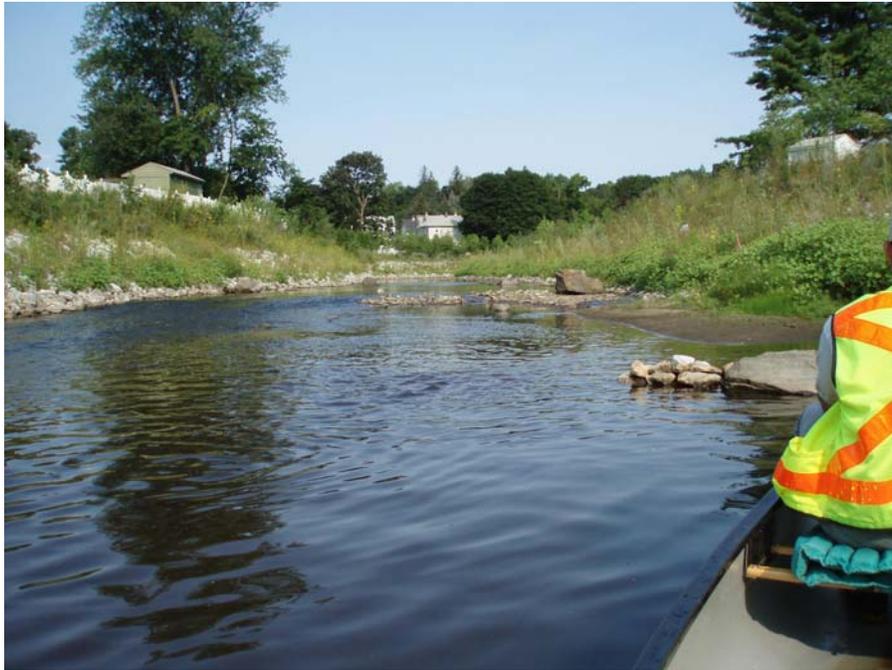
Photo 8: Aquatic Habitat Structures and Vegetated Streambanks, Monitoring Area 3

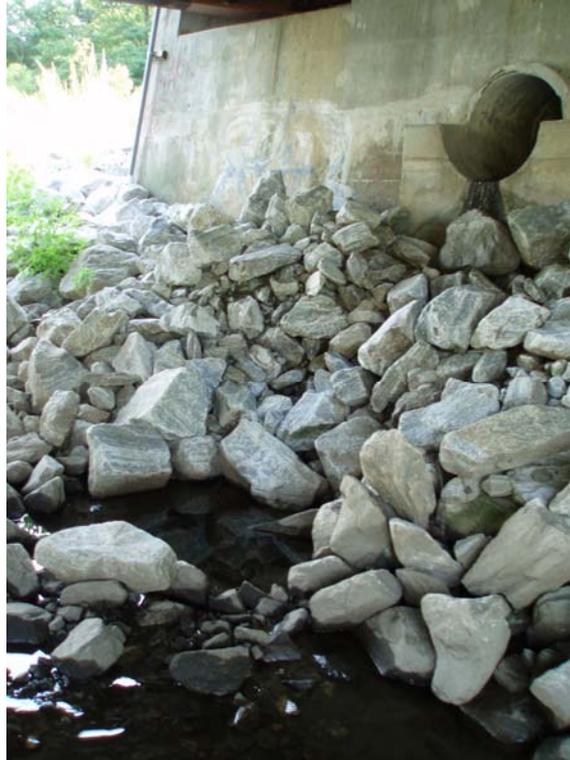
Riverbed Riprap – No indications of displacement or failure of the riverbed riprap were observed between the bridges delimiting this monitoring area. Some erosion of riprap was observed under the left abutment of the Pomeroy Avenue Bridge immediately adjacent to a culvert that discharges through the bridge abutment wall (Photo 9).

**Photo 9: Scour Adjacent to Culvert Discharge
Left Abutment of Pomeroy Avenue Bridge**

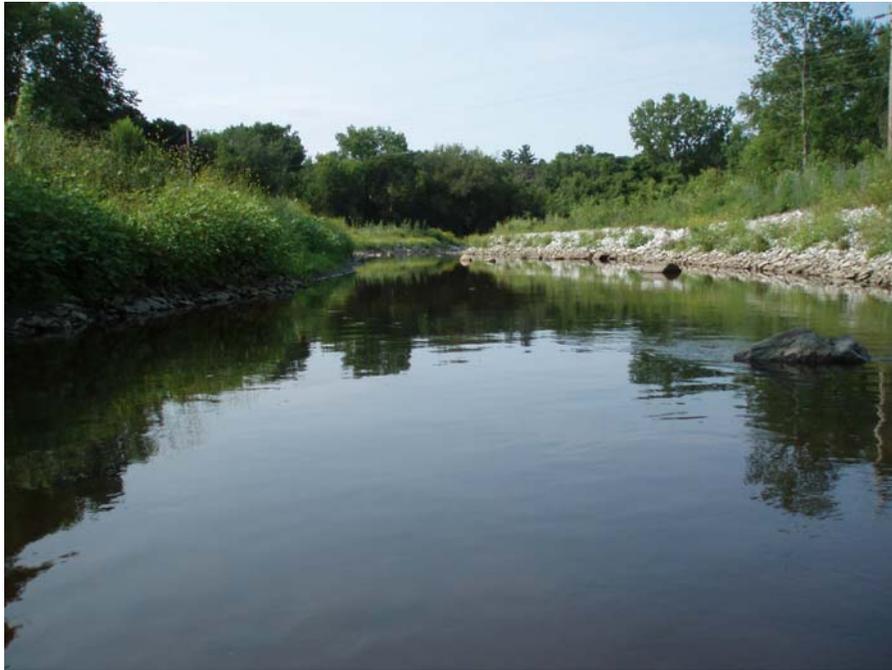
Riverbank Riprap – No deficiencies in the riverbank riprap were observed. The riverbank riprap was not observed where sedimented material has accreted (Photo 10).

Photo 10: Riverbanks and Aquatic Habitat Structures, Monitoring Area 4
