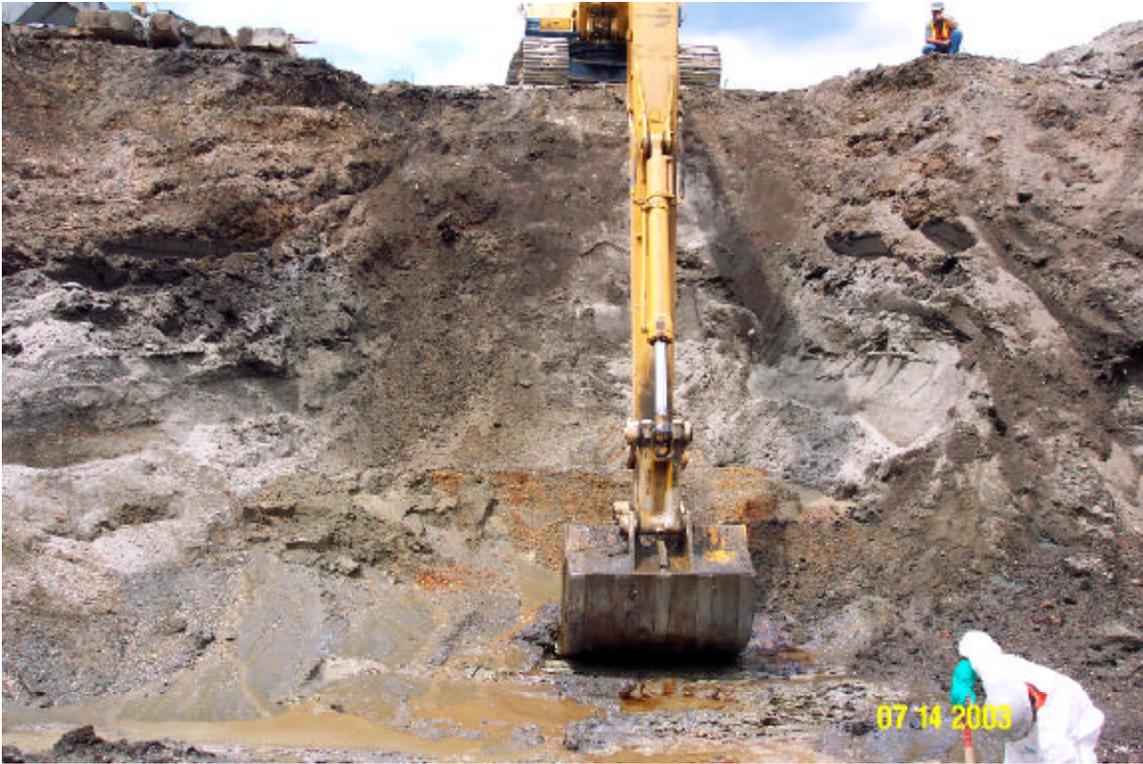
**Photograph 1 – Cell 12A, Excavation of NAPL impacted materials that extended into the riverbank**

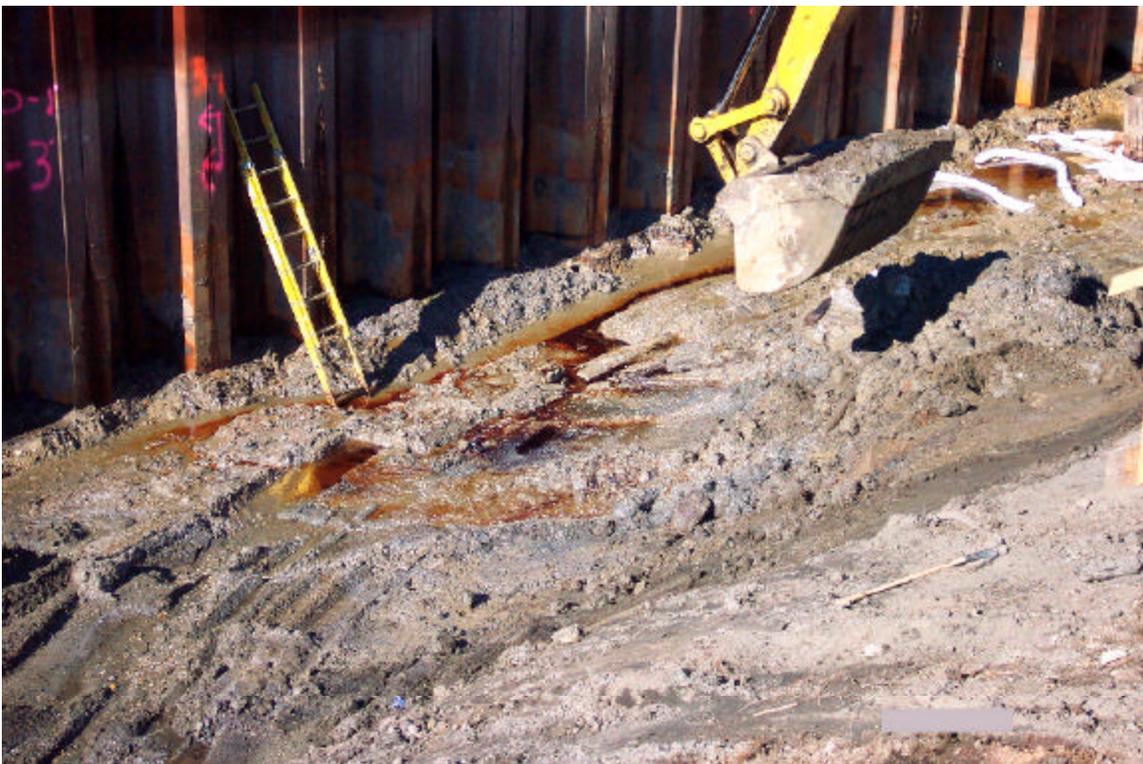
**Photograph 2 – Cell 12A NAPL Excavation**

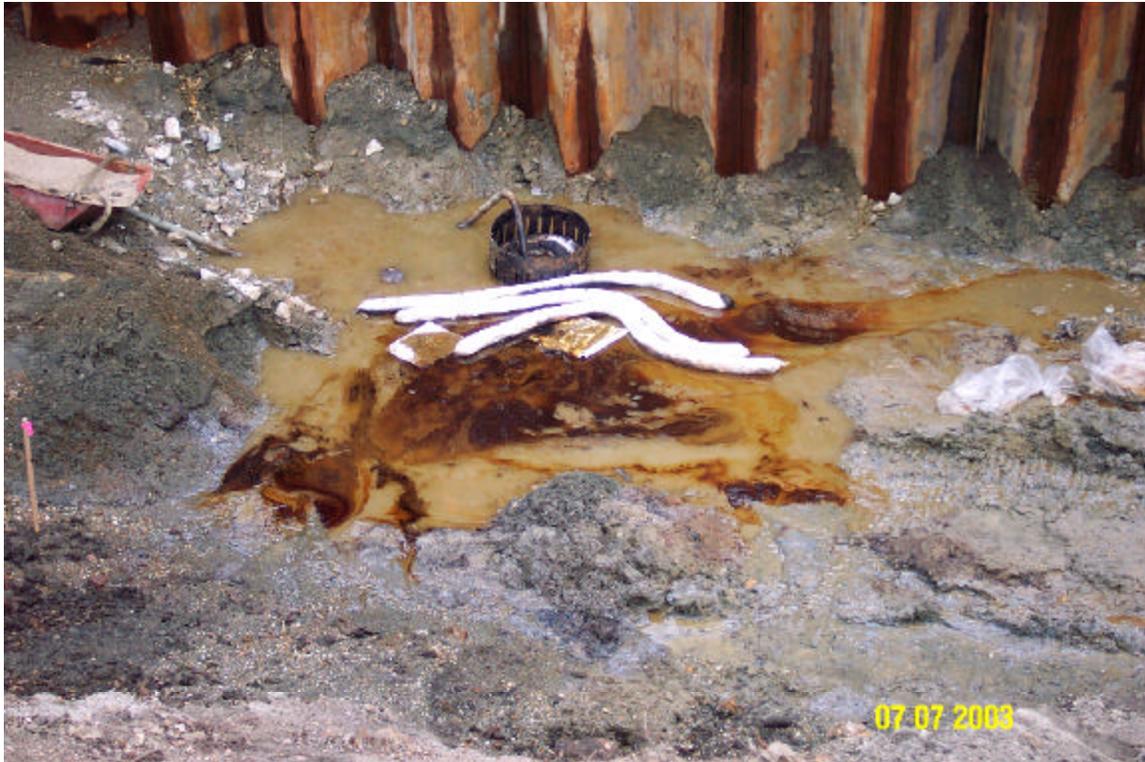
**Photograph 3 – Cell 12A NAPL**

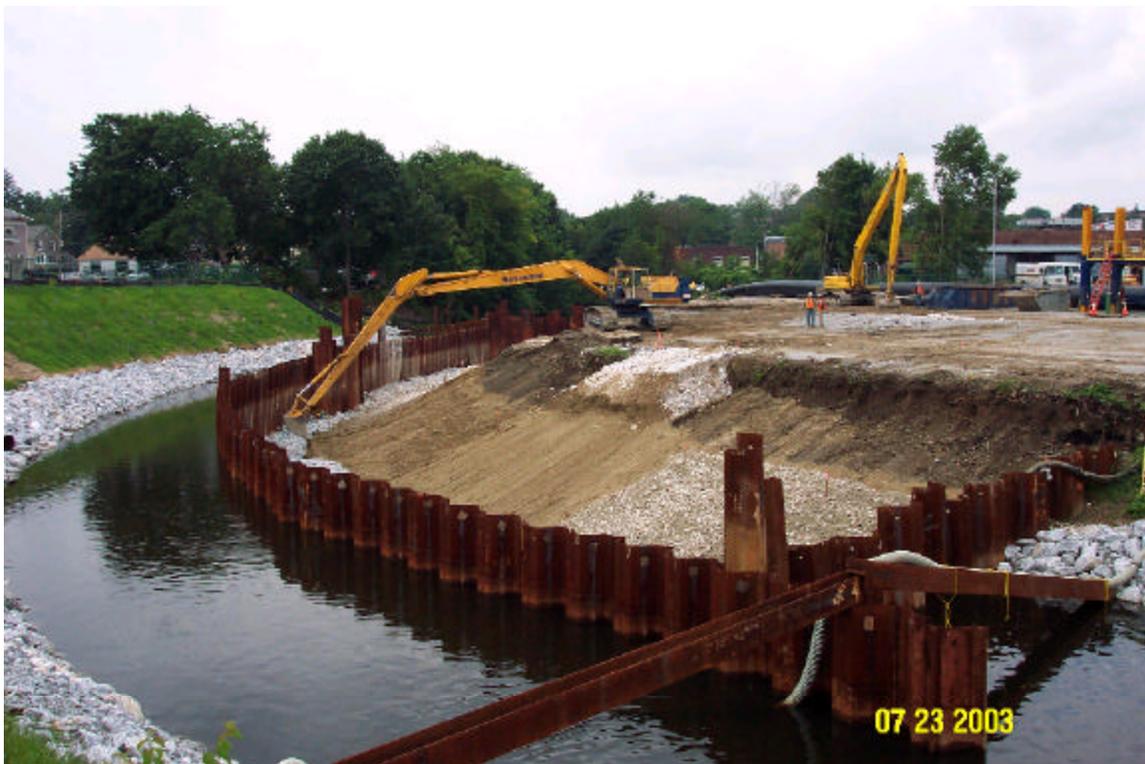
**Photograph 4 – Cell 12A Backfilling Activities**

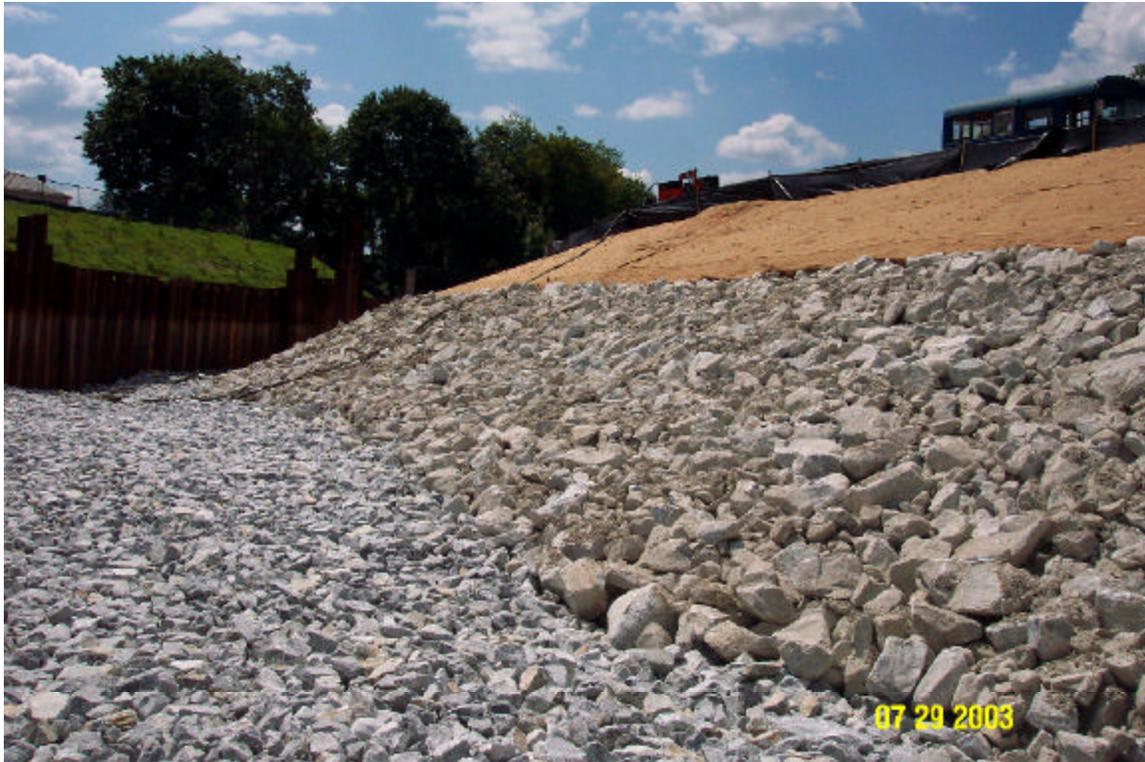
**Photograph 5 – Cell 12A Restored**

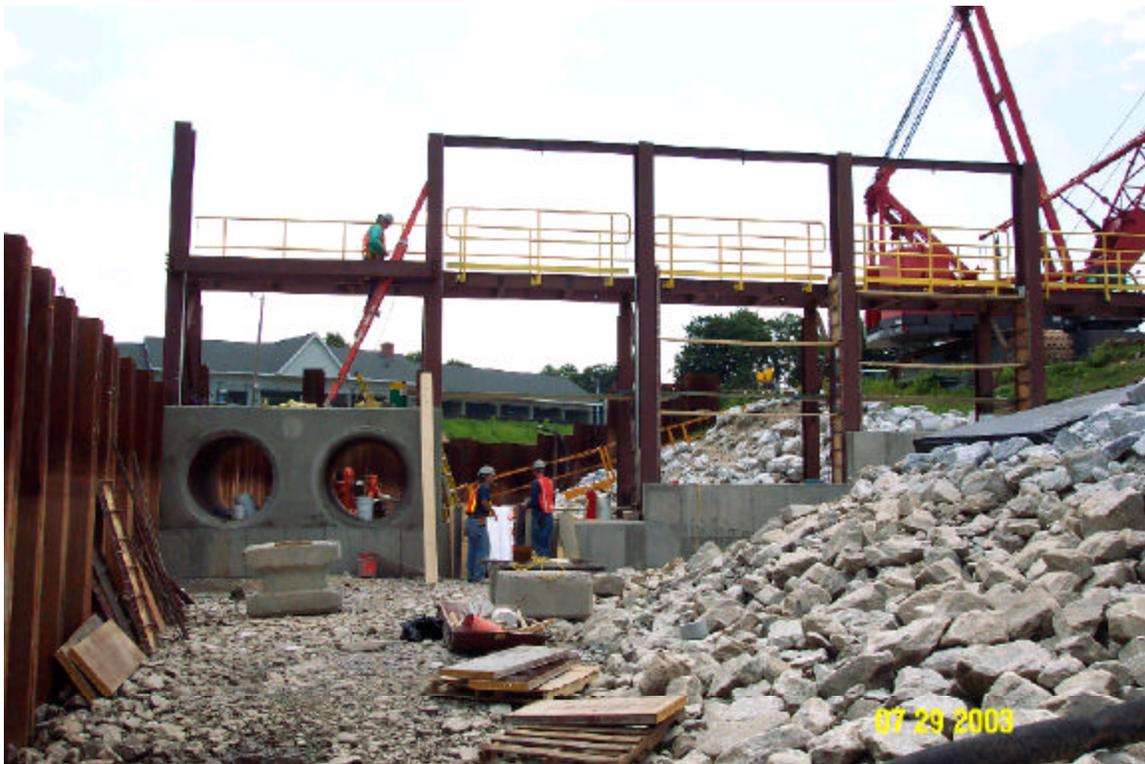
**Photograph 6 – Temporary Dam Construction**

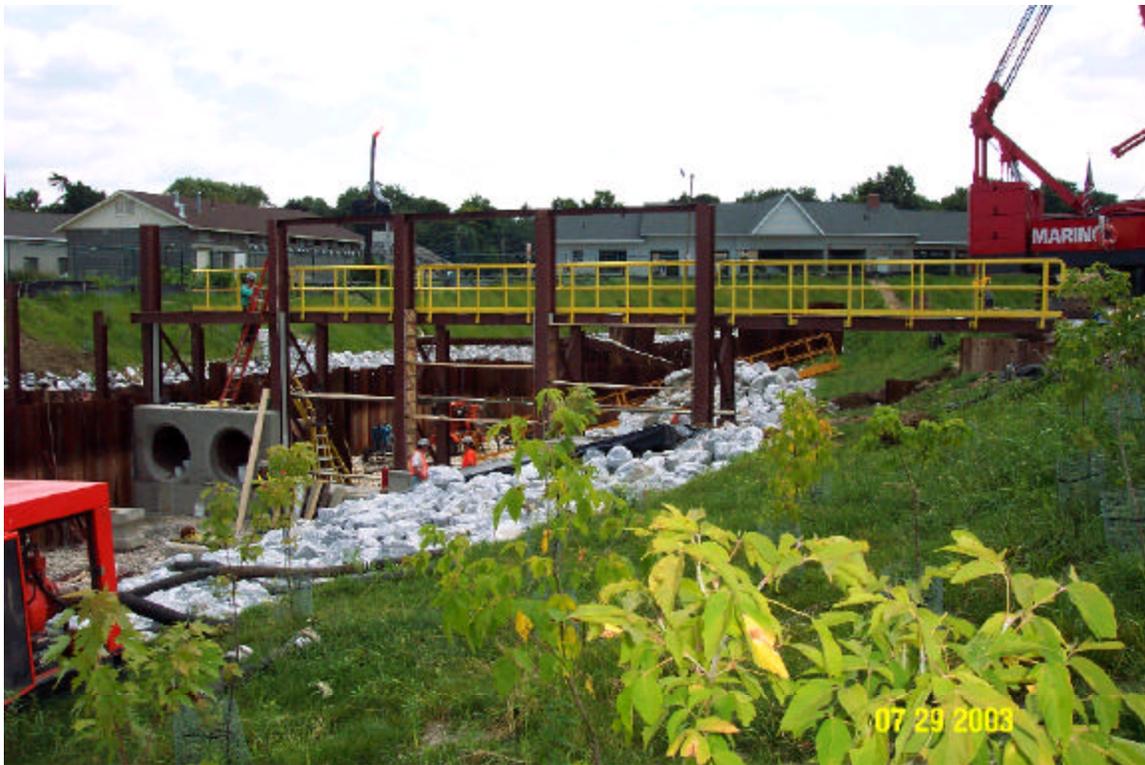
**Photograph 7 – Temporary Dam Construction**

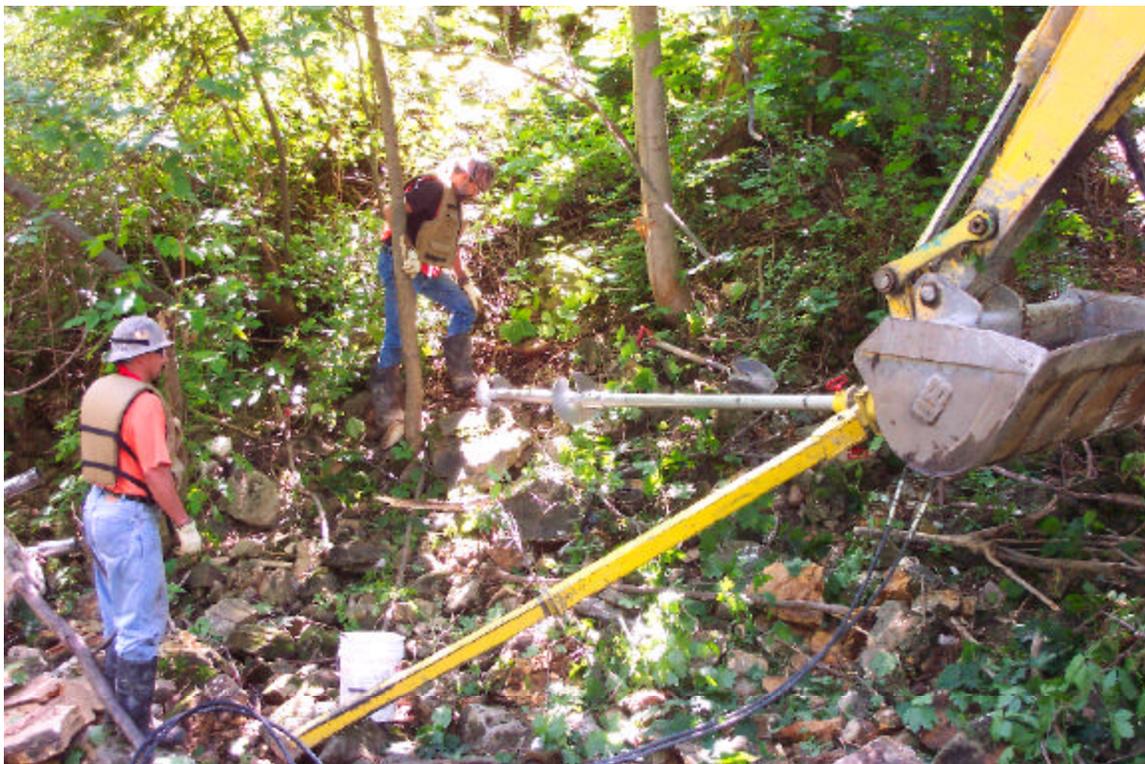
**Photograph 8 – Installation of the Helical Anchors for the 54-inch Pipe**
