June 20, 2008

**Re: Floodplain GE-Pittsfield/Housatonic River Site  
Floodplain Residential and Non-Residential Properties Adjacent to 1½ Mile Reach of  
Housatonic River (GECD710 and GECD720)  
Summary of May 2008 Inspection Activities for the Remediated Phase 2 Floodplain  
Properties**

**GENERAL ELECTRIC COMPANY  
 PITTSFIELD, MASSACHUSETTS  
 MAY 2008 INSPECTION**

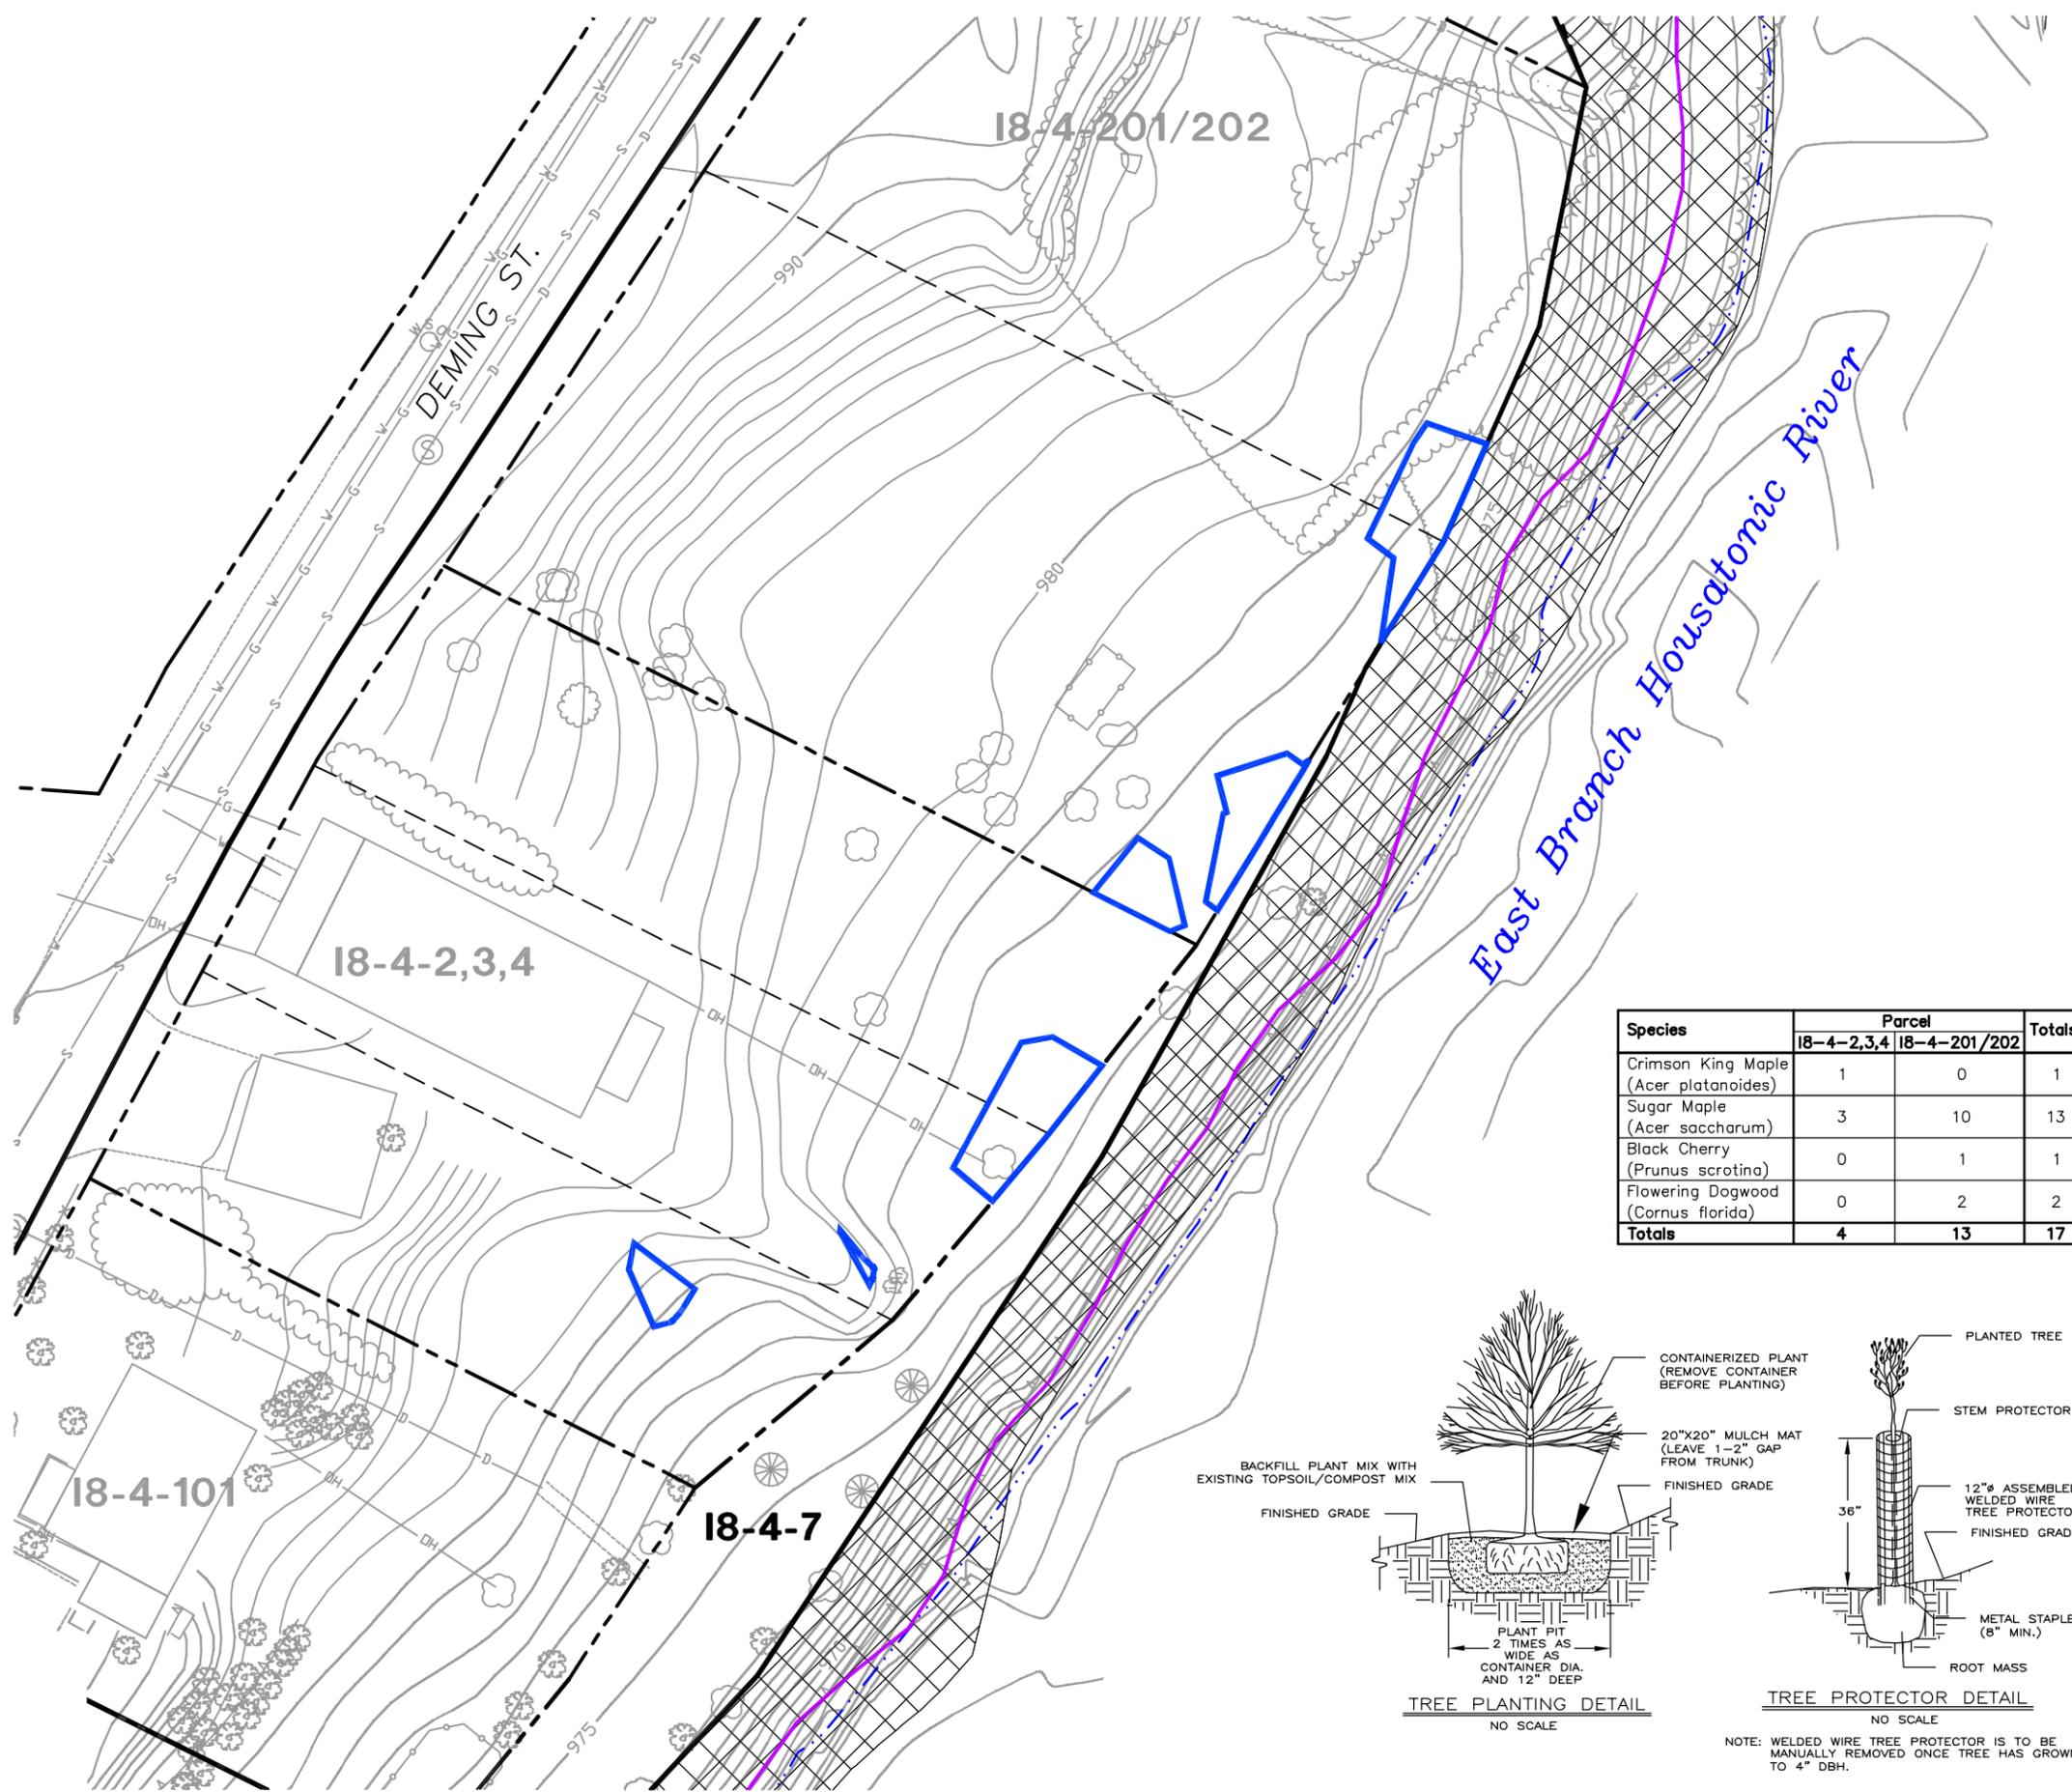
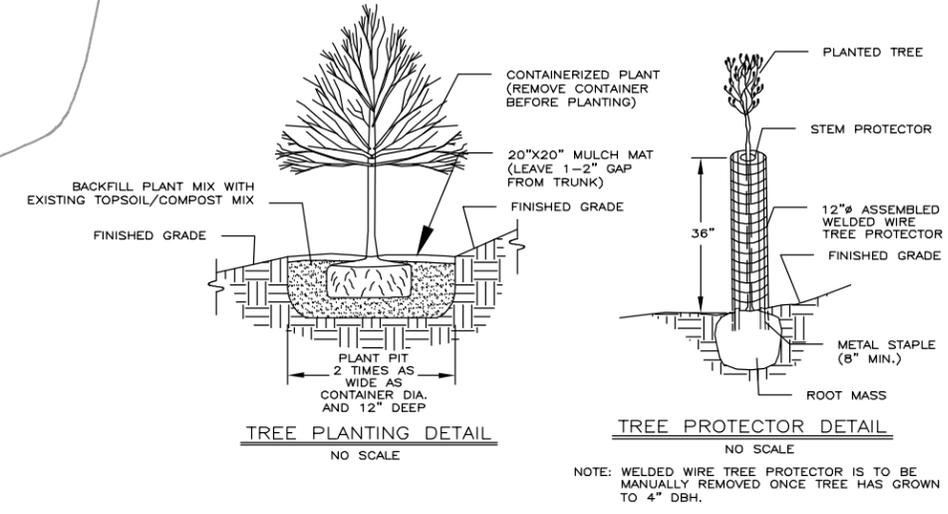
FIGURE  
**2**

In addition, the May 2008 inspection included observations of the trees and shrubs planted as part of restoration activities at Parcels I8-4-201/202 and Parcels I8-4-2, -3, -4 to ensure that they are in good general health. Figure 2 contains the restoration planting plan for Parcels I8-4-201/202 and Parcels I8-4-2, -3, -4. Observations at these properties included a stem count of planted and newly established trees/shrubs (quantity per species per parcel) in good health and a stem count of trees/shrubs that were dead or dying or showing evidence of stress, if any, within each property. (Since no trees/shrubs were planted on Parcel I8-4-7, stem counts were not performed at that property.) The results of the observations were used to evaluate if all (100%) of the originally planted trees/shrubs (as specified on Figure 2) are surviving. Additionally, each tree/shrub observed was measured to determine the average height and range of heights of each species of tree/shrub within each property. In conjunction with the tree and shrub observations, GE evaluated the need for tree guards for the plantings on these properties, as no tree guards or cages had previously been installed.

As indicated on the forms in Attachment A, the May 2008 inspection indicated that the backfilled/restored areas at the inspected properties were in good overall condition. The inspection identified one stressed flowering dogwood on Parcels I8-4-201/202 and one dead sugar maple on Parcels I8-4-2, -3, -4, and it also identified the need to install tree guards on all of the planted trees on Parcels I8-4-201/202 and Parcels I8-4-2, -3, -4. The results of the tree/shrub counting, measuring, and observation activities are summarized in the following table:

1. The quantity of each species planted corresponds to the quantity identified on Figure H-1 from the draft 1½ Mile Residential Floodplain FCR and included as Figure 2 to this letter.
2. This column lists the number of dead trees/shrubs observed and then the number of trees/shrubs that were not dead but were stressed.
3. This column shows the percentage of trees/shrubs that were alive (including stressed plants) relative to the original planted quantity.

Based on the May 2008 inspection, GE will replace the dead sugar maple on Parcels I8-4-2, -3, -4, monitor the flowering dogwood on Parcels I8-4-201/202 showing evidence of stress, and install tree guards on all of the planted trees at both of these properties. The replacement of the dead sugar maple and the installation of tree guards will be conducted prior to the next inspection in August or September 2008. The replanted tree will be installed in accordance with the previously approved planting plan and will be equipped with a tag identifying the species, installation date, and general size at the time of installation. Going forward, when trees or shrubs are replanted, GE will revise the Restoration Planting Plan (Figure 2) to include the species, installation date, and size at the time of replanting of any replanted trees or shrubs; and the revised plan will serve as the basis for the next inspection.
