GE
159 Plastics Avenue
Pittsfield, MA 01201
USA

June 12, 2008

**Re: Floodplain GE-Pittsfield/Housatonic River Site
Floodplain Residential and Non-Residential Properties Adjacent to 1½ Mile Reach of
Housatonic River (GECD710 and GECD720)
Summary of May 2008 Inspection Activities for the Group 4C Floodplain Properties**

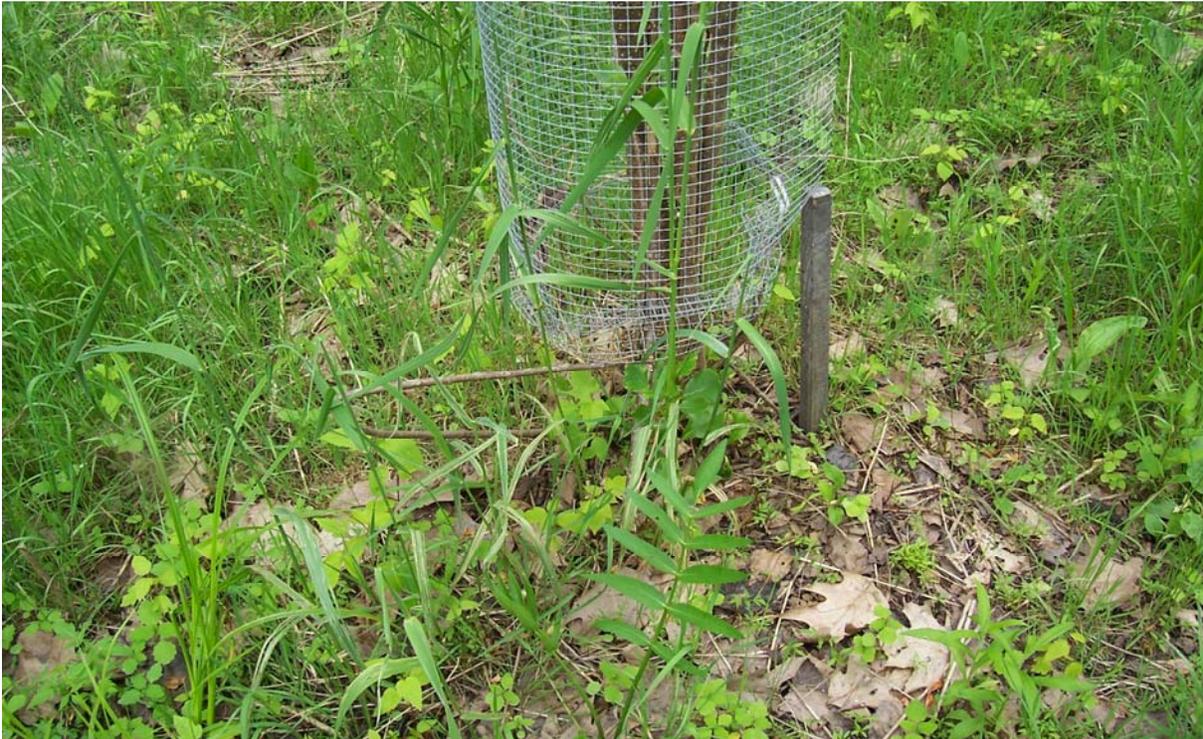
- Dogwoods in planting area adjacent to vernal pool require trimming (8 dogwoods).
 - Several tree guards in planting area adjacent to vernal pool have been damaged.

Photo #6: Vernal Pool - Example of Tree Guard Damage

- For trees/shrubs in planting area adjacent to vernal pool with exposed roots, cover roots with topsoil or reinstall.
- Trim dogwoods in planting area adjacent to vernal pool (8 dogwoods).
- Adjust and/or replace several tree guards in planting area adjacent to vernal pool.
- Repair and/or replace damaged tree guard in planting area west of vernal pool.

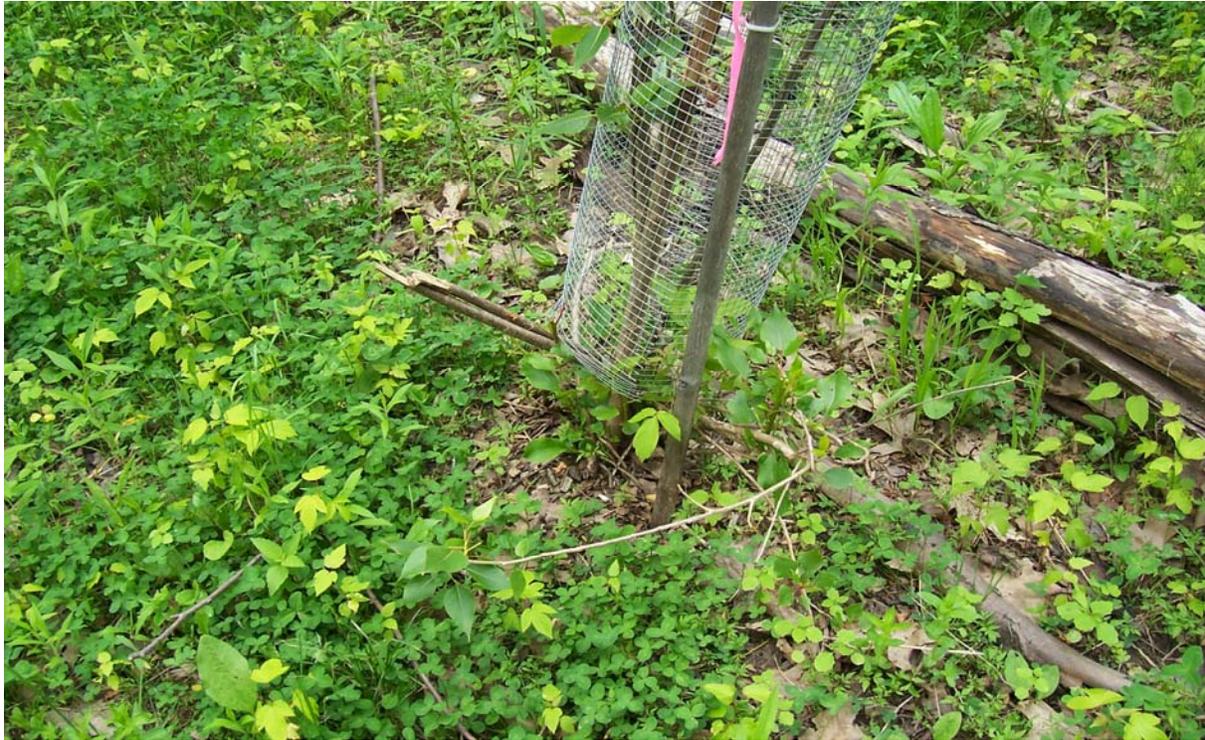
Photo #7: Vernal Pool - Example of Tree Guard Damage

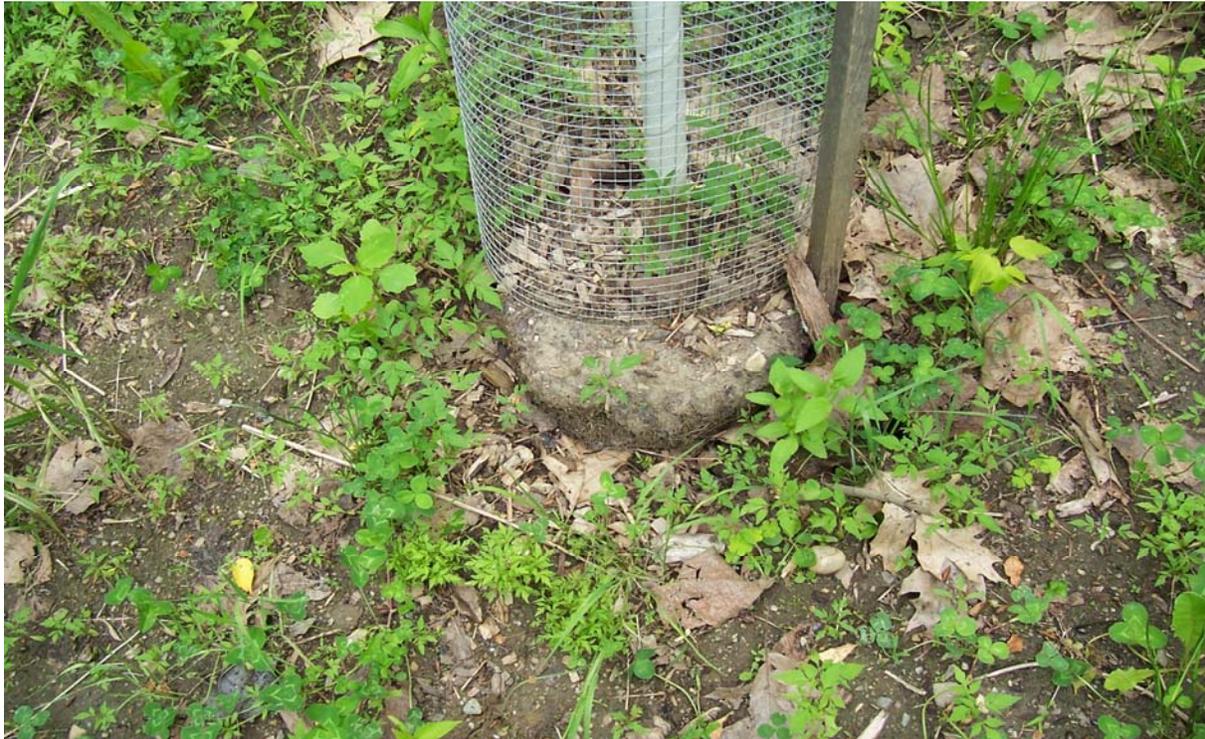
- Herbaceous vegetative cover is in good condition.
 - Tree/shrub stem counts are consistent with Restoration Planting Plan (Figure 2 attached herein).
 - Several trees/shrubs in planting area adjacent to vernal pool have exposed roots (see tables in Attachment B).

Photo #8: Vernal Pool - Exposed Root Mass
