GE
159 Plastics Avenue
Pittsfield, MA 01201
USA

July 9, 2008

**Re: Floodplain GE-Pittsfield/Housatonic River Site
Floodplain Residential and Non-Residential Properties Adjacent to 1½ Mile Reach of
Housatonic River (GEC710 and GEC720)
Revised Summary of May 2008 Inspection Activities for the Group 4C Floodplain Properties**

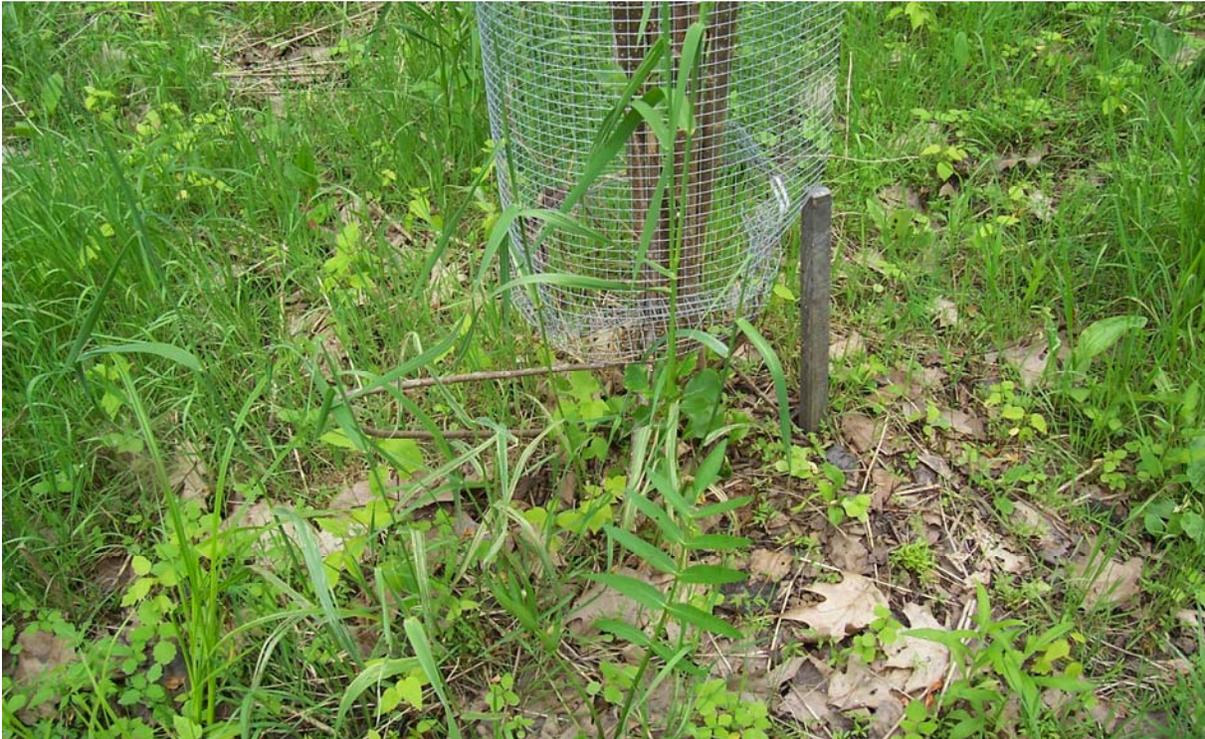
- Dogwoods within the vernal pool area require trimming (8 dogwoods).
 - Several tree guards within the vernal pool area have been damaged.
 - The top of one tree guard in planting area west of vernal pool has been damaged.

Photo #6: Vernal Pool - Example of Tree Guard Damage

- For trees/shrubs within the vernal pool area with exposed roots, cover roots with topsoil or reinstall.
- Trim dogwoods within the vernal pool area (8 dogwoods).
- Adjust and/or replace several tree guards on plantings within the vernal pool area.
- Repair and/or replace damaged tree guard in planting area west of vernal pool.

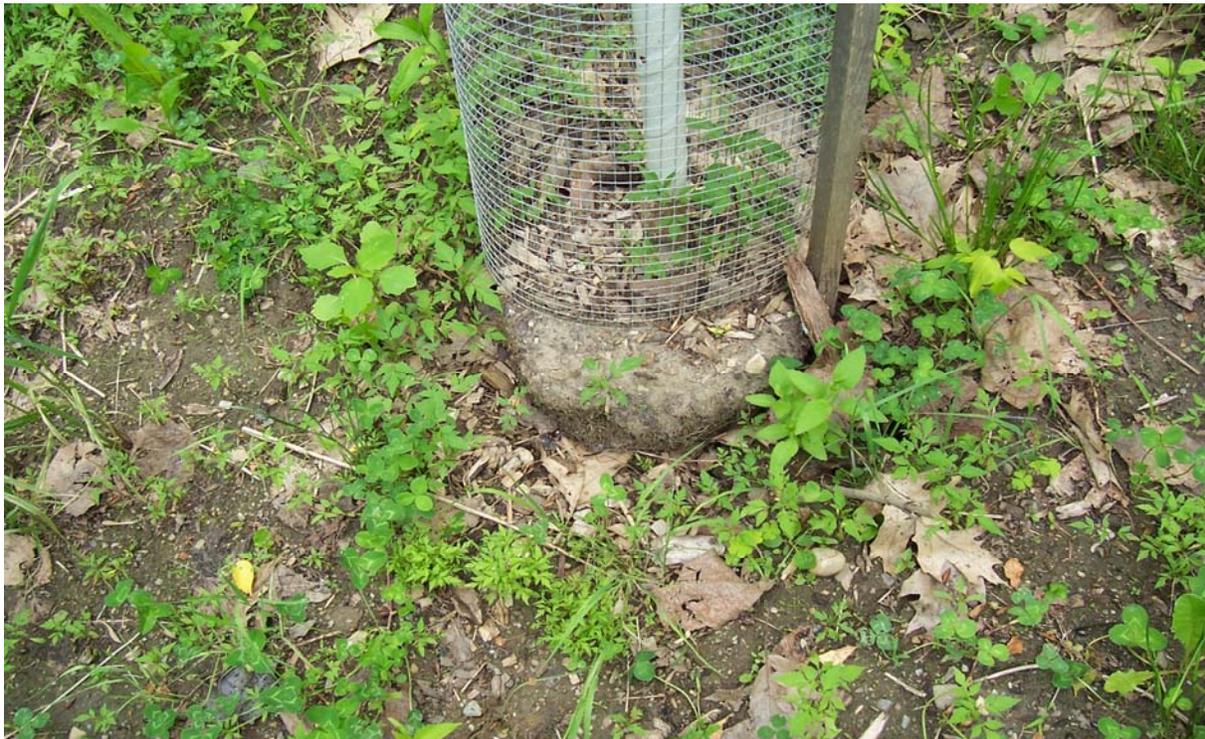
- Herbaceous vegetative cover is in good condition.
 - Several trees/shrubs within the vernal pool area have exposed roots (see tables in Attachment B).

Photo #8: Vernal Pool - Exposed Root Mass
