**Re: GE-Pittsfield/Housatonic River Site  
Building 71 On-Plant Consolidation Area (GECD220)  
Summary of June 2007 Post-Closure Inspection Activities**

**GENERAL ELECTRIC COMPANY - PITTSFIELD, MASSACHUSETTS  
BUILDING 71 ON-PLANT CONSOLIDATION AREA (OPCA)**

**POST-CLOSURE INSPECTION FORM**

GENERAL ELECTRIC COMPANY • PITTSFIELD, MASSACHUSETTS  
 HILL 78 AND BUILDING 71 OPCAs  
**POST CLOSURE INSPECTION**  
**JUNE 1, 2007**

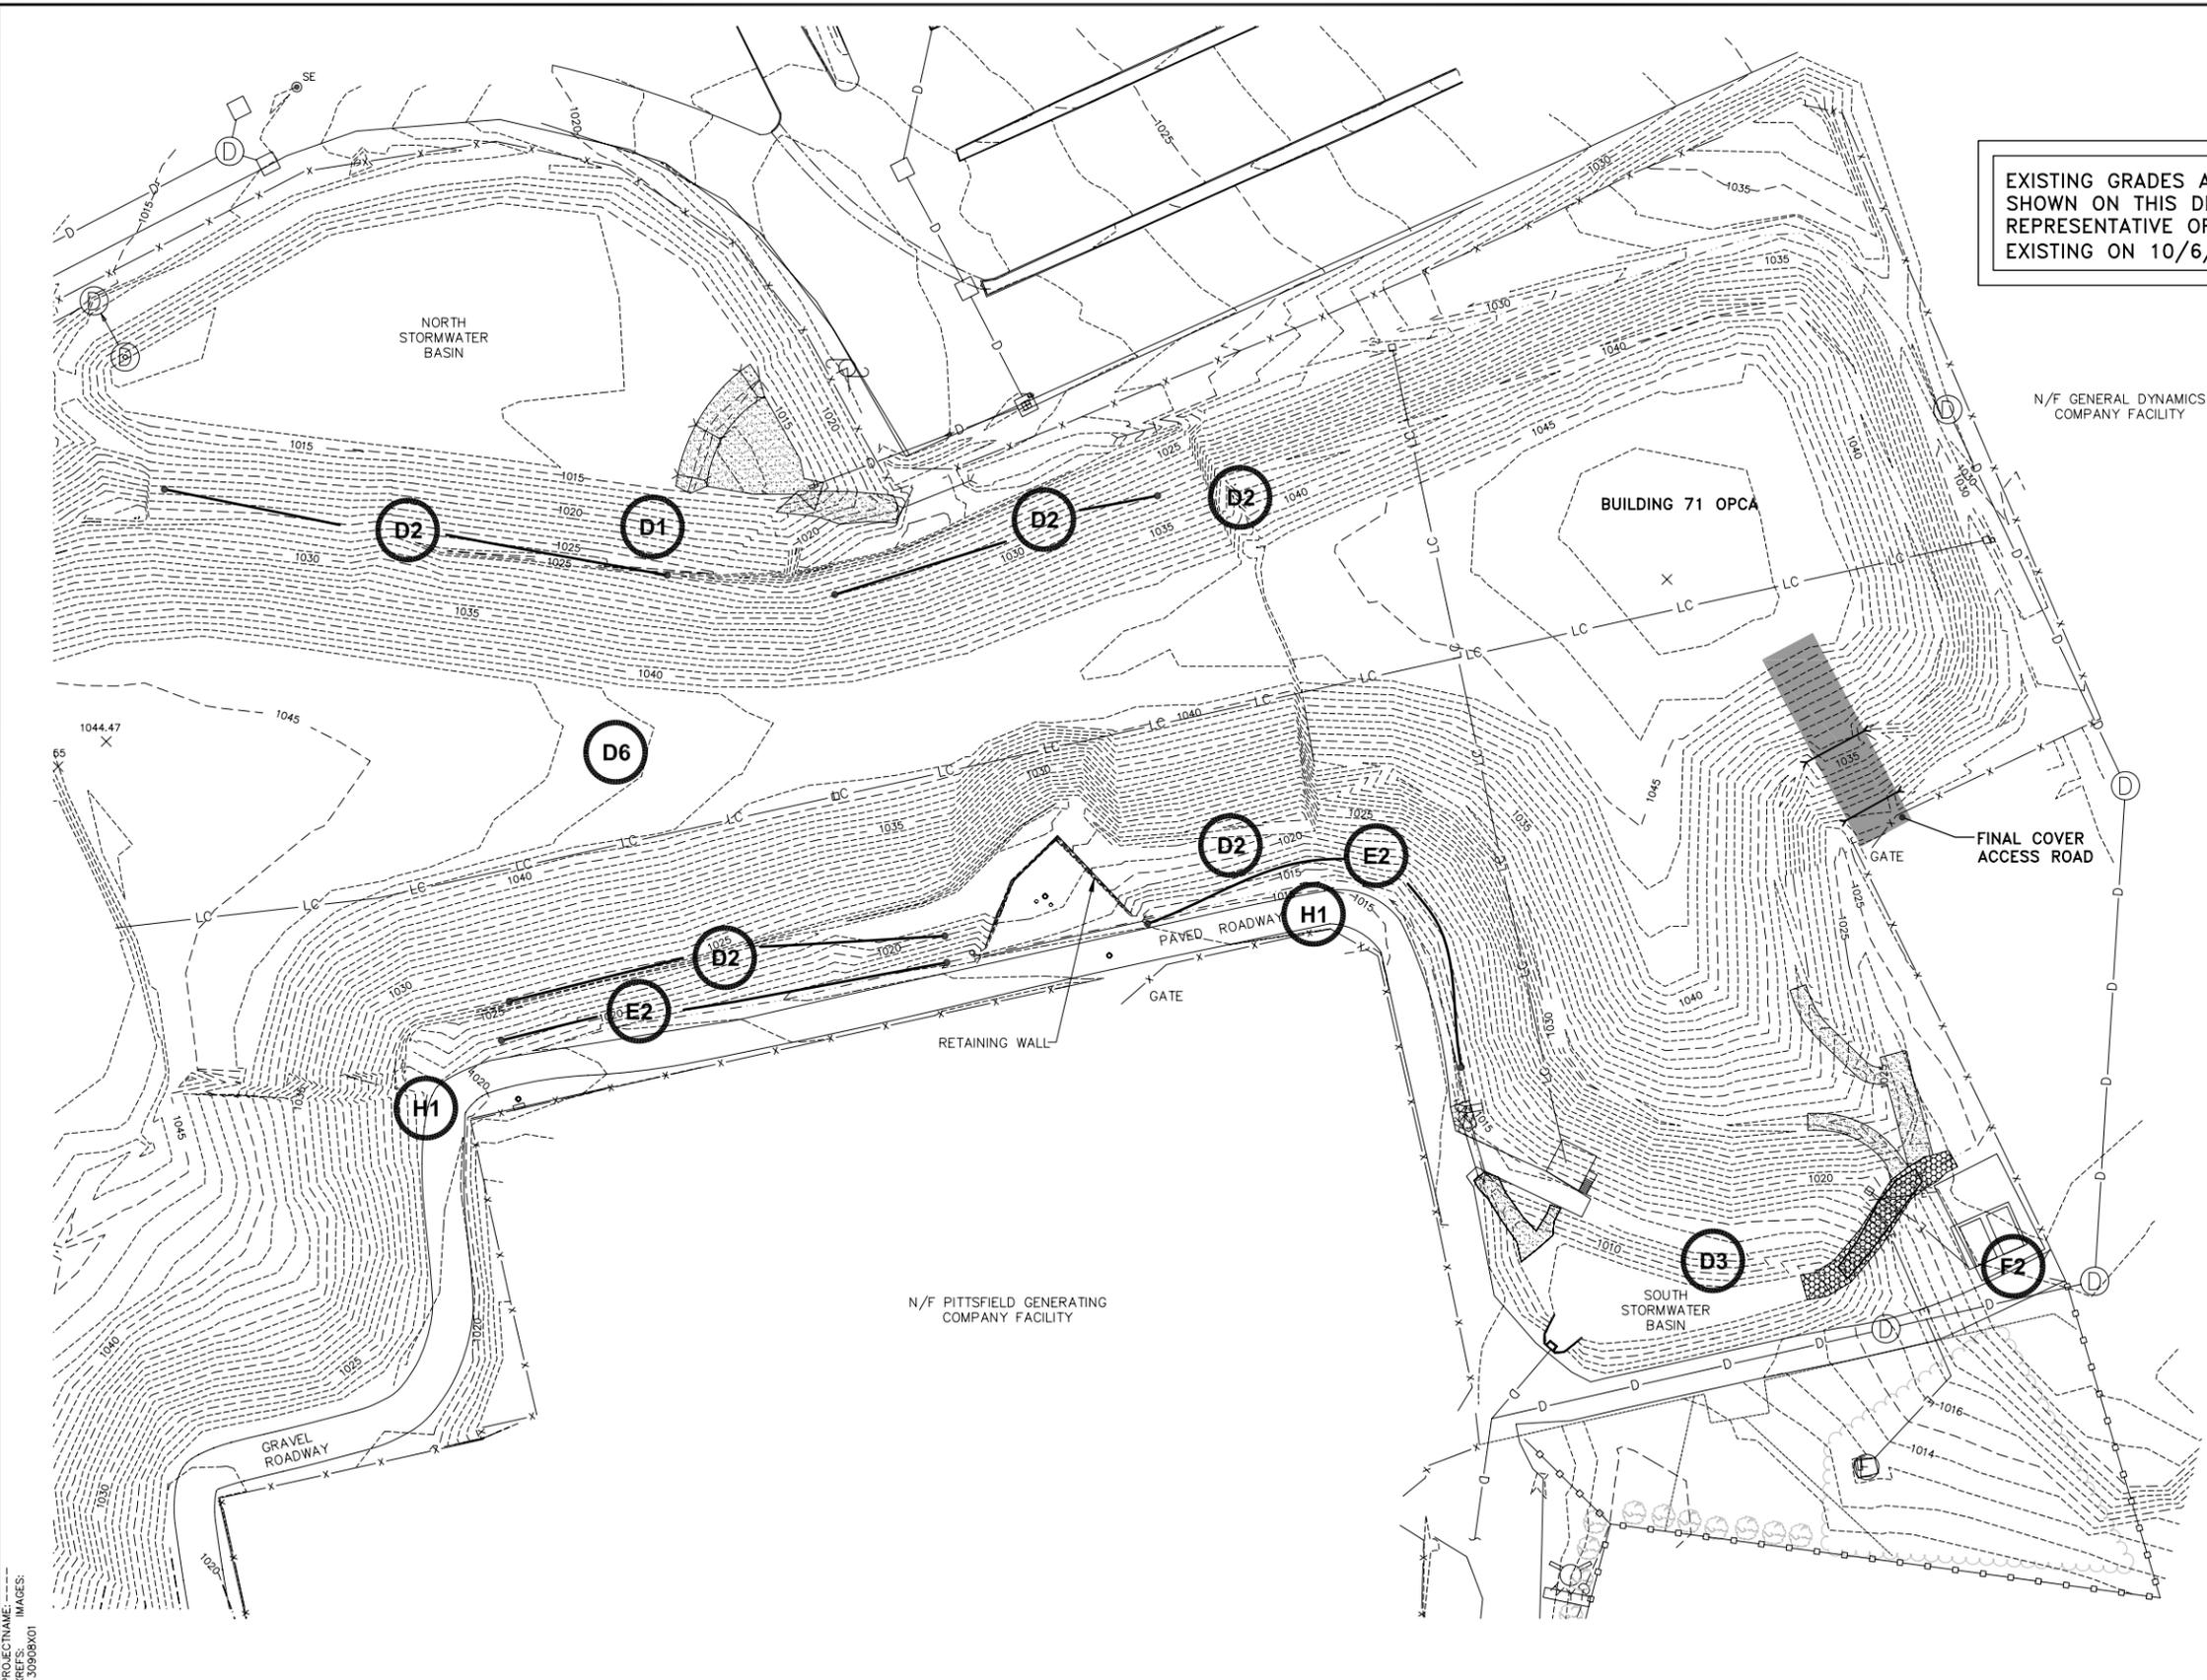
Site Figure

- D1. An area on the northern sideslope of the final cover installed in 2006 is void of vegetation.
- D2. Sideslope erosion was noted along the sideslopes of the final cover installed in 2006. Additionally, prior to this inspection, it was observed that the western termination of the northern midslope swale was eroded.
- D3. Animal burrow holes were noted within the southern Sedimentation Basin.
- D6. Sparse vegetation was observed on the plateau of the final cover installed in 2006.
- E2. Excessive sediment accumulation was observed within the perimeter ditches on the south side of the Building 71 OPCA.
- F2. Tank access covers need to be painted.

1. BASE MAP INFORMATION SHOWN ON THIS DRAWING FROM "EXISTING SITE PLAN" BY ARCADIS BBL, DATED APRIL 2007.
2. ELEVATIONS SHOWN ARE REFERENCED TO NATIONAL GEODETIC VERTICAL DATUM (NGVD 1929).
3. HORIZONTAL DATUM IS REFERENCED TO THE MASSACHUSETTS STATE PLANE COORDINATE SYSTEM (NAD 1927).
4. CONTOUR INTERVAL EQUALS 1 FOOT.
5. INSPECTION OBSERVATION ITEMS CORRESPOND TO THE INSPECTION OBSERVATIONS DESCRIBED IN THE JUNE 1, 2007 POST-CLOSURE INSPECTION FORM.

- D2. At the time of this inspection, the western termination of the midslope swale had been repaired by reconfiguring a silt fence, filling the erosion with topsoil, regrading, seeding, and mulching. Sideslope erosion should be filled with topsoil, regraded and seeded in conjunction with mid-slope swale construction. Sediment accumulation resulting from erosion along the northern toe of the final cover installed in 2006 should be removed and riprap should be placed along the toe at the designed locations.

- D3. The burrowing animals should be removed from the OPCAs. Animal burrow holes should be filled with topsoil and seeded.
- D6. The plateau of the final cover installed in 2006 should be reseeded.

- E2. Sediment accumulation should be removed to restore ditches to design depth. Where regrading is necessary, the area should be reseeded and lined with temporary erosion control mat.

- F2. Tank access covers should be repainted as part of ongoing maintenance activities.

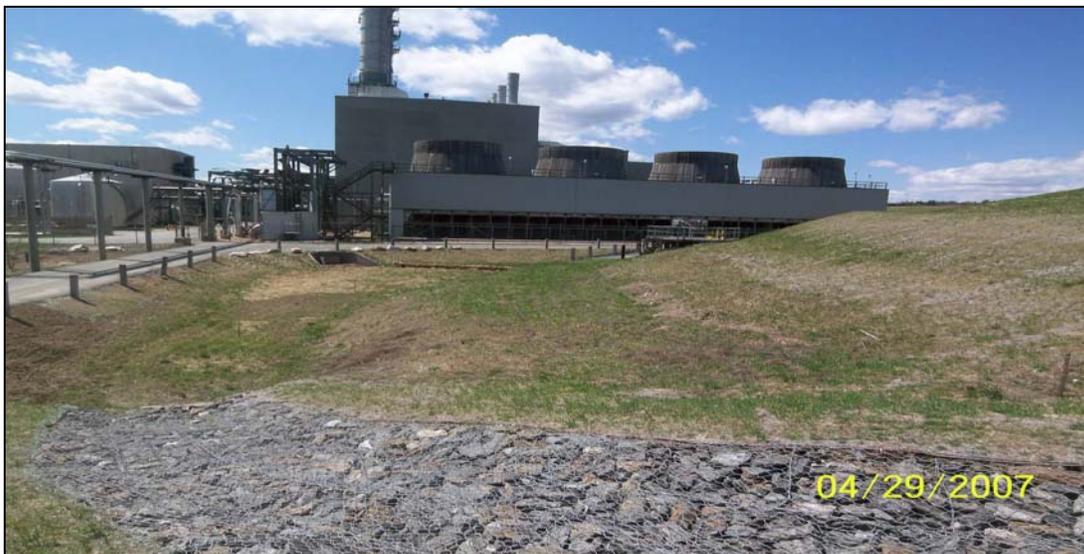
Description: View of Southern Sedimentation Basin (looking west).

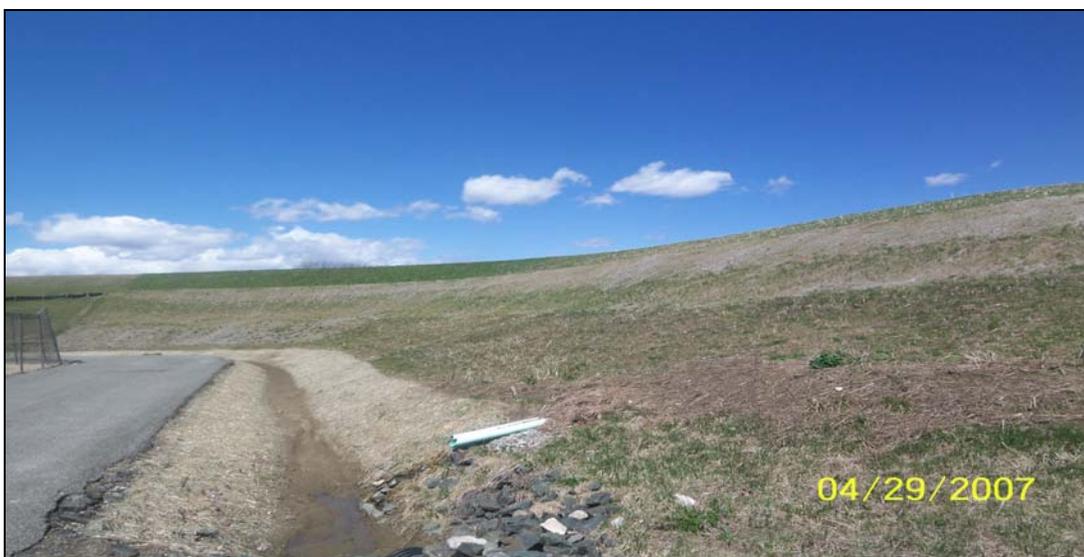
Description: View of Building 71 OPCA southwestern sideslope and perimeter ditch (looking north).

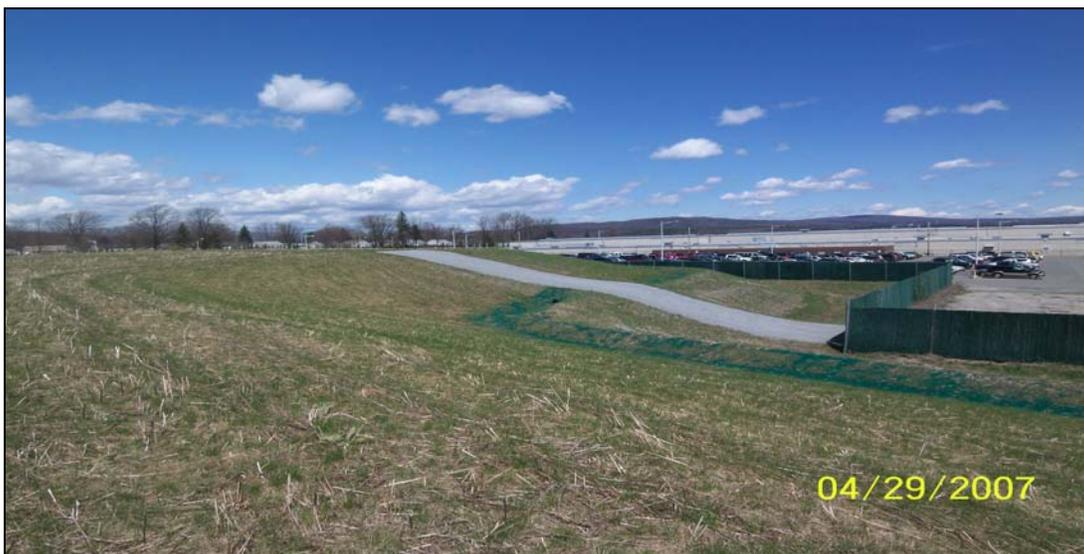
Description: View of Building 71 OPCA southeastern sideslope, mid-slope swale and final cover access road (looking east).

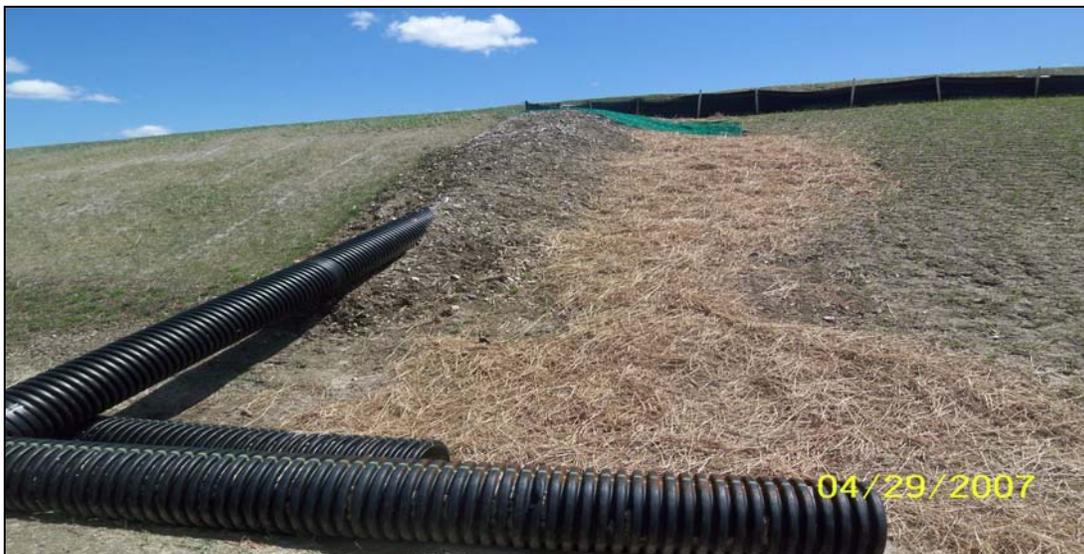
Description: View of the repaired western termination of the northern mid-slope swale of the Building 71 OPCA (looking south).

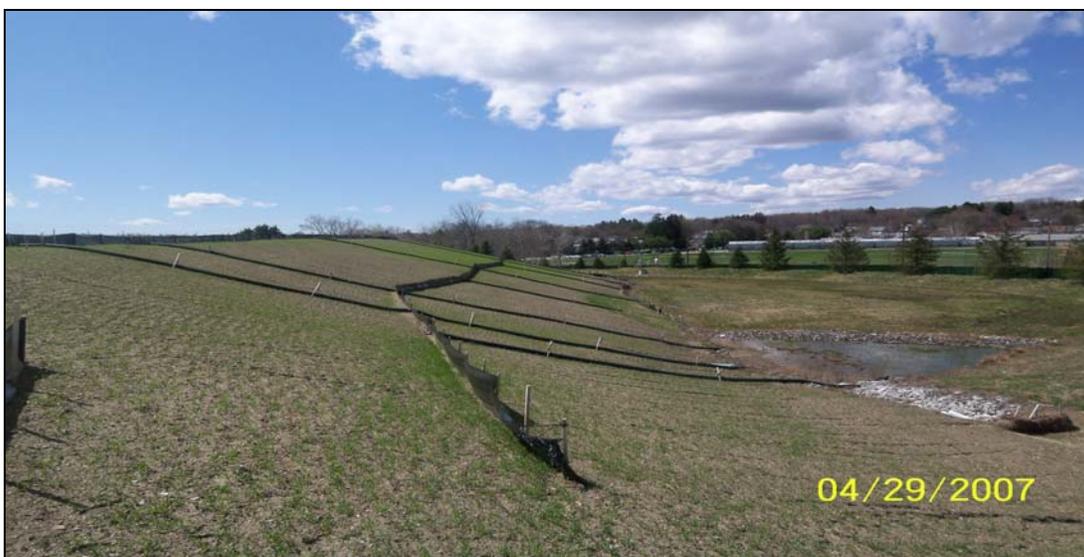
Description: View of Building 71 OPCA northern sideslope and northern Sedimentation Basin (looking west).

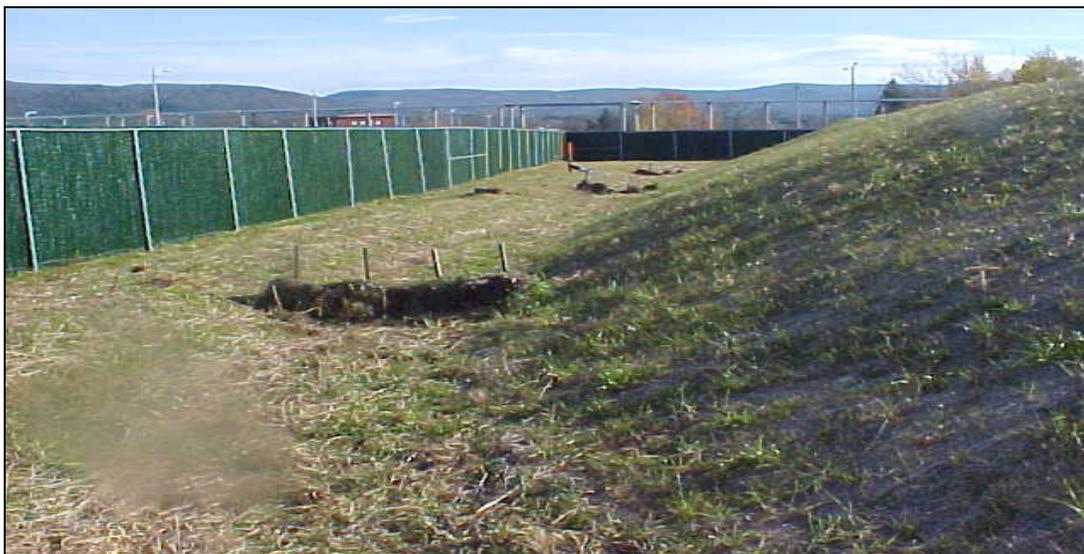
Description: View of Building 71 OPCA perimeter ditch and eastern sideslope (looking south).

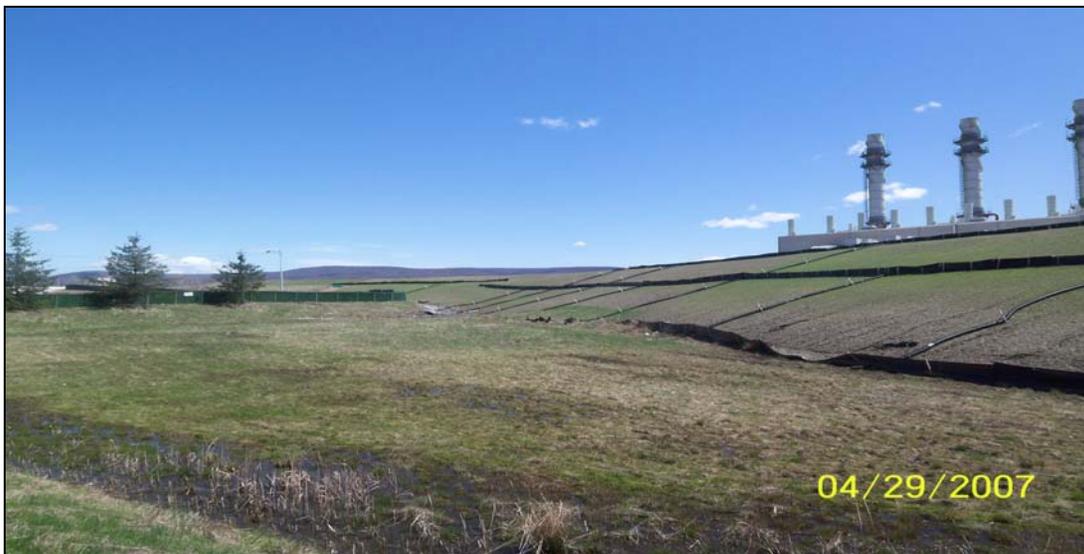
Description: View of Building 71 northern sideslope erosion and northern Sedimentation Basin (looking east).

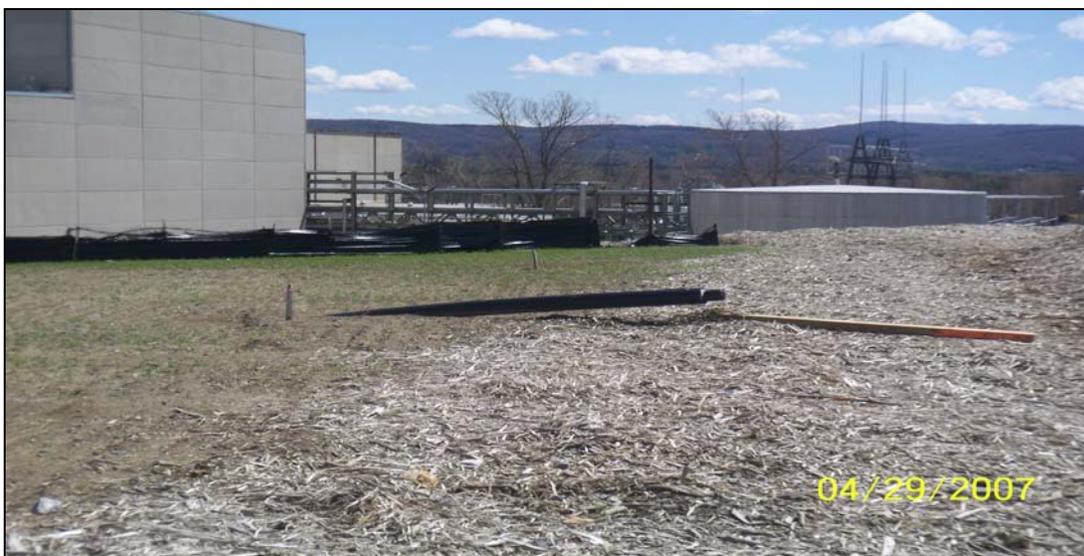
Description: View of Building 71 OPCA plateau and leachate collection pipe cleanout (looking south).

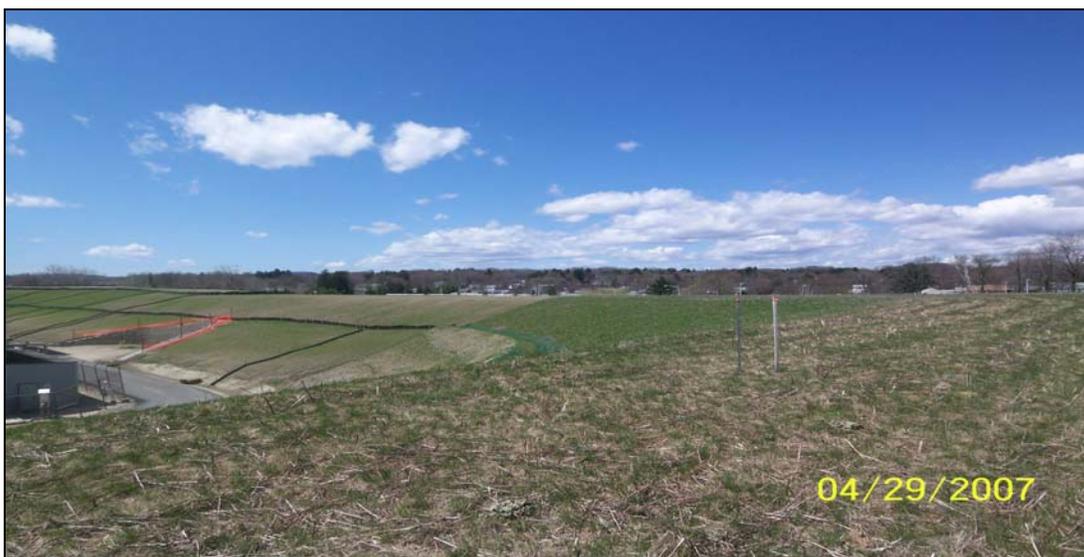
Description: View of Building 71 OPCA plateau and southern sideslope (looking northwest).
