**Re: GE-Pittsfield/Housatonic River Site
Building 71 and Hill 78 On-Plant Consolidation Areas (GECD210 & GECD220)
Summary of Spring 2008 Post-Closure Inspection Activities**

**GENERAL ELECTRIC COMPANY - PITTSFIELD, MASSACHUSETTS
BUILDING 71 AND HILL 78 ON-PLANT CONSOLIDATION AREAS (OPCAs)**

POST-CLOSURE INSPECTION FORM

GENERAL ELECTRIC COMPANY • PITTSFIELD, MASSACHUSETTS
HILL 78 AND BUILDING 71 OPCAs
POST CLOSURE INSPECTION
MAY 16, 2008
GENERAL

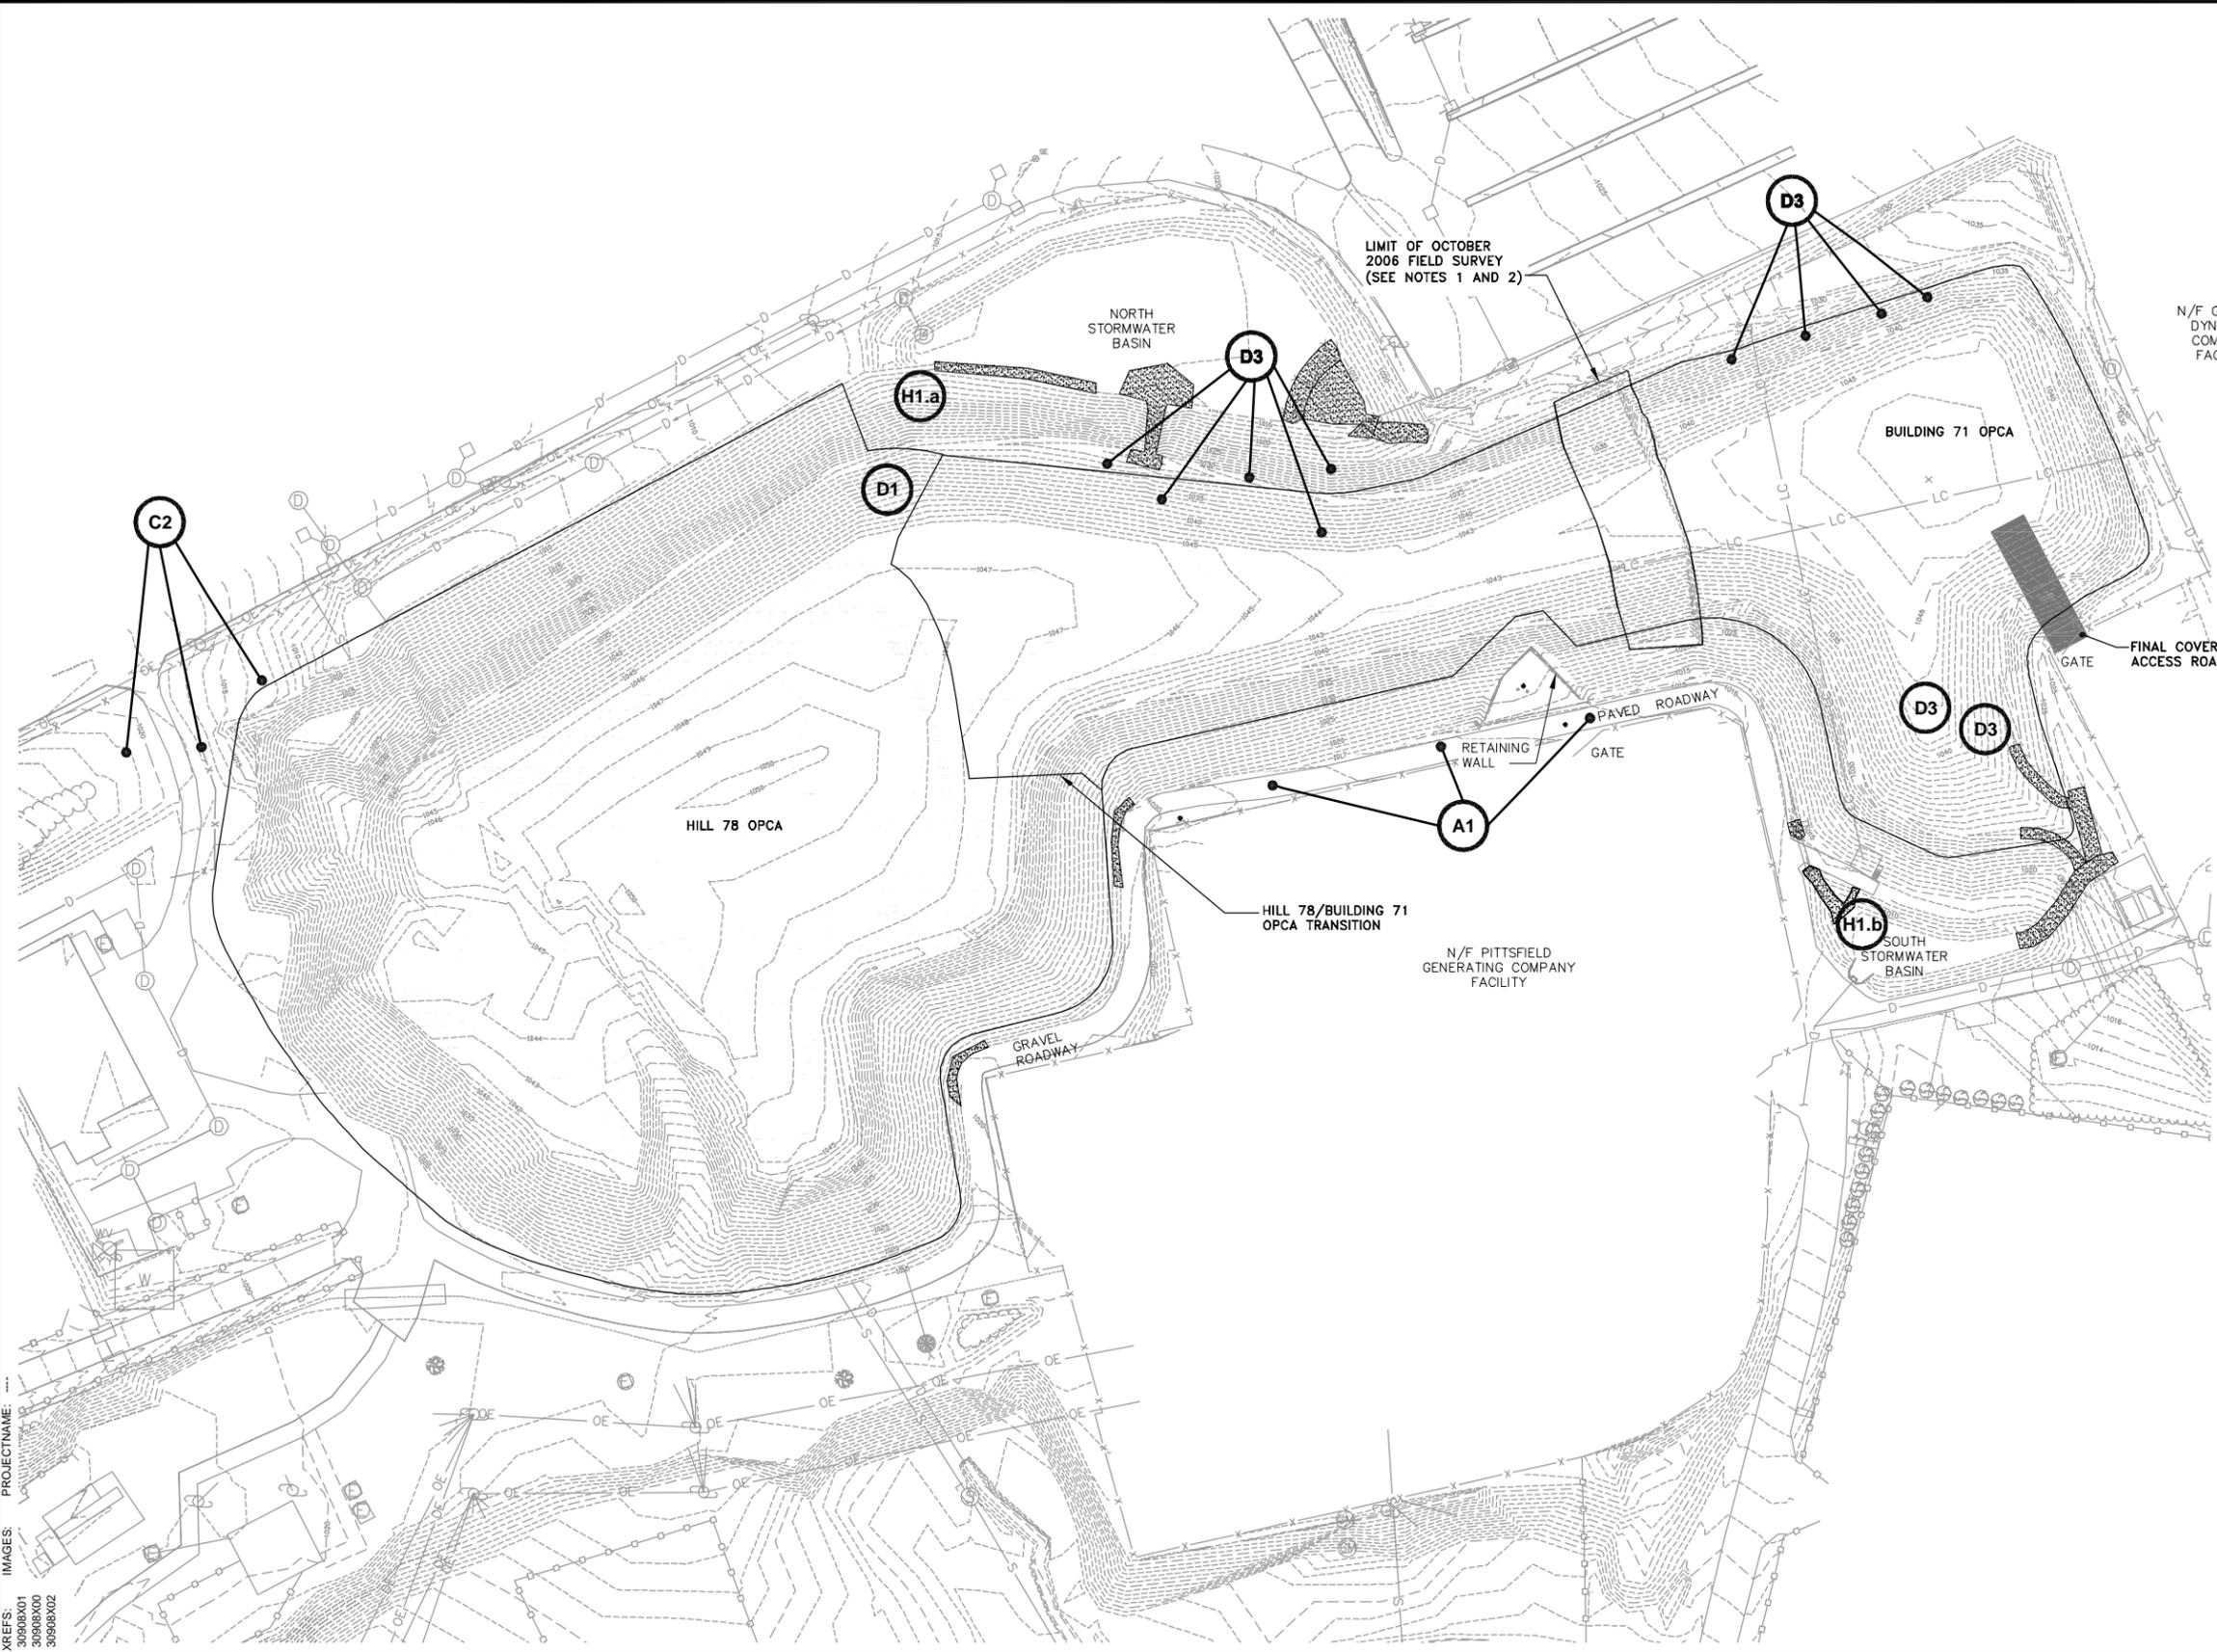
Site Figure

- A1. There is a limited amount of pavement cracking and/or spalling at the north edge of the paved access road (road section adjacent to the sound barrier wall).
- C2. There is temporary fencing on the NW corner of the Hill 78 OPCA that is being used for the sanitary sewer/storm drain pipe re-route project.
- D1. Sparse vegetation was observed on the northern final cover sideslope at the Hill 78 and Building 71 OPCA transition.
- D3. Animal burrow holes were noted at several locations on the Building 71 OPCA.
- H1.a A dead tree fell at the northwest corner of the Building 71 OPCA.
- H1.b Degraded hay bales were observed in the eastern corner of the Southern Sedimentation Basin.

- A1. Cracks and/or spalling noted at the pavement edge do not significantly affect the use or function of the access road. This condition will be reassessed during Fall 2008 inspection.
- C2. Permanent fencing should be installed after completion of the sanitary sewer/storm drain pipe re-routing project.
- D1. The location of sparse vegetation should be reseeded and mulched.
- D3. The burrowing animals should be removed from the OPCAs and the burrow holes filled with topsoil, seeded, and mulched.
- H1.a The dead tree and branches should be removed and disposed of.
- H1.b The degraded hay bales should be removed from the Southern Sedimentation Basin.
