WHEN LOW TECHNOLOGY IS THE ANSWER: RESPONSE TO A REMOTE OIL SEEP:

Robert M. Mandel

Federal On-Scene Coordinator
United States Environmental Protection Agency
75 Hawthorne St.
San Francisco, CA 94105 USA

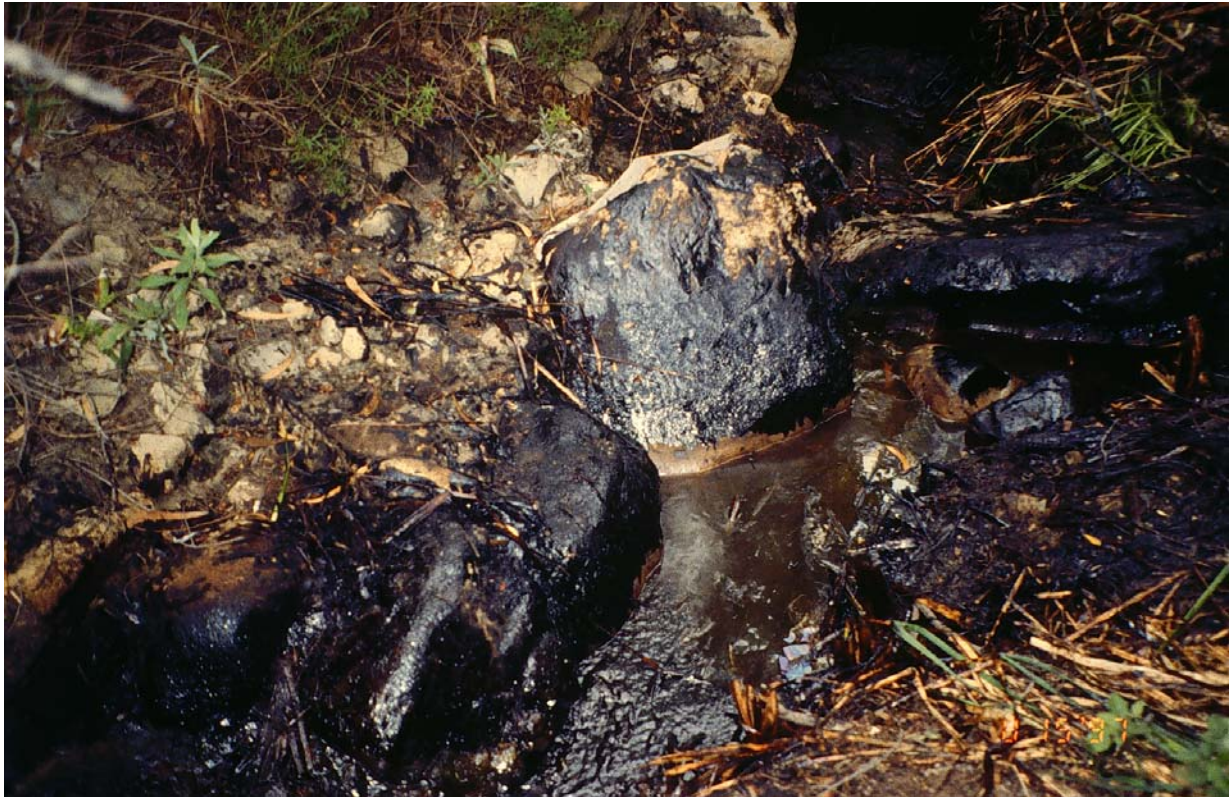
In July 1997, a vandal disabled the OWS, resulting in a major spill of over 3,000 gallons (13,200 liters) of oil to Toro Creek. From the oil seep to the Pacific, Toro Creek was oiled for its full 4.5-mile (7.24 km) length. DFG again responded to the oil spill, but exhausted available response funds before completing the response. On July 24, 1997 United States Environmental

Protection Agency (EPA) responded at the request of DFG. Figure 1 shows a heavily oiled portion of Toro Creek on July 24, 1997. The EPA Federal On-Scene Coordinator (OSC) determined that a release of oil to Toro Creek was on-going, that Toro Creek was a water of the United States, and that other parties were unable to address the oil spill. This determination brought the oil spill under the authority of the Oil Pollution Act of 1990 (OPA), and allowed response funds to be authorized from the Oil Spill Liability Trust Fund.

- Fig 1: A heavily oiled portion of upper Toro Creek during July 1997.
- Fig 2: Workers set the 3-chambered OWS clarifier in position.
- Fig 3: The chemical hose holding the oil is enclosed within the PVC pipe to provide secondary containment.

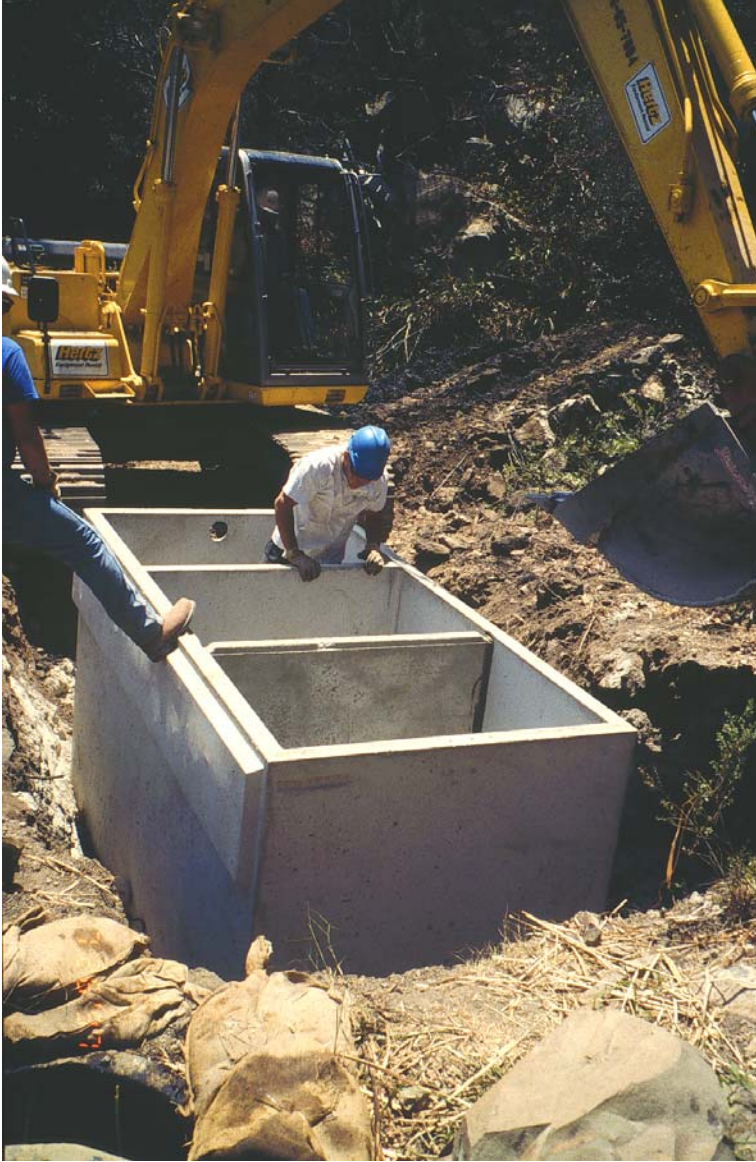
three separation chambers in a concrete industrial water clarifier. This clarifier was readily available because industrial wastewater dischargers in the area commonly used it. The clarifier was transported up the dirt road in a sling suspended from an excavator and installed mostly below-grade. Figure 2 shows the OWS clarifier being positioned. Oil was separated by gravity in the primary and secondary chambers prior to flowing into a chemically resistant two-inch (5.1 cm) hose. This hose was encased within a 4-inch (10.2 cm) schedule 80 polyvinyl chloride (PVC) pipe. Figure 3 shows the hose inside the PVC pipe. This arrangement provided secondary containment in case the chemical hose ruptured. This pipeline was buried 24 inches (61 cm) deep under the dirt access road. Figure 4 shows the pipeline trench. The pipeline ran 900 feet (275 meters) downhill to a buried underground storage tank (UST). The vertical drop for this run of pipe was just over 300 feet (91.5 meters), almost a 30% gradient. This tank, a 6,000-gallon (26,400 liters) capacity conventional double-walled fiberglass tank, provides secondary containment and is typical of those being installed currently at gasoline stations in the US. Buried to provide security both from vandals and the threat of wild fire, the UST uses conventional pipe fittings. Figure 5 shows the UST being installed. The void between the walls provides the ability to detect leaks and collect oil should the inner tank leak.

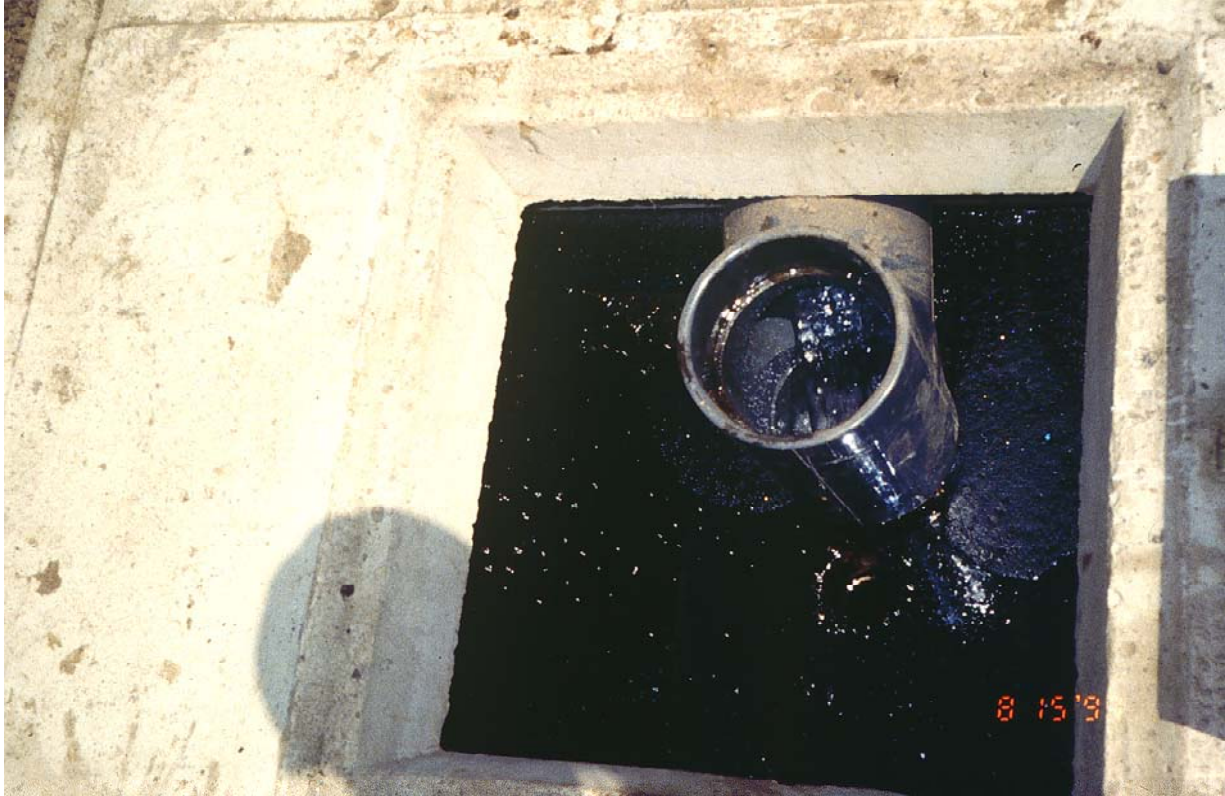
The seep water, after flowing through the two separation chambers, flows into a third chamber where it can be observed and sampled (if necessary) prior to its discharge to the headwaters of Toro Creek. Figure 6 shows the oil layer that accumulates in the first separation chamber of the OWS.

- Fig 4: Pipeline trench containing the secondary containment hose and electrical wiring for the high level alarm.
- Fig 5: The UST is installed.
- Fig 6: Here is the thick oil layer that accumulates in the primary separation chamber.

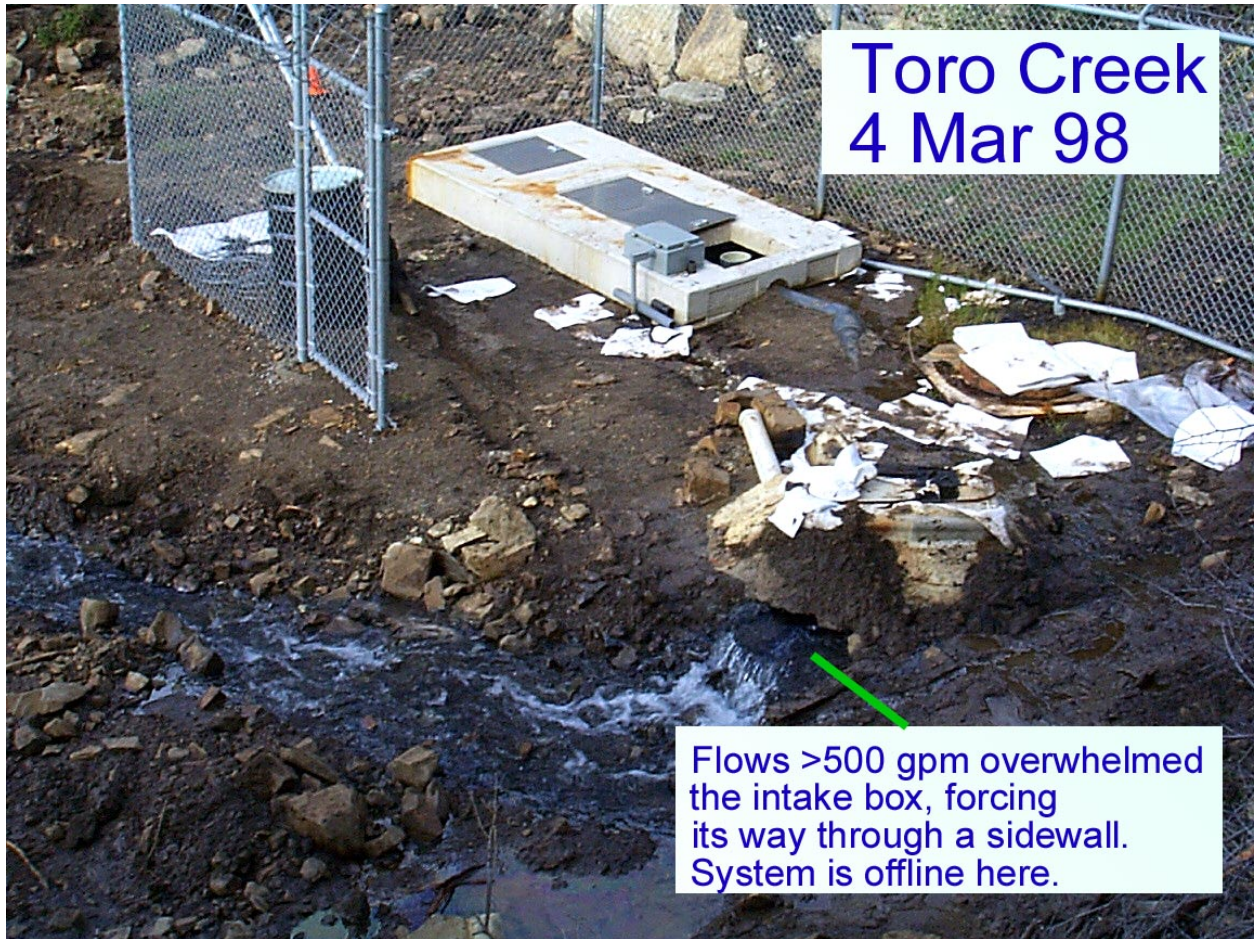
Although the collection system was sized for five times normal flow 125 gpm (473 LPM), it proved inadequate for heavy rains associated with the El Nino storms of February 1-3, 1998, when 9.48 inches (241 mm) of rain fell at Toro Creek. This deluge caused landslides, flash flooding, and greatly increased flows to the OWS estimated to be in excess of 800 gpm (3520 LPM). The enormous flow ruptured the concrete vault that conveyed seep fluids into the OWS. Figure 8 shows the blowout that occurred in the collector vault. High flows also overwhelmed the OWS in both separation chambers forcing water, instead of just oil, to flow down the pipeline to the UST. This situation quickly over-filled the UST with storm water. Fortunately, the UST was piped to function as an OWS when excessive water flowed into it. Slides and flooding eroded several sections of the buried secondary pipeline, exposing but not breaking it. Figure 9 shows this erosional damage. The alarm systems functioned as designed, alerting responders to

- Fig 7: Vacuum truck removes oil from the UST periodically.
- Fig 8: El Nino flows ruptured the concrete intake structure upstream of the OWS.
- Fig 9: An example of erosional damage resulting from the El Nino storms.

After inspecting the damage, we decided to increase the capacity of the OWS collection and treatment system to handle peak flows of 800 gpm (3520 LPM). An additional clarifier was added upstream of the existing OWS designed to handle increased flows when necessary, and act as pre-treatment for the existing OWS. The new OWS was fabricated as a bottom-less stainless steel box with underflow baffles for oil-water separation. Figure 10 shows the artesian seep just prior to the new OWS being placed on top of it. It was placed directly on top of the seep resulting in an upflow from the bottom into the new OWS. A stainless steel wire mesh coalescer was added to the bottom of the new OWS to agglomerate the finer oil particles and make them more amenable to separation.

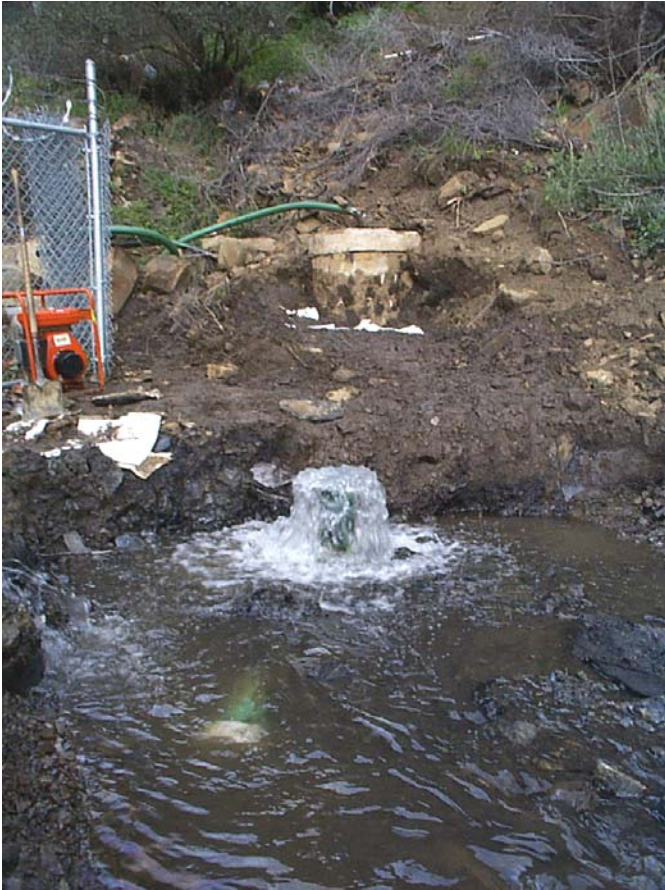
Figure 10

- Fig 10: The artesian flow of the seep at Toro Creek prior to the installation of the new primary OWS.
- Fig 11: Badly eroded pipeline trench required re-burial and the construction of surface diversion berms.

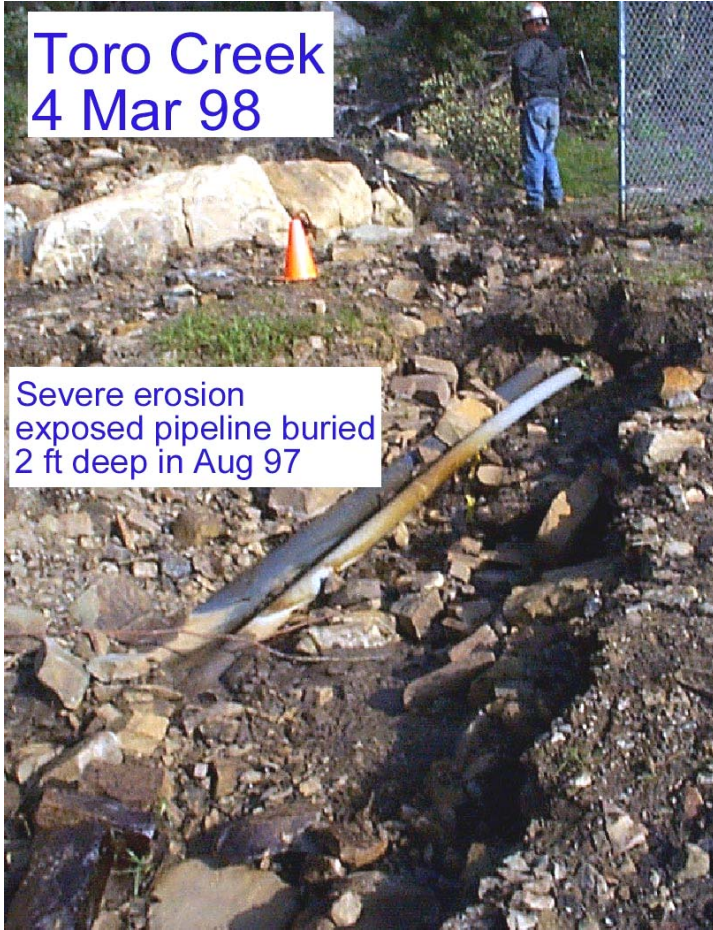
The exposed portions of the pipeline were re-buried and a large dirt and rock berm constructed to direct high surface water flows and debris flows away from sensitive areas. Figure 11 shows the serious erosion around the buried secondary containment pipeline resulting from the El Nino storms. Figures 12 and 13 show the new OWS being placed and the final configuration of the OWS system. Figure 14 shows a schematic of the OWS system as built at Toro Creek.

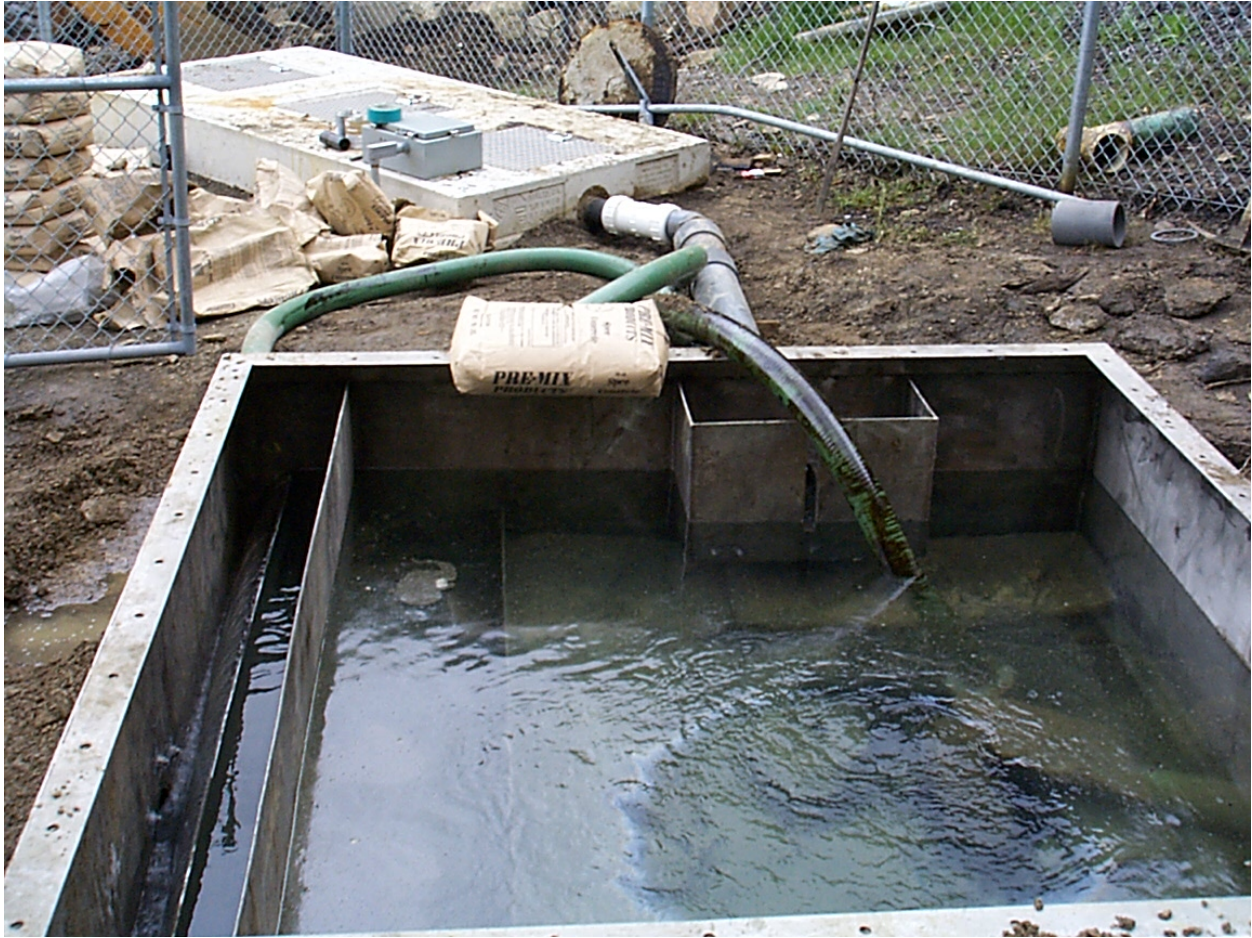
Figure 12

- Fig 12: New primary clarifier in place directly over the seep.
- Fig 13: Current OWS system configuration.
- Fig 14: Diagram of final as-built for the OWS system at Toro Creek.
