**2006 ANNUAL RESTORATION MONITORING REPORT  
1 ½ MILE REMOVAL REACH  
GENERAL ELECTRIC (GE)/HOUSATONIC RIVER SITE,**

**Environmental Remediation Contract  
GE/Housatonic River Project  
Pittsfield, Massachusetts**

**DCN: GE-021207-ADME**

**February 2007**

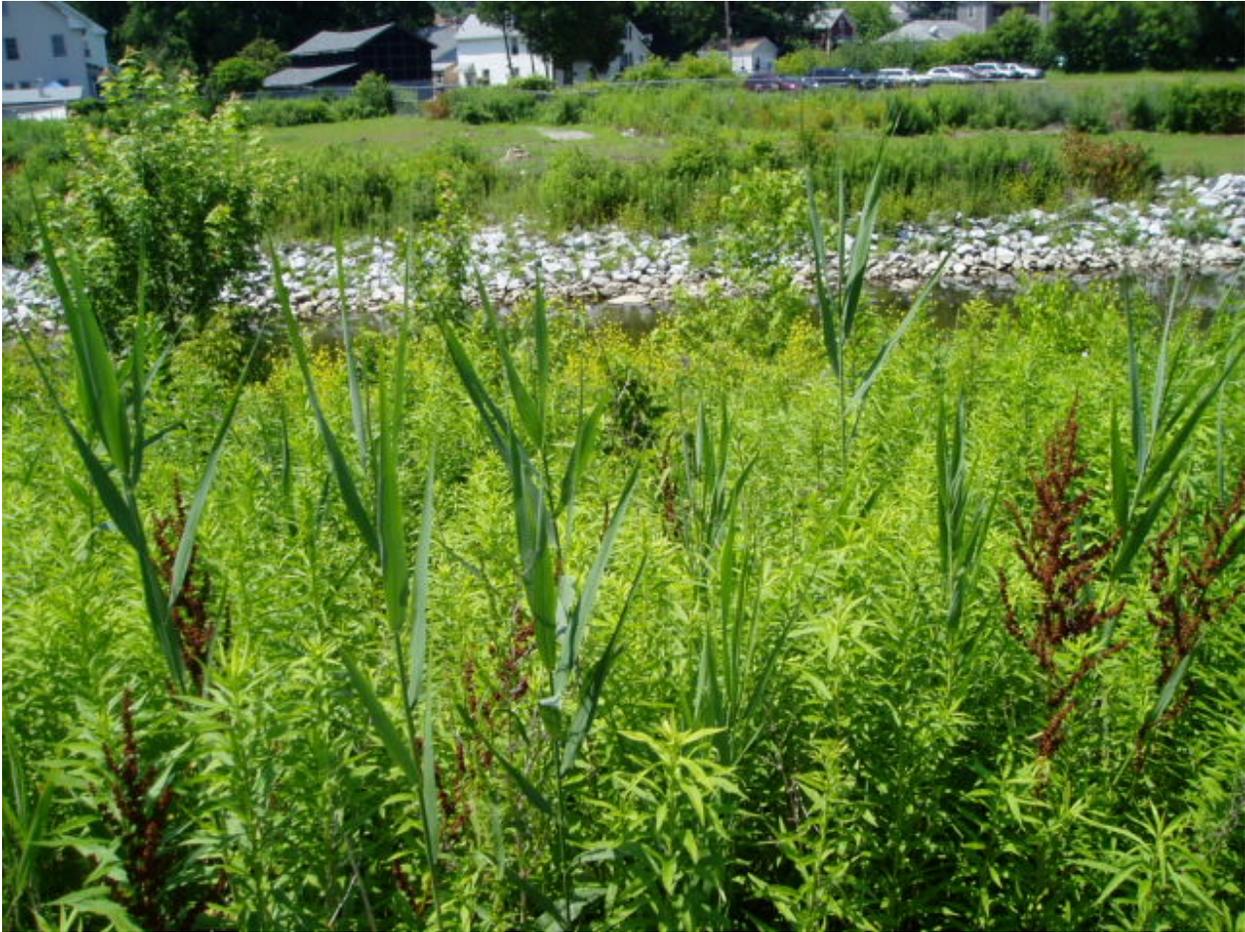
A stand of common reed (*Phragmites australis*) was observed adjacent to the road near Station 512 (see photo 1). This is the first observance of this invasive species within or near the restoration area. *Phragmites australis* is a highly invasive species that will likely expand its dominance if not controlled soon. Other invasive species encountered in this reach include Japanese knotweed (*Polygonatum cuspidatum*), Norway maple (*Acer platanoides*), and multiflora rose (*Rosa multiflora*). Purple loosestrife (*Lythrum salicaria*) was observed growing within the rip rap.

Photo 1. *Phragmites australis* stand near Station 512.

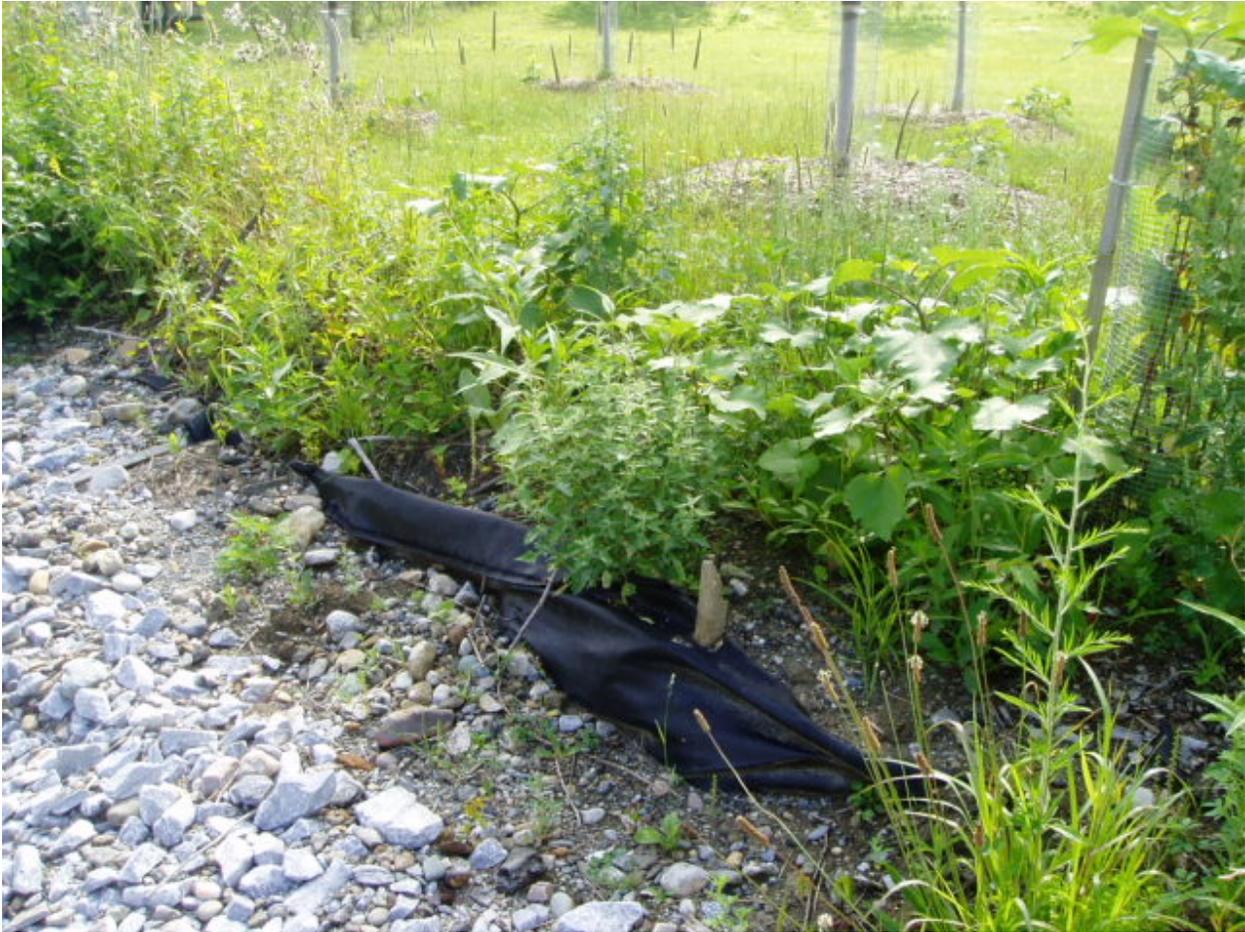
**Photo 2. Exposed sediment fence on east bank between Dawes Avenue and Pomeroy Road.**

- Re-assess the observed gaps in the ROD band in the Elm to Dawes and Dawes to Pomeroy Reaches during the Summer 2006 inspection, and based on findings, evaluate potential planting of additional ROD in these areas in Fall 2006.
- Continue invasive plant control work, including addressing the presence of Japanese knotweed (*Polygonum cuspidatum*), multiflora rose (*Rosa multiflora*), Norway maple (*Acer platanoides*), garlic mustard (*Alliaria petiolata*), and common reed (*Phragmites australis*). Also it is recommended that false hedge bindweed be periodically removed from tree cages.
- Remove the cages around the shrubs between Dawes and Pomeroy Avenues as soon as possible.
- Remove or trim to ground the exposed silt fence/geotextile at Station 545+25

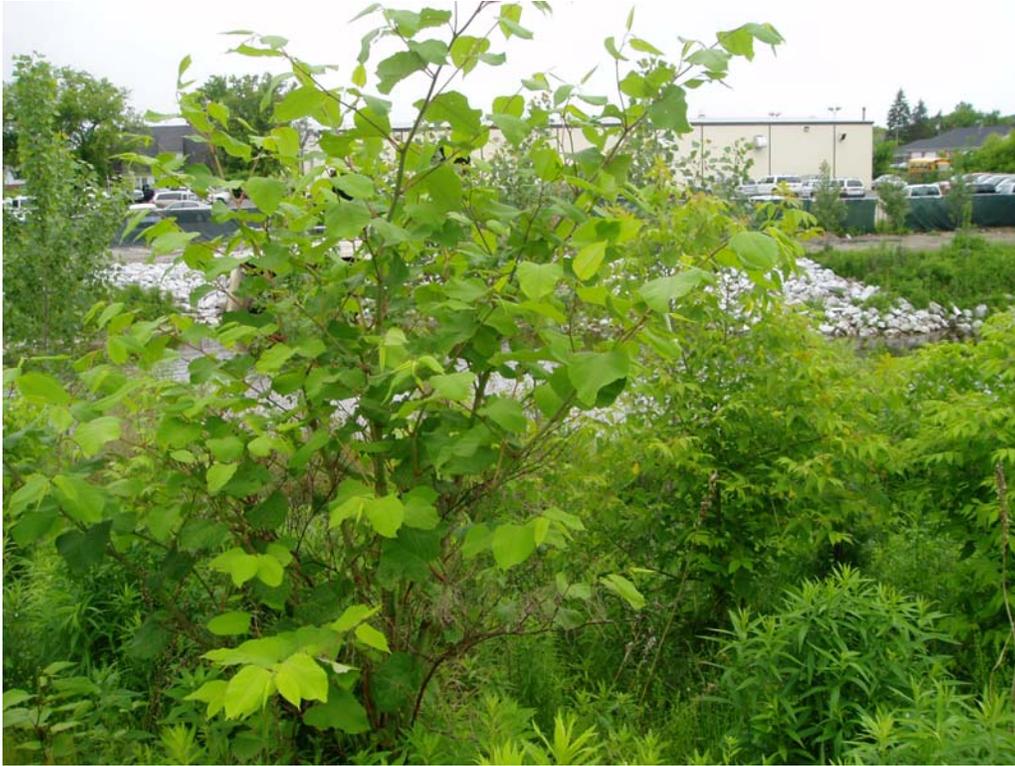
**Photo 3. Japanese knotweed (*Polygonum cuspidatum*) overgrowing planted species**

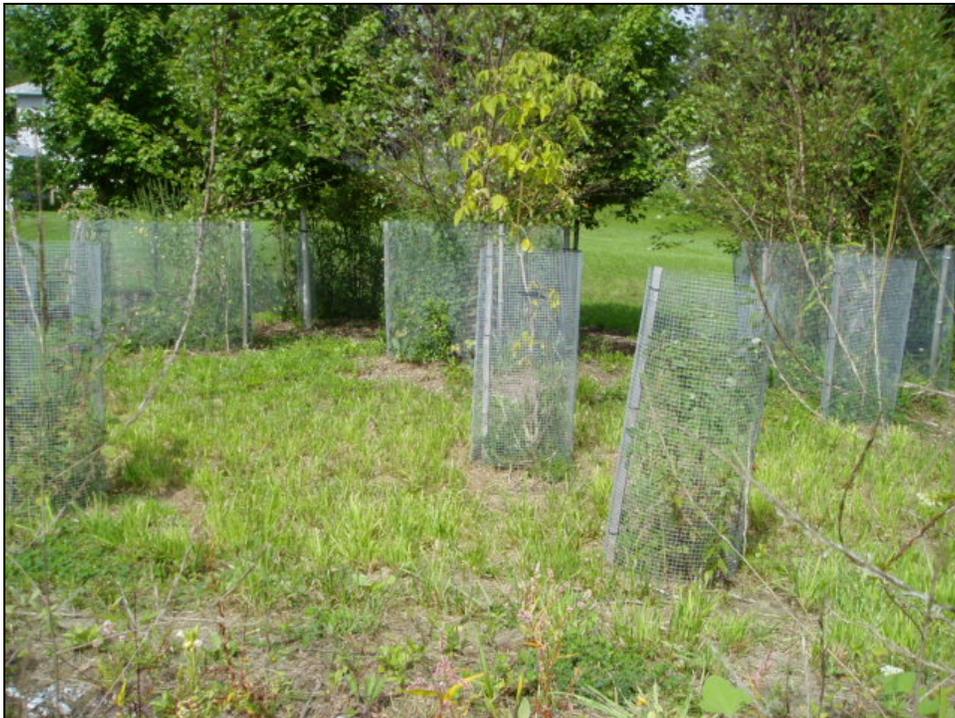
**Photo 2. Bare Ground Apparently Resulting from Mowing Activities (Plot 3-W-2).**

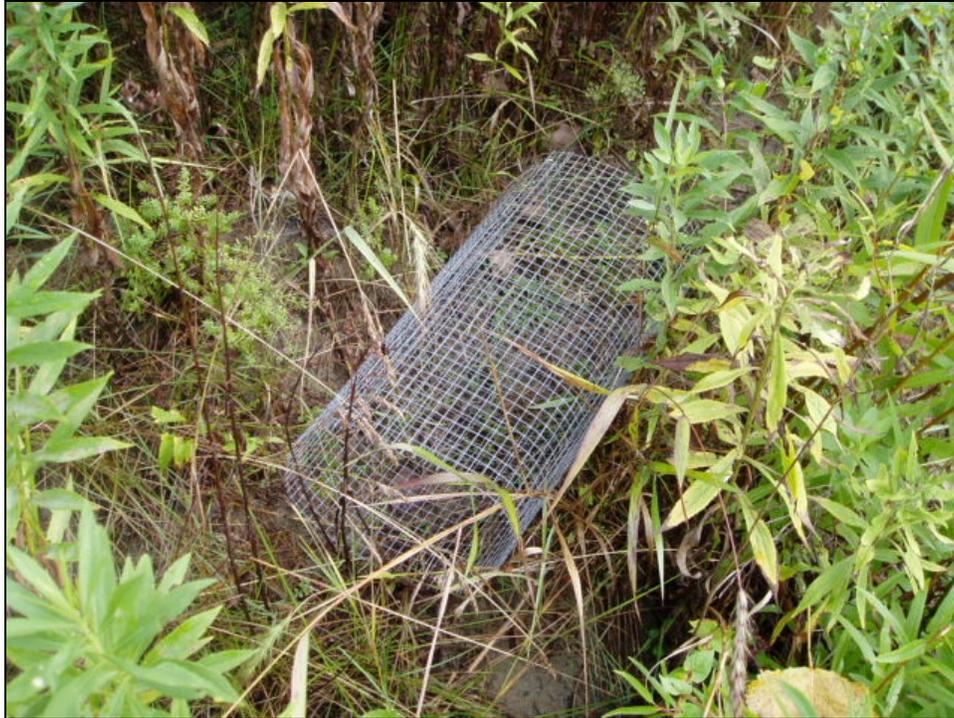
**Photo 3. Tipped Over/Empty Tree Cage.**

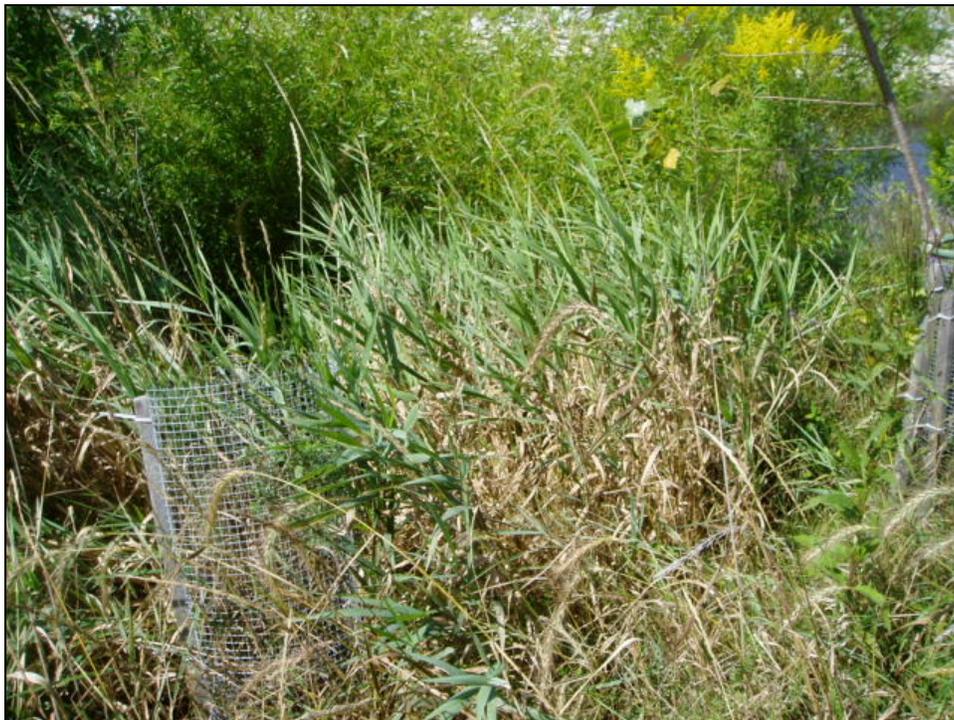
**Photo 4. Invasive Reed Canary-Grass (*Phalaris arundinacea*) on East Bank Between Lyman Street and Elm Street.**

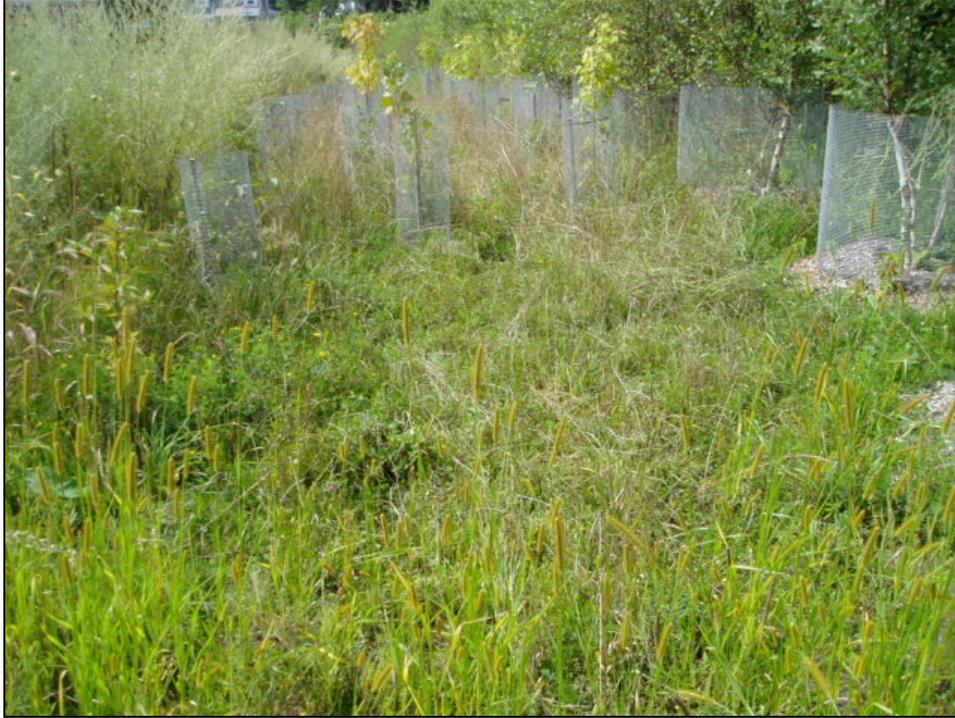
**Photo 5. Area Recommended for Additional Planting on West Bank Between Dawes Avenue and Pomeroy Avenue.**

- Install supplemental plantings on properties between Dawes Avenue and Pomeroy Avenue as described in this memo.

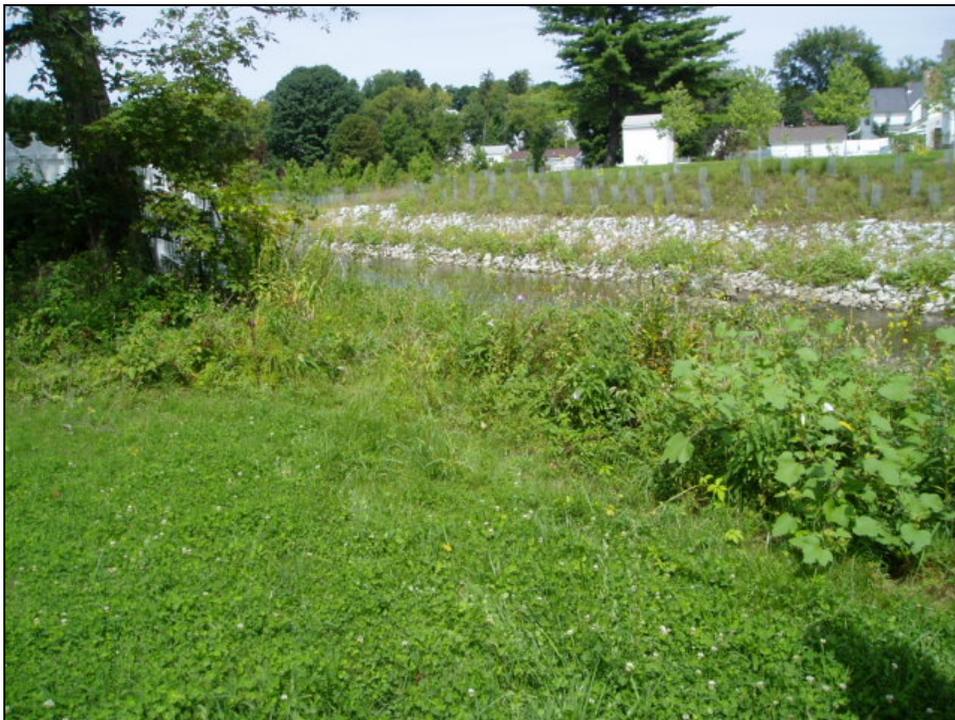
**Photo 6. Area Recommended for Additional Planting on West Bank Between Dawes Avenue and Pomeroy Avenue.**

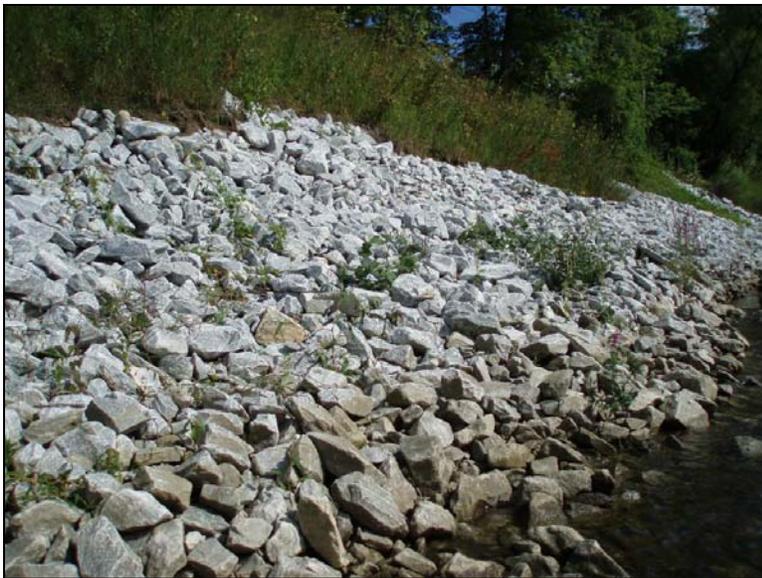
**Photo 4: Monitoring Area 2, View Upstream of Area of Potential Riprap Movement, West Bank, Sta. 525+25 (Approx.)**

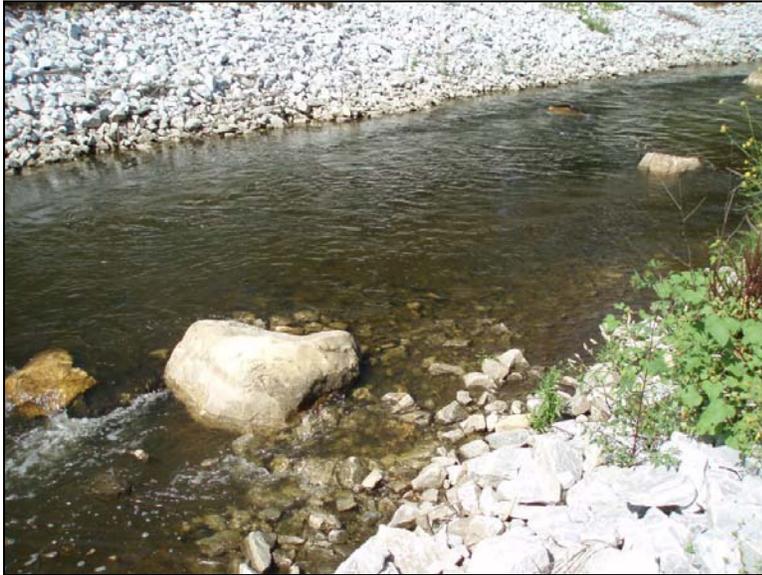
**Photo 5: Monitoring Area 2, View Upstream of Riprap Adjacent to Installed Boulder, from Sta. 528+00 (Approx.)**

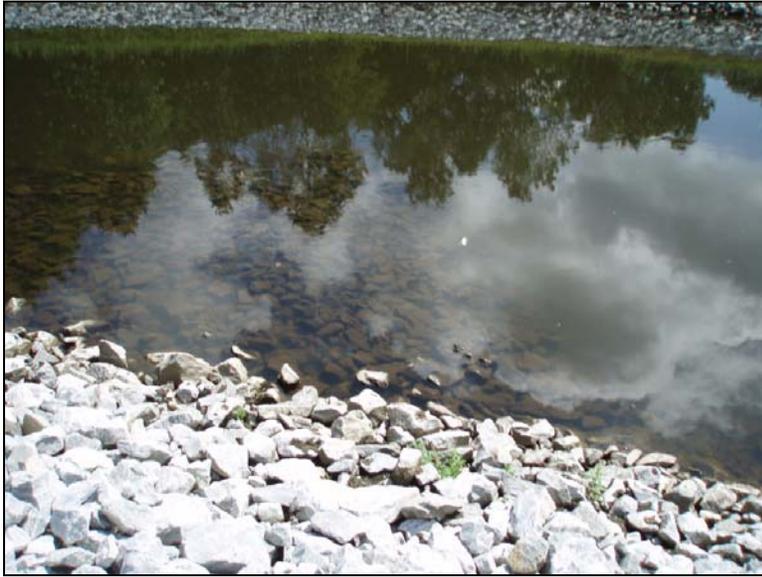
**Photo 11: Monitoring Area 4, Submerged Wing Deflector from West Bank, Sta. 574+00 (Approx.)**

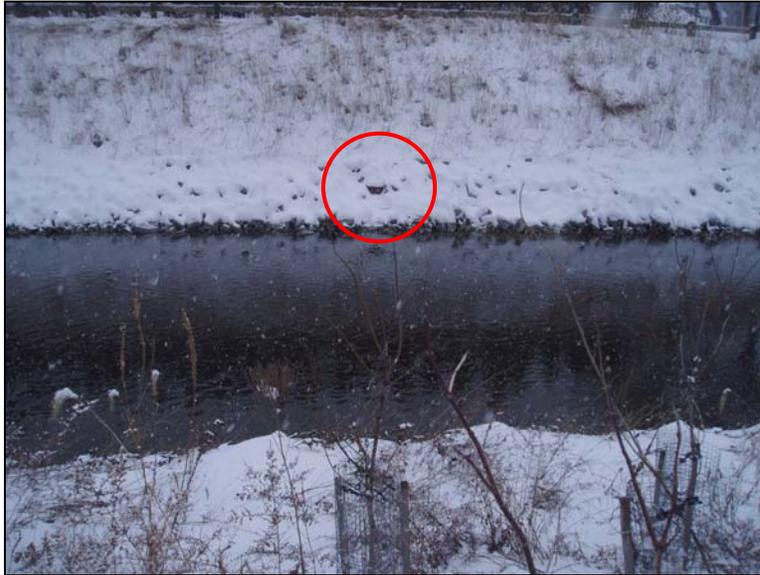
No areas of substantial erosion were observed during the monitoring work. Two possible indicators of minor erosion were observed during the monitoring work, including 1) a section of exposed sheet pile along the east river bank in the Transition Phase area, and a short length of exposed soil at the riprap-soil interface along the west river bank in the Phase 2 area. The extents of the aforementioned areas was less than approximately 10 feet in both cases, and no remedial action other than continued observation is recommended at this time.

**Photo 1: Exposed Sheet Pile, Transition Phase Area**

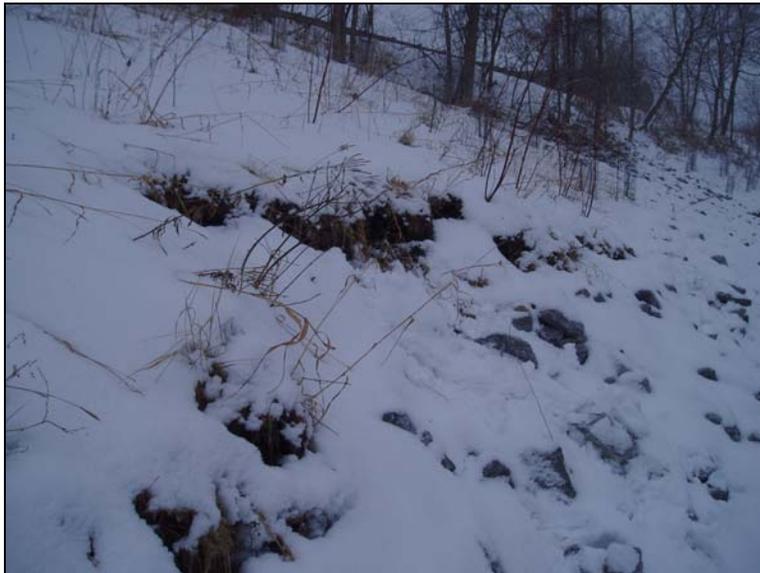
**Photo 2: Exposed Soil at the Riprap-Soil Interface, Phase 2 Area**

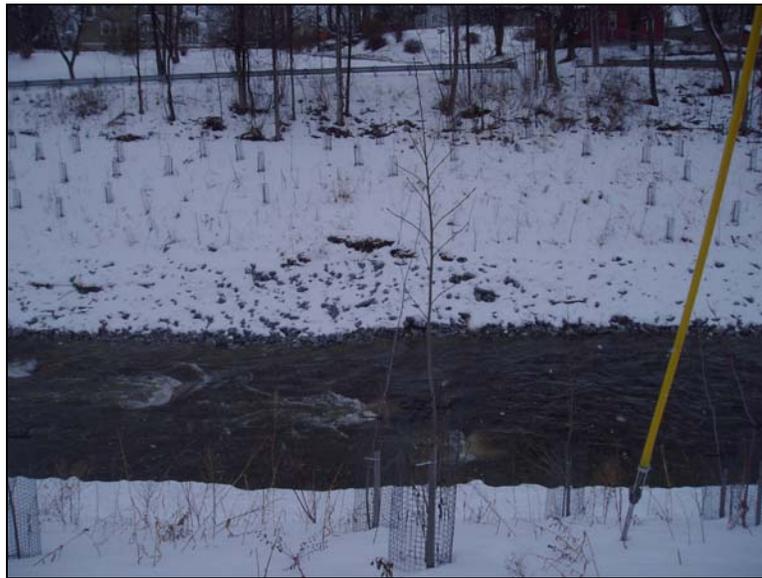
**Photo 3: Exposed Soil at the Riprap-Soil Interface, Phase 2 Area**
