GE  
159 Plastics Avenue  
Pittsfield, MA 01201  
USA

**Re: GE-Pittsfield/Housatonic River Site  
Building 71 On-Plant Consolidation Area (GEC220)  
Summary of September 2006 Post-Closure Inspection Activities**

**POST-CLOSURE INSPECTION FORM**

GENERAL ELECTRIC COMPANY • PITTSFIELD, MASSACHUSETTS  
HILL 78 AND BUILDING 71 OPCAs  
**POST CLOSURE INSPECTION**  
**(SEPTEMBER 8, 2006)**

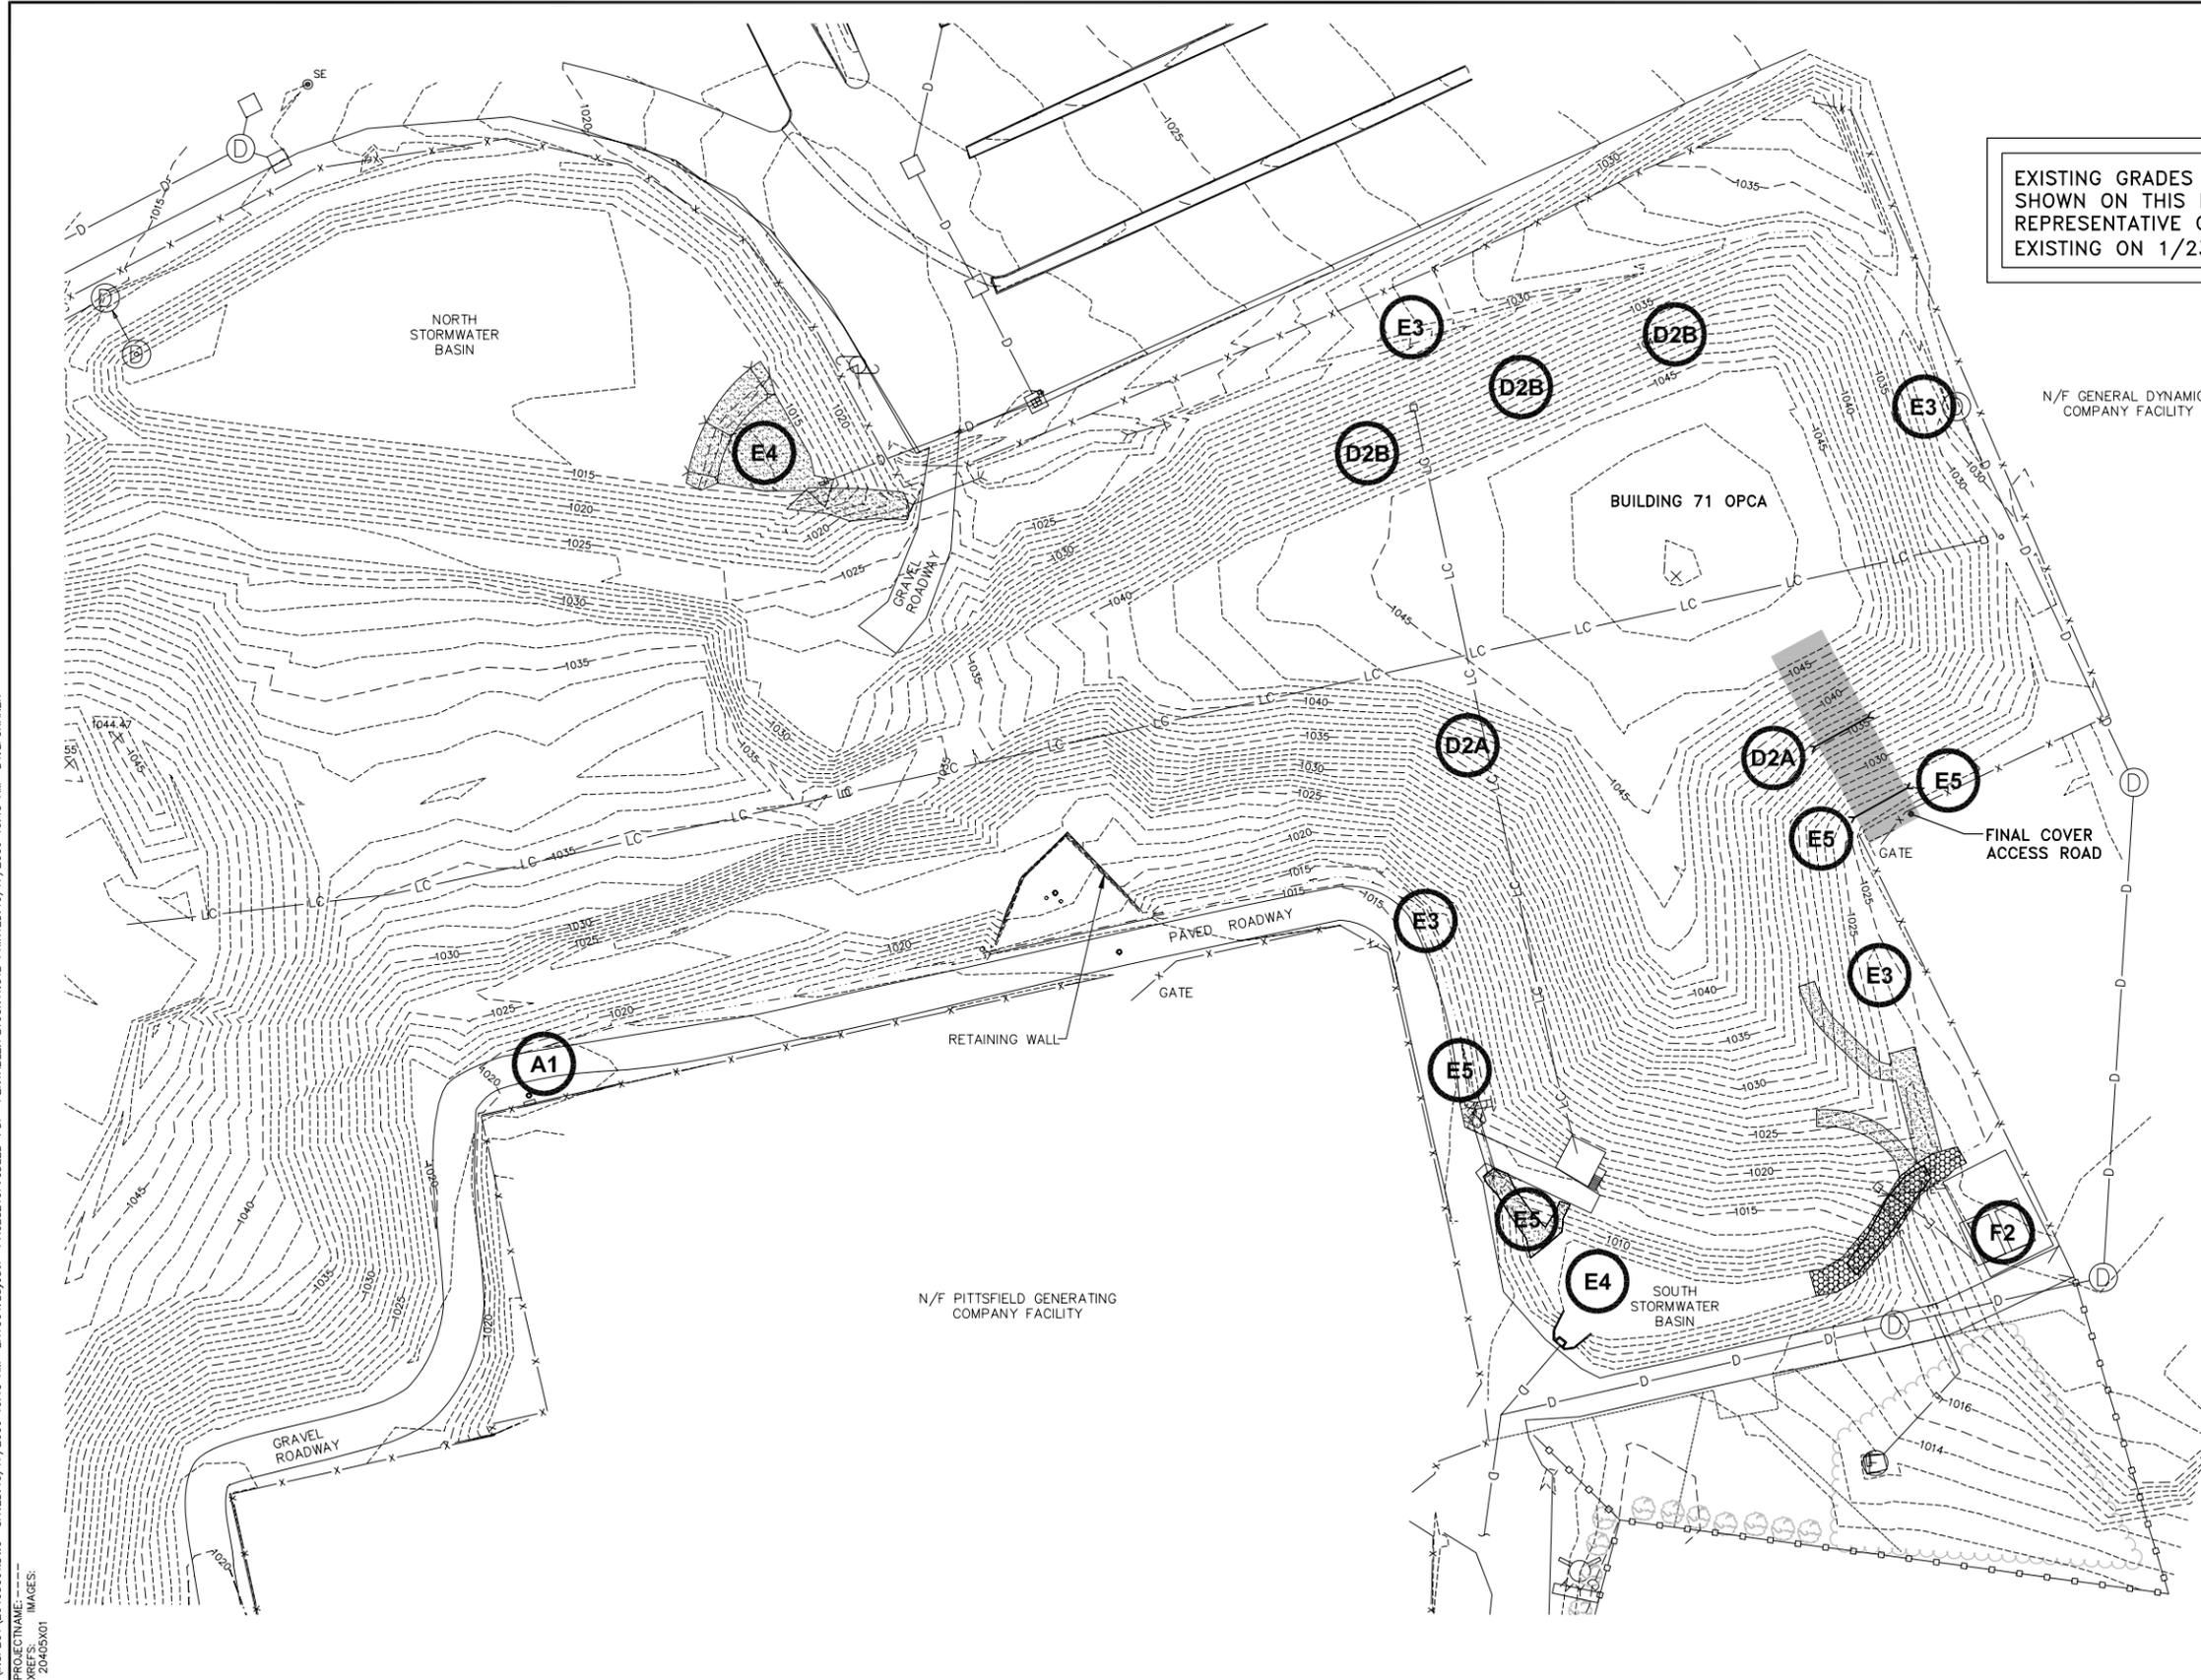
**Figure**

- A1. A pothole was observed at the end of the paved site access road near Hill 78.
- D2. Sideslope erosion was noted in five separate locations. Two locations should be addressed (D2A): one at the eastern slope convergence above the mid-slope swale, and one at the western slope convergence also above the mid-slope swale. The three remaining locations (D2B) should be monitored.

- E2, E3, E5. Excessive vegetation growth and sediment accumulation were observed within the perimeter ditches and drainage/culvert pipes. In addition, debris accumulation was also observed within some of the culvert pipes.

- E4. Excessive vegetation growth and sediment accumulation, as well as erosion of the northern sideslope, adjacent to the paved site access road, was observed within the southern Sedimentation Basin. In addition, the silt screen within the southern Sedimentation Basin outlet structure is not functioning. Within the northern Sedimentation Basin, excessive vegetation growth and sediment accumulation was observed within the forebay area. Insufficient stone was observed around the northern and southern Sedimentation Basin outlet structures.

- F2. Tank access covers need to be painted.
- H1. Site needs to be mowed with minor seeding in select areas.

- A1. Pothole should be repaired.
- D2. Sideslope erosion should be filled with topsoil, regraded, seeded and lined with a temporary erosion control mat.

- E2, E3, E5. Perimeter ditches should be mowed and sediment accumulation removed to restore ditches to design depth. The entire north perimeter ditch, as well as the entire south perimeter ditch east of the retaining wall, should also be regraded and seeded. Temporary erosion control mat should be installed within regraded portion of ditch.

- E4. Sedimentation Basins should be mowed. Sediment should be removed from the south Sedimentation Basin floor as needed to restore original design elevations. The silt screen within the south Sedimentation Basin should be removed. Additional stone should be placed around the northern and southern Sedimentation Basin outlet structures (i.e., a min. of 6 inches above outlet holes).

- F2. Tank access covers should be repainted as part of ongoing maintenance activities.
- H1. Final cover and adjacent areas should be mowed.

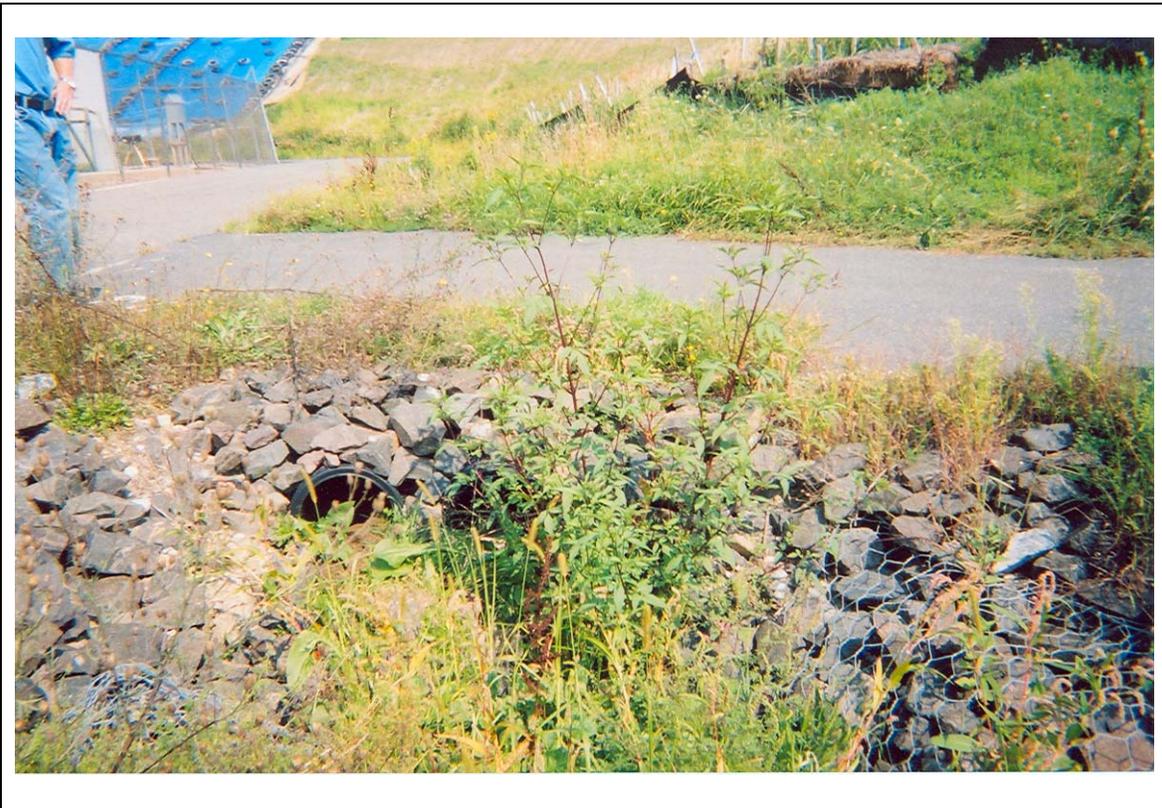
Description: View of southern culvert ends draining into Southern Sedimentation Basin.

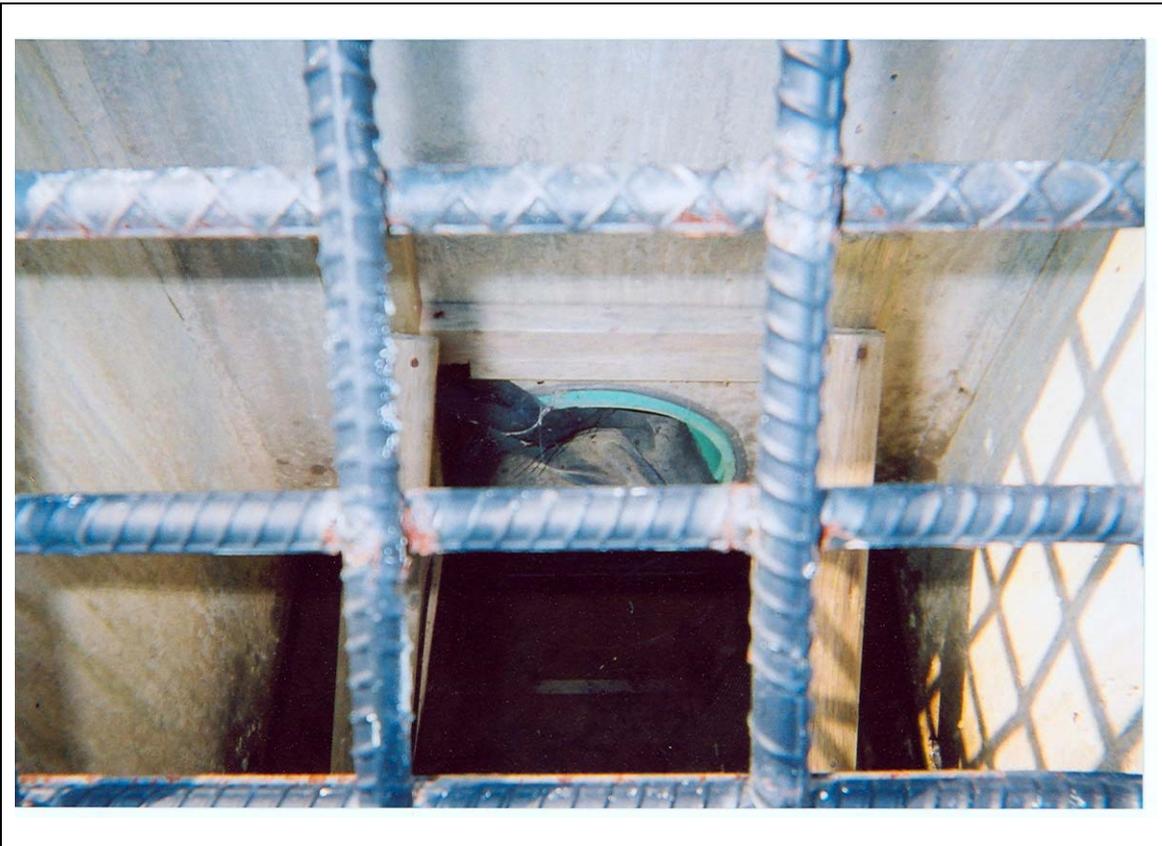
Description: View of Southern Sedimentation Basin Outlet structure.

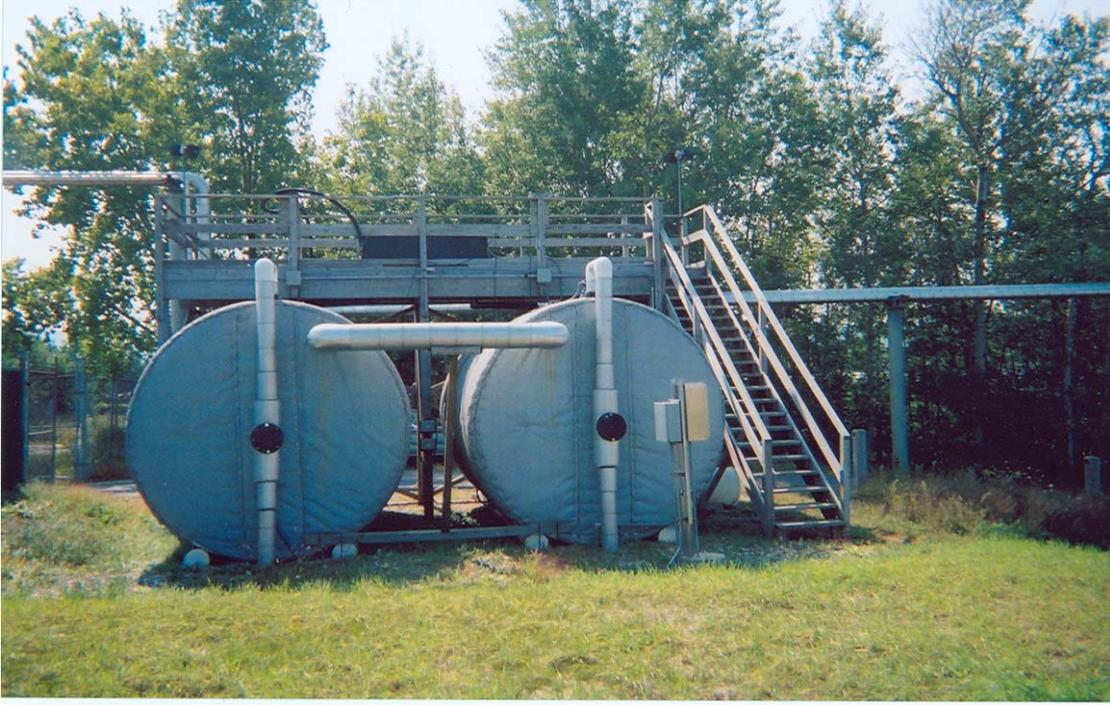
Description: View of leachate storage tanks.

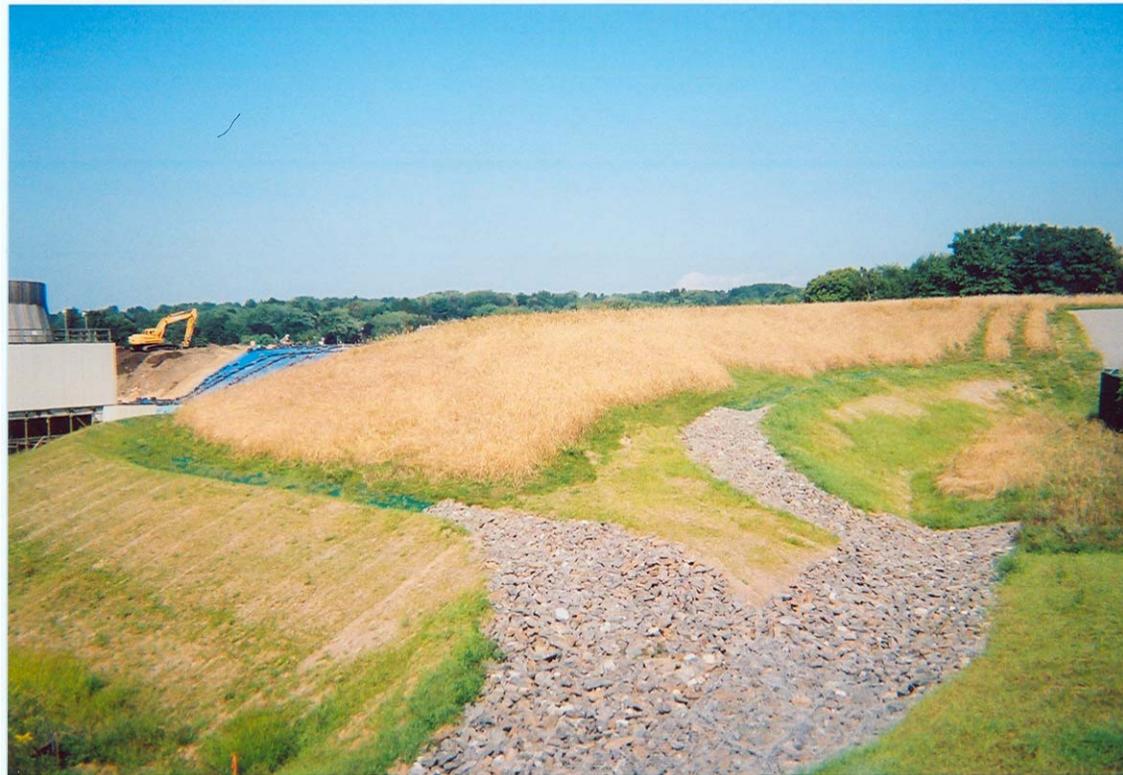
Description: View of mid-slope drainage swale outlets located at southeastern corner of Building 71 OPCA.

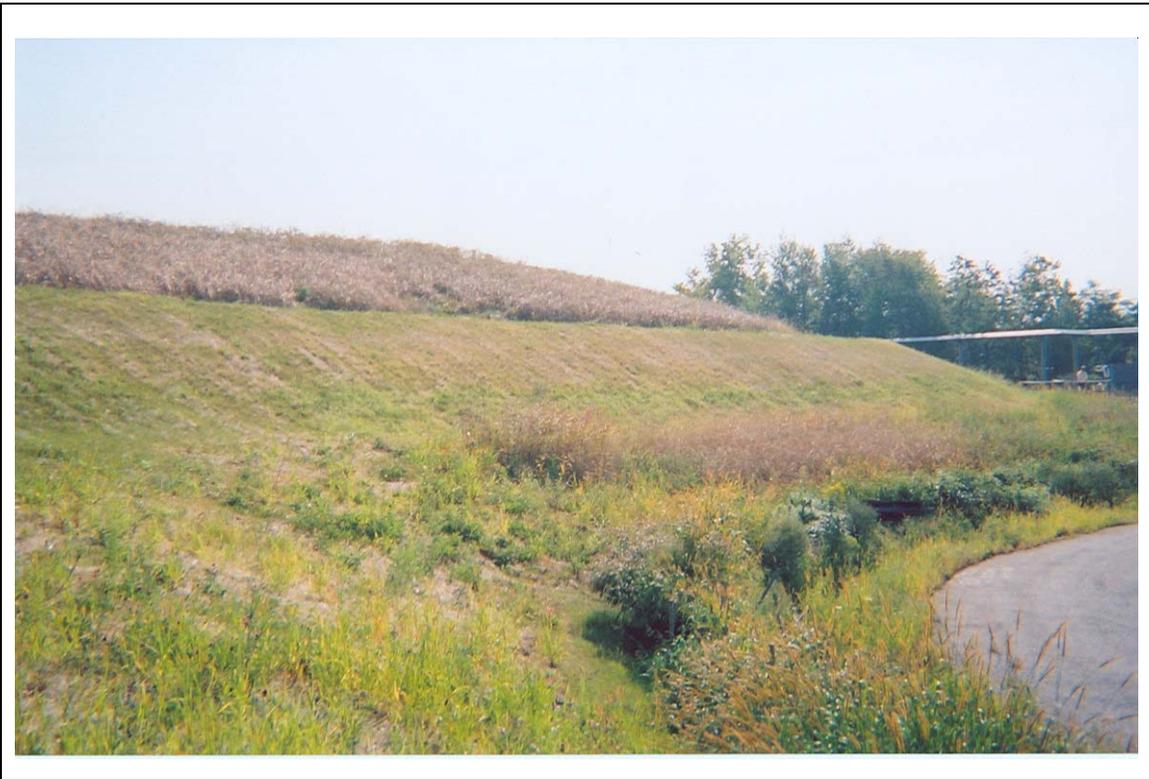
Description: View of southwestern slope of Building 71 OPCA.

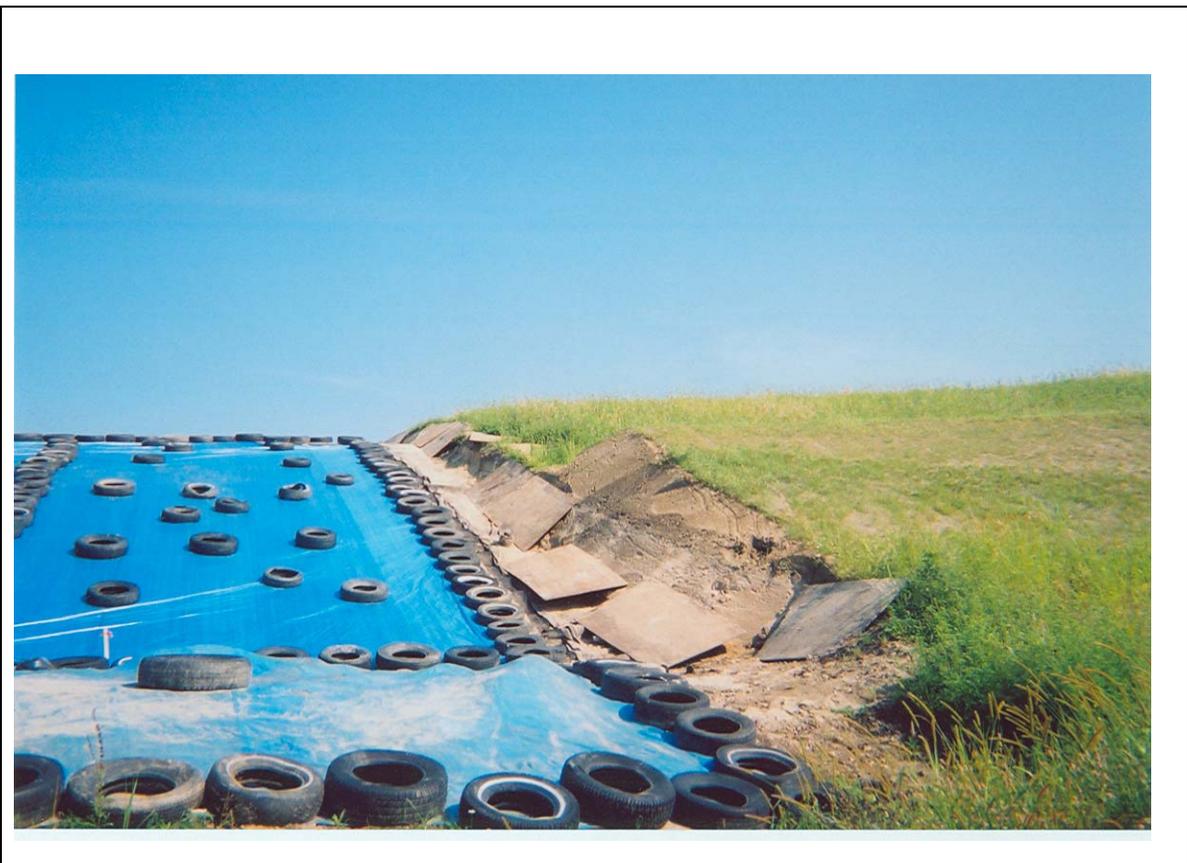
Description: View of exposed existing liner system in preparation for future tie-in.

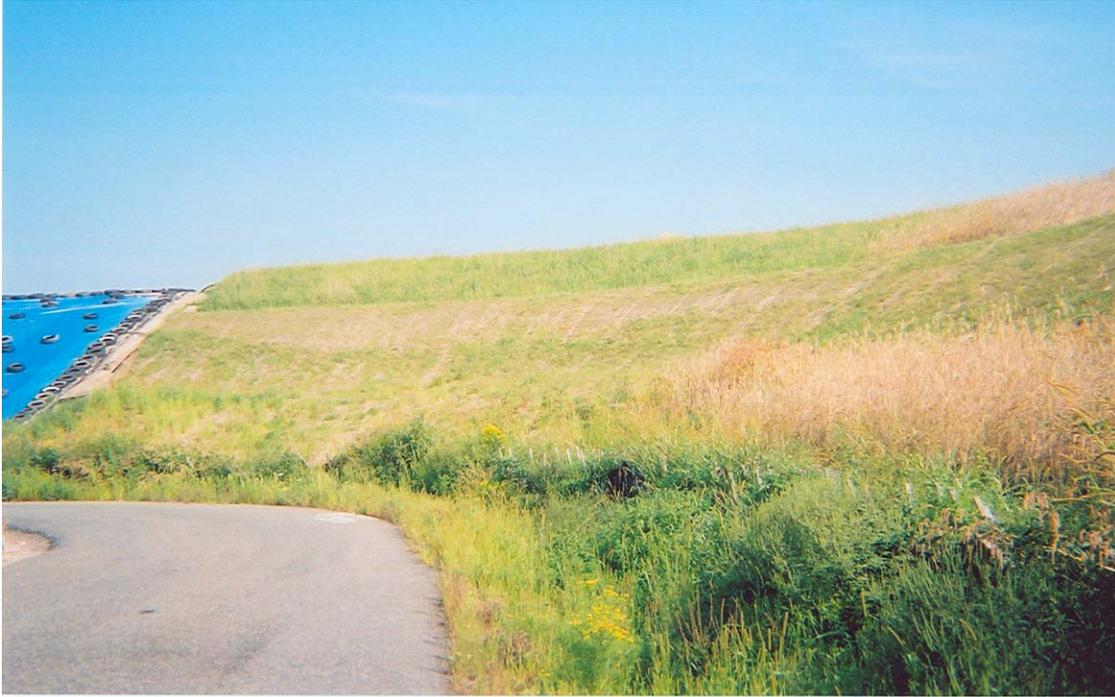
Description: View of southern slope of Building 71 OPCA.

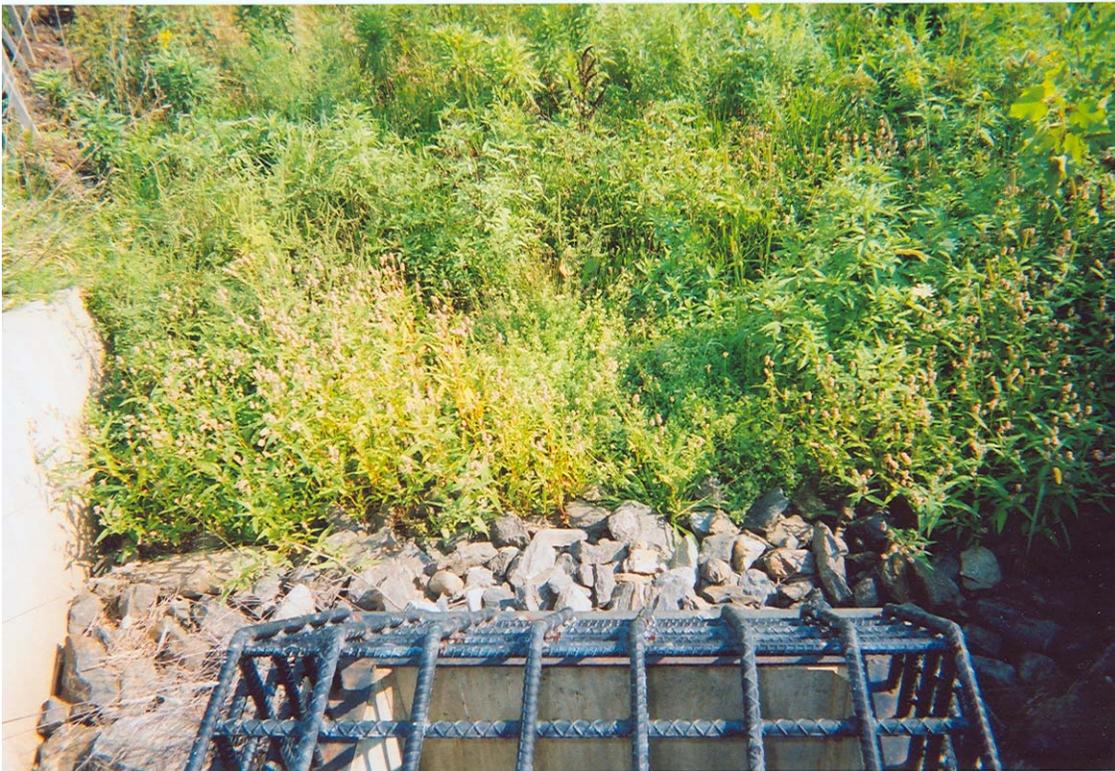
Description: View of vegetation and rip-rap at outlet structure with Southern Sedimentation Basin.

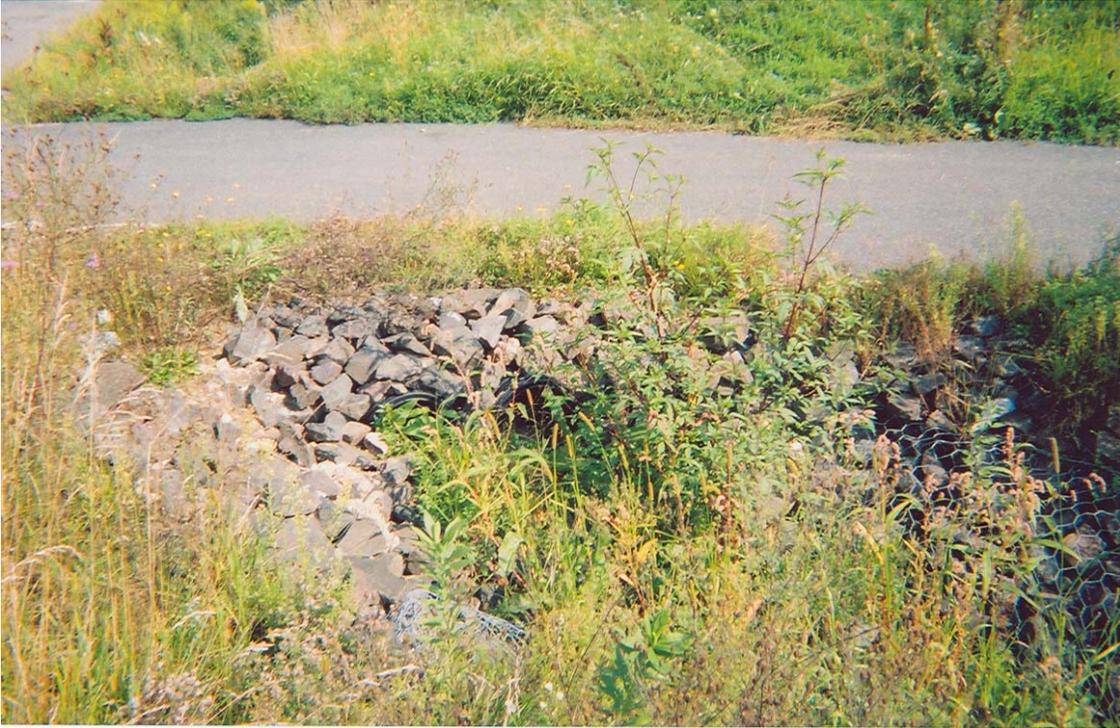
Description: View of southern culvert ends drainage into Southern Sedimentation Basin.

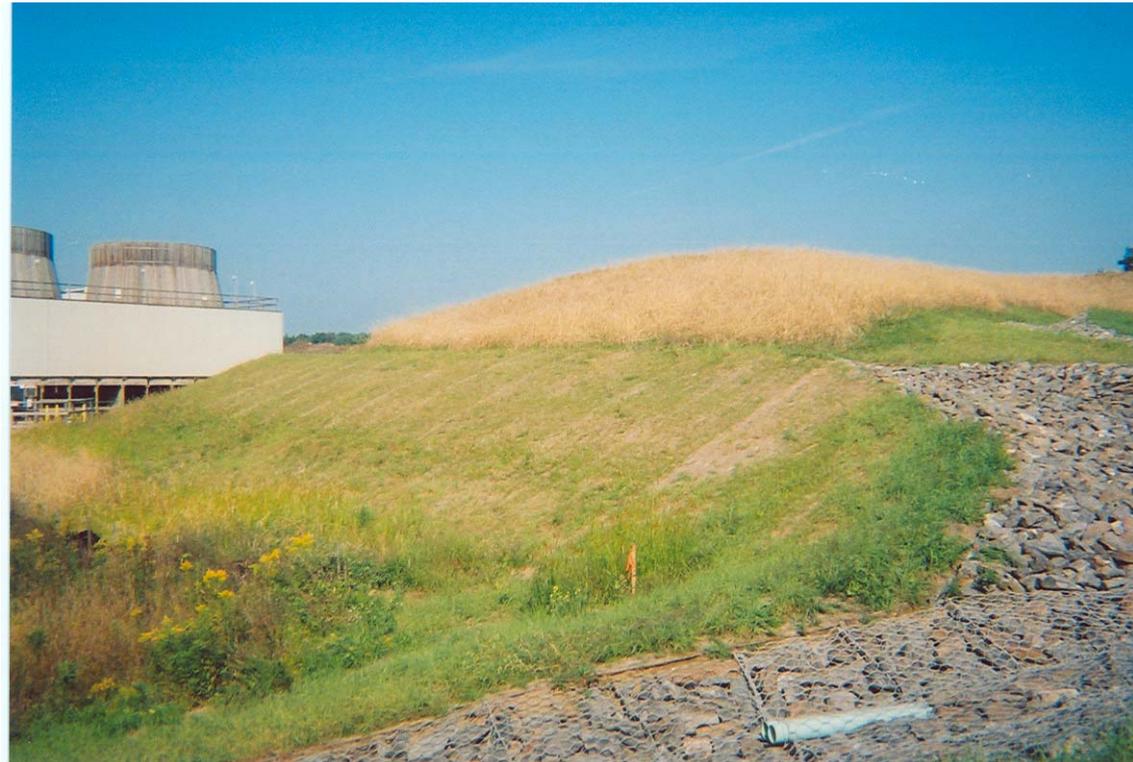
Description: View of southern slope of Building 71 OPCA.

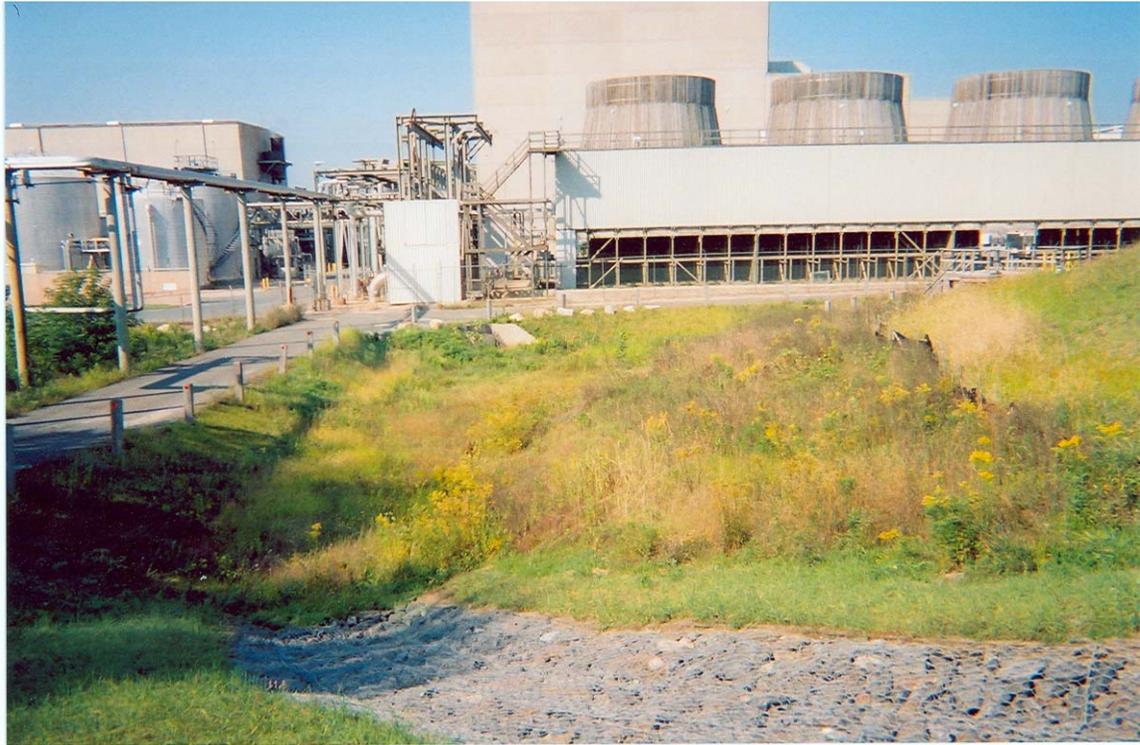
Description: View of Southern Sedimentation Basin (looking west).

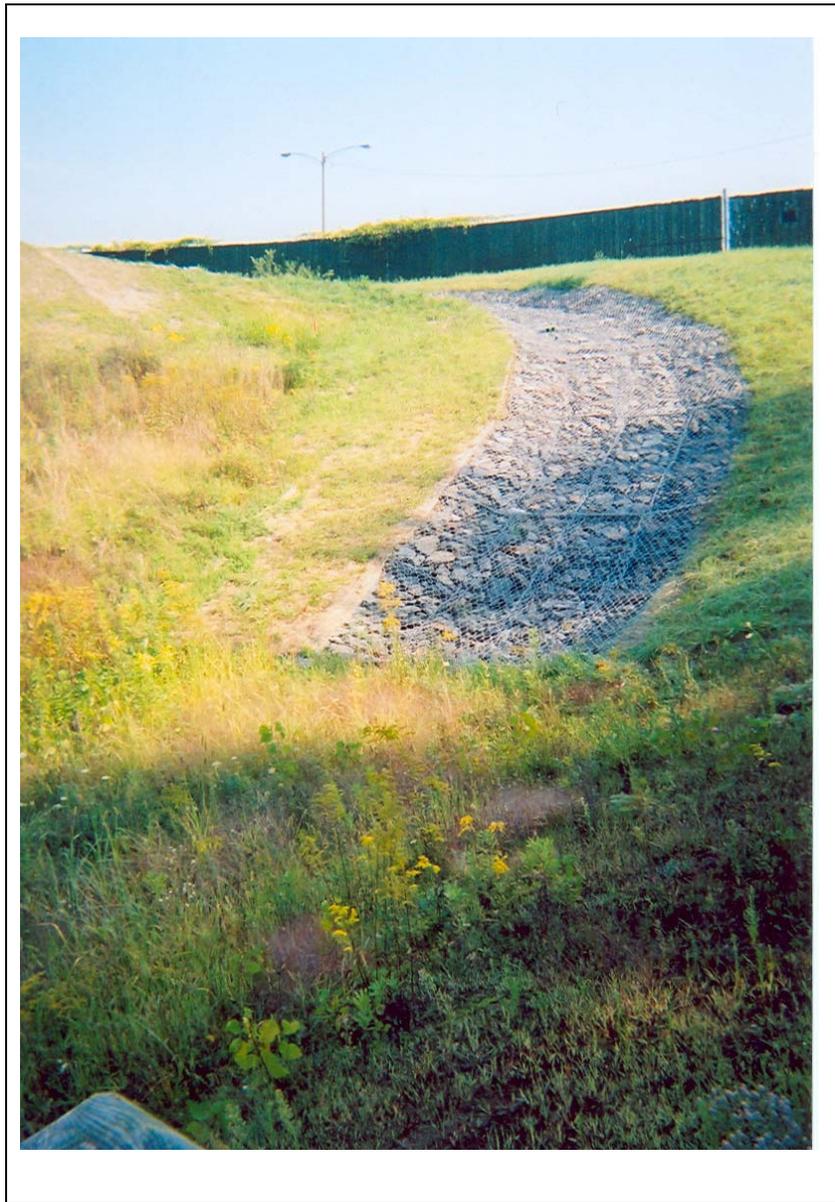
Description: View of drainage swale located at eastern corner of Southern Sedimentation Basin.

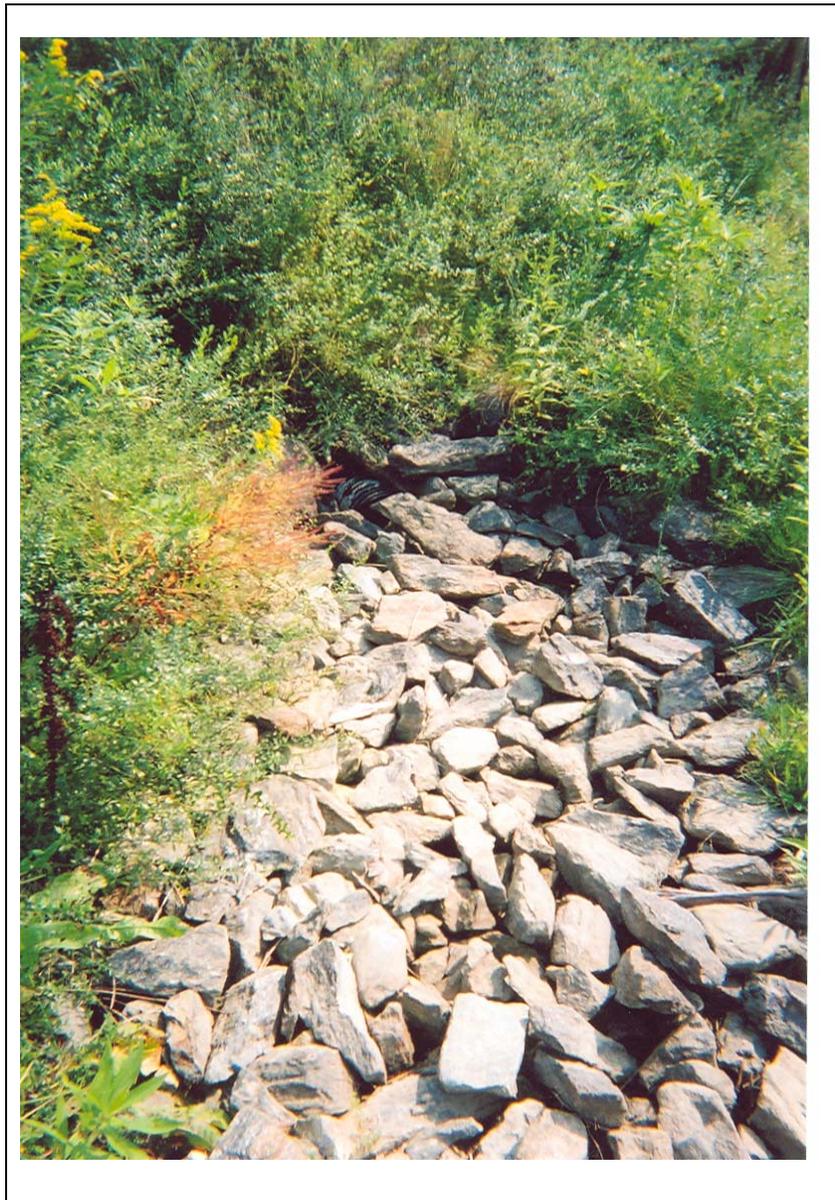
Description: View of drainage pipe located along northern slope of Building 71 OPCA.

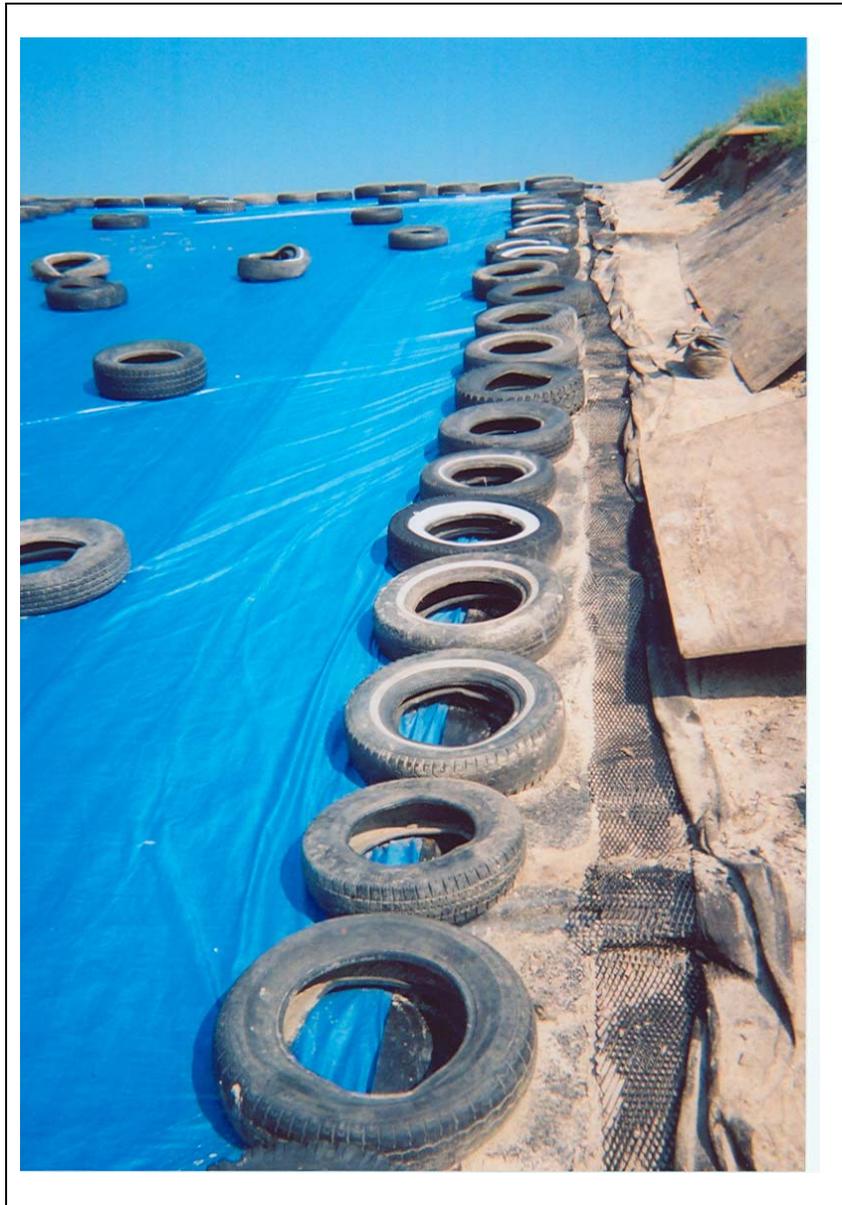
Description: View of exposed existing liner in preparation for future tie-in.

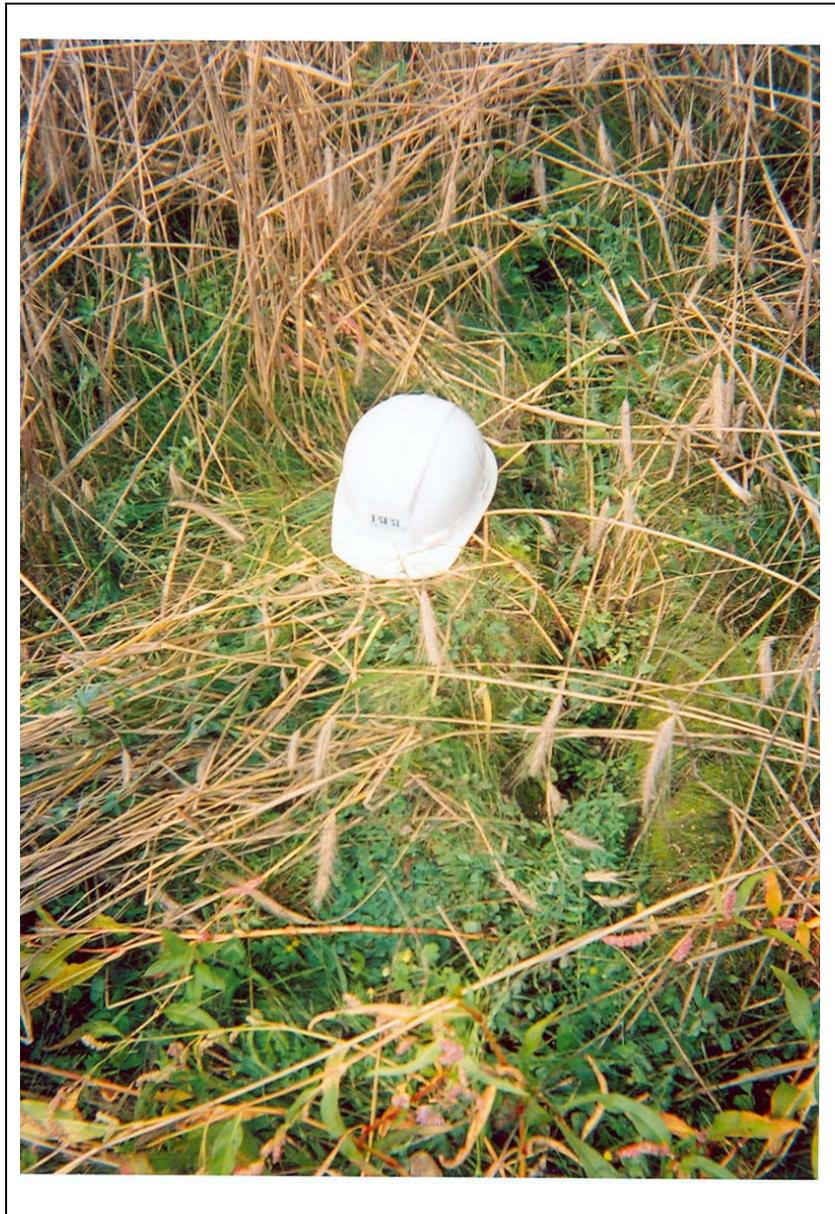
Description: View of an erosion fill on northern slope of Building 71 OPCA.
