**THIRD FIVE-YEAR REVIEW
FOR THE
MID-SOUTH WOOD PRODUCTS SUPERFUND SITE
MENA, ARKANSAS**

SEPTEMBER 2007

**UNITED STATES ENVIRONMENTAL PROTECTION AGENCY
REGION 6
DALLAS, TEXAS**

**THIRD FIVE-YEAR REVIEW FOR
MID-SOUTH WOOD PRODUCTS SUPERFUND SITE
MENA, ARKANSAS
EPA ID# ARD092916188**

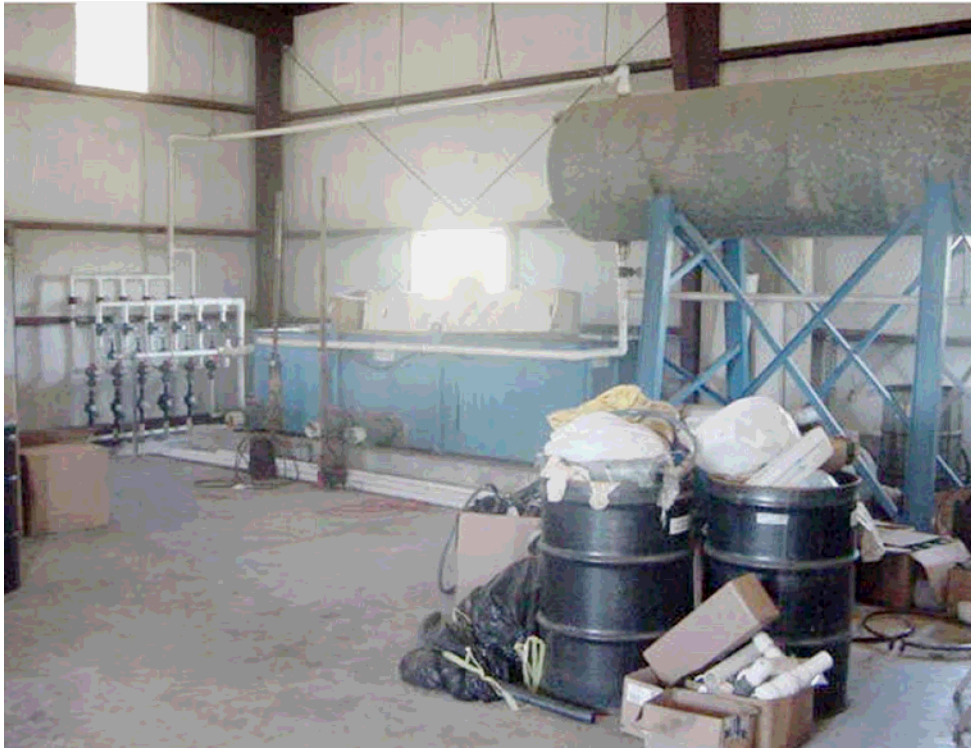
Photo 1: Oil-Water separator within wastewater treatment plant (WWTP)

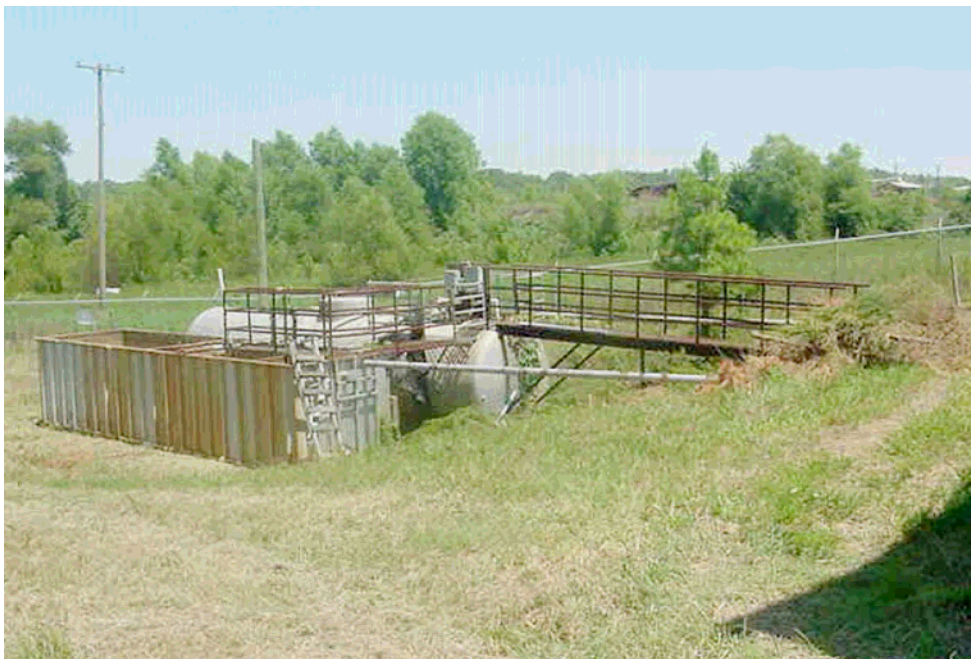
Photo 2: Storage and Overflow tanks north of (WWTP)

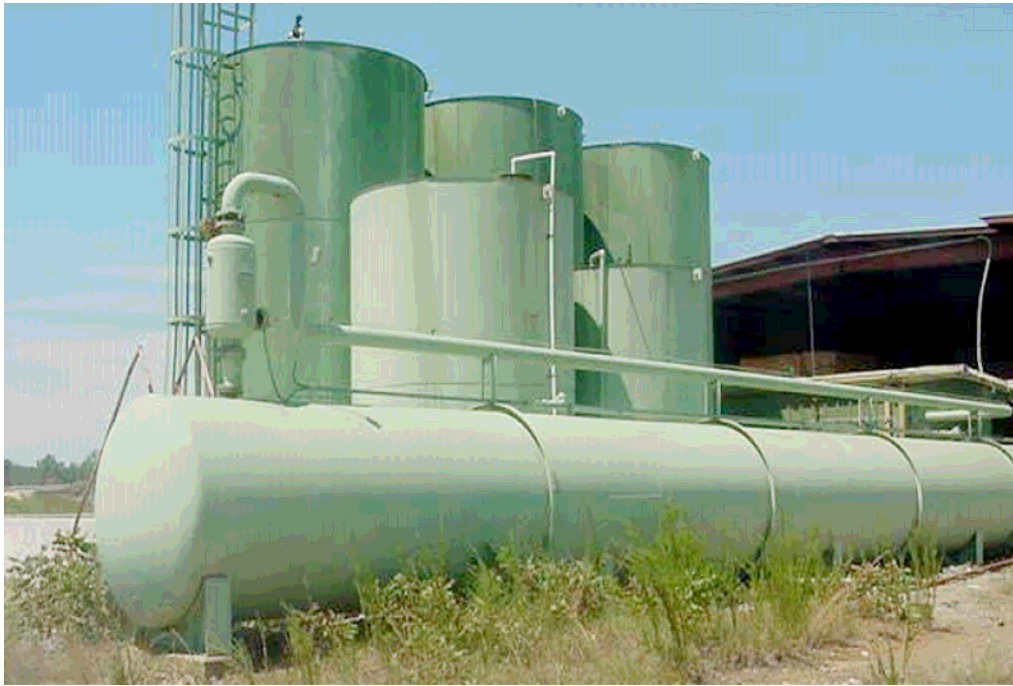
Photo 3: Chromated Copper Arsenate (CCA) treatment cylinder and storage tanks

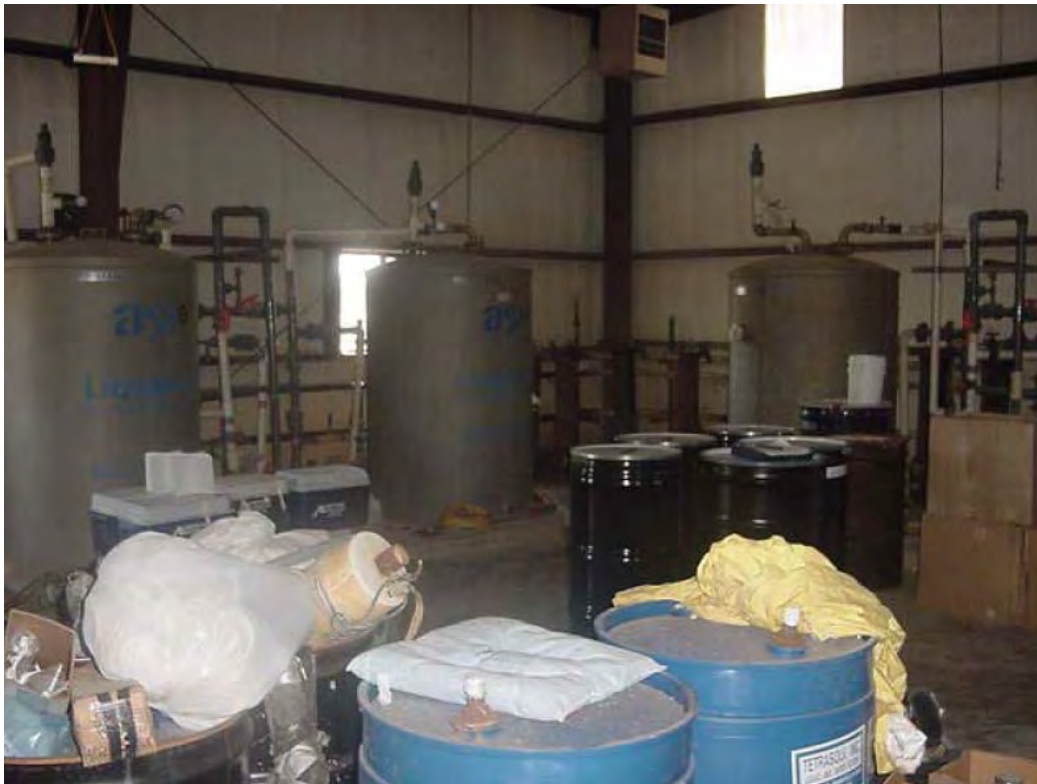
Photo 6: Activated carbon canisters and fabric filters on south side of WWTP
