**Re: GE Pittsfield/Housatonic River Site  
Upper ½-Mile Reach of Housatonic River (GEC800)  
2011 Inspection of Aquatic Habitat Enhancement Structures and Armor Stone**

SUBJ: **Upper ½-Mile Reach of the Housatonic River  
2011 Monitoring Visit Trip Report  
Inspection of Aquatic Habitat Enhancement Structures/Armor Stone**

DATE: September 22, 2011

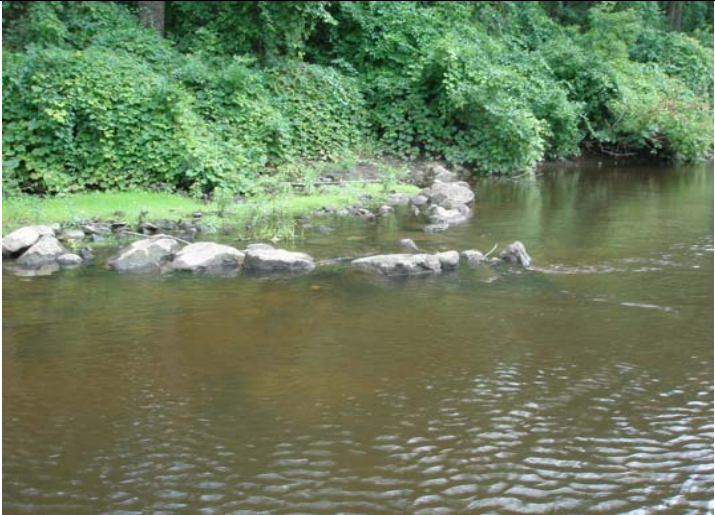
Cell	Aquatic Structures	Aquatic Structure Condition/General Biological Observations	
B	1. Single wing deflector

<div style="border: 1px solid black; padding: 10px;"> <ol style="list-style-type: none"> <li>1. Structures appear stable</li> <li>2. Structure induced variations observed in areas immediately downstream of the deflector</li> </ol> </div>

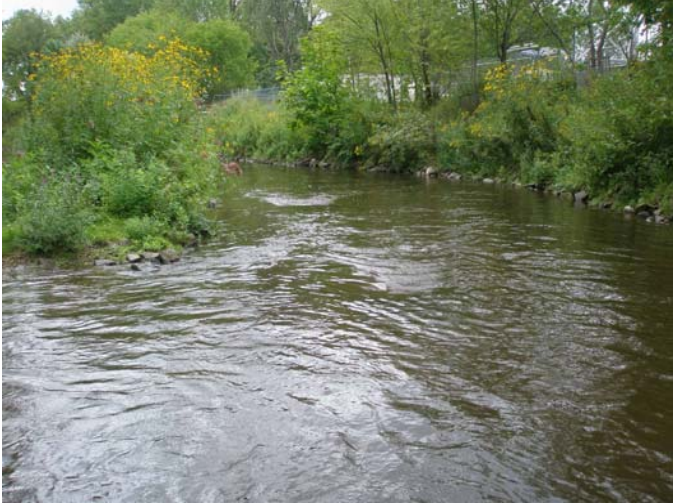
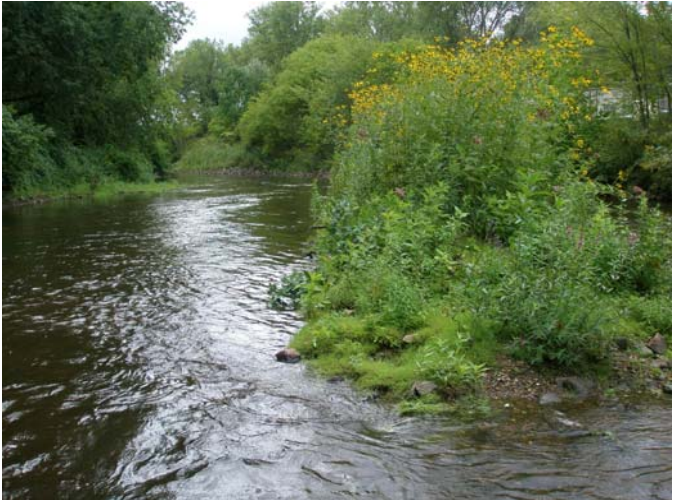
Cell	Aquatic Structures	Aquatic Structure Condition/General Biological Observations	
C	<ol style="list-style-type: none"> <li>1. Boulders</li> <li>2. Island</li> </ol>

<div style="border: 1px solid black; padding: 10px;"> <ol style="list-style-type: none"> <li>1. Structures appear stable</li> <li>2. Structure induced variations observed in areas immediately downstream of the island</li> <li>3. The island is well vegetated with wetland herbaceous species</li> <li>4. Boulders near island are causing scouring in the immediate area; good cover</li> </ol> </div>

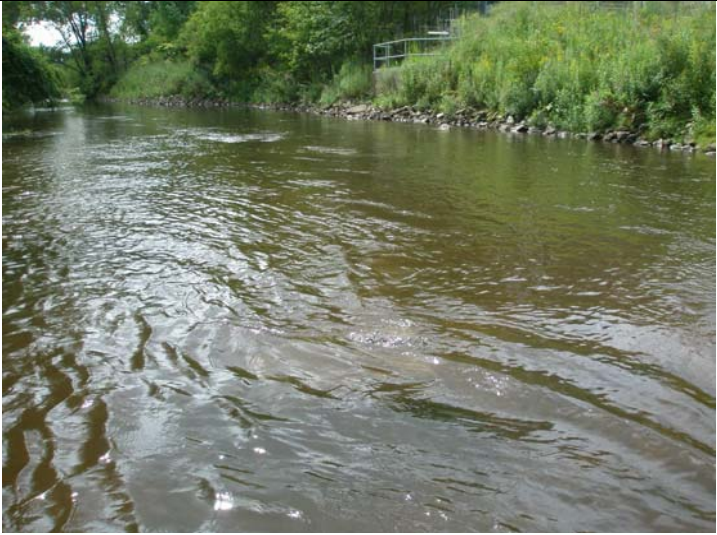
Cell	Aquatic Structures	Aquatic Structure Condition/General Biological Observations	
D	1. Boulders

<p>1. Structures were functional and providing variation in habitat</p>
G1	1. Boulder Cluster

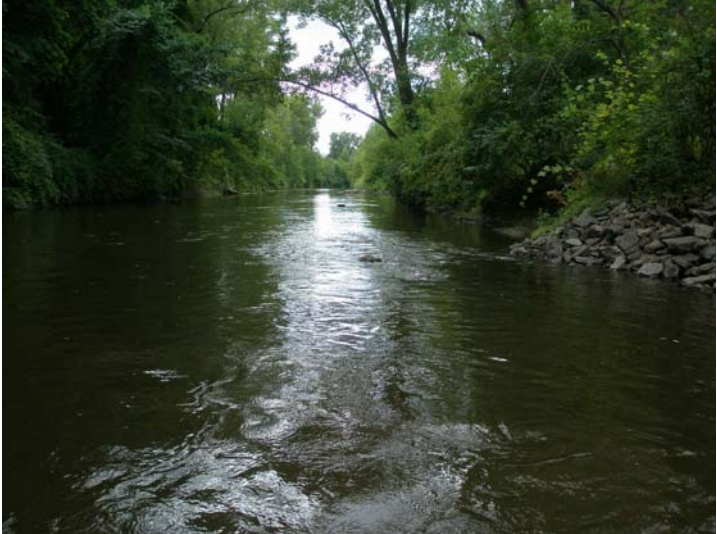
<p>1. Structures were functional and providing variation in habitat</p>

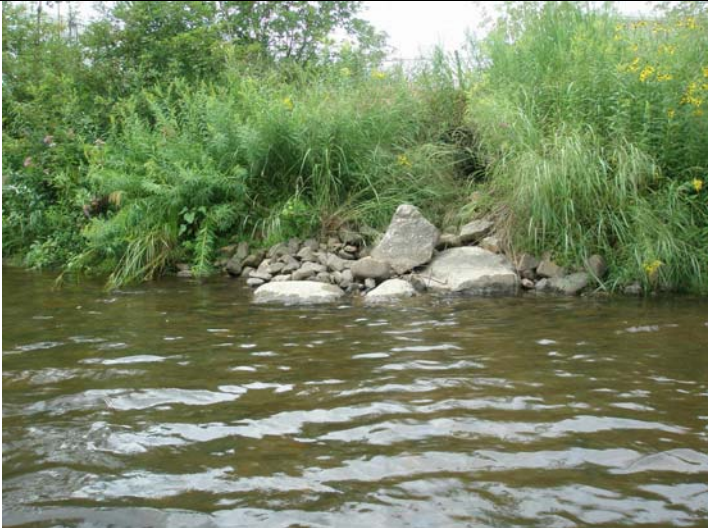
Cell	Aquatic Structures	Aquatic Structure Condition/General Biological Observations	
G2/F2	1. W-weir

<div data-bbox="1304 380 1894 620" style="border: 1px solid black; padding: 10px;"> <ol style="list-style-type: none"> <li>1. Much of the weir is buried in soft silt/sand; portion that is present appears to offer good cover for aquatic organisms</li> </ol> </div>
G3	1. Three-boulder cluster

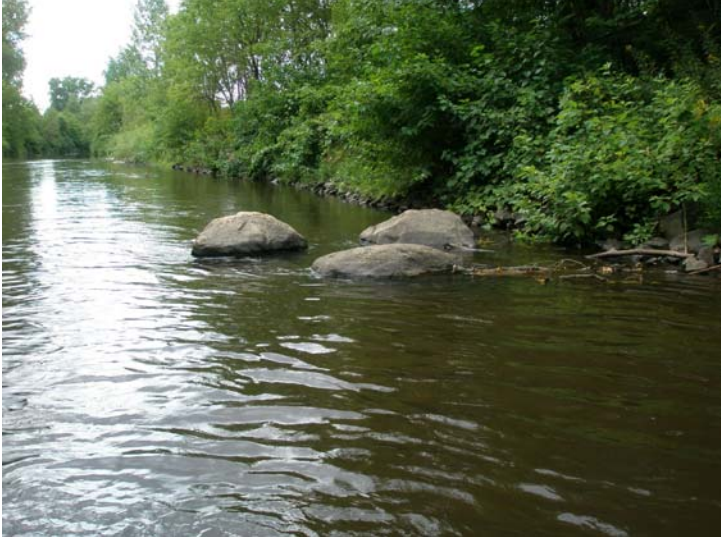
<div data-bbox="1304 971 1894 1221" style="border: 1px solid black; padding: 10px;"> <ol style="list-style-type: none"> <li>1. Structure appeared stable, no issue or concern</li> <li>2. Structure was functional and providing variation in habitat</li> </ol> </div>

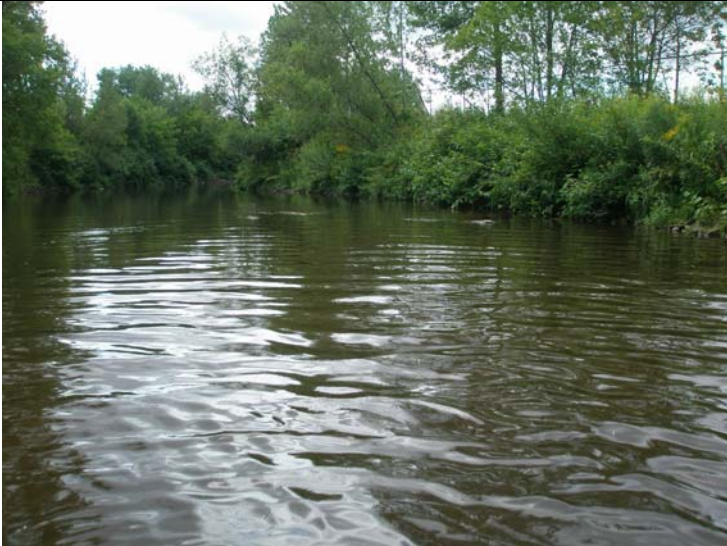
Cell	Aquatic Structures	Aquatic Structure Condition/General Biological Observations	
F3	<ol style="list-style-type: none"> <li>1. Three-boulder cluster</li> <li>2. Two-boulder cluster</li> <li>3. Three-boulder cluster</li> </ol>

<ol style="list-style-type: none"> <li>1. All structures in this cell appear stable</li> <li>2. Structures appear to be providing diversity in habitat</li> </ol>
H1	<ol style="list-style-type: none"> <li>1. Boulder cluster</li> </ol>

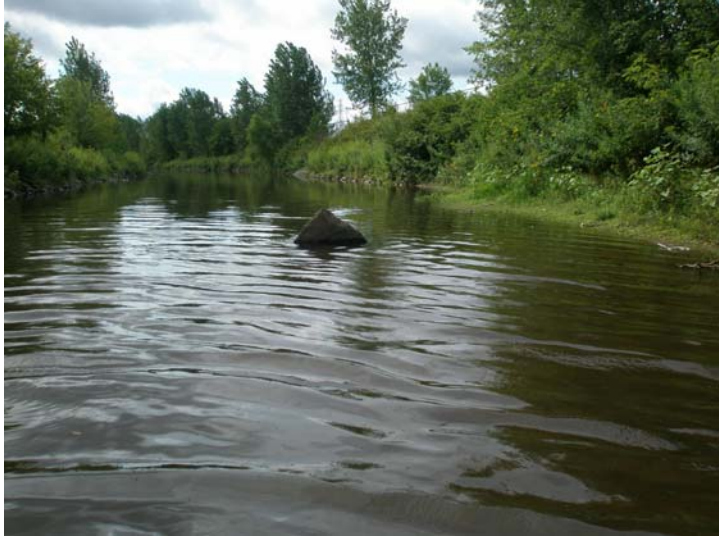
<ol style="list-style-type: none"> <li>1. Structure appears stable and is providing diversity in habitat</li> <li>2. Good habitat, variations in velocity around structure producing variations in stream bottom topography</li> </ol>

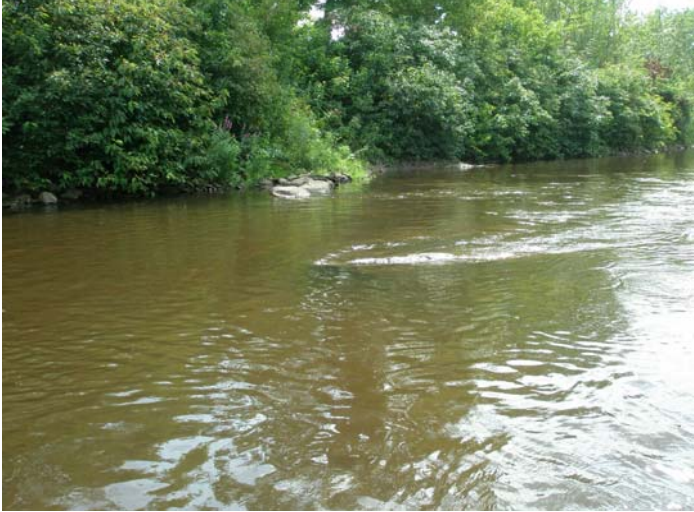
Cell	Aquatic Structures	Aquatic Structure Condition/General Biological Observations	
I1/J1	1. Vortex weir

<ol style="list-style-type: none"><li>1. Much of the weir is buried in soft silt/sand</li><li>2. Structure appears stable and is providing diversity in habitat</li><li>3. Good habitat, variations in velocity</li></ol>
H2	1. Single boulder

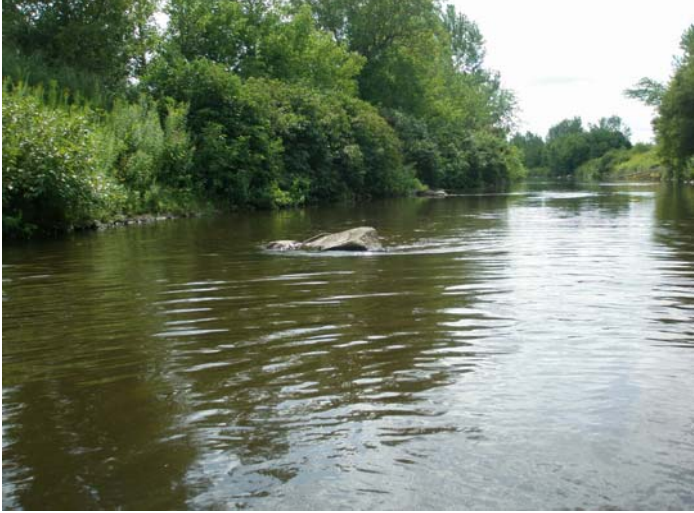
<ol style="list-style-type: none"><li>1. Structure appears stable and is providing diversity in habitat</li><li>2. Good habitat, variations in velocity around structure producing variations in stream bottom topography</li></ol>

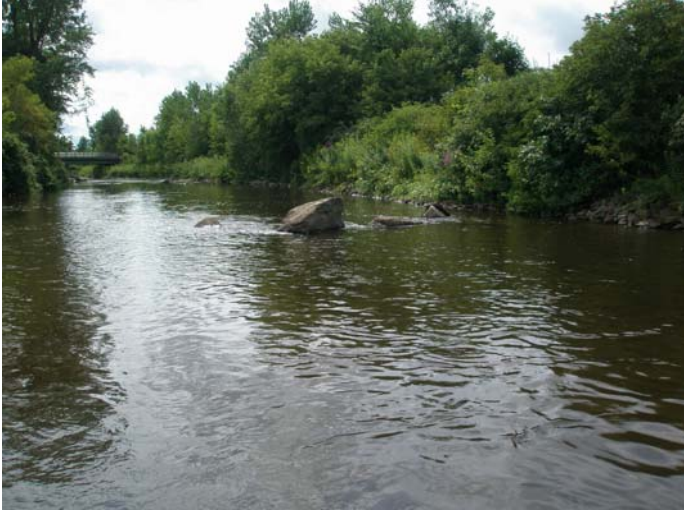
Cell	Aquatic Structures	Aquatic Structure Condition/General Biological Observations	
J1	<ol style="list-style-type: none"> <li>1. Two-boulder cluster</li> <li>2. Three-boulder cluster</li> <li>3. Single-boulder</li> </ol>

<div style="border: 1px solid black; padding: 10px;"> <ol style="list-style-type: none"> <li>1. Structures appears stable and is providing diversity in habitat</li> <li>2. Good habitat, variations in velocity around structures producing variations in stream bottom topography</li> <li>3. Boulders are being used as perches for feeding birds</li> </ol> </div>
J2	<ol style="list-style-type: none"> <li>1. "J"- boulder formation</li> </ol>

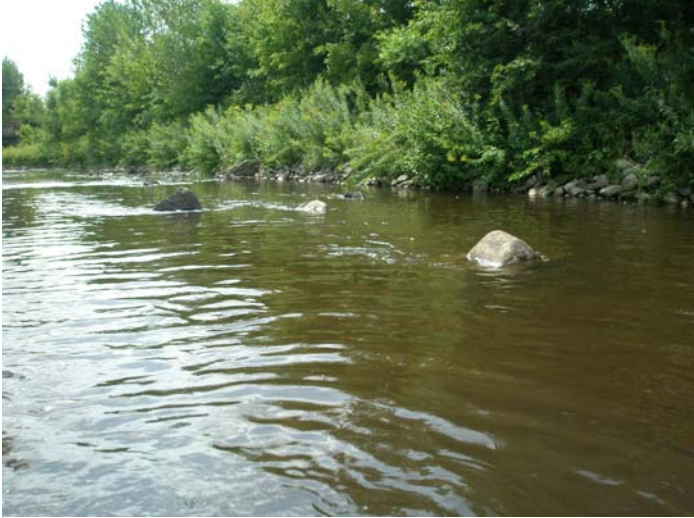
<div style="border: 1px solid black; padding: 10px;"> <ol style="list-style-type: none"> <li>1. Structure appears stable and is providing diversity in habitat</li> <li>2. Good habitat, variations in velocity around structure producing variations in stream bottom topography</li> </ol> </div>

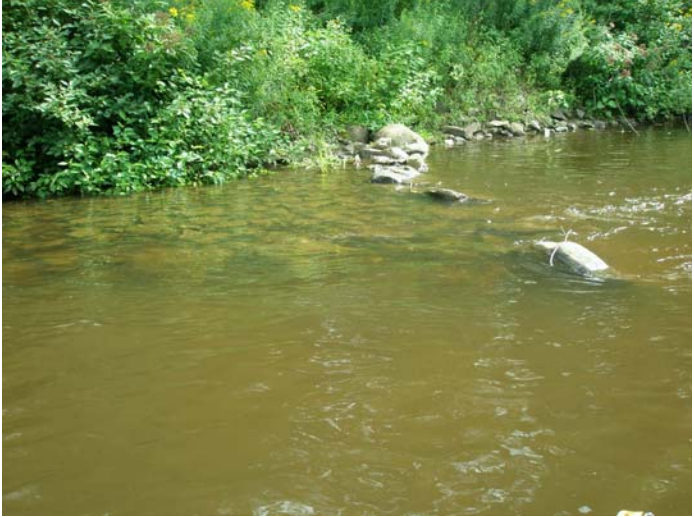
Cell	Aquatic Structures	Aquatic Structure Condition/General Biological Observations	
I3	1. Single-wing deflector

<ol style="list-style-type: none"><li>1. Structure appears stable and is providing diversity in habitat</li><li>2. Good habitat, variations in velocity around structure producing variations in stream bottom topography</li></ol>
I3/J3	1. Vortex rock weir

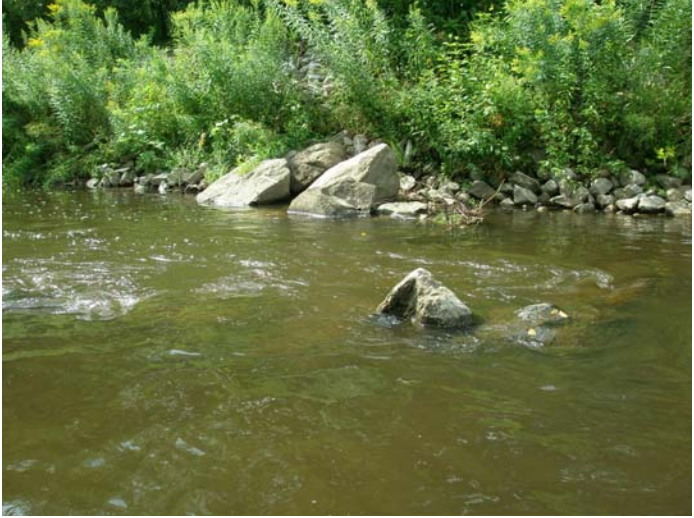
<ol style="list-style-type: none"><li>1. Structure appears stable and is providing diversity in habitat</li><li>2. Good habitat, variations in velocity around structure producing variations in stream bottom topography</li></ol>

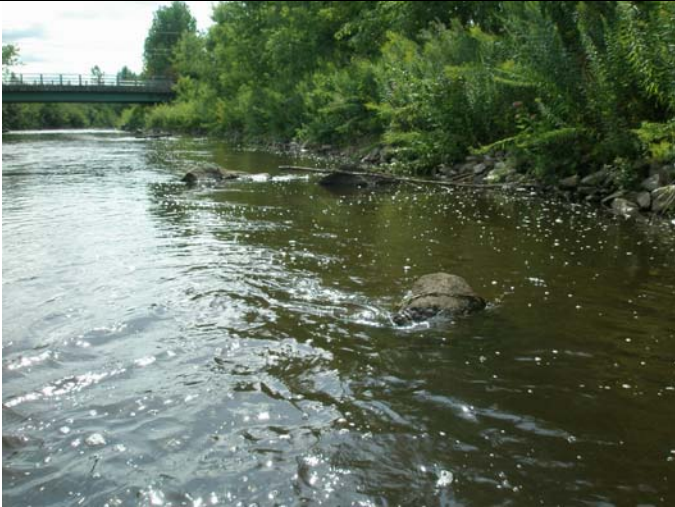
Cell	Aquatic Structures	Aquatic Structure Condition/General Biological Observations	
J3	<ol style="list-style-type: none"><li>1. Boulder cluster</li><li>2. Three-boulder cluster</li><li>3. Three-boulder cluster</li></ol>

<ol style="list-style-type: none"><li>1. Structures appears stable and is providing diversity in habitat</li><li>2. Good habitat, variations in velocity around structures producing variations in stream bottom topography</li></ol>
