**PHOTOGRAPH LOG**

<b>Project Name</b>	<i>Republic Steel Corp. Quarry, Elyria, Ohio - USEPA Region V</i>
---------------------	---

<p><b>Project:</b> 1131.003 <b>Date:</b> 8/25/03 <b>Photographed By:</b> <i>Hilary Janousek</i></p>

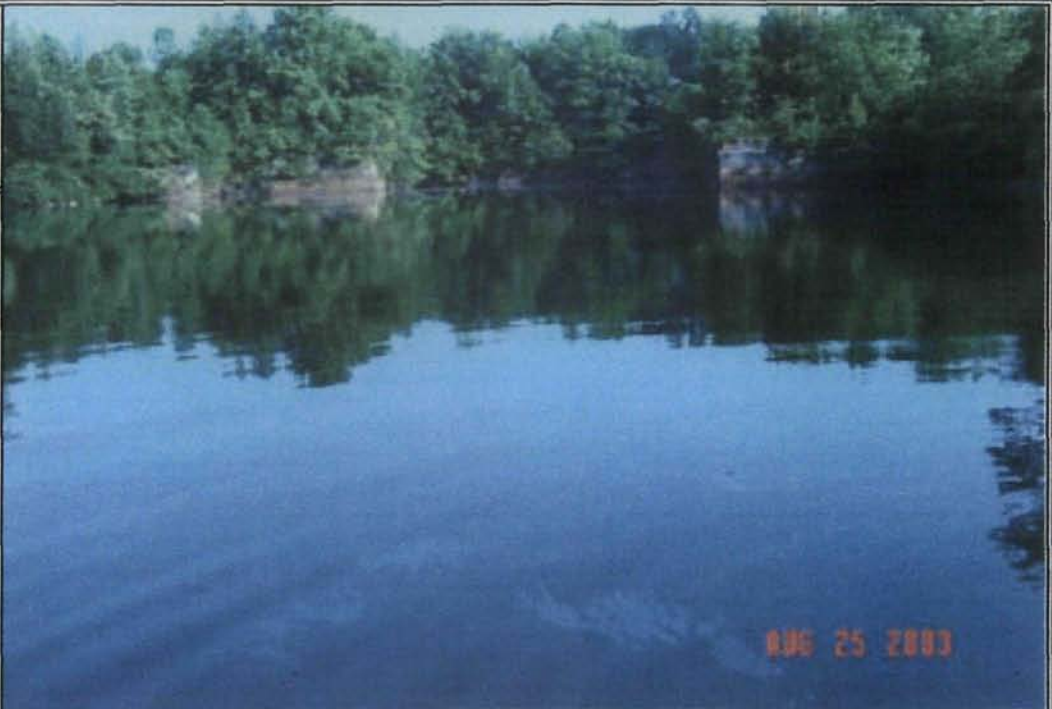
<p><b>Description:</b> <i>View of the Republic Steel Corp. Quarry as seen from the boat ramp on the south end of the quarry.</i></p> <p><b>PHOTO #1</b></p>

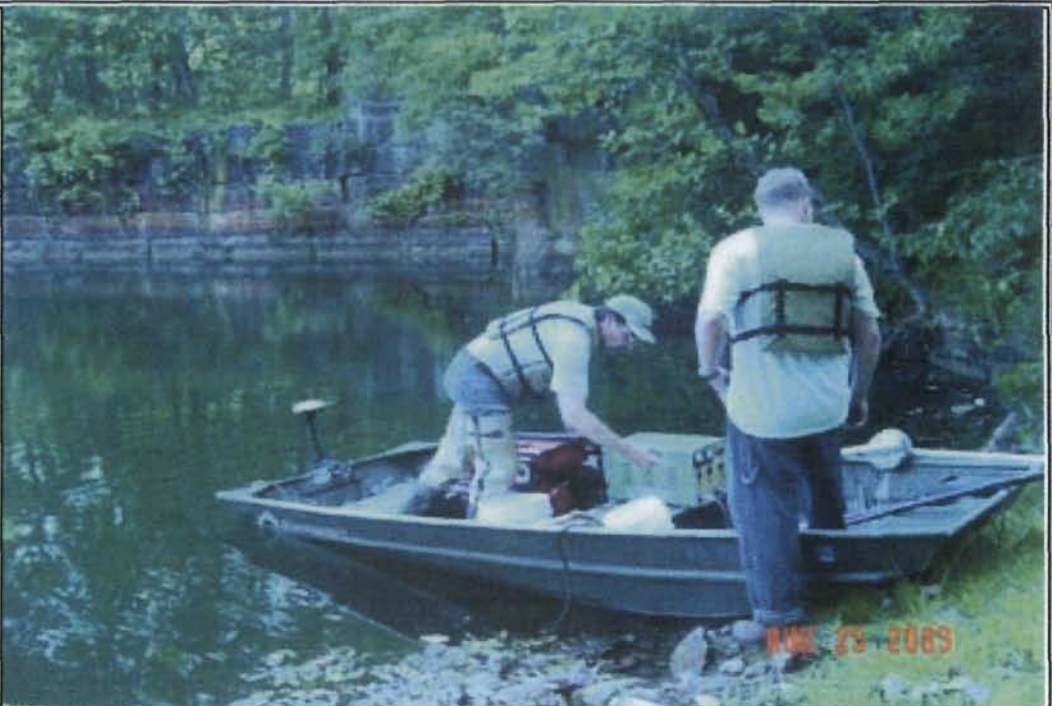
<p><b>Description:</b> <i>View of flat boat with electroshock fishing equipment docked at the boat ramp.</i></p> <p><b>PHOTO #2</b></p>

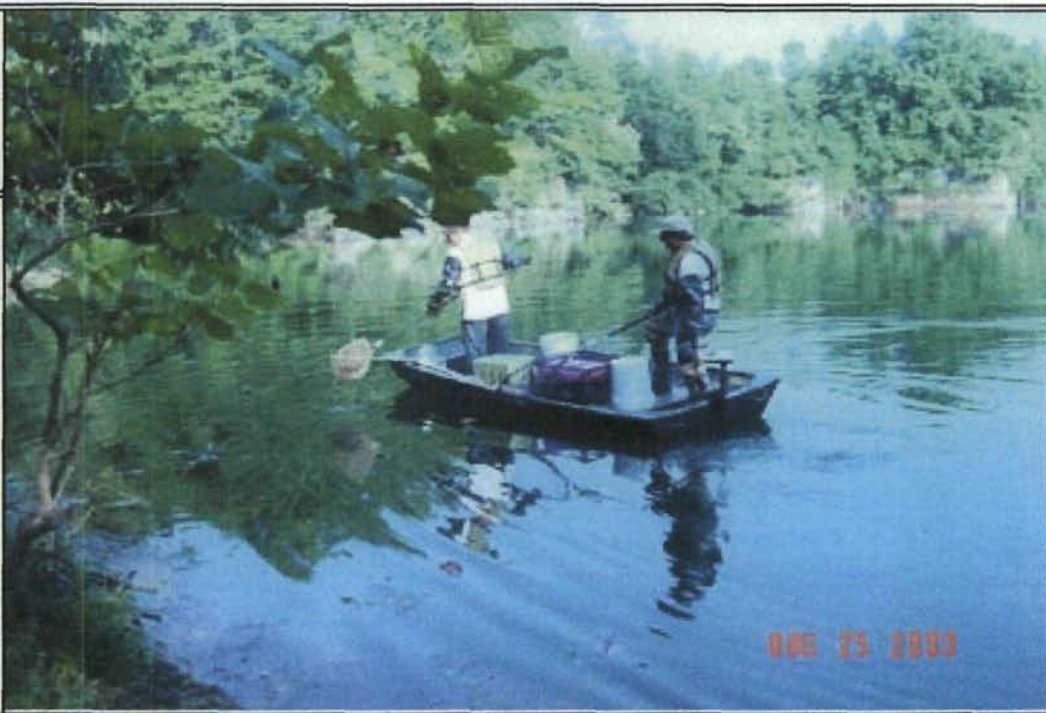
**PHOTO #3**

*View of electroshock fishing activities in the quarry.*

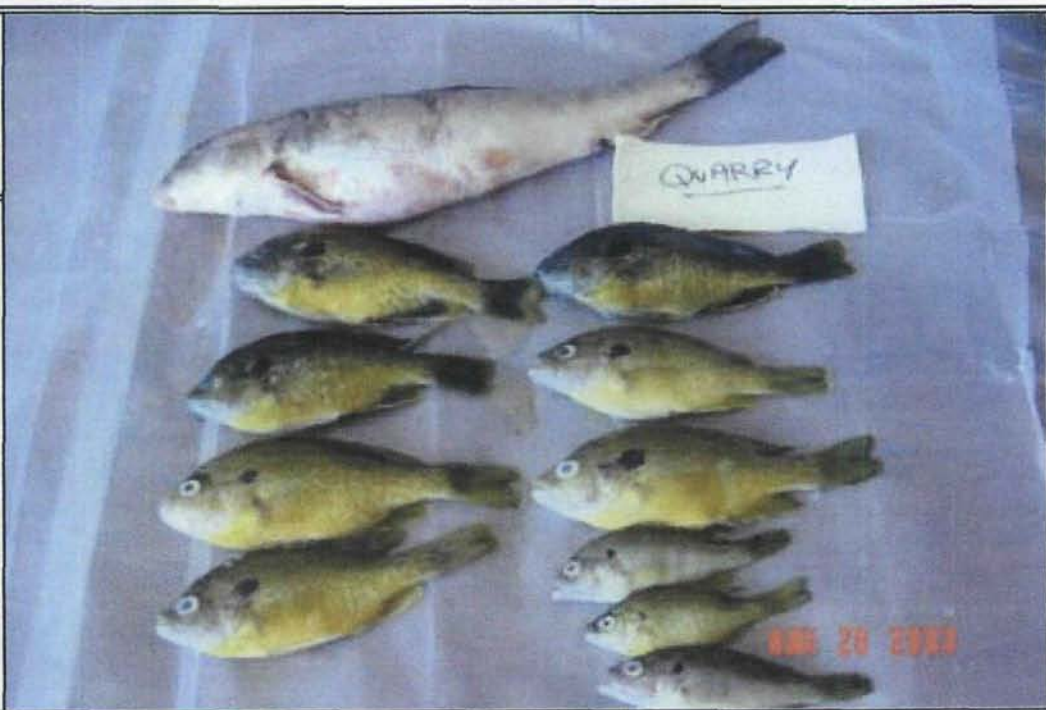
**PHOTO #4**

*View of fish collected from the quarry submitted for sample analysis.*

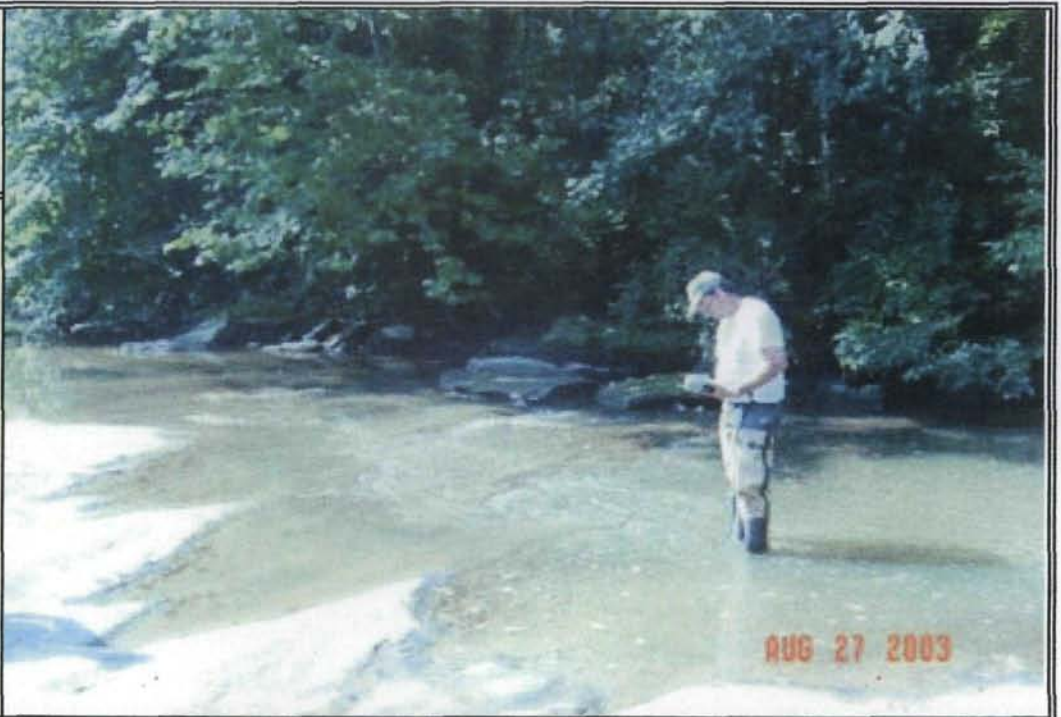
**PHOTO #5**

**Description:**  
*View of C. Young measuring the conductivity of the water using a YSI multi parameter field instrument*

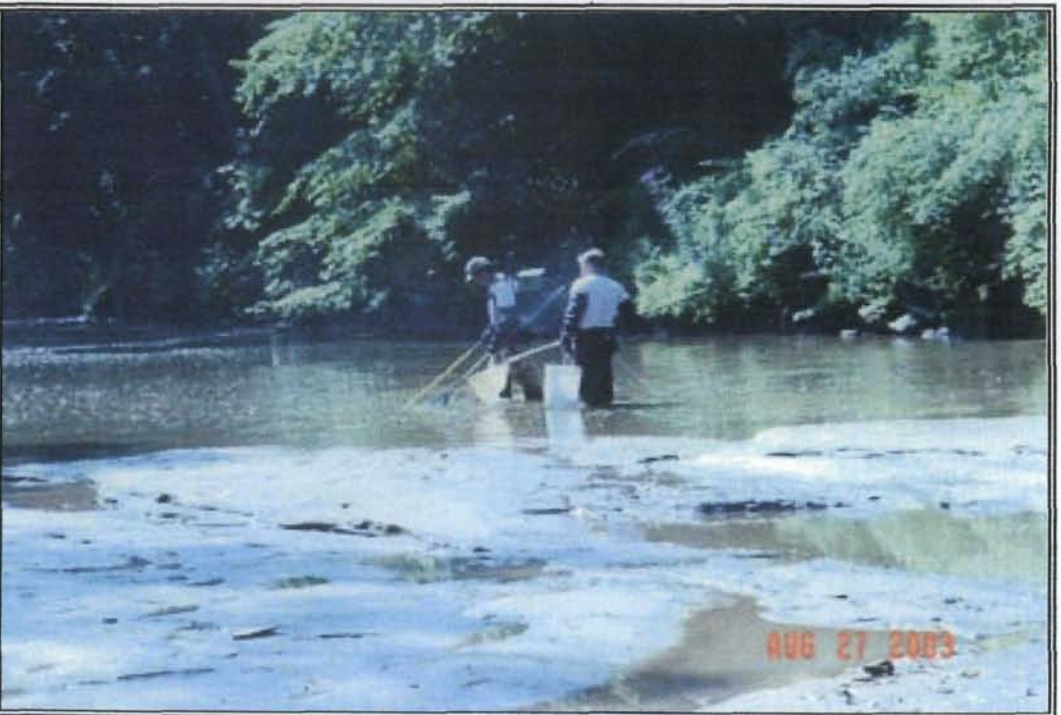
**PHOTO #6**

**Description:**  
*View of electroshock fishing downstream of the quarry*

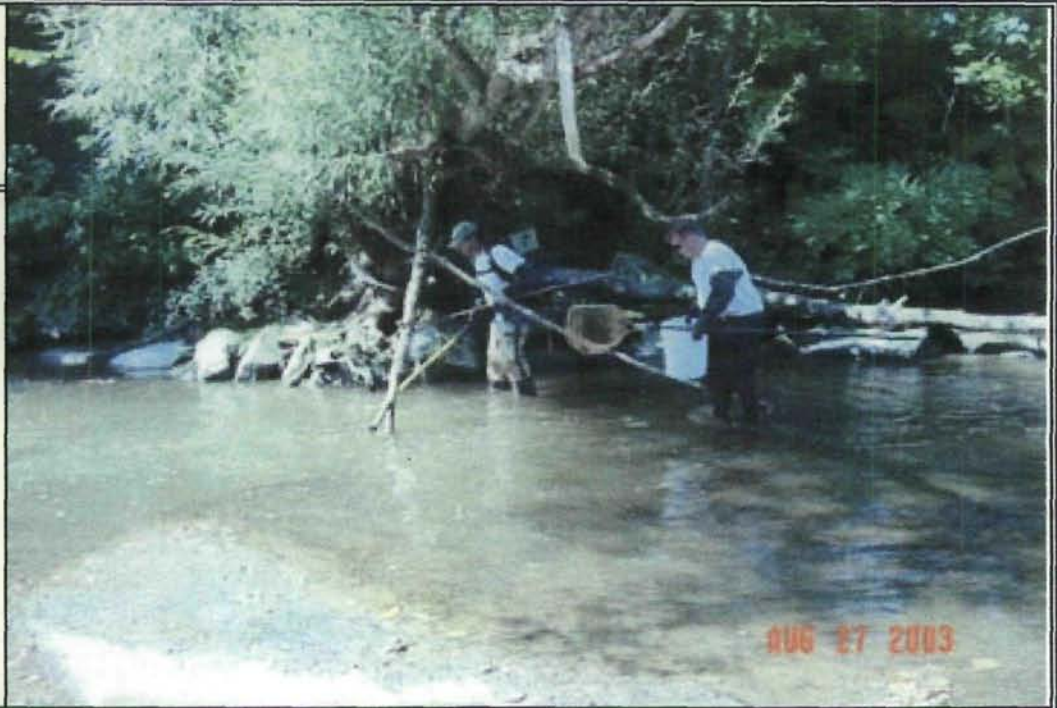
**PHOTO #7**

**View of electroshock fishing near the outfall.**

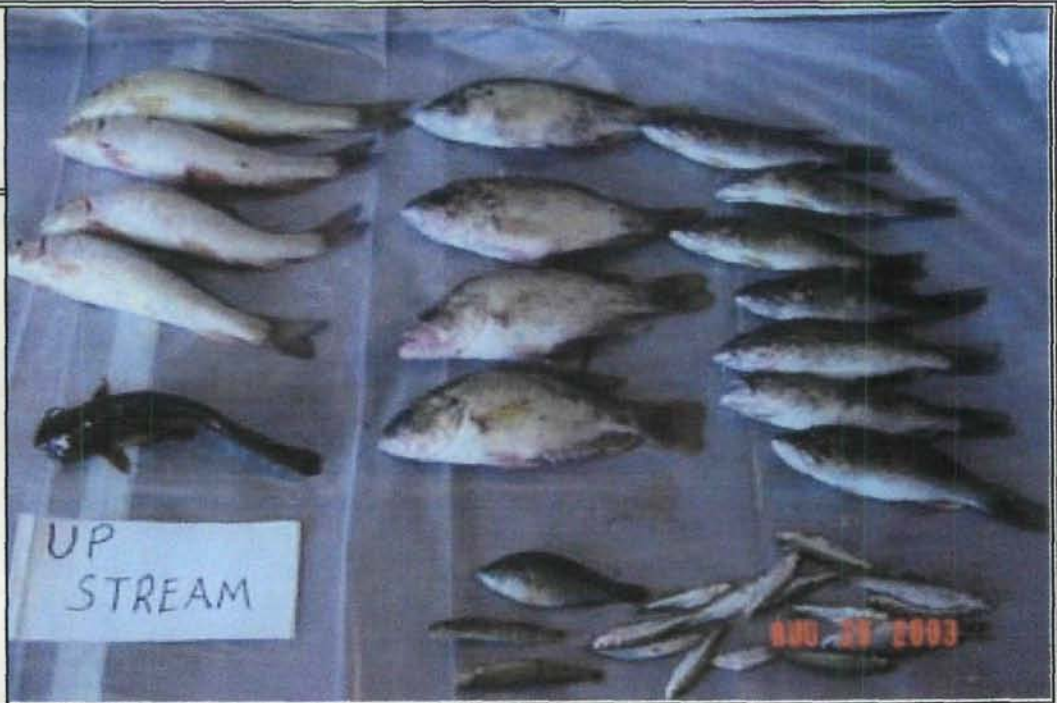
**PHOTO #8**

**View of fish collected from the Black River upstream from the quarry submitted for sample analysis.**

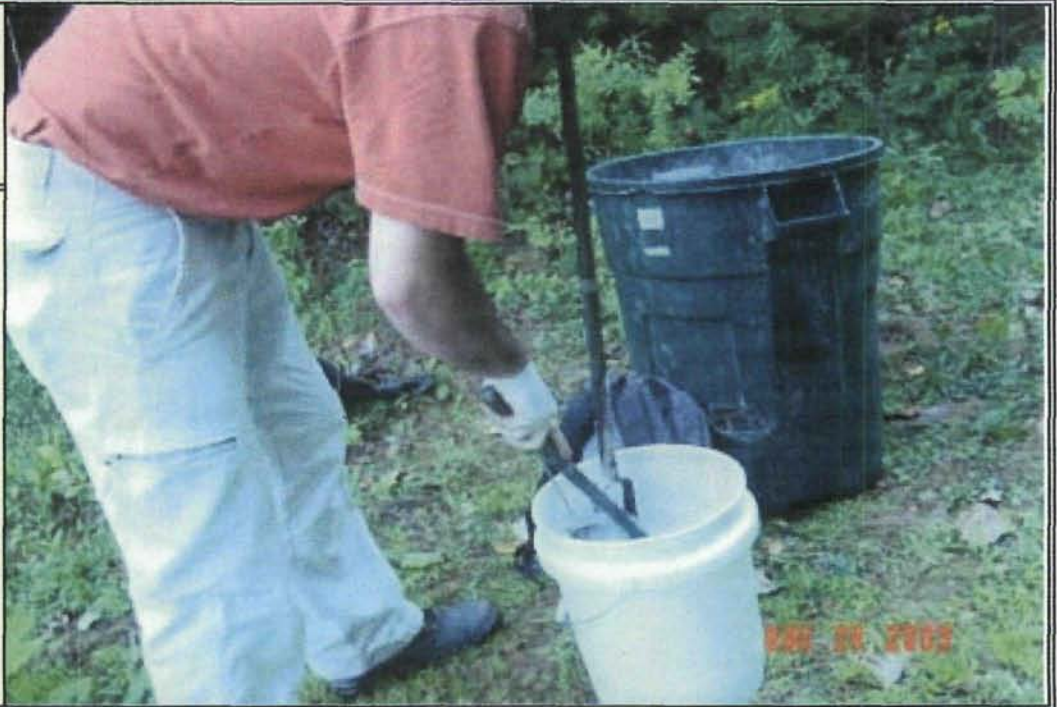
**PHOTO #11**

*View of deconning activities between soil sample collections.*

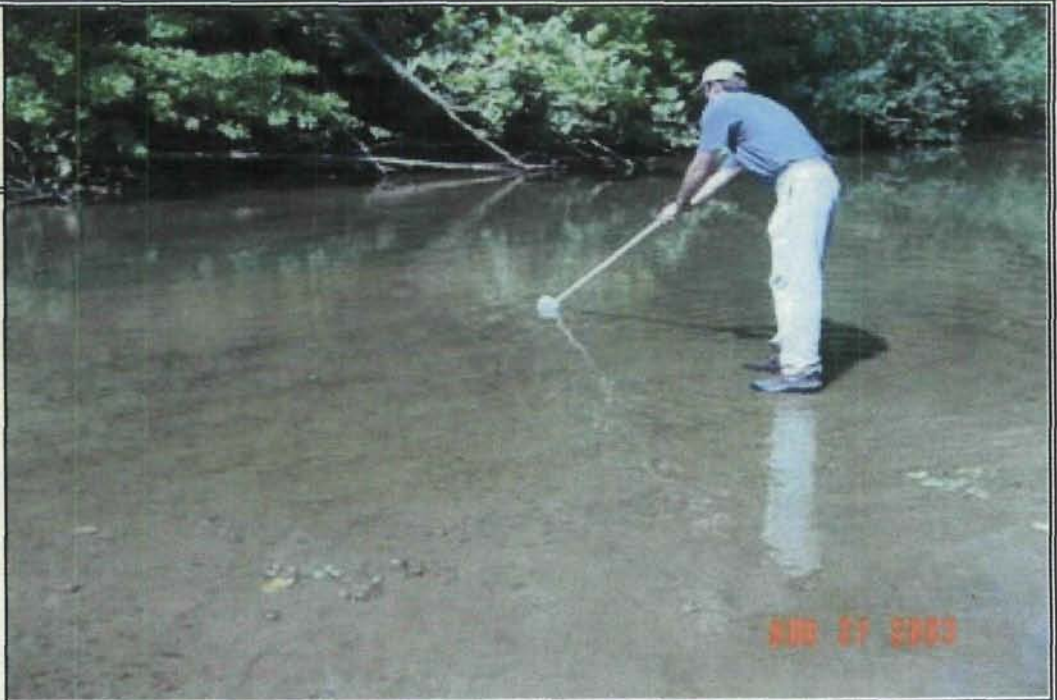
**PHOTO #12**

*View of surface water sampling in the Black River downstream of the quarry.*

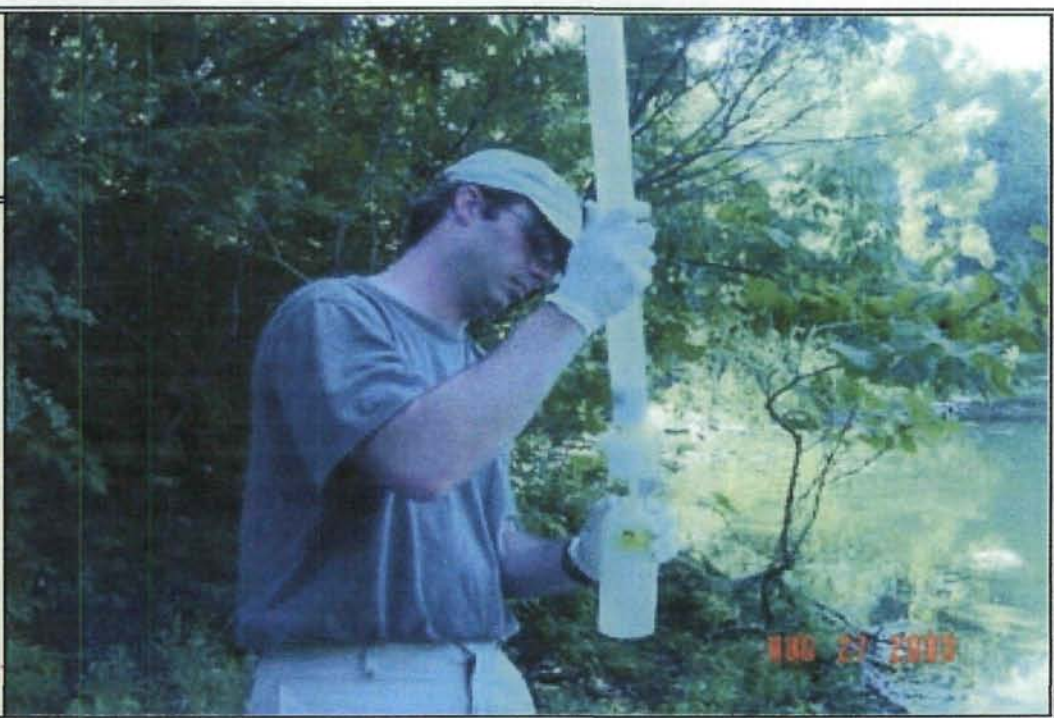
**PHOTO #15**

**Description:**  
*View of surface water filtering for dissolved metal analysis.*

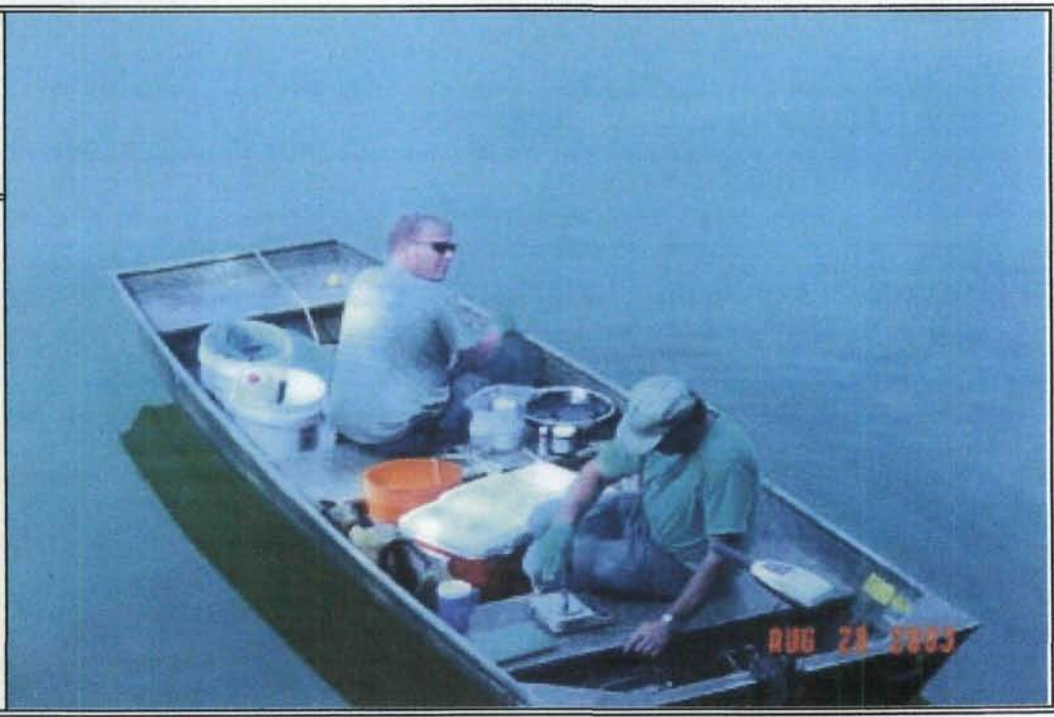
**PHOTO #16**

**Description:**  
*View of sediment sampling using a ponor dredge.*

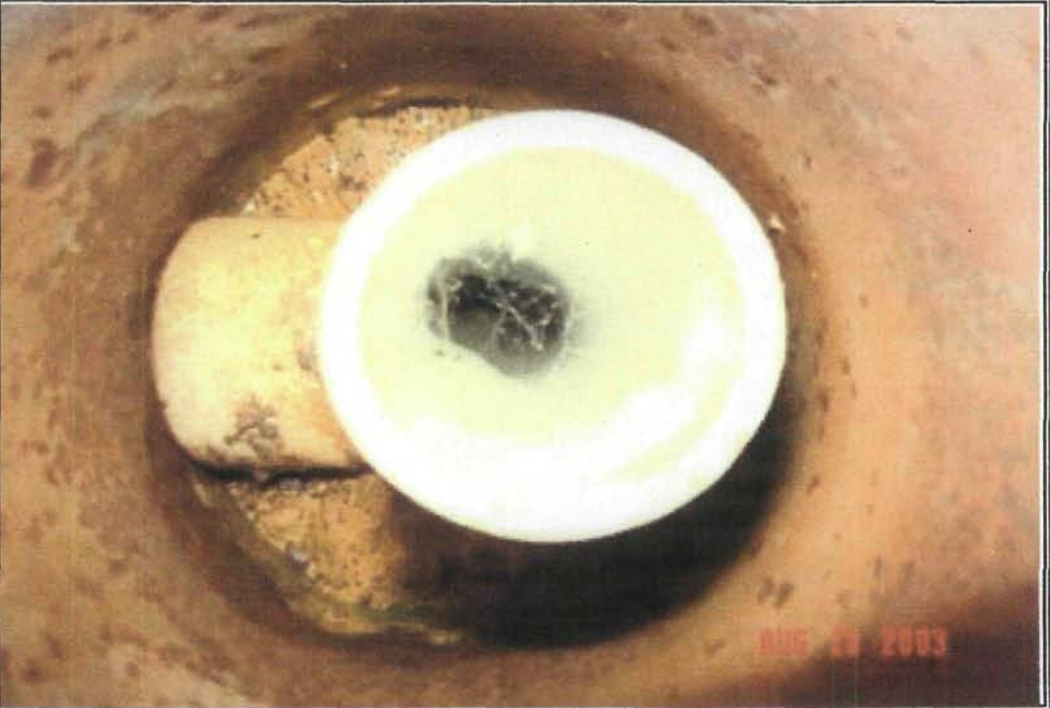
**PHOTO #19**

<p><b>Description:</b> <i>View of collapsed Well 4 with fungus observed around the casing.</i></p>

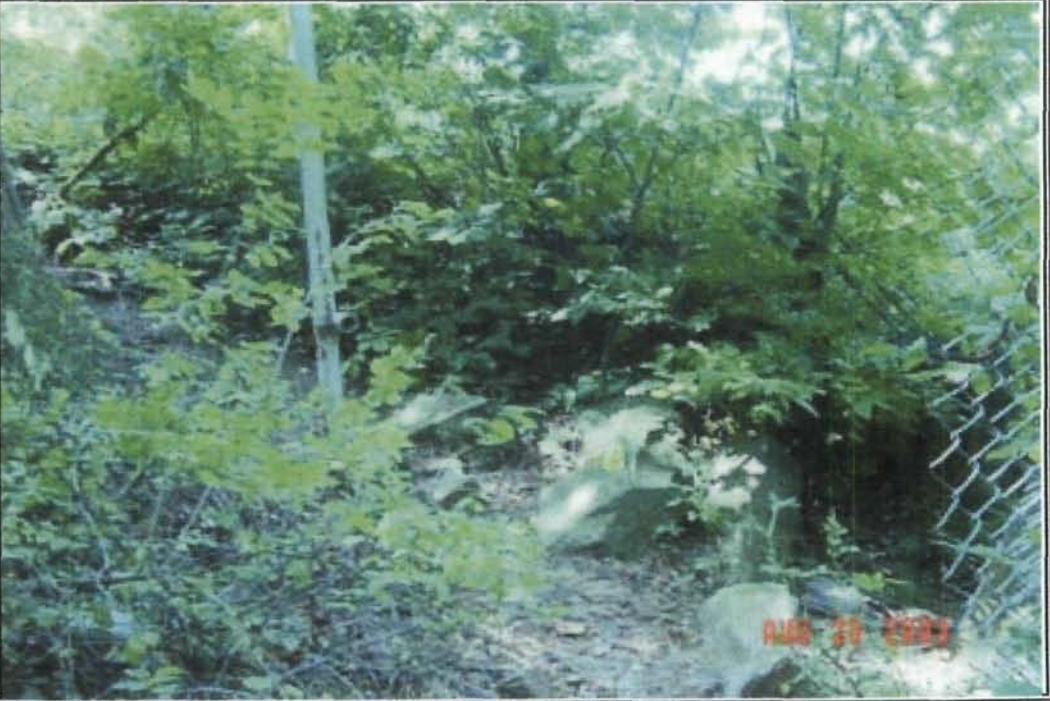
**PHOTO #20**

<p><b>Description:</b> <i>View of breach in the fence on the east side of the quarry. The opening provides an access way for trespassers observed swimming in the quarry.</i></p>
