Second Five-Year Review Report Vandale Junkyard Superfund Site Washington County, Ohio

February 2009

United States Environmental Protection Agency
Region 5
Chicago, Illinois

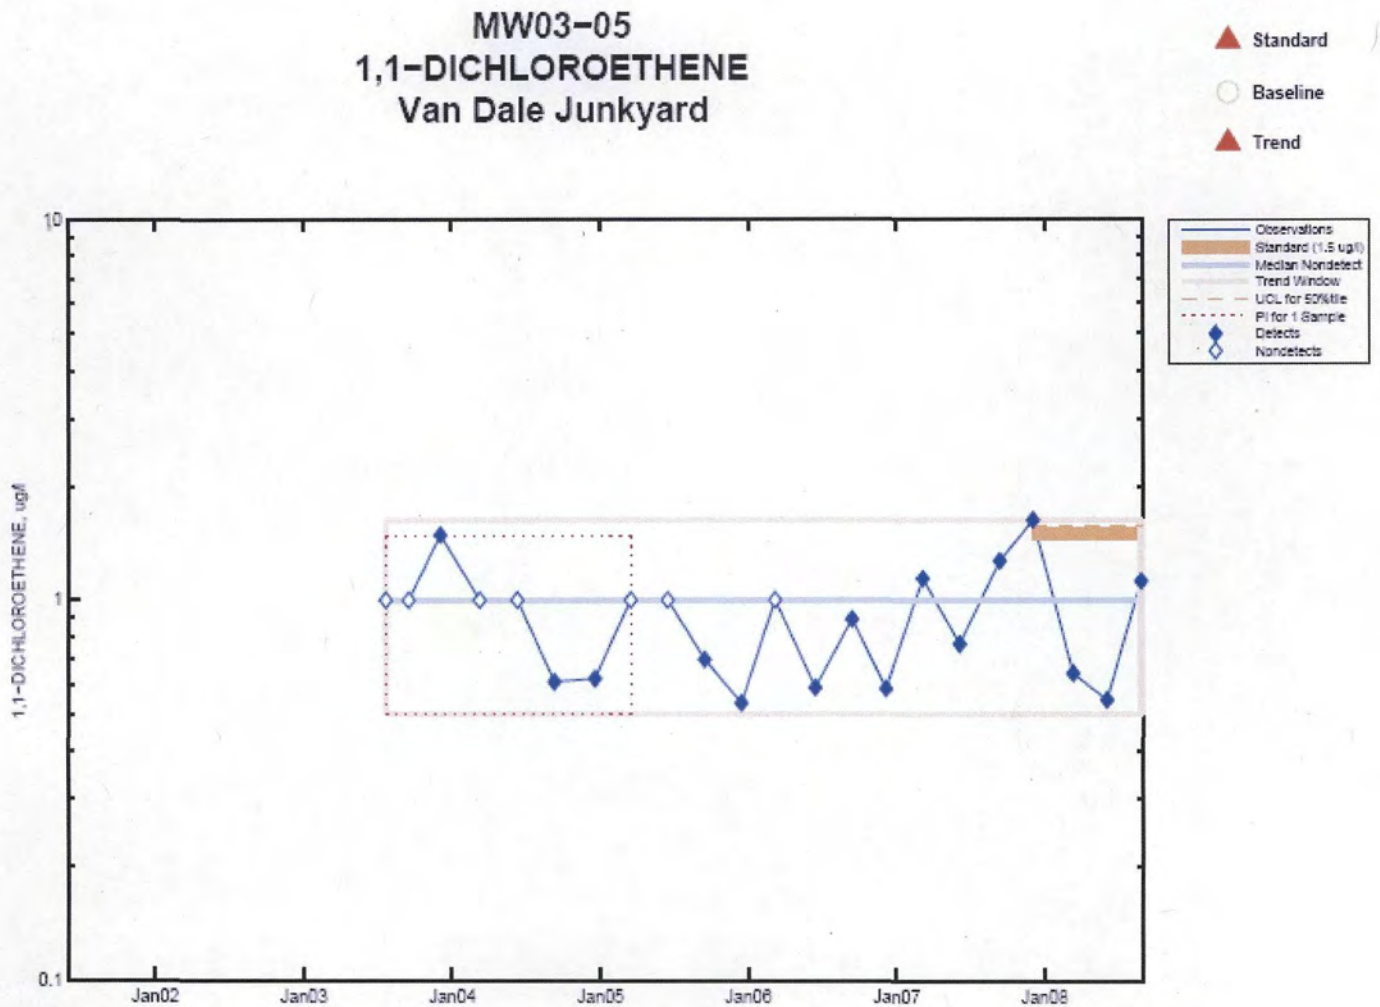
Figure 4: Statistically Increasing Trend for 1,1-DCE at Well MW03-05

The contaminants that had an increasing trend since 2001 were 1,1-DCE and cis-1,2-DCE. Generally, the presence of 1,1 DCE is most likely due to the degradation of 1,1,1-TCA, and increases of cis-1,2-DCE are likely due to the degradation of trichlorethene (TCE). Consequently, increases in daughter products 1,1- DCE and cis-1,2-DCE may indicate that natural attenuation is functioning according to expectations, when the increase is coupled with an appropriate decrease in parent compounds. However, there are higher levels of daughter products being detected at the Site than would be expected based on the levels of parent compounds 1,1,1-TCA and TCE, and the source of the daughter products 1,1- DCE and cis-1,2-DCE at the levels detected is unclear.

Standard Test (95%): Exceedance <UCL = 1.57e+000 ug/l>
 Baseline Test (95%): No Change <UPL/LPL = 1.49e+000/5.00e-001 ug/l>
 Trend Test (90%): Upward <Slope = 3.22e-002 log-ug/l/year>
 Statistical Note: ND surrogate = 0.5 X Median of nondetects' PQLs

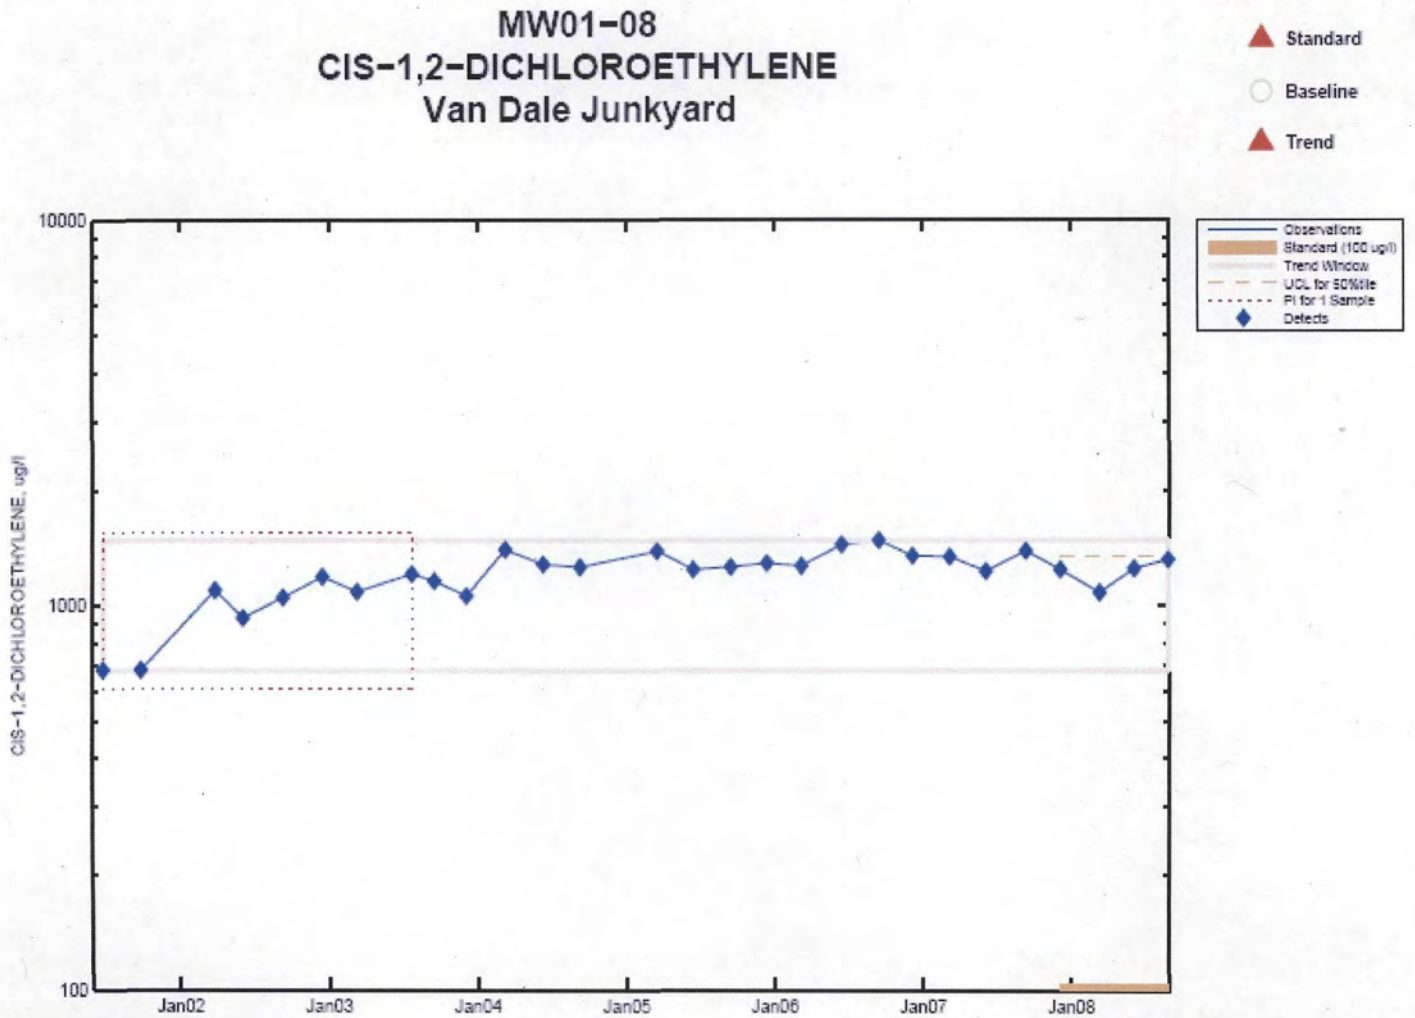
Figure 5: Statistically Increasing Trend for Cis-1,2-DCE at Well MW01-08

Standard Test (95%): Exceedance <UCL = 1.34e+003 ug/l>
 Baseline Test (95%): No Change <UPL/LPL = 1.55e+003/5.07e+002 ug/l>
 Trend Test (90%): Upward <Slope = 4.25e-002 log-ug/l/year>
 Statistical Note: ND surrogates = 0.5 X Median of nondetects' PQLs

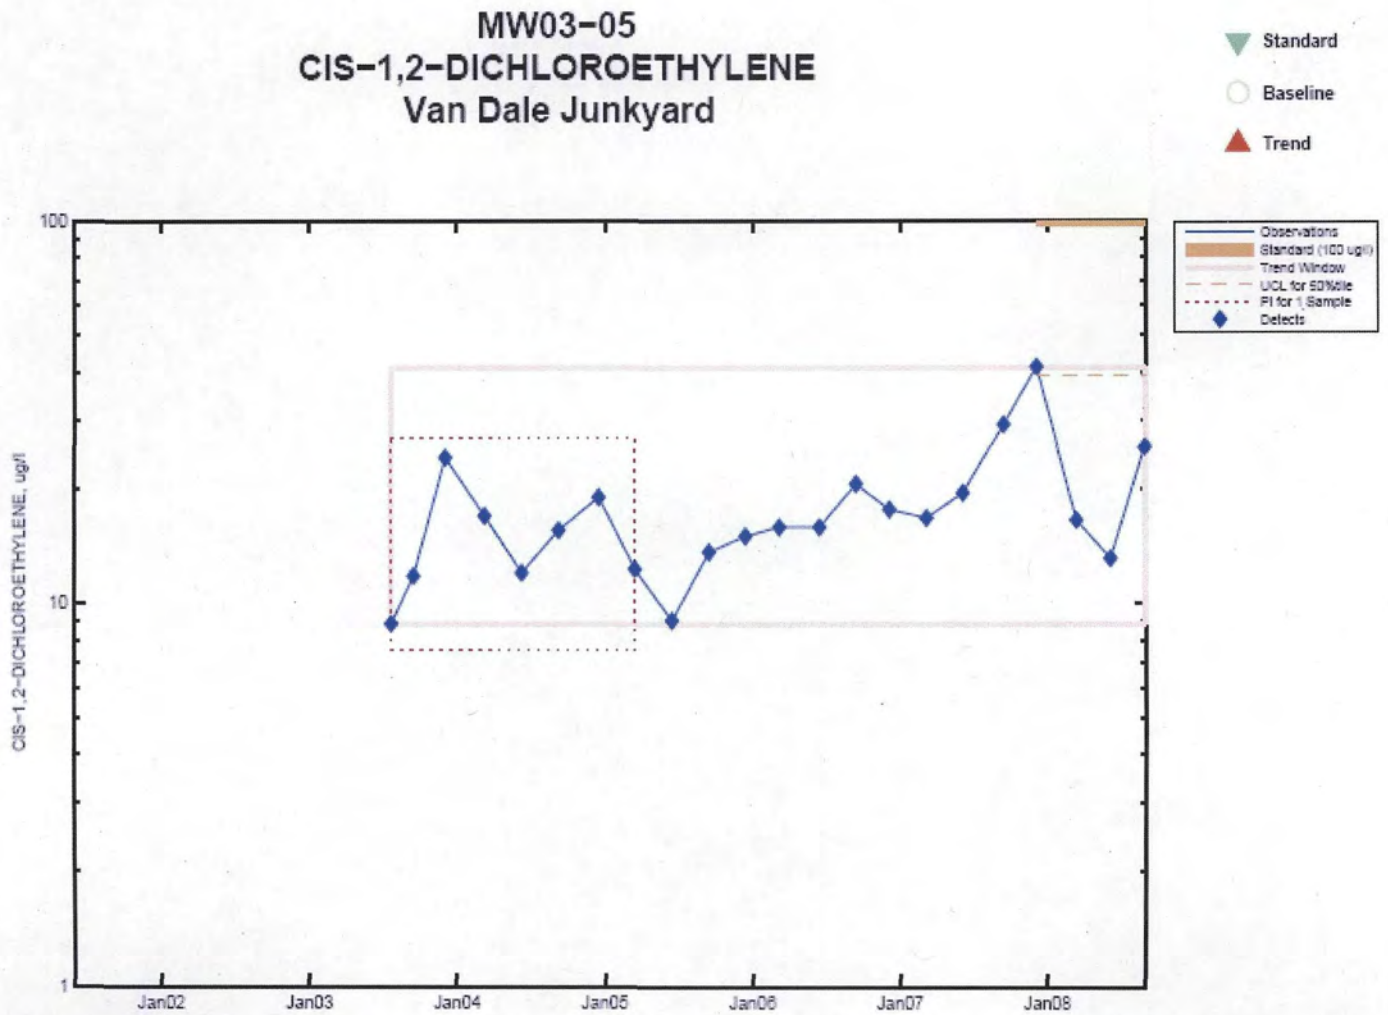
Figure 6: Statistically Increasing Trend for Cis-1,2-DCE at Well MW03-05

Standard Test (95%): Compliance <UCL = 3.91e+001 ug/l>
 Baseline Test (95%): No Change <UPL/LPL = 2.70e+001/7.50e+000 ug/l>
 Trend Test (90%): Upward <Slope = 1.33e-001 log-ug/l/year>
 Statistical Note: ND surrogate = 0.5 X Median of nondetects' PQLs

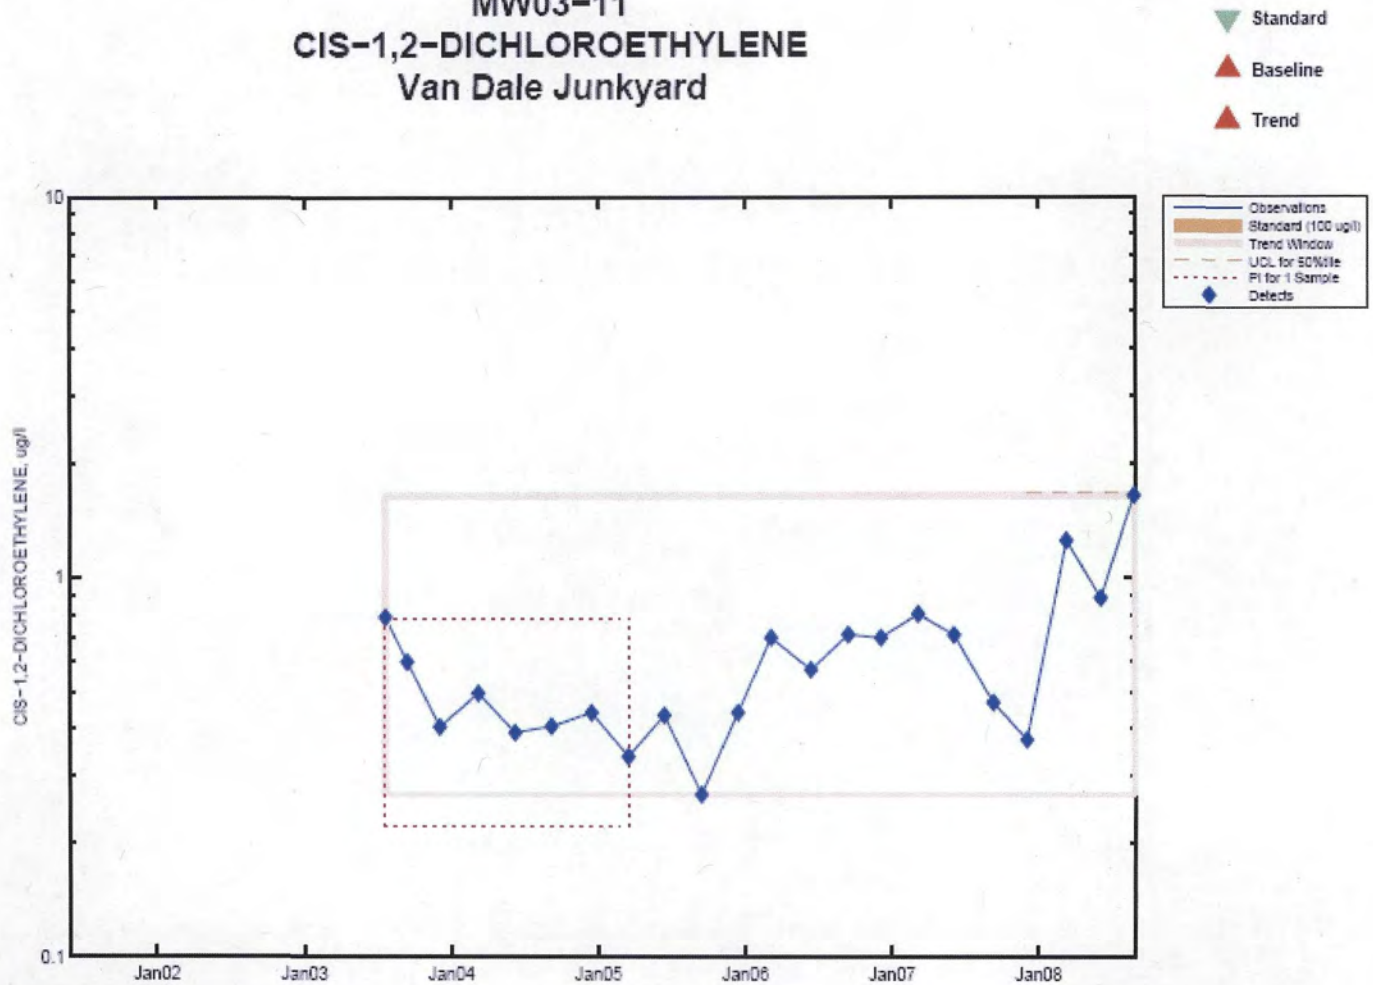
Figure 7: Statistically Increasing Trend for Cis-1,2-DCE at Well MW03-11

Standard Test (95%): Compliance <UCL = 1.67e-000 ug/l>
 Baseline Test (95%): Worse <UPL/LPL = 7.84e-001/2.22e-001 ug/l>
 Trend Test (90%): Upward <Slope = 5.74e-002 log-ug/l/year>
 Statistical Note: ND surrogate = 0.5 X Median of nondetects' PQLs

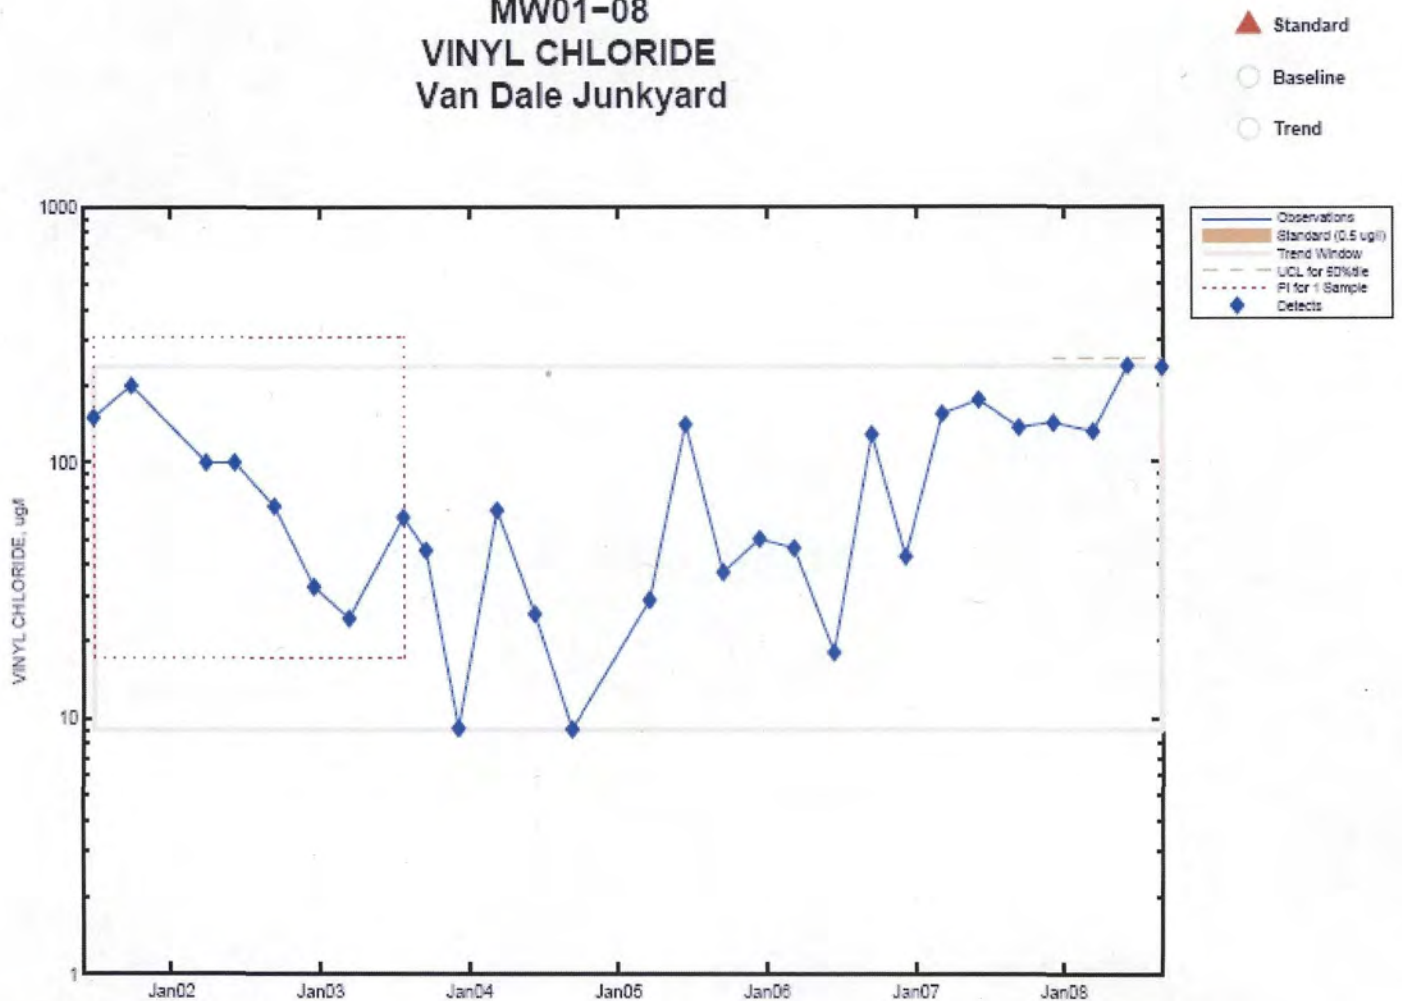
**Figure 8: Statistically Increasing Trend (from December 2003 through August 2008)
for Vinyl Chloride at Well MW01-08**

Standard Test (95%): Exceedance <UCL = 2.55e+002 ug/l>
 Baseline Test (95%): No Change <UPL/LPL = 3.13e-002/1.74e-001 ug/l>
 Trend Test (90%): No Trend <Slope = 1.35e-001 log-ug/l/year>
 Statistical Note: ND surrogate = 0.5 X Median of nondetects' PQLs
