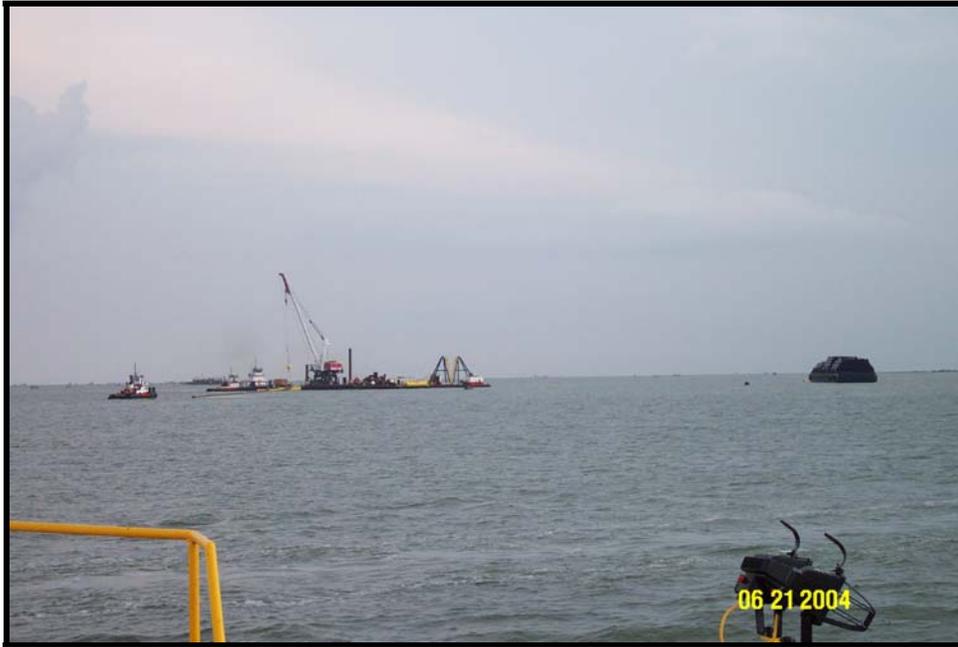
Photo 1. *Dredge discharge pipe staging area north of Timbalier Island*

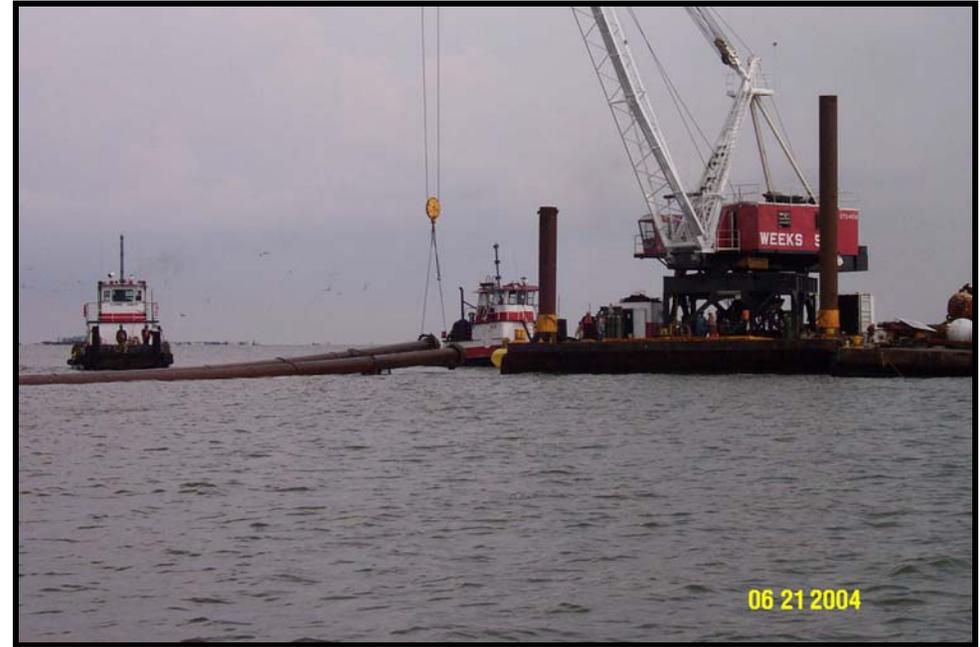
Photo 3. *Preparing dredge pipe for transport and installation (submerged pipe)*

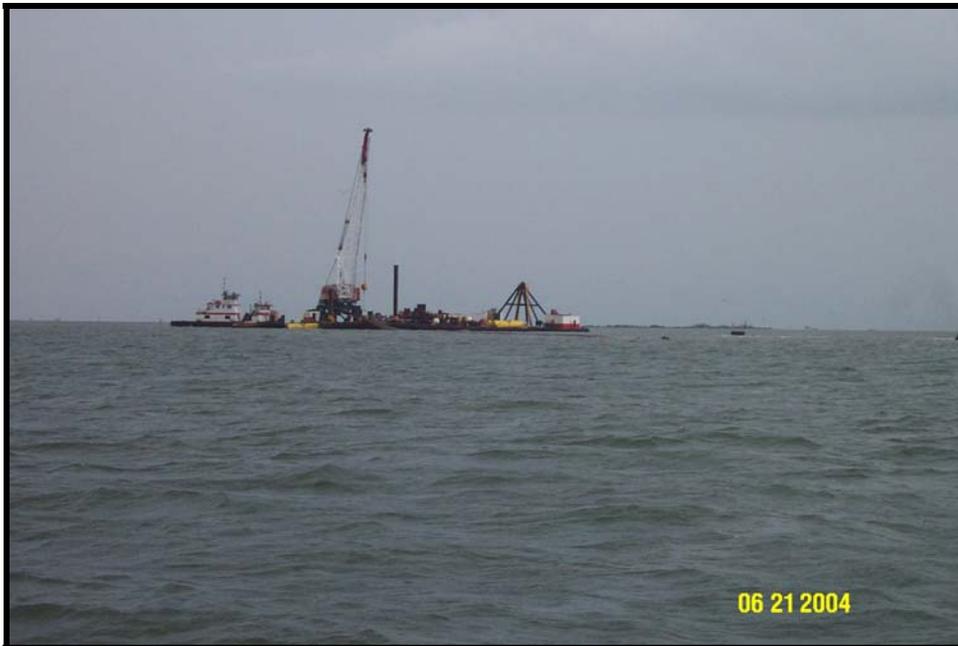
Photo 2. *Dredge discharge pipe staging area north of Timbalier Island*

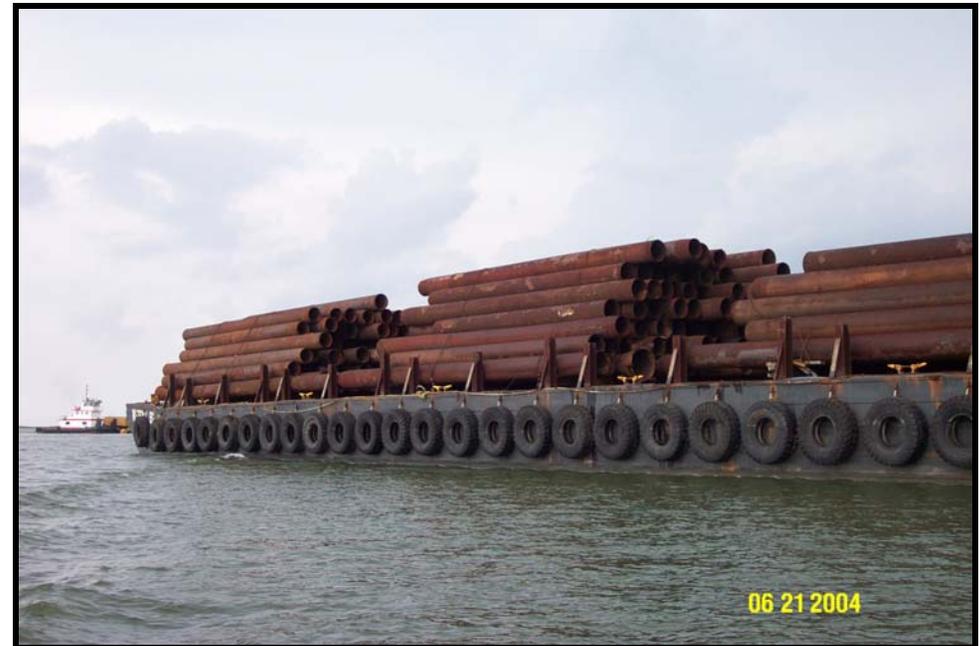
Photo 4. *Dredge discharge shore pipe on barge*

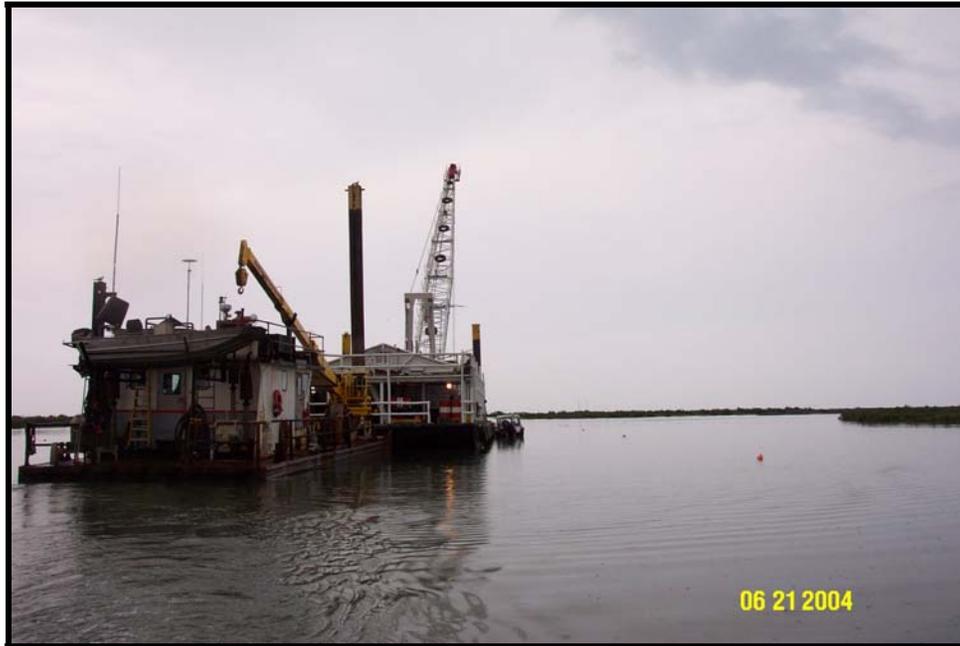
Photo 5. Dredging access channel with spud barge-mounted bucket dredge, looking south

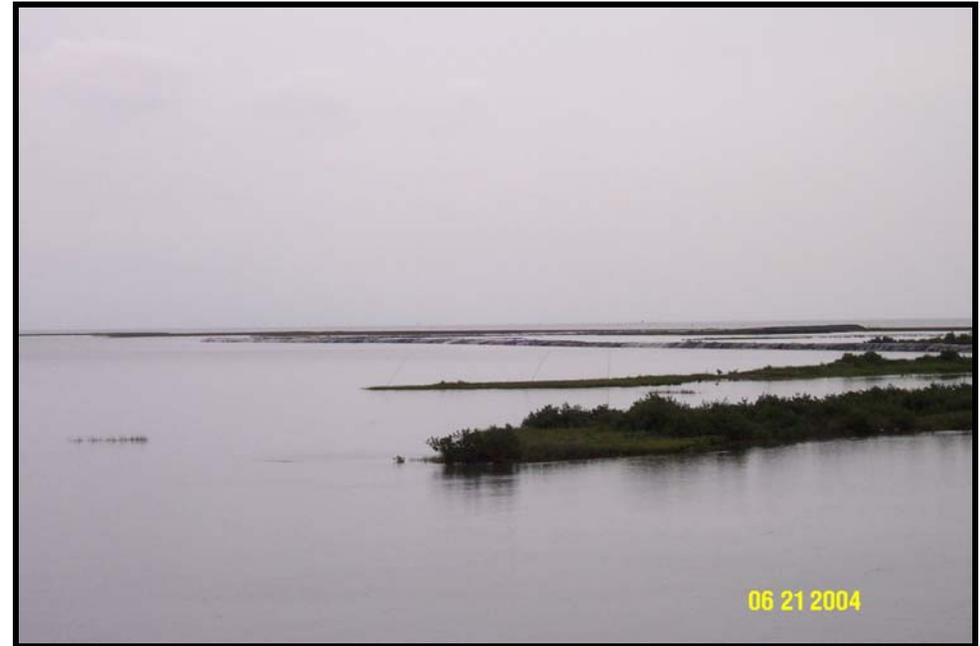
Photo 7. View of back dike from within access channel looking southeast

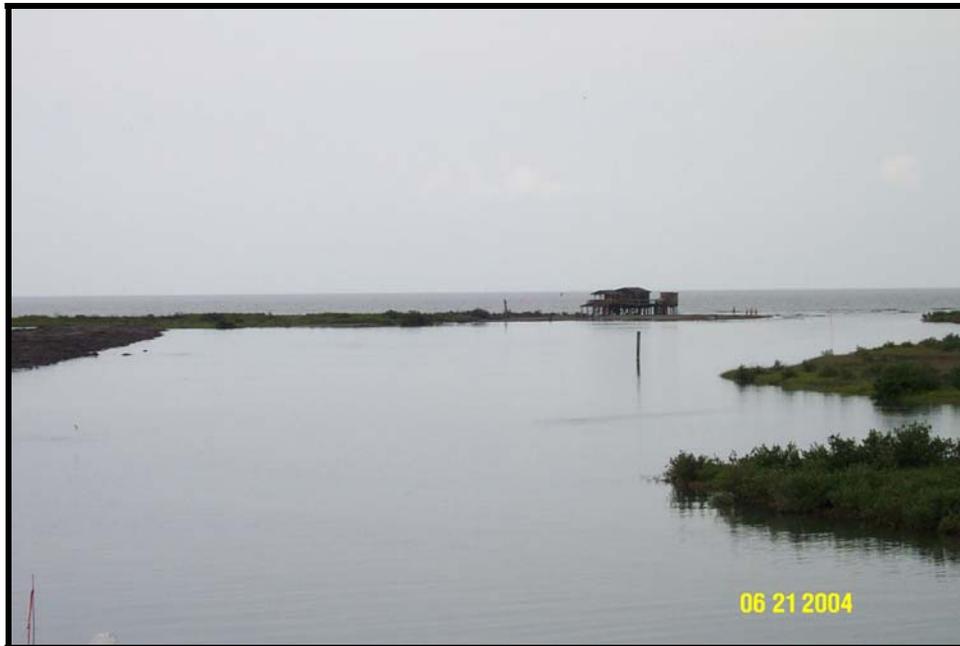
Photo 6. Camp at Sta. 167+00, photo taken from within access channel on bucket dredge barge looking south.

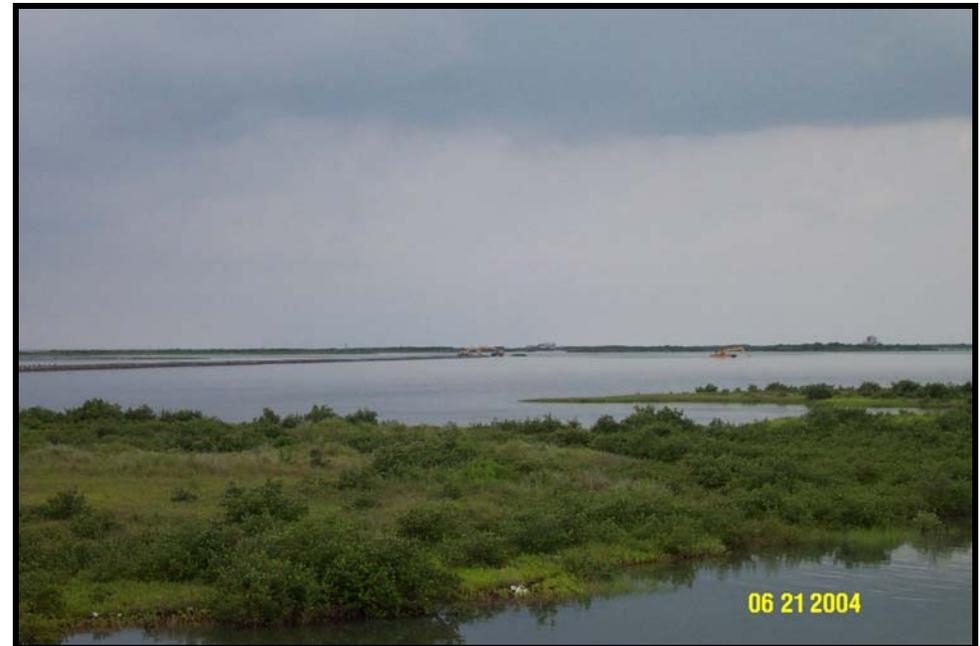
Photo 8. Construction of back dike with marsh buggy excavators progressing westward, looking southwest from within access channel

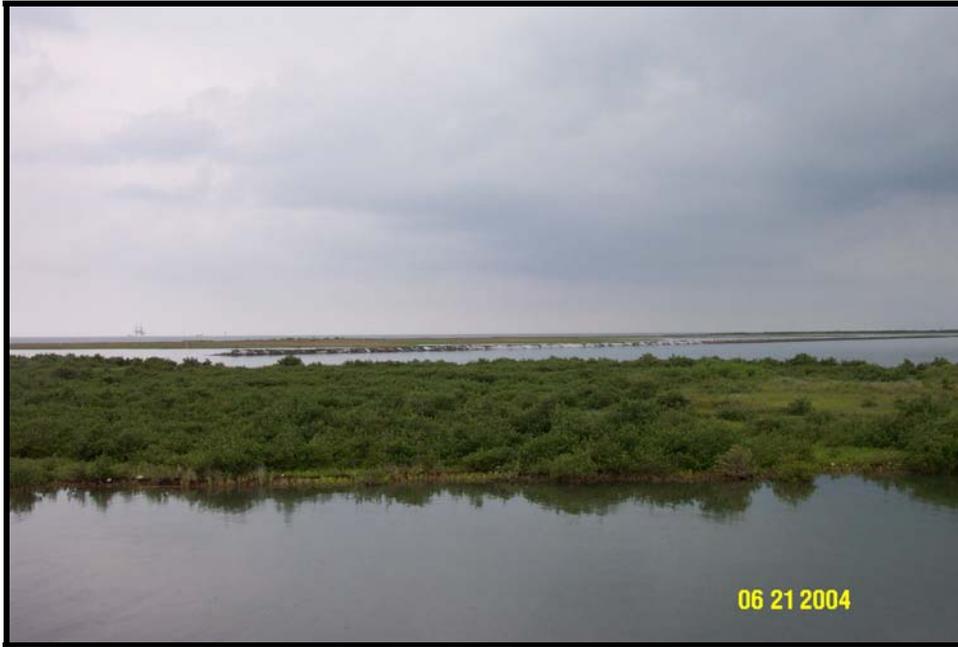
Photo 9. View of back dike constructed west of access channel looking southwest from within access channel

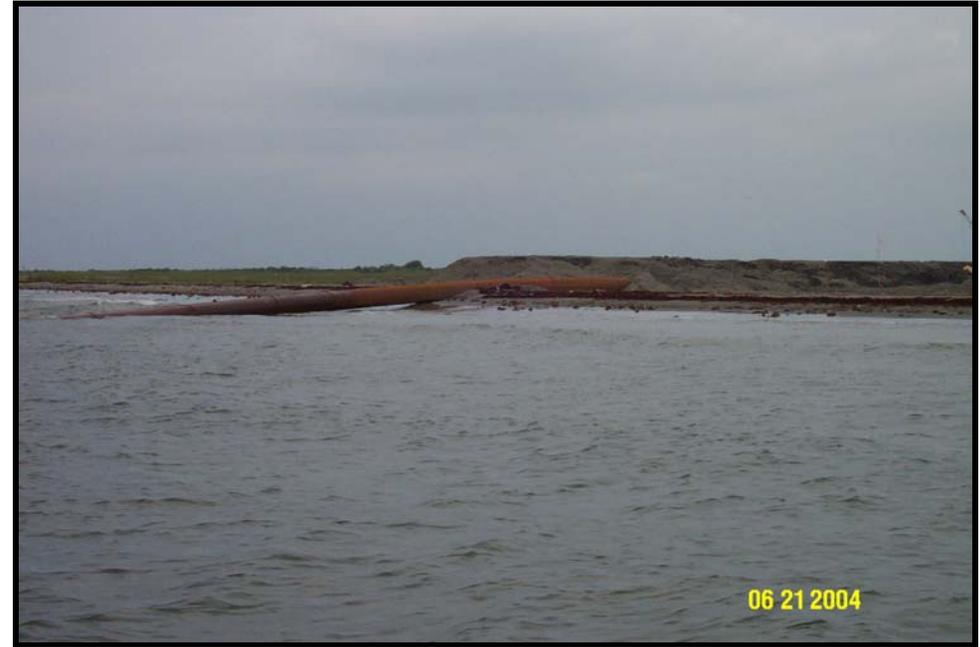
Photo 11. View of east dike and end of submerged dredge pipe at east end of project looking northwest from the Gulf (before shore pipe installation)

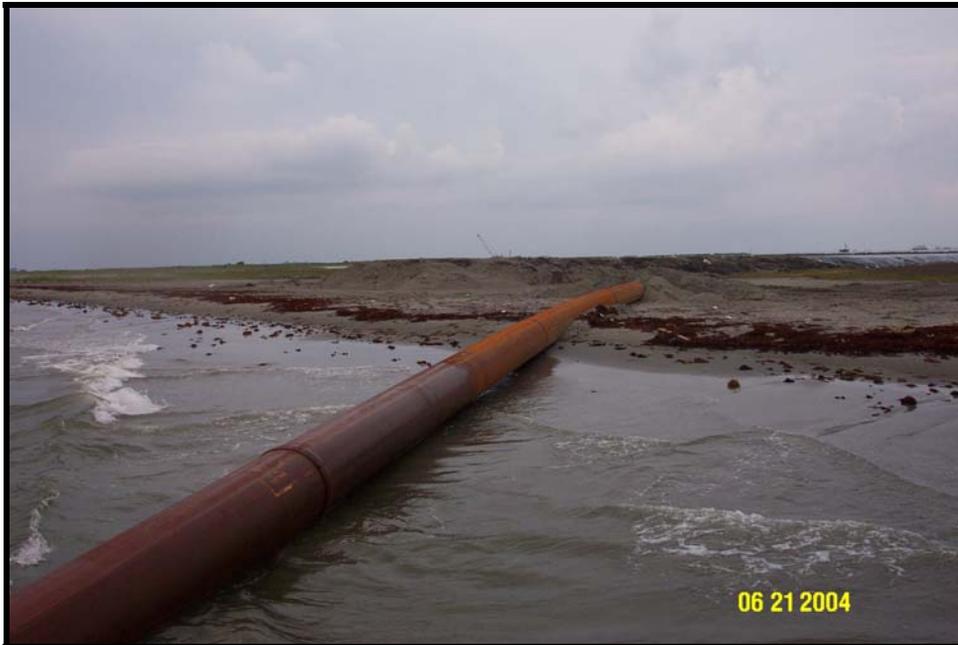
Photo 10. Island end of submerged dredge pipe at east end of project looking northwest from the Gulf (before shore pipe installation)

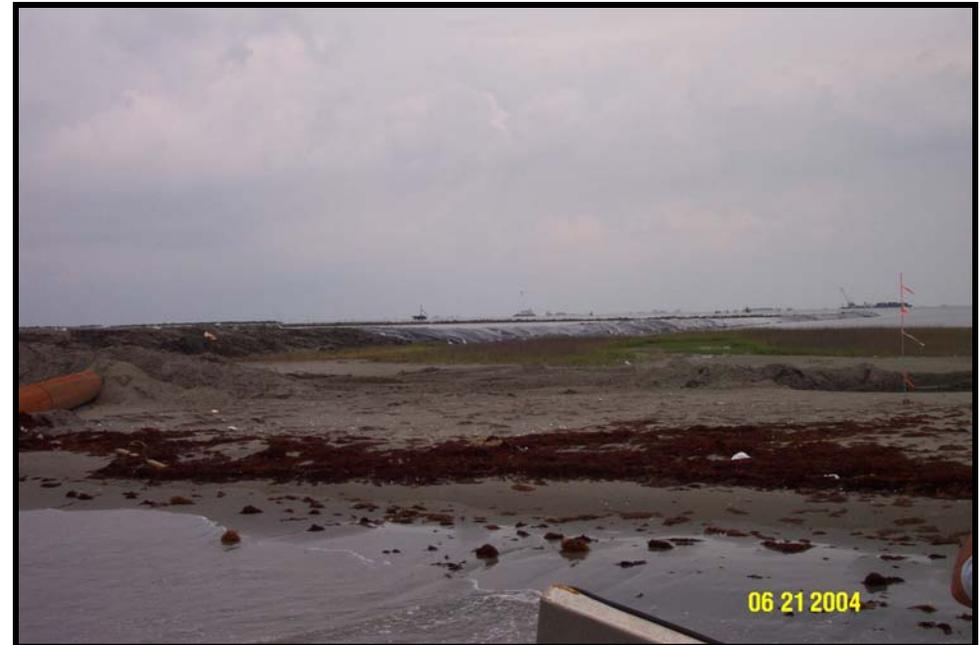
Photo 12. View of east dike at east end of project looking northwest from the Gulf

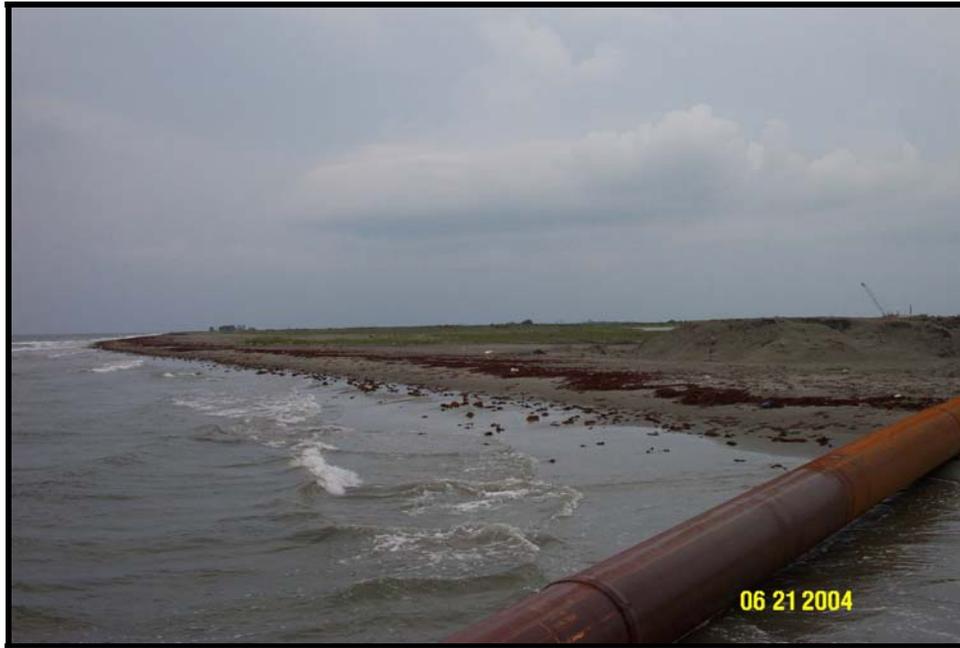
Photo 13. *View of shoreline looking west from east end of project*

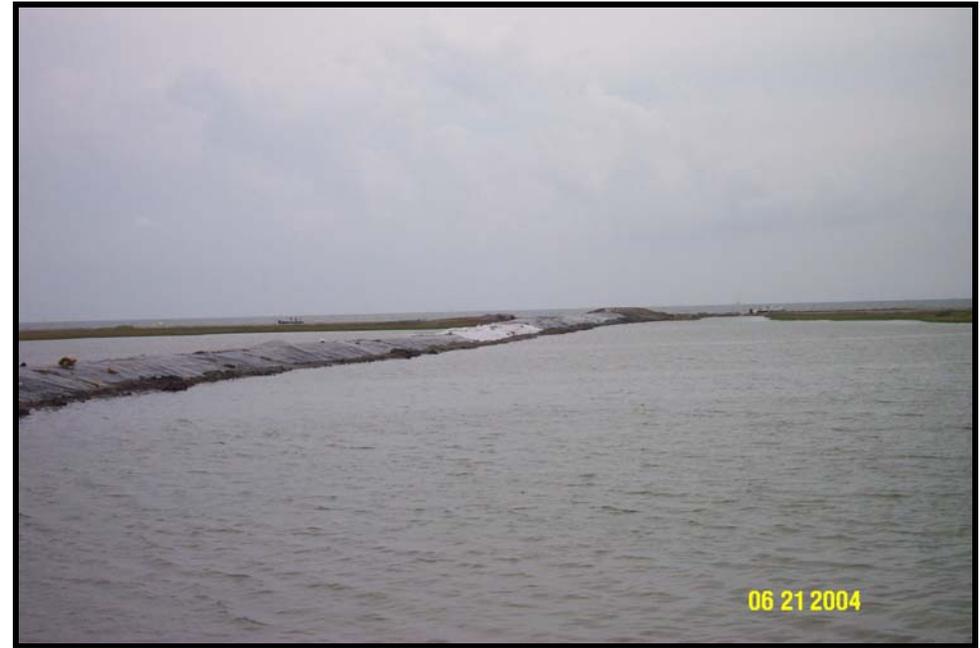
Photo 15. *East dike at end of project (Sta. 206+00), looking south from back dike*

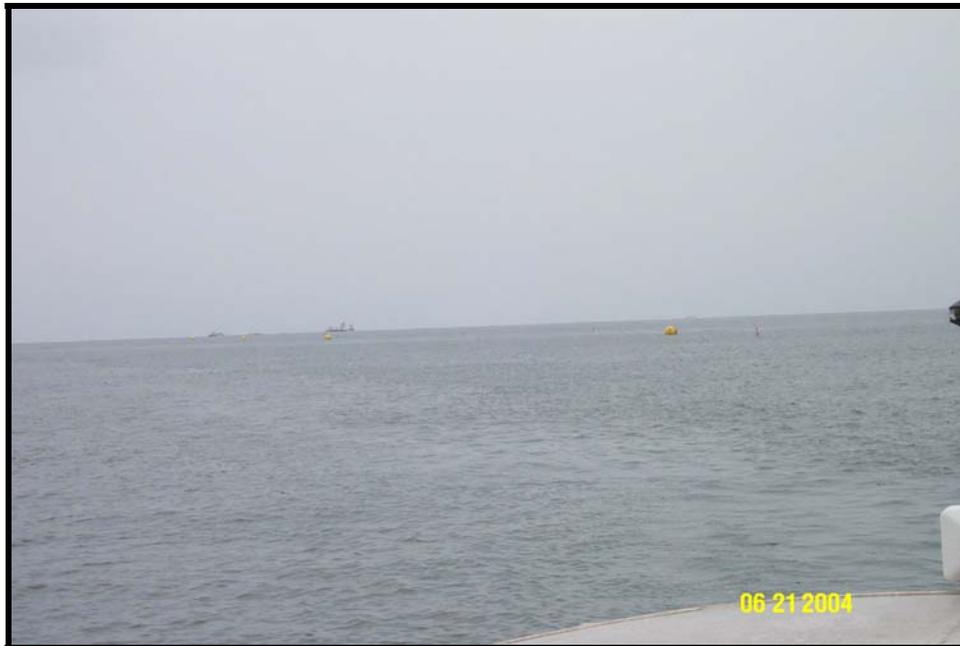
Photo 14. *View of buoys marking submerged dredge pipe looking southeast from island*

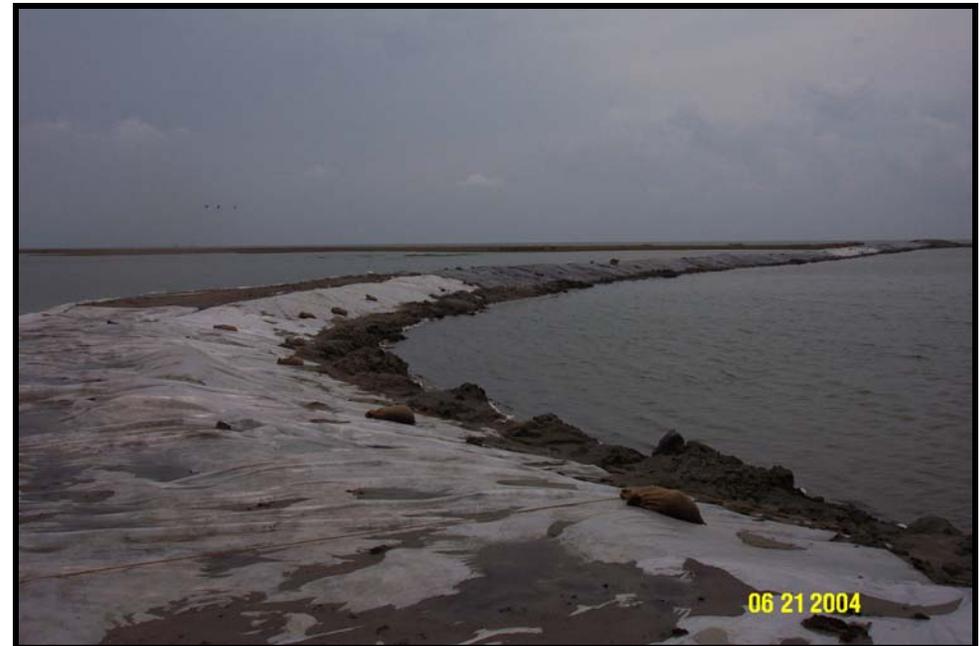
Photo 16. *East dike at end of project (Sta. 206+00), looking southeast from back dike*

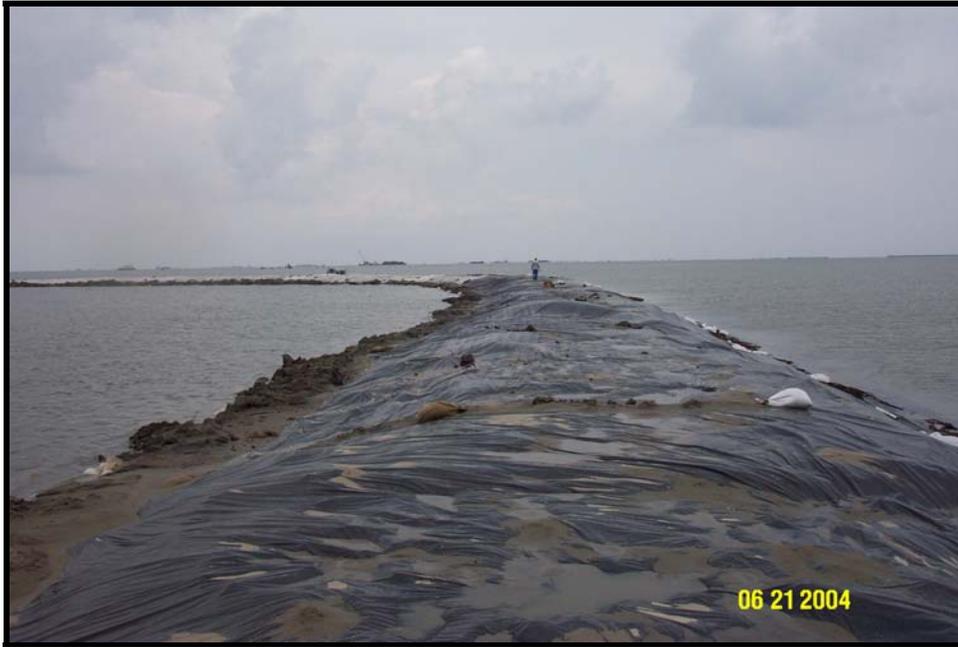
Photo 17. East dike at end of project (Sta. 206+00), looking north

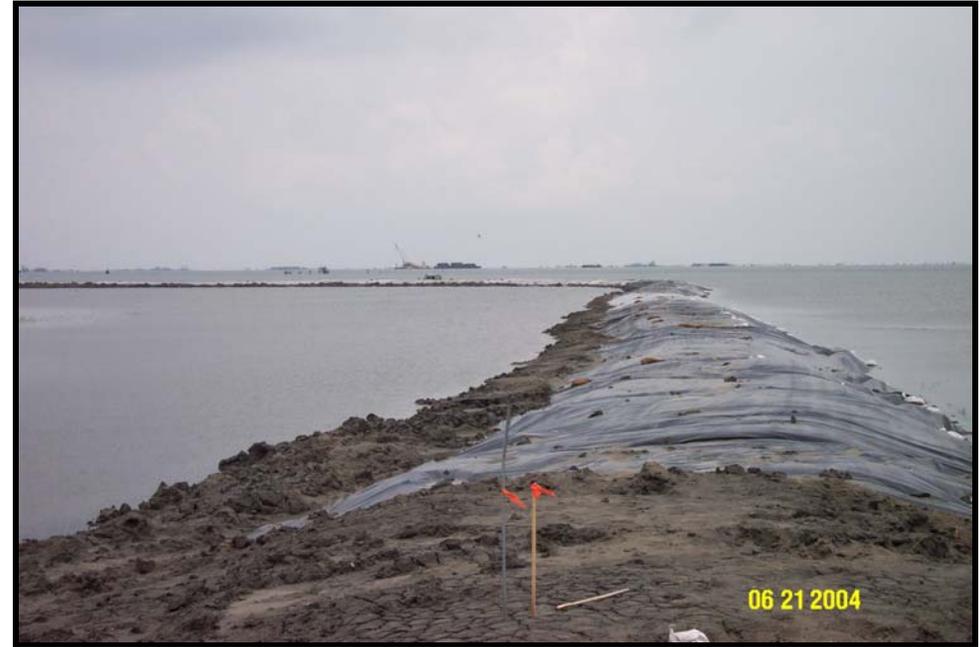
Photo 19. East dike at end of project (Sta. 206+00), looking north

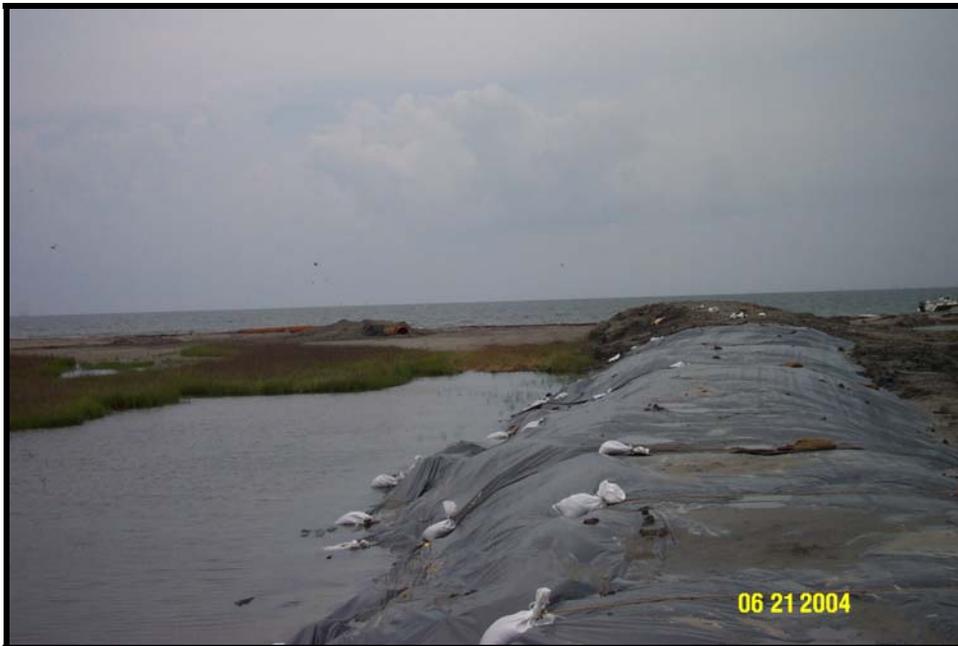
Photo 18. East dike at shoreline and end of submerged dredge pipe, looking south

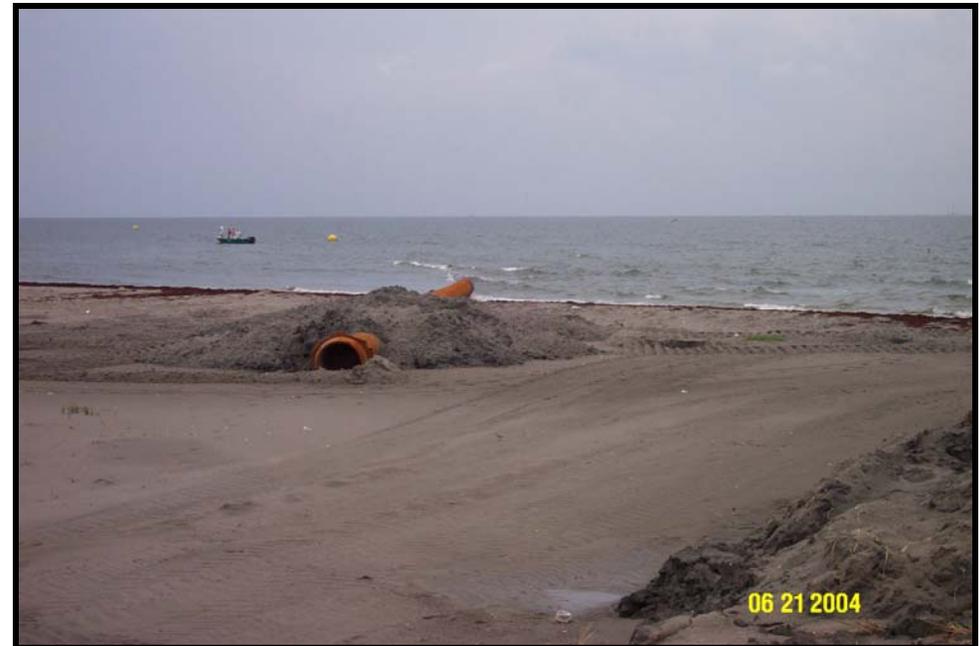
Photo 20. End of submerged dredge pipe at east end of project, looking south

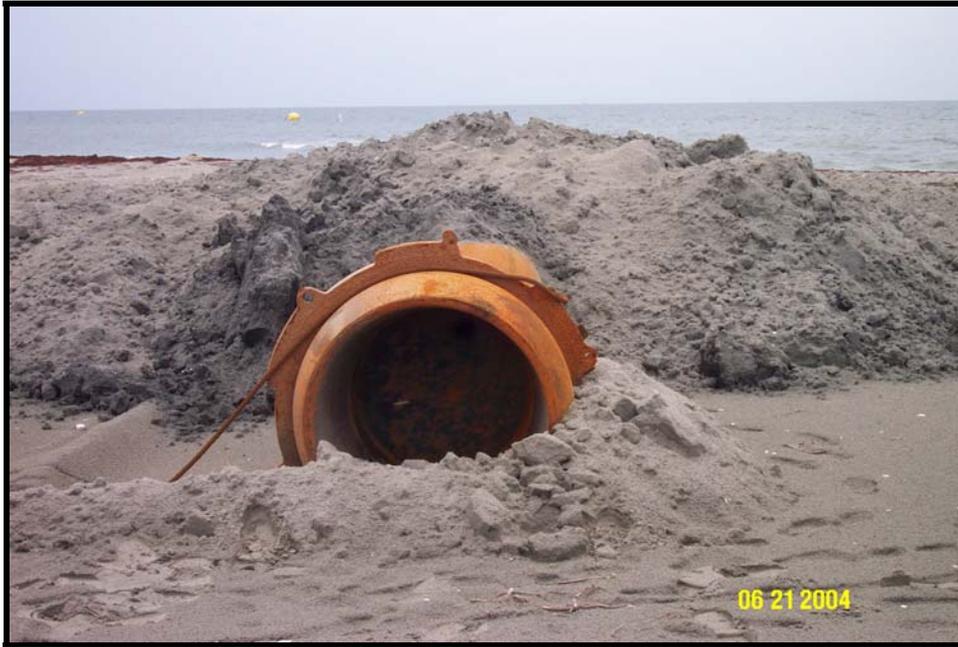
Photo 21. End of submerged dredge pipe at east end of project, looking south

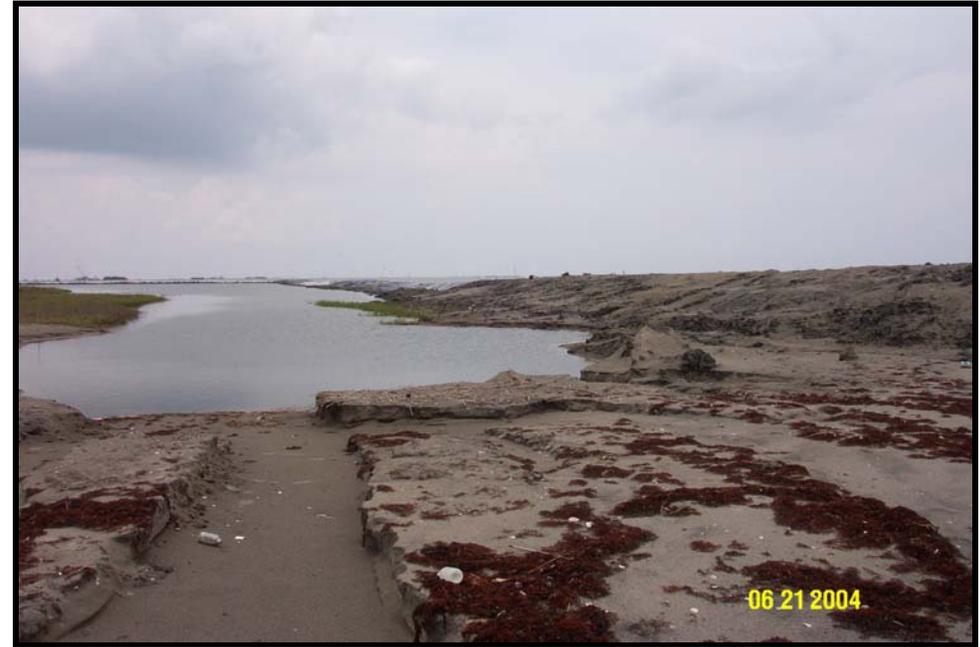
Photo 23. East dike at east end of project, looking north from Sta. 205+00

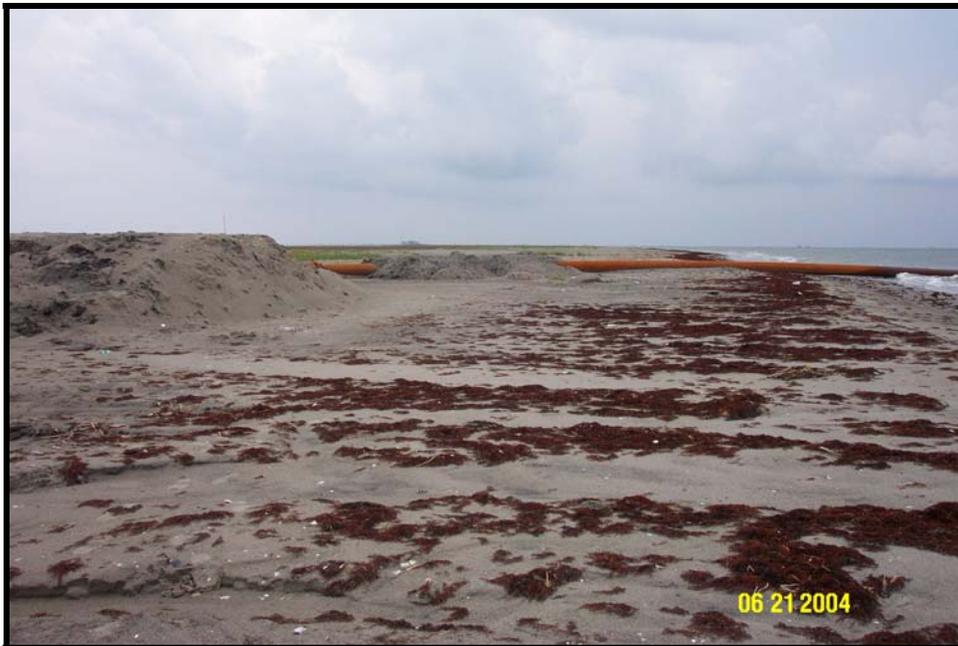
Photo 22. End of east dike at beach, looking east

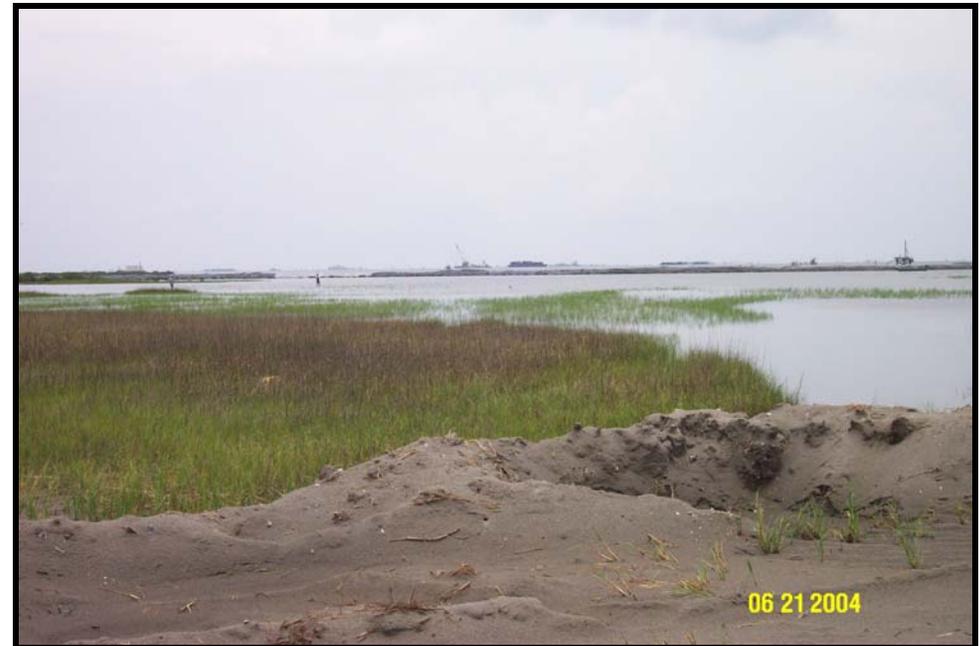
Photo 24. View of back dike looking north from beach (appx. Sta. 200+00)

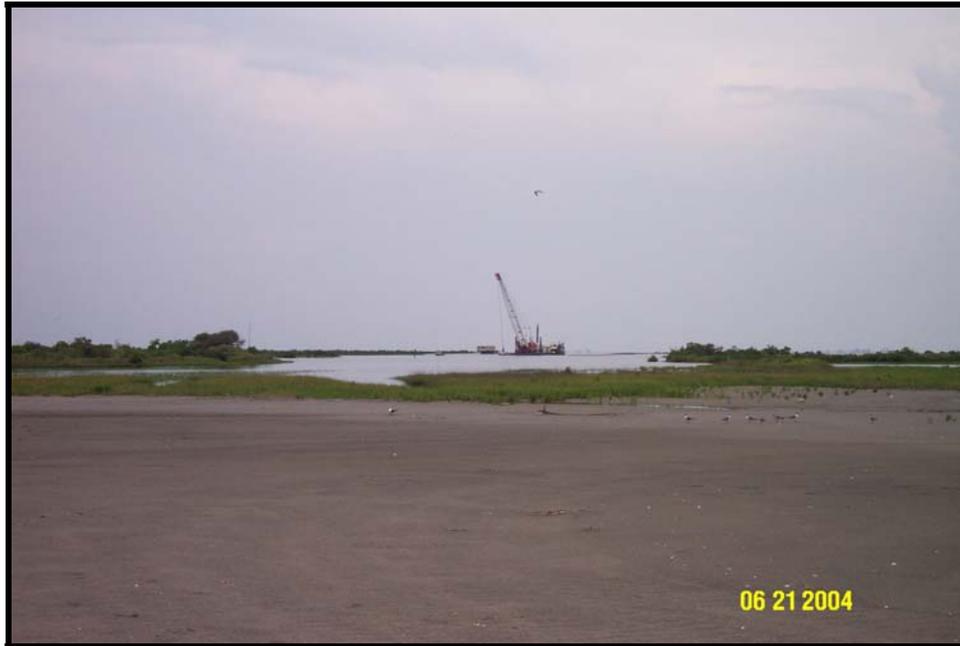
Photo 25. *Dredging access channel with bucket dredge, looking northwest from beach at appx. Sta. 187+00*

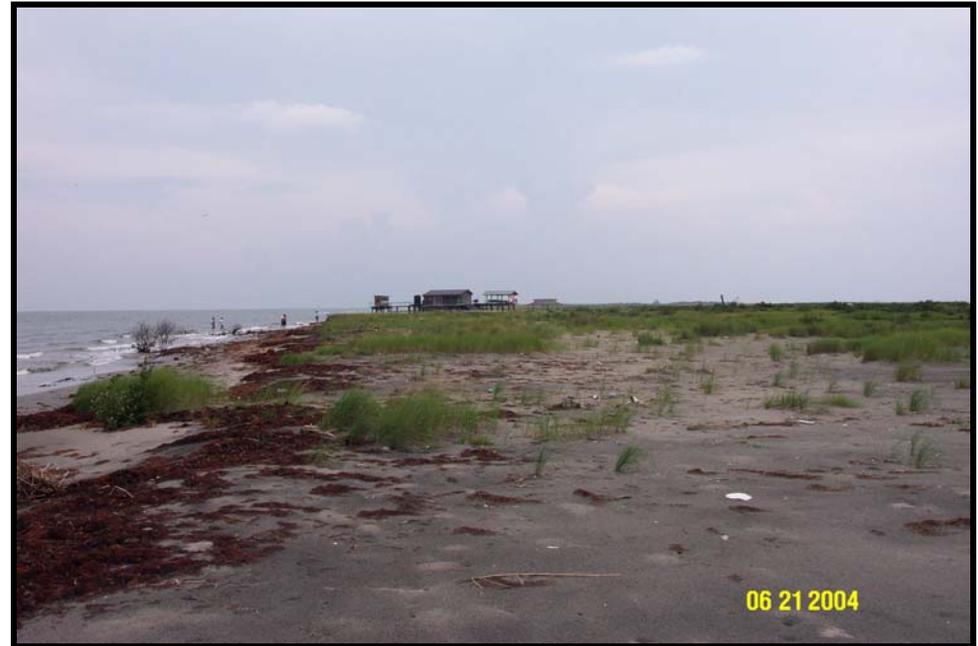
Photo 27. *View of camp (at Sta. 167+00), looking west*

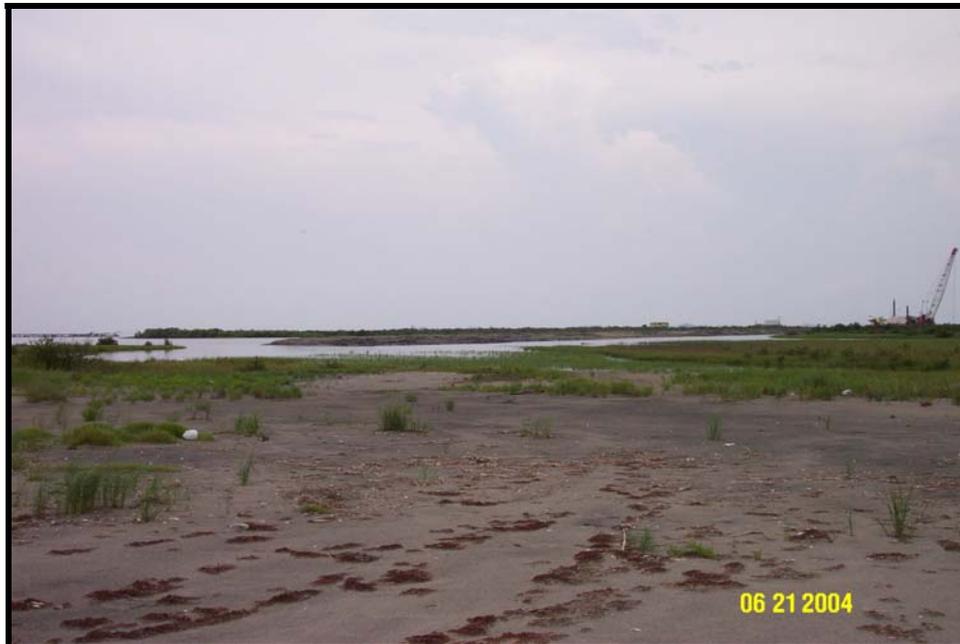
Photo 26. *View of access berm at end of access channel, looking northwest*

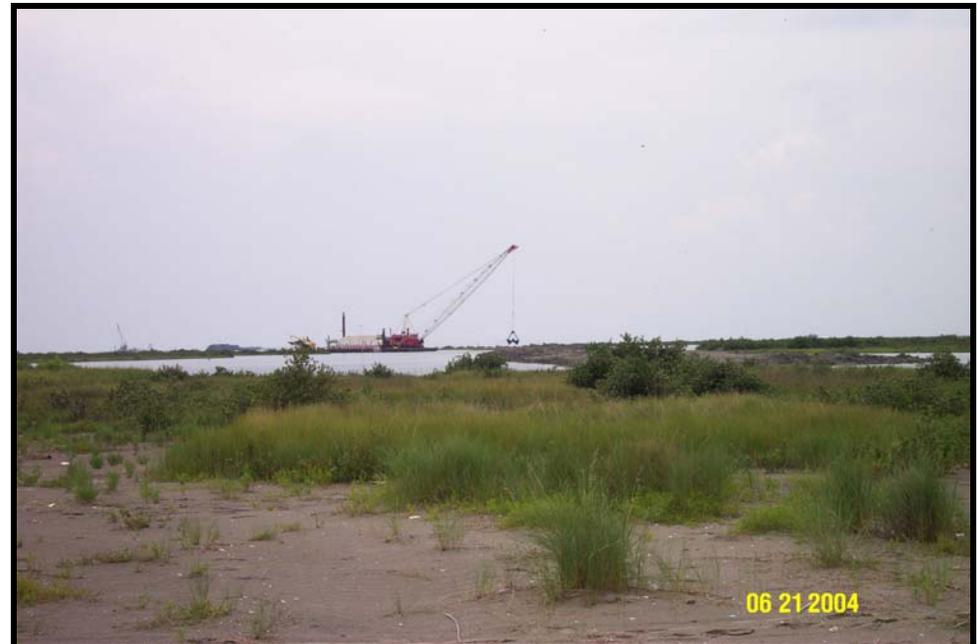
Photo 28. *Dredging access channel with bucket dredge, looking north from appx. Sta. 170+00*

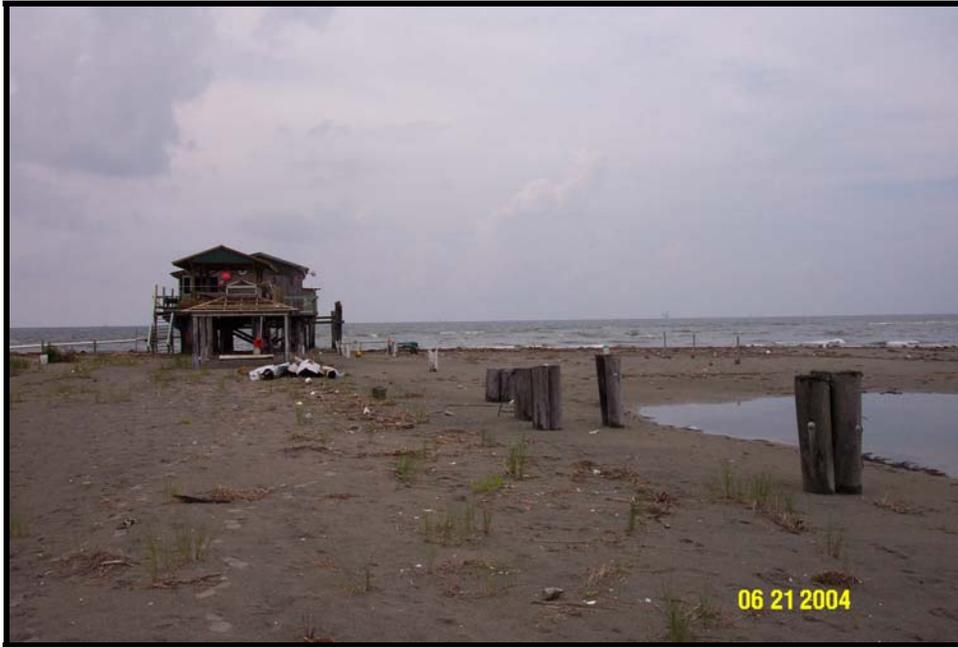
Photo 29. View of camp at Sta. 167+00 looking south

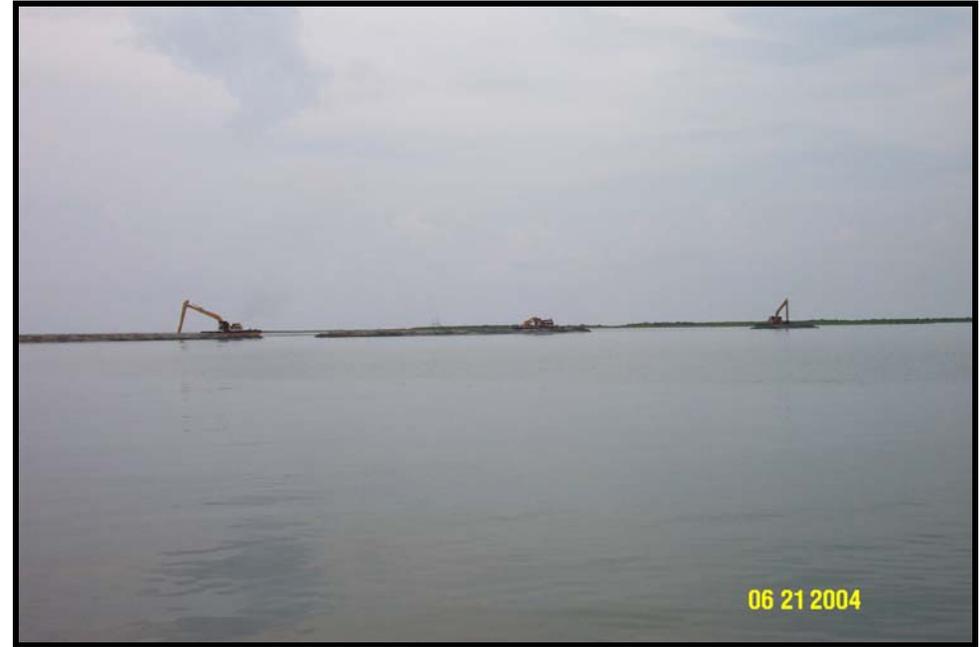
Photo 31. Construction of back dike at appx. Sta. 125+00 using marsh buggy excavators, looking south from bay

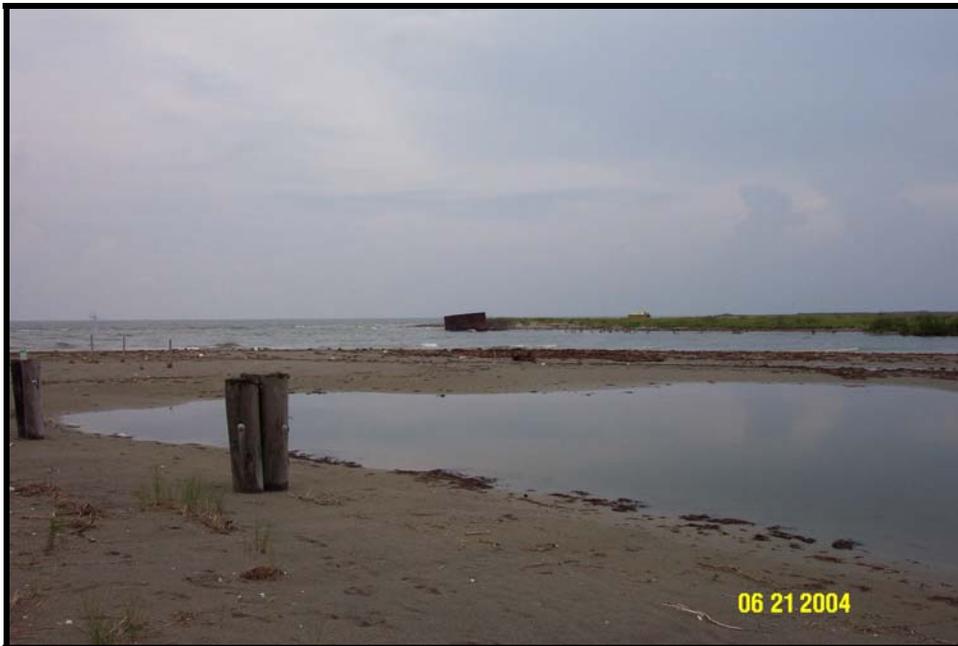
Photo 30. View of cut in island (at Sta. 165+00) looking southwest from Sta. 167+00

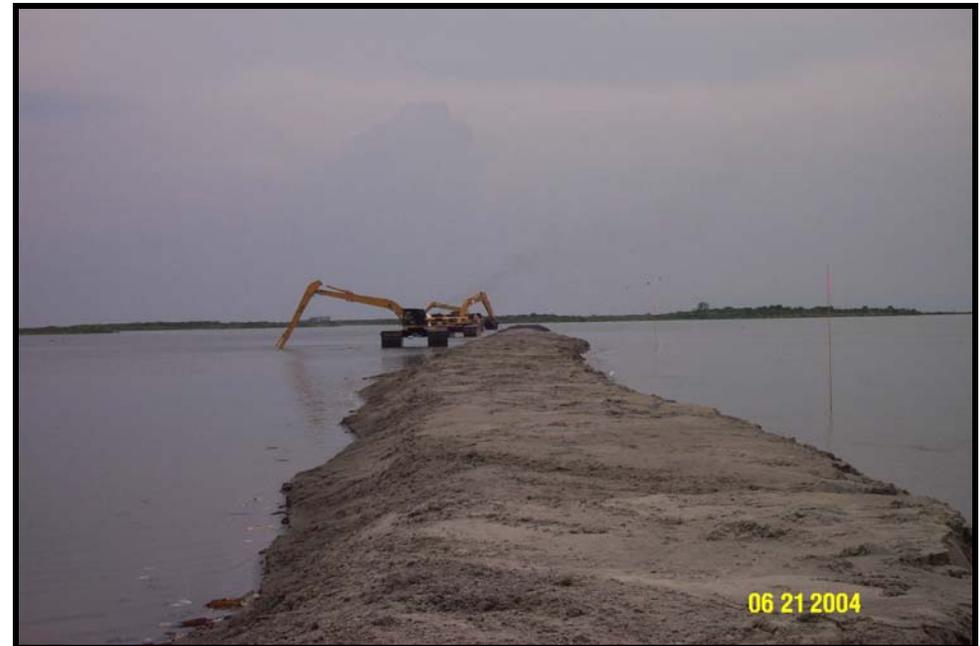
Photo 32. Construction of back dike at appx. Sta. 125+00 using marsh buggy excavators, looking west

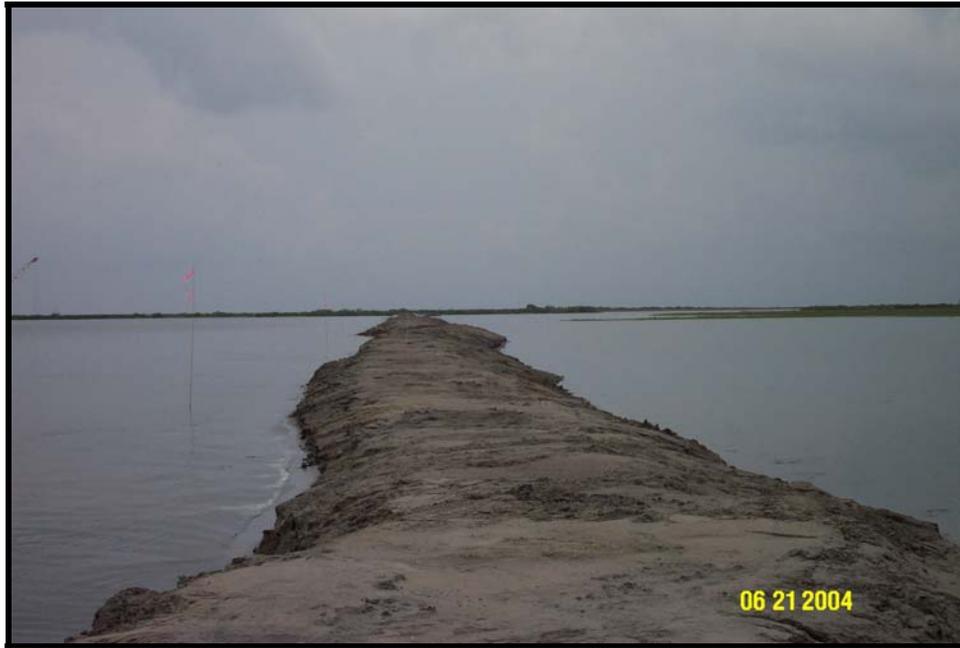
Photo 33. View of back dike looking east from appx. Sta. 129+00

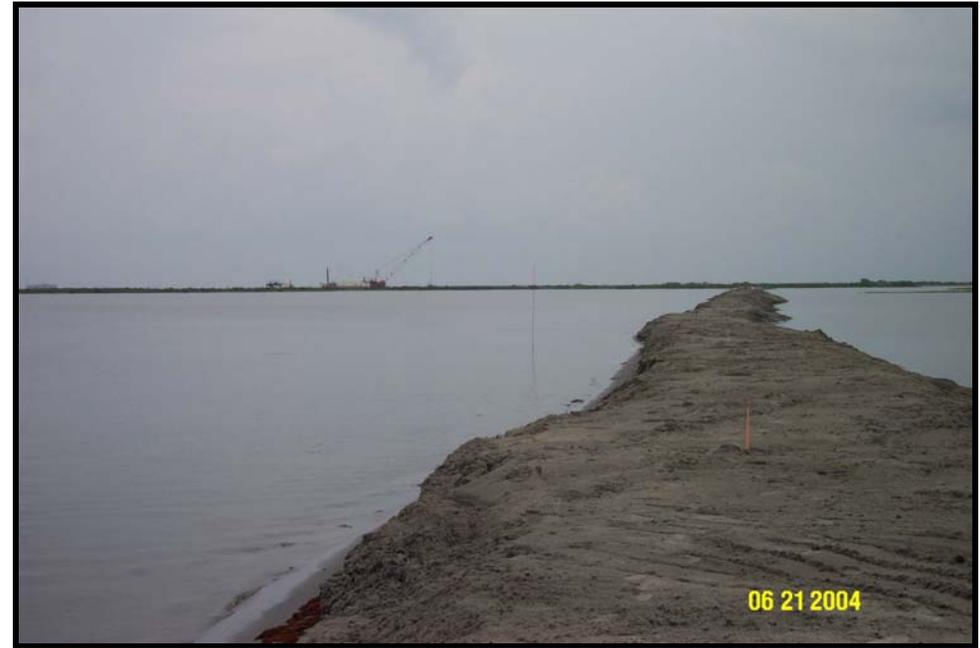
Photo 35. View of back dike looking east from appx. Sta. 127+00

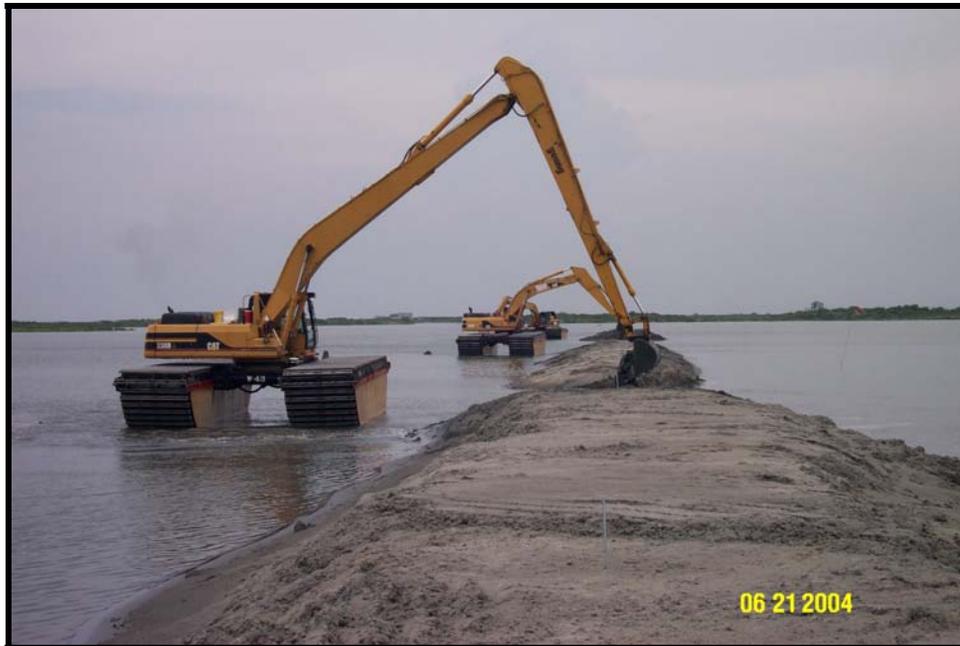
Photo 34. Construction of back dike at appx. Sta. 125+00 using marsh buggy excavators, looking west
