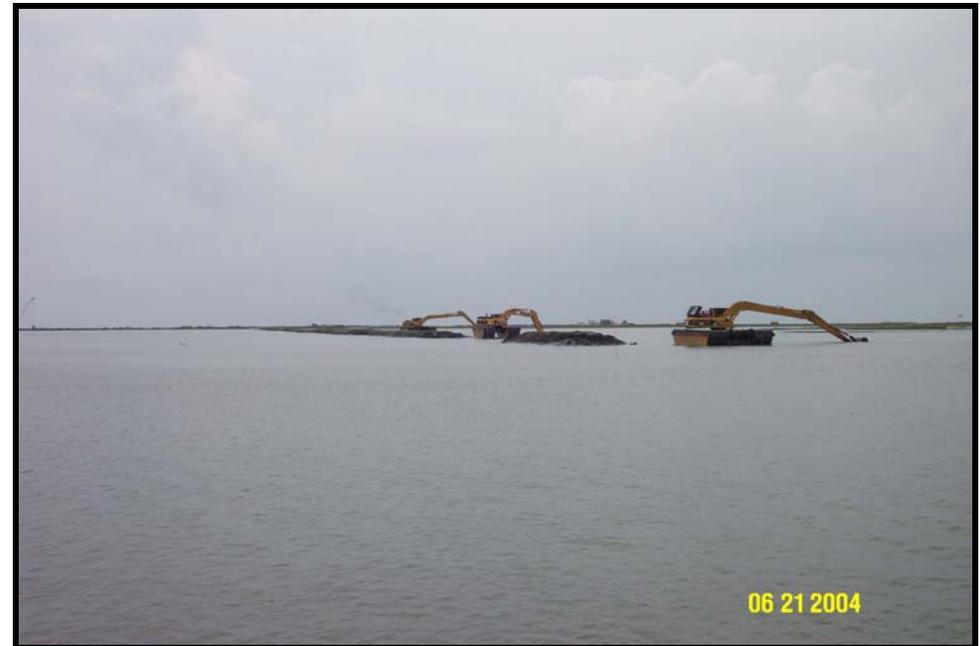
Photo 36. Construction of back dike at appx. Sta. 125+00 using marsh buggy excavators, looking southeast from bay
