**Subpart A Inspection Report
in Response to the February 14, 2014 WIPP Incident**

April 7 - 29, 2014

**U. S. ENVIRONMENTAL PROTECTION AGENCY
Office of Radiation and Indoor Air
Center for Waste Management and Federal Regulation
1200 Pennsylvania Avenue, NW
Washington, DC 20460**

September 2014

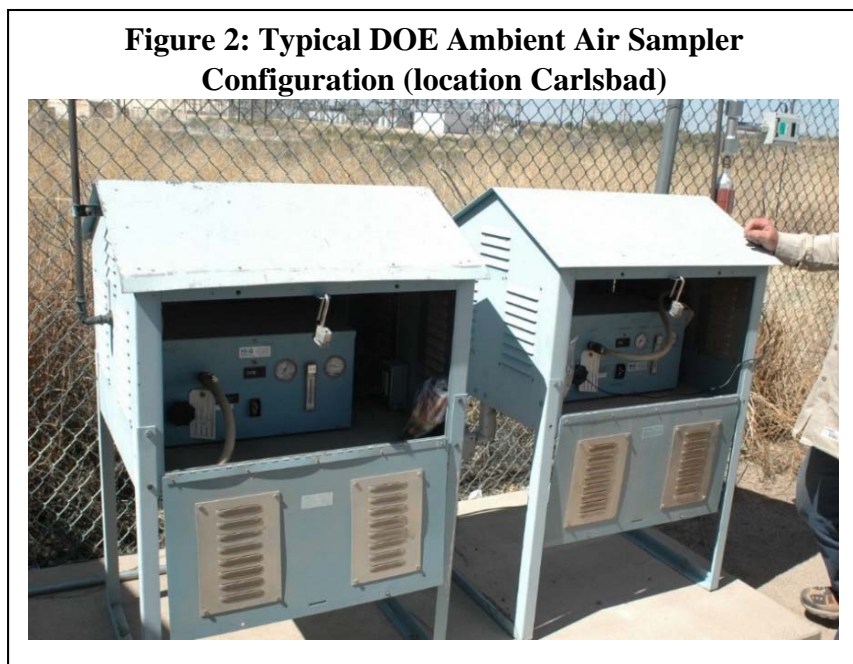
Figure 2: Typical DOE Ambient Air Sampler Configuration (location Carlsbad)

All of the ambient environmental air samplers are Hi-Q Model CMP-0523CU, housed in metal “birdhouses.” Figure 2 shows these samplers as they are typically set up. The sampling heads protrude vertically from the housing and face downward, at heights that vary between 4 and 8 feet (see Figure 3). A pump inside the birdhouse draws air through the sample head, which contains a filter that captures particulate material. The ambient air samplers have an integrated analog flow meter and pressure gauges. This instrumentation is not used, and therefore does not have a formal maintenance or calibration program. Instead, when a new filter is installed, a calibrated digital flow meter is used to adjust the pump so that 2.0 cubic feet per minute (cfm) of air is drawn across the filter. When the filter is removed, the same calibrated flow meter is used to measure flow across the filter, which typically decreases slightly as material builds up on the filter. Total flow across the filter is calculated by averaging these two flow rates, and multiplying the result by the amount of time that the filter was in operation. This time is measured by a digital timer on the sampler. These digital timers are hand-verified on an annual basis, and paper tags on the unit are used to indicate the date of the last timer verification.

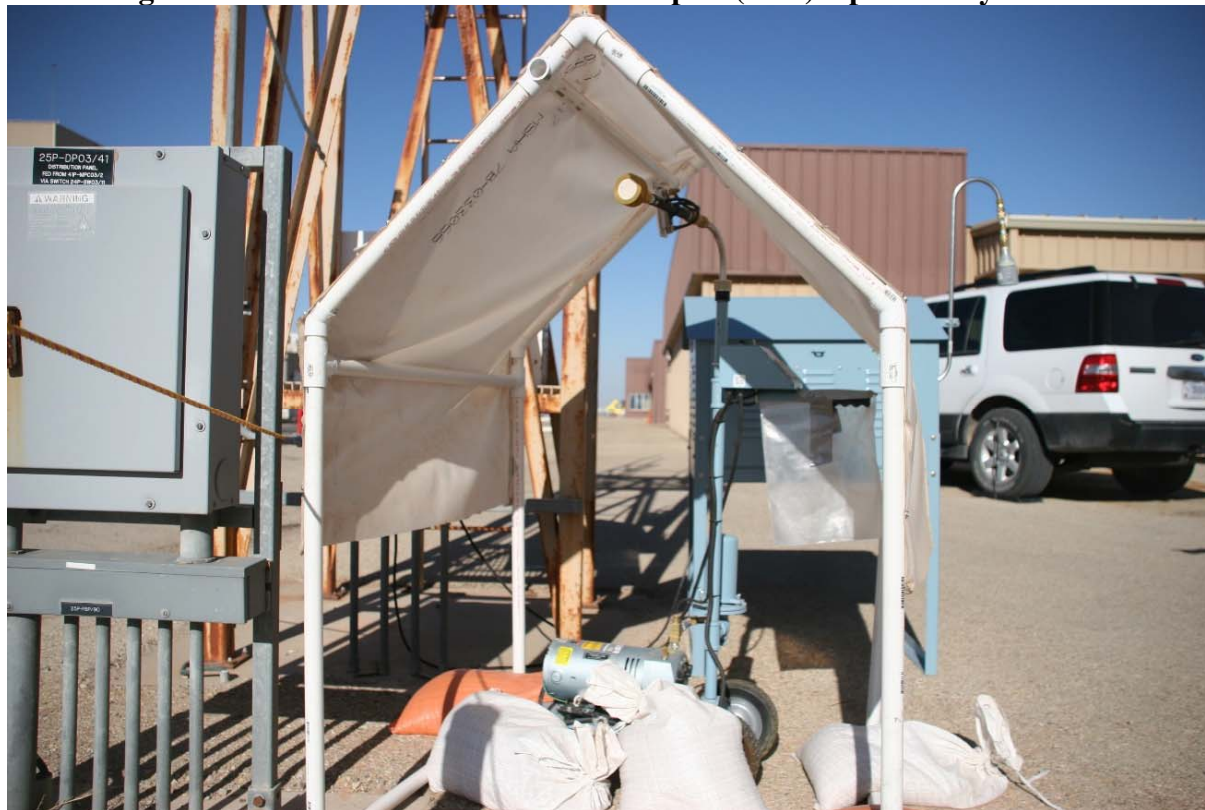
Figure 4: “Gooseneck” Portable Air Sampler (PAS) Operated by RadCon

In addition to the network of air samplers that is operated by NWP’s Environmental Monitoring program, a separate organization under NWP, Radiation Control (RadCon), has deployed ambient air samplers throughout the site during recovery operations. Sampling activities such as these can be performed at the discretion of the RadCon program, and are typically not subject to EPA oversight because they do not relate directly to regulatory compliance. During the recovery from this incident, however, EPA wanted to be sure that DOE had taken adequate steps to rule out releases from points other than the exhaust shaft. DOE provided information on sampling and monitoring equipment that had been placed around the site to accomplish this task, and the EPA inspection team verified that this equipment was present and operating as DOE had stated.

On Wednesday, April 9, the EPA team inspected the sampling equipment at the Salt Handling and Air Intake Shafts. Because of the underground contamination, the aboveground physical structure (shaft collar) and area surrounding each shaft has been restricted as a Radiological Buffer Area (RBA). The EPA team walked the exterior of the salt shaft, up to the RBA boundary. Brattice cloth, used in mine operations to restrict air flow, had been placed over and around the structure of the shaft collar, making it impossible to view the continuous air monitor at that location without entering the RBA. Four Hi-Q “gooseneck” portable air samplers (PASs) were observed: 240-R1-000-0861, 240-R1-000-1101, 240-R1-000-0062, and 240-R1-000-1610. These instruments are free-standing, low-volume air samplers that do not have any external housing. The sample heads are at waist height and parallel to the ground surface (see Figure 4). Units 0861 and 1101 were outside the boundary of the RBA. Analog flow rate meters in line with the filter head indicated that each was operating at 2 cfm. Although some of the

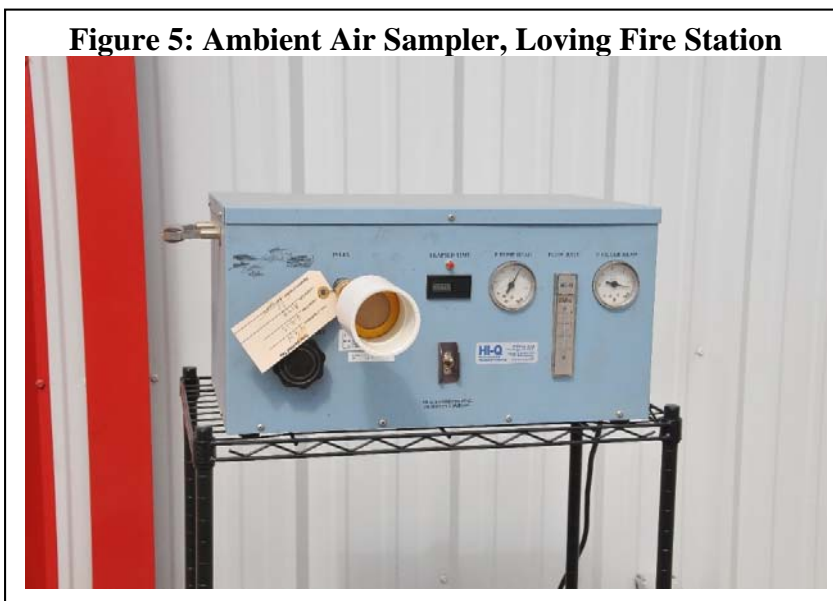
The physical positioning of several ambient air samplers needs to be improved for the samplers to function properly. The ambient air samplers located at the Carlsbad location were partially obstructed by a large outdoor shed and closely parked maintenance trucks, potentially preventing air flow from the desired 270 degree sampling area or even the 180 degree minimum sampling area. The presence of vehicles could also provide bias from vehicle emissions, which may interfere with collection efficiency. The newly established ambient air samplers located at Artesia, Loving, Hobbs and Eunice were all closely located to structures more than three times the height of the samplers (Figure 5). Each of these samplers should be moved to attempt to get a 270 degree sampling area away from buildings. In addition, samplers in Artesia and Eunice station were located next to regularly plowed farm land, which could reduce the collection efficiency of gathering the targeted radionuclides due to early loading of the sample filters with soil particulates. Lastly, the sampler in Artesia was placed under an exhaust vent for the adjacent fire station. Particulate exhaust from this vent may reduce collection efficiency.

This sampler should be moved away from this exhaust. These observations are made in consideration of 40 CFR Part 58, Appendix E, Probe and Monitoring Path Siting Criteria for Ambient Air Quality Monitoring. The samplers sited at WIPP Far Field, WIPP East, WIPP South, Mills Ranch, Smith Ranch, Southeast Control, Met Tower, Salt Hoist, Training Building and the WIPP Guard & Security Building were placed in excellent locations for sample collection.

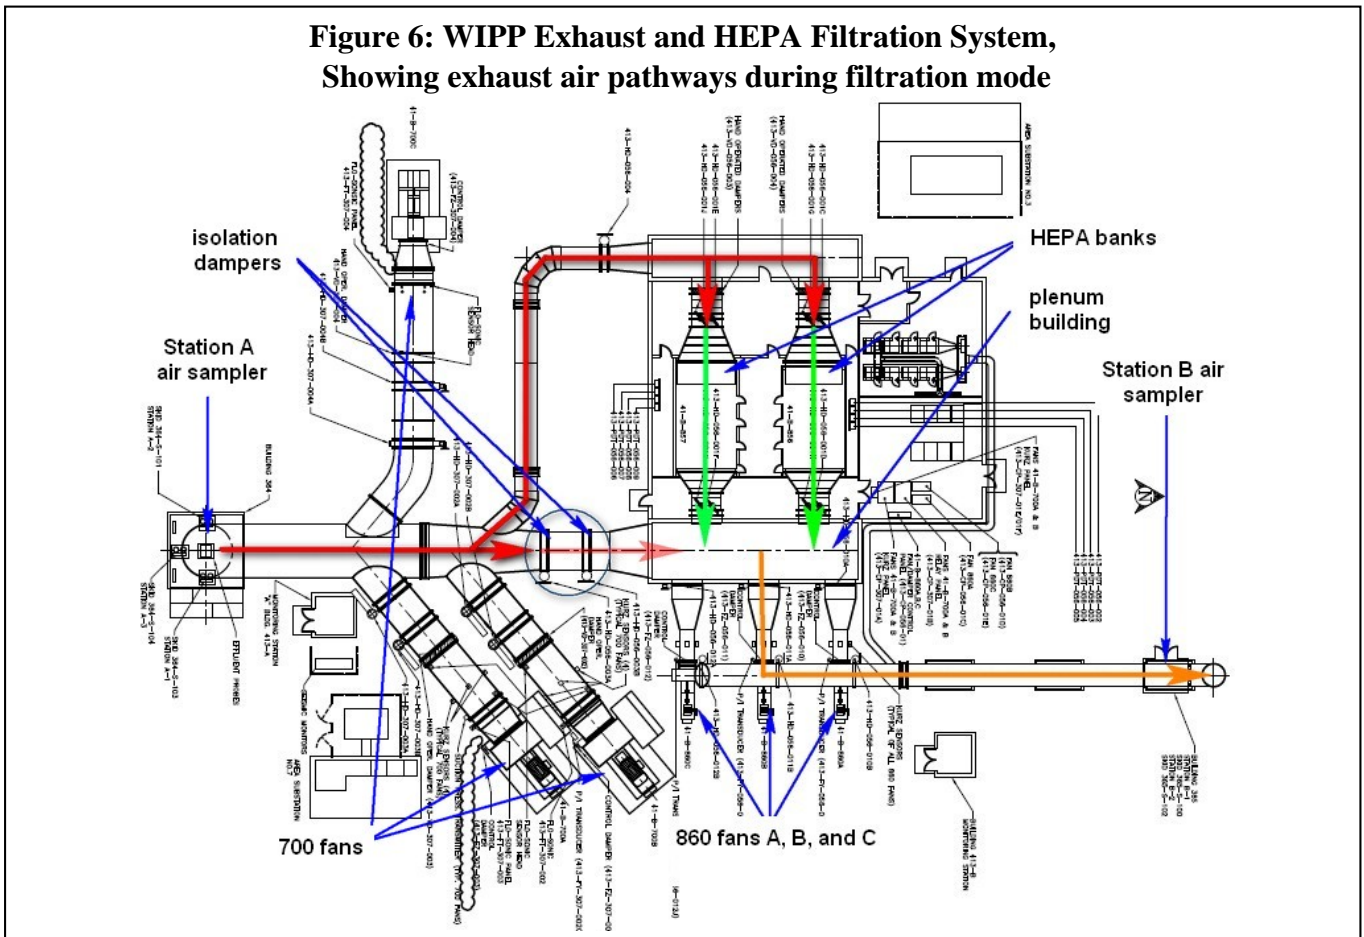
The exhaust system can be operated in several configurations. If the facility is not in filtration mode and one or more of the three “860” fans is being operated, exhaust air passes through the open dampers into the plenum building, and is then exhausted at Station B. In filtration mode, a single 860 fan is operated and the dampers are closed, forcing air through the HEPA filtration banks. Because the plenum building remains under negative pressure, some unfiltered air passed through the dampers and was exhausted without being filtered, prior to the sealing of this leak pathway. However, because all of this air is exhausted through the same pathway, air samples taken at Station B capture all radioactive material that enters the environment. In Figure 6, the red arrows denote the path of unfiltered mine exhaust, the green arrows show the path of filtered air, and the orange arrow shows the mixture that is exhausted from the plenum building. There are similar sets of dampers on each of the three “700” fans (the typical exhaust points for high ventilation configurations) that are likewise closed when the facility enters filtration mode. However, these dampers are under constant negative pressure, so any leakage at those locations would pull exterior air into the effluent stream.

Discussions with engineering staff confirmed that the HEPA system had been tested regularly against its original design standard. At the time of the inspection, considerable effort was being devoted to planning the change-out of the filter media. The site was planning to replace all components (mod or roughing filter which is designed to capture large particles, high-efficiency filter, and two HEPA filters) on one side, and the mod filter on the other side. Pressure gauges are located between each of the filter stages, and the pressure differential (measured in pounds per square inch, or psi) across each component of the filter is used to monitor its performance. As more material builds up on a filter component, air encounters greater resistance when passing through, and the differential pressure increases.

At the time of the inspection, staff were closely watching the roughing filters, and based on conversations with the manufacturers, raised the differential pressure alarm point from 2.0 psi to 2.5 psi, shortly before the previous alarm point was reached on April 7. The previous alarm point was more conservative than necessary, and the filter is designed to withstand a differential pressure greater than 2.5 psi.

In the event that filter loading creates too high a pressure differential across the roughing filter, the filter would tear, creating a pathway for unfiltered air. Because each HEPA bank includes four filter stages in series, however, failure of the roughing filter would not compromise overall filter efficiency. Instead, the next filtration stage, the high efficiency filter, would begin loading at an accelerated rate. Engineering personnel did not anticipate any obstacles to the continued operation of the HEPA filters. A 5 psi pressure differential across the entire HEPA bank is currently the alarm point that would force the site to secure ventilation by shutting down the exhaust fan. (Securing ventilation would increase the risk of contamination escaping through the air intake and salt handling shafts. It is for this reason that brattice cloth has been placed at each of those locations.) Loss of effectiveness of the HEPA filtration system is unlikely to occur through a sudden, catastrophic failure. Rather, many warning signs, alarms and smaller failures would take place before any event could compromise overall HEPA efficiency, allowing DOE to shut down the system if necessary.
