List of key personnel interviewed EPA Internal Review Team of the Gold King Mine Spill, Colorado

Gold King Mine 2015 EPA Working Assumptions

Gold King Mine Flow Data and Chart

Photos and Google Earth Images

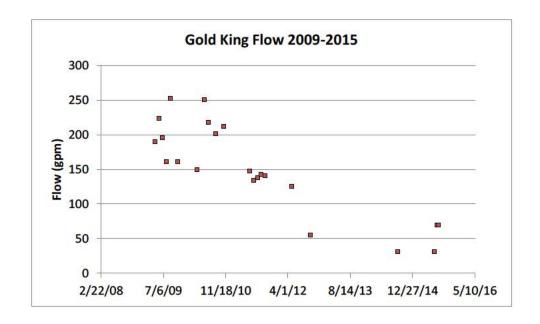
Gold King Mine flow data is available from 2009 through 2014, with multiple sampling events from 2009-2011 and fall sampling from 2012-2014. Gold King Mine spring flow was not measured from 2012 to the present due to high snow and potential avalanche conditions, and flow was not measured during fall 2013 due to the government shutdown. Flow was also measured by START during 2014 and 2015 site visits.

For years with multiple flow measurements (2009, 2010, 2011), the Gold King Mine discharge varied by up to 45 percent within 1 year (2009), when the November flow was 45 percent greater than the August flow.

The Gold King Mine discharge annual average runoff flow varied from the annual average non-runoff flow by up to 22 percent (2010).

Older historic data from START showed flow was 42 gpm in July 2005, 135 gpm in September 2005, and 314 gpm in October 2006. This widely variable flow may have been due to backup of water behind the American Tunnel reaching the elevation of the Gold King rather than an indication of the variability of flow from the Gold King Mine.

Measurements in 2015 included 31 gallons per minute (gpm) on June 24 (similar to Fall 2014), and 69 gpm on both July 15 and July 23.

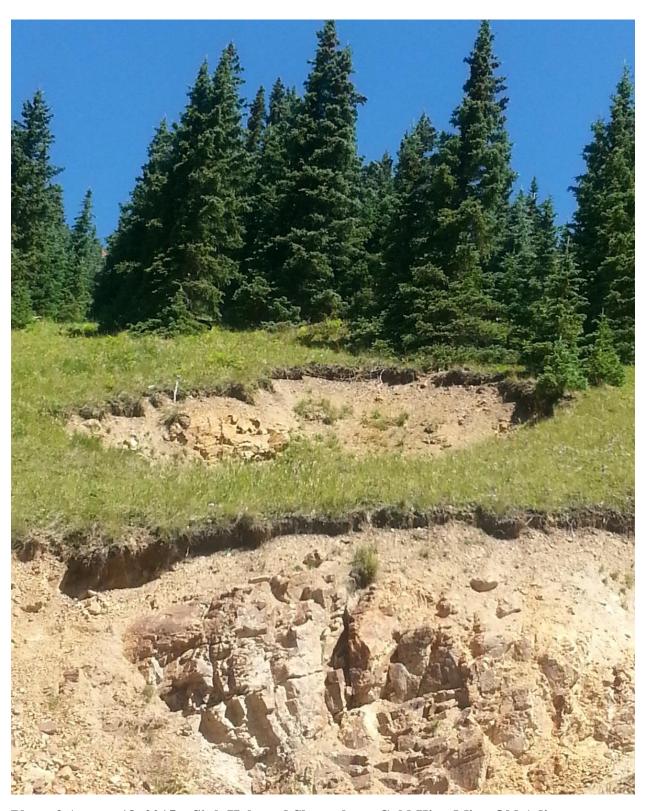
Photo 3 August 18, 2015 – Sink Hole and Slope above Gold King Mine Old Adit

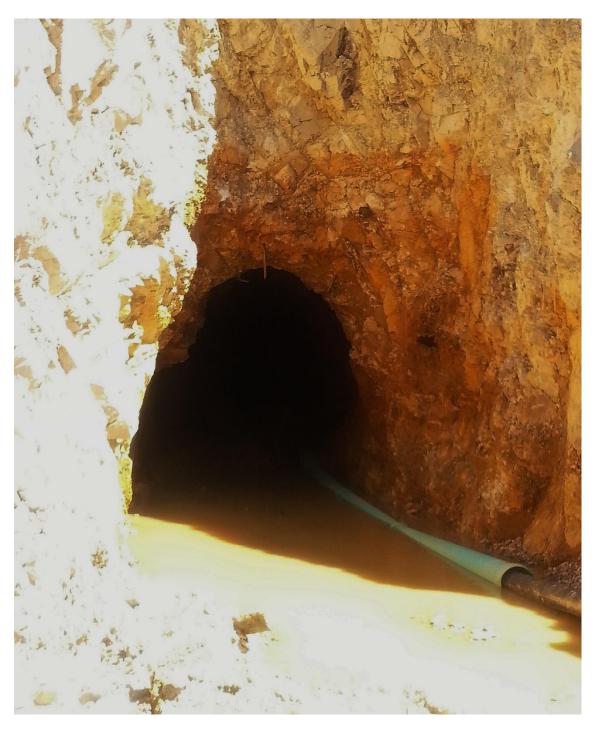
Photo 4 August 18, 2015 – Gold King Mine Level 7 Adit post-blowout
