Long-Term Stewardship Assessment Report

Rosedale Landscape Depot

EPA ID #: MDD981041601

Assessment Date: August 4, 2015 Report Date: August 11, 2015

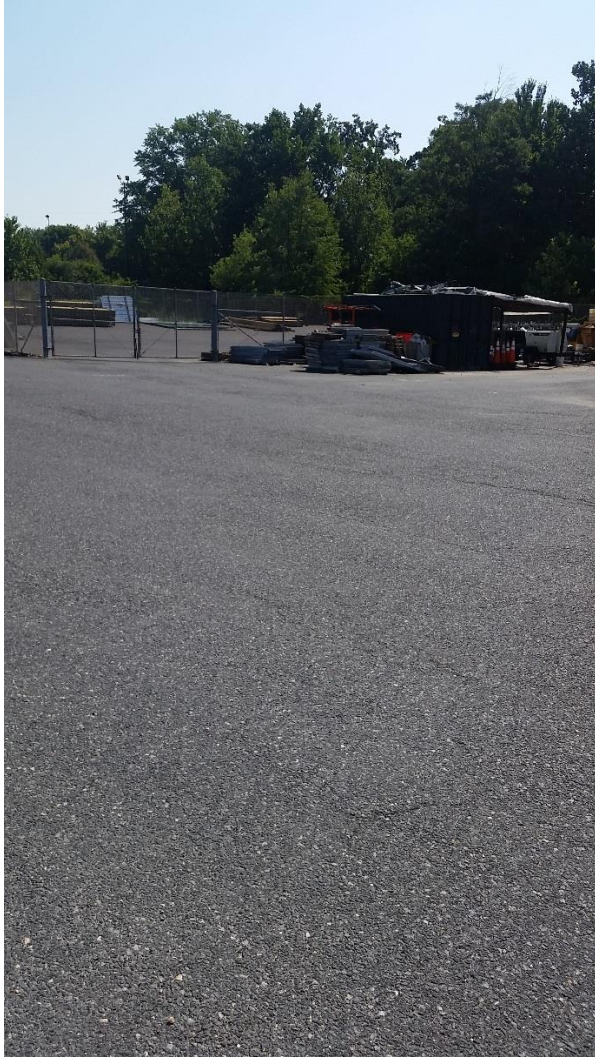
Picture 1: Overview of Multilayer Cap

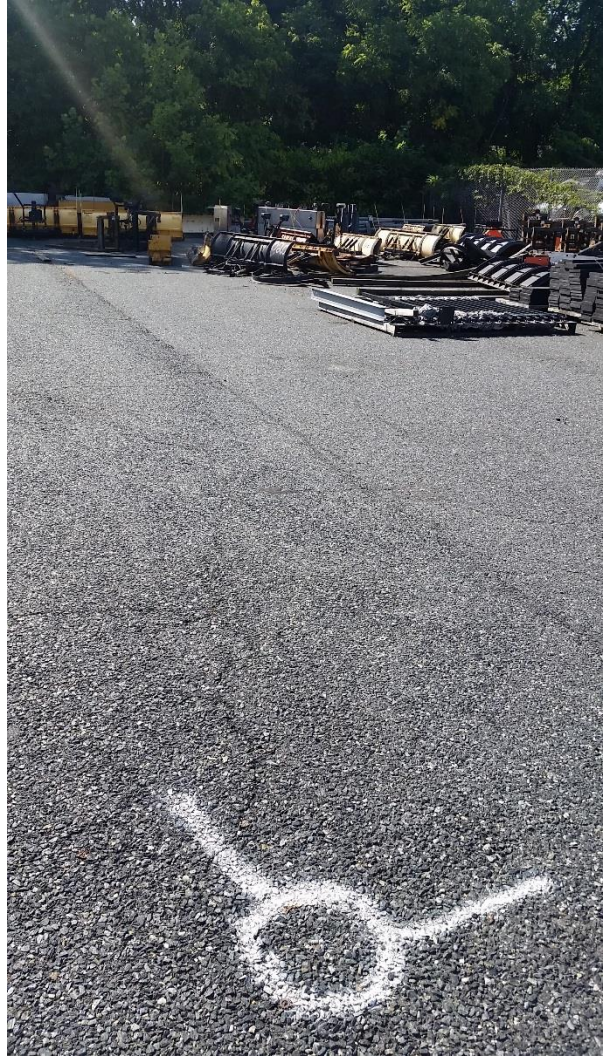
Picture 2: View from North Corner of Cap

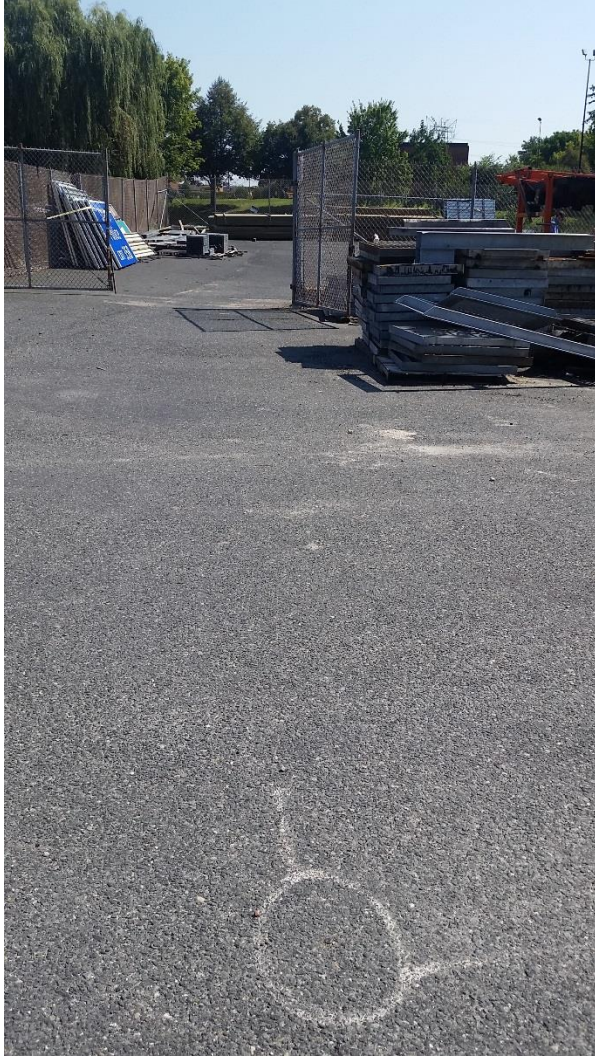
Picture 3: View from West Corner of Cap

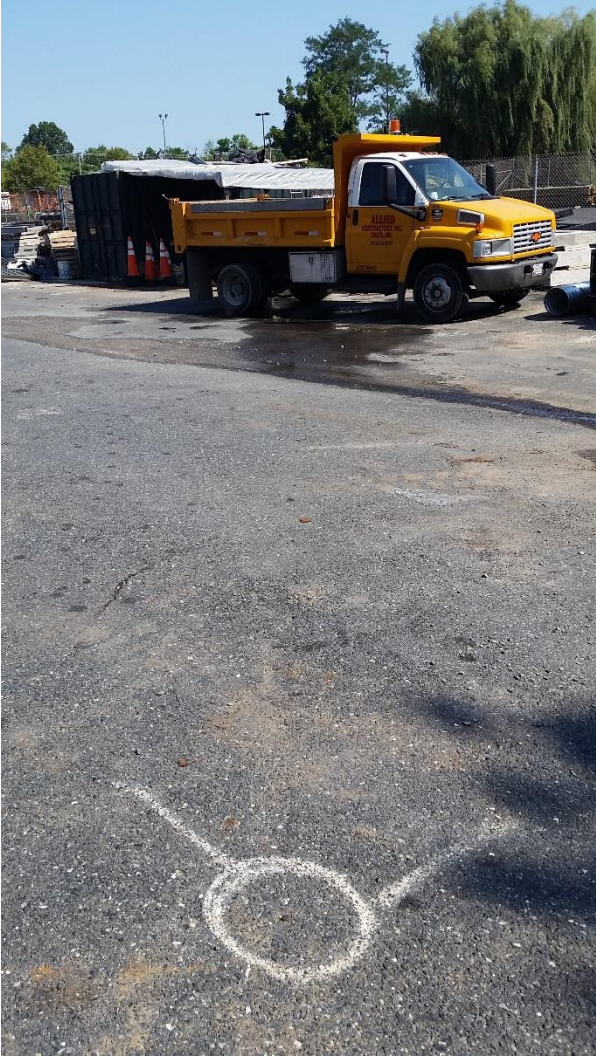
Picture 4: View from South Corner of Cap

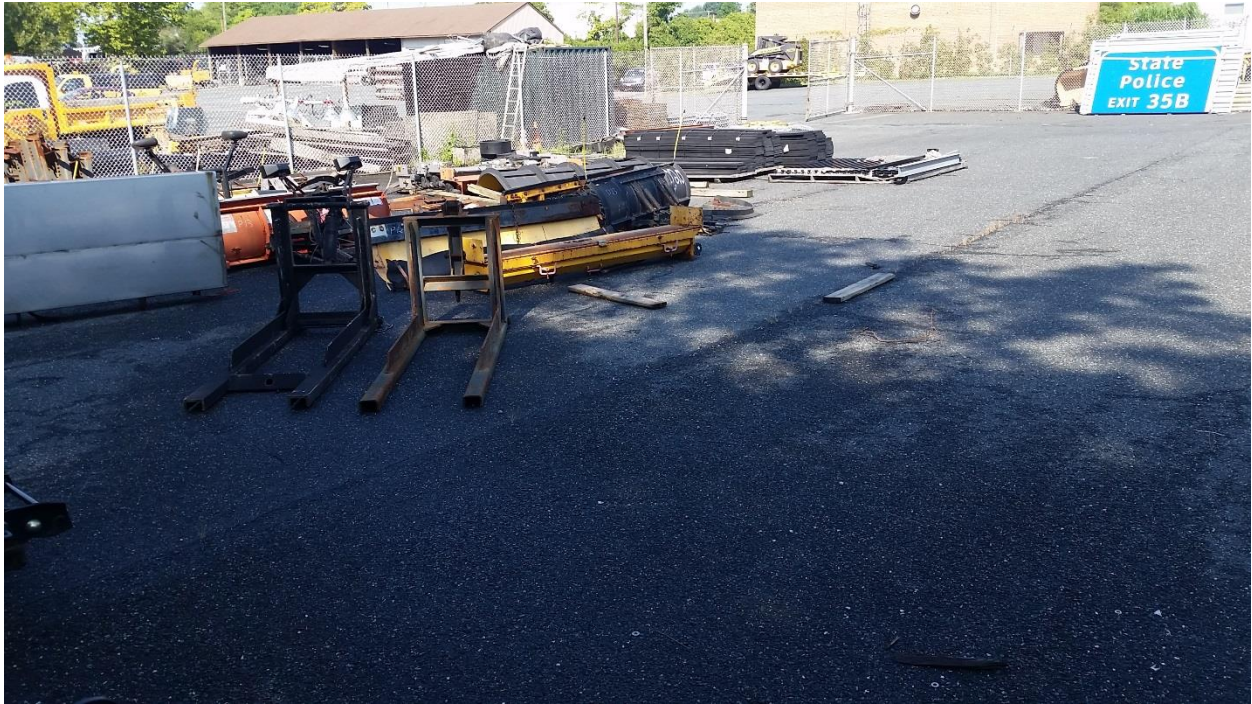
Picture 5: View from East Corner of Cap

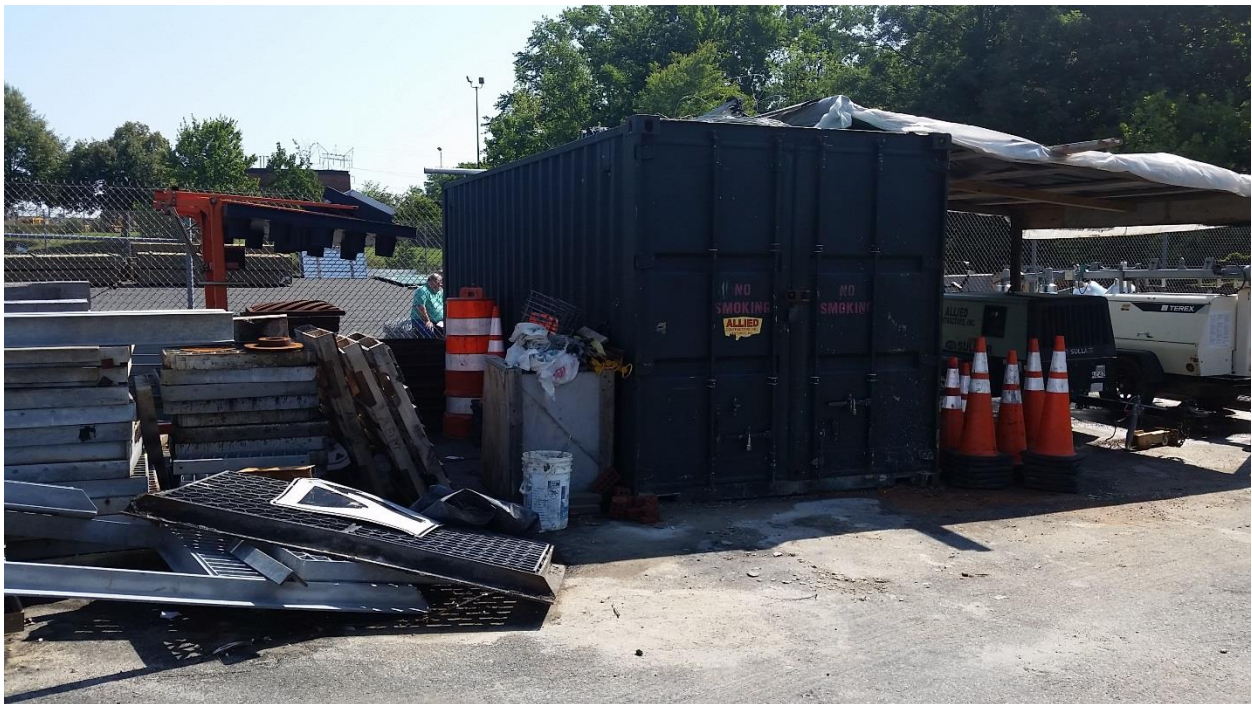
Picture 6: Maintenance Equipment stored on Cap

Follow-up Activities: Clear off large equipment on pad areas above cap during annual inspections and cool seal current surface cracks in asphalt within the next year. Also, retrieve more information from SHA and MDE about the structure and cross section of the multilayer cap. Make note of the potential hazard of exposure at the fence in the cap area if the fence is to be modified or removed.

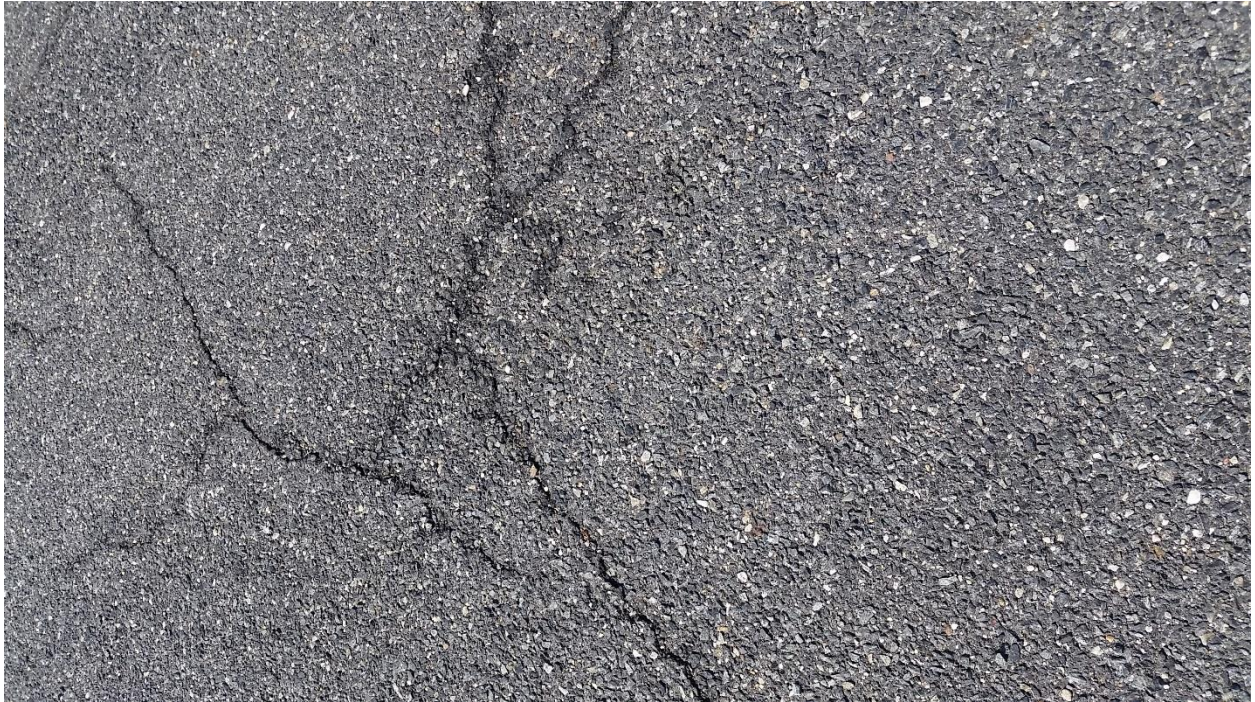
Picture 7: Cracks near North Corner of Cap

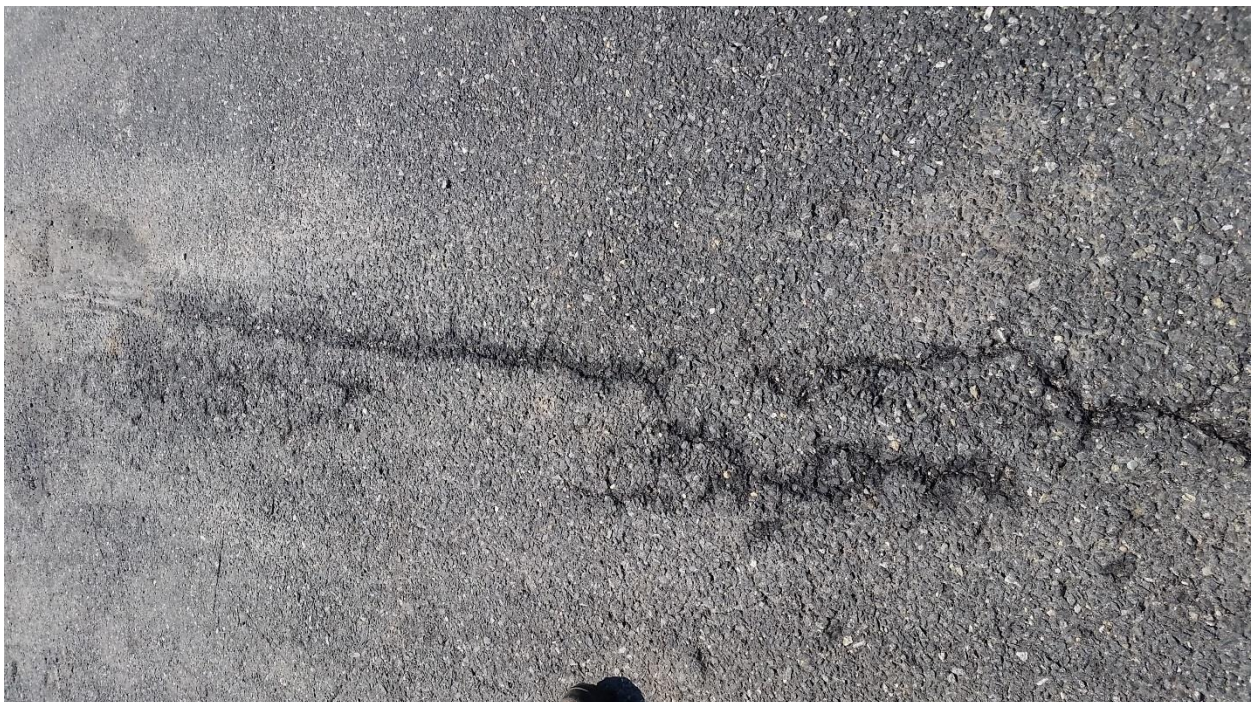
Picture 8: Cracks near South Corner of Cap
