### DRAFT TECHNICAL MEMORANDUM

**TO:** [REDACTED] EPA Region 8, On-Scene Coordinator  
**FROM:** [REDACTED], Superfund Technical Assessment and Response Team (START)  
**DATE:** August 12, 2015  
**SUBJECT:** Gold King Mine Investigation and Blowout Event

# PHOTOGRAPH LOG

<b>Project Name:</b> Gold King Mine	<b>Site Location:</b> Silverton, San Juan County, Colorado	<b>Project No.:</b> 0001/1408-01
--	---	-------------------------------------

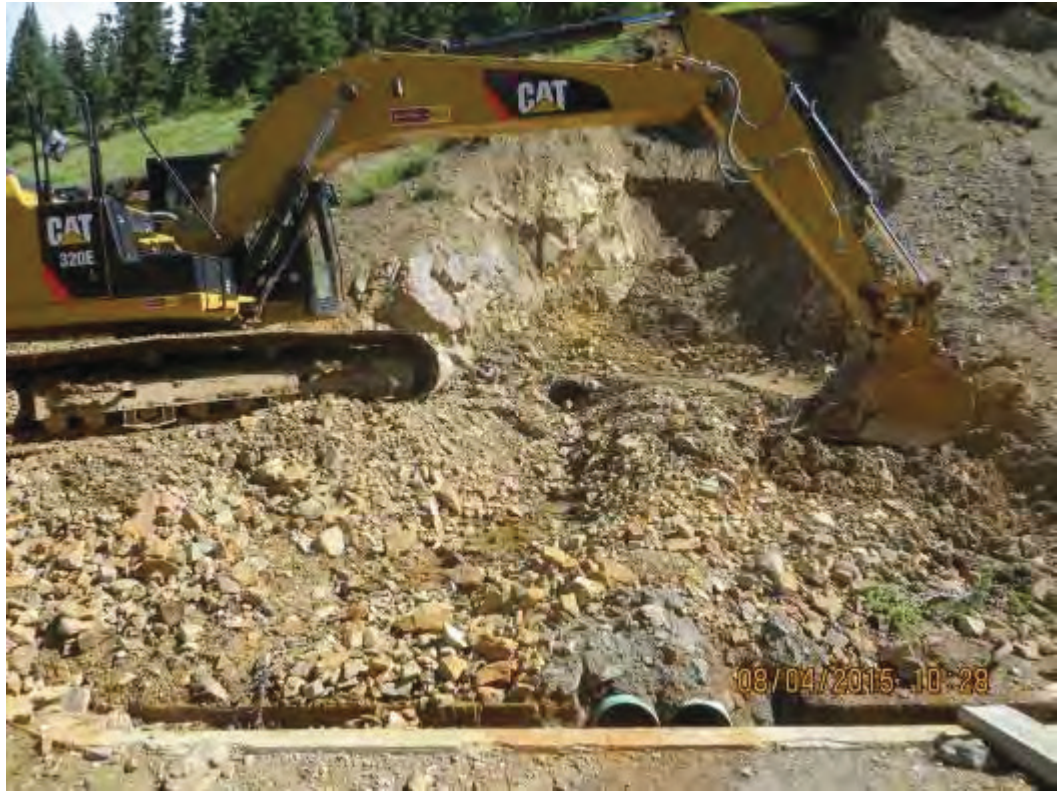
**Photo No.**  
**1**

**Description:**  
Beginning investigation into collapsed adit.

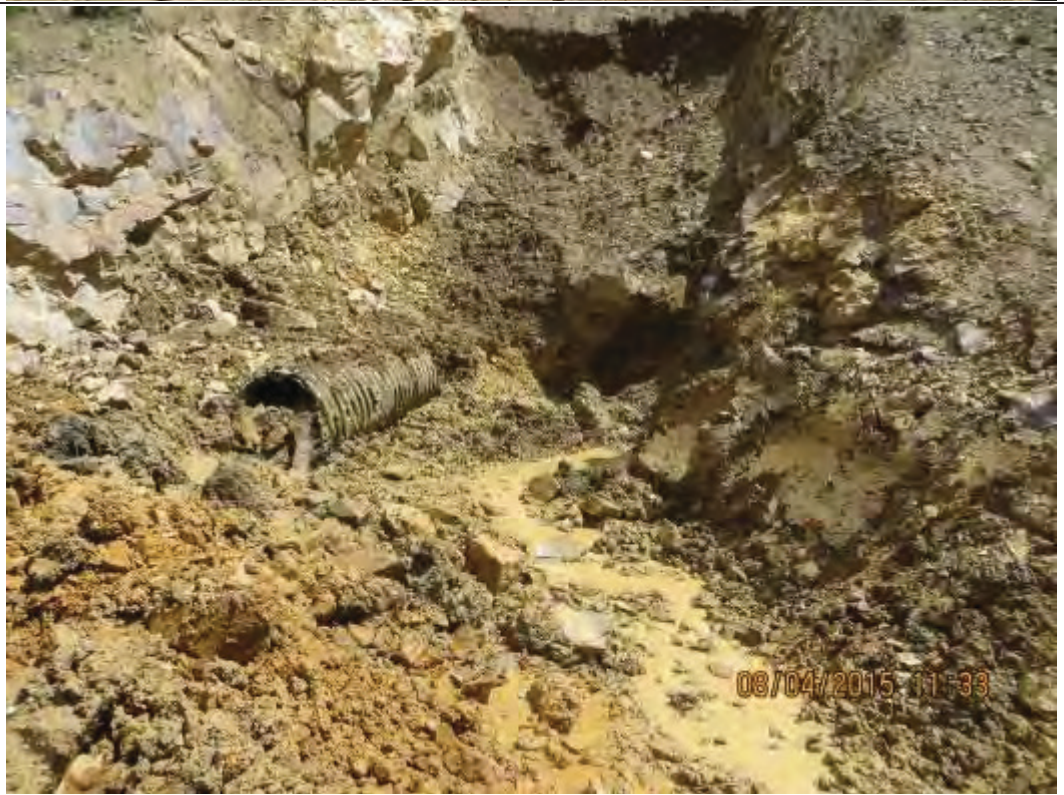
**Photo No.**  
**2**

**Description:**  
Excavated next to DRMS-installed culvert, water muddy from soil disturbance.

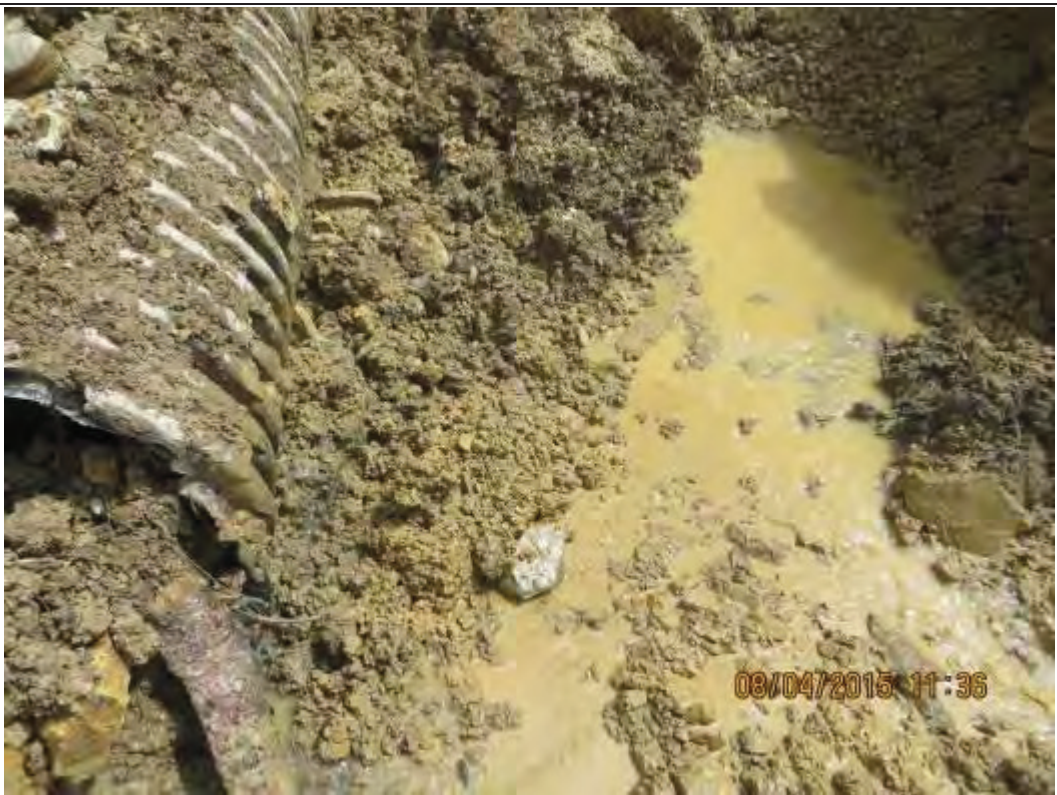
<b>Photo No.:</b> <b>3</b>	<b>Date:</b> 08/04/2015
<b>Direction Photo Taken:</b>  Down	
<b>Description:</b> Seepage from soil next to piping.

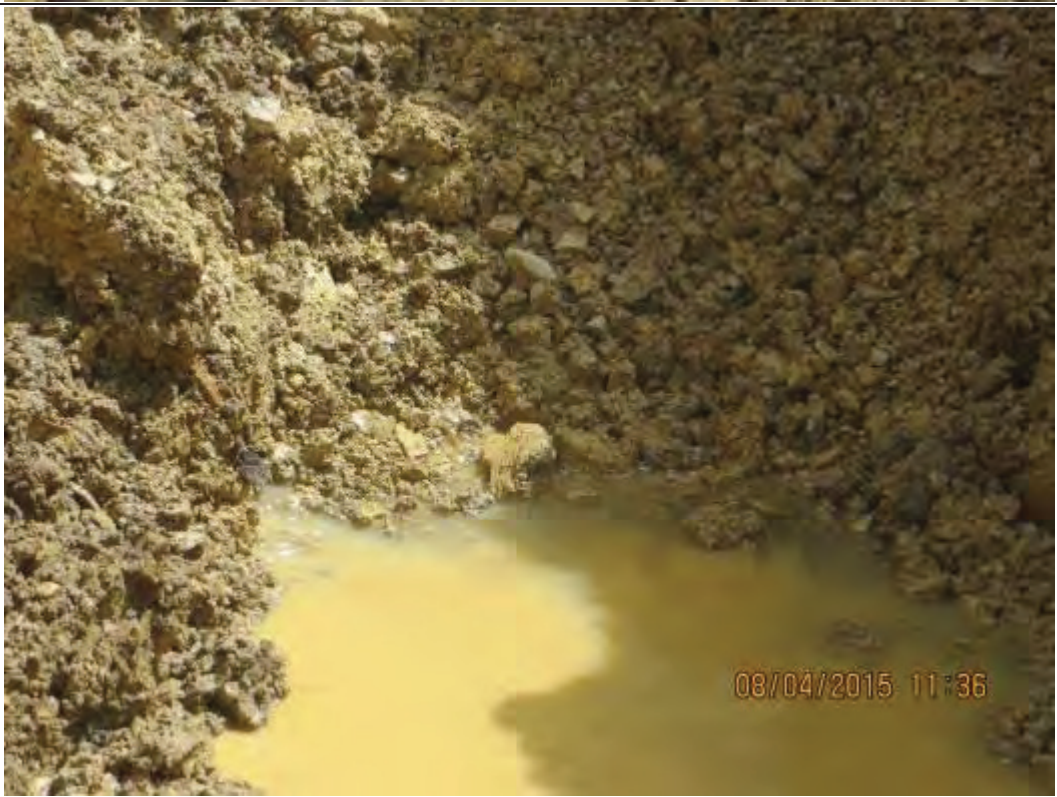
<b>Photo No.:</b> <b>4</b>	<b>Date:</b> 08/04/2015
<b>Direction Photo Taken:</b>  Down	
<b>Description:</b> Seepage next to the pipe is clear until entering disturbed soil.

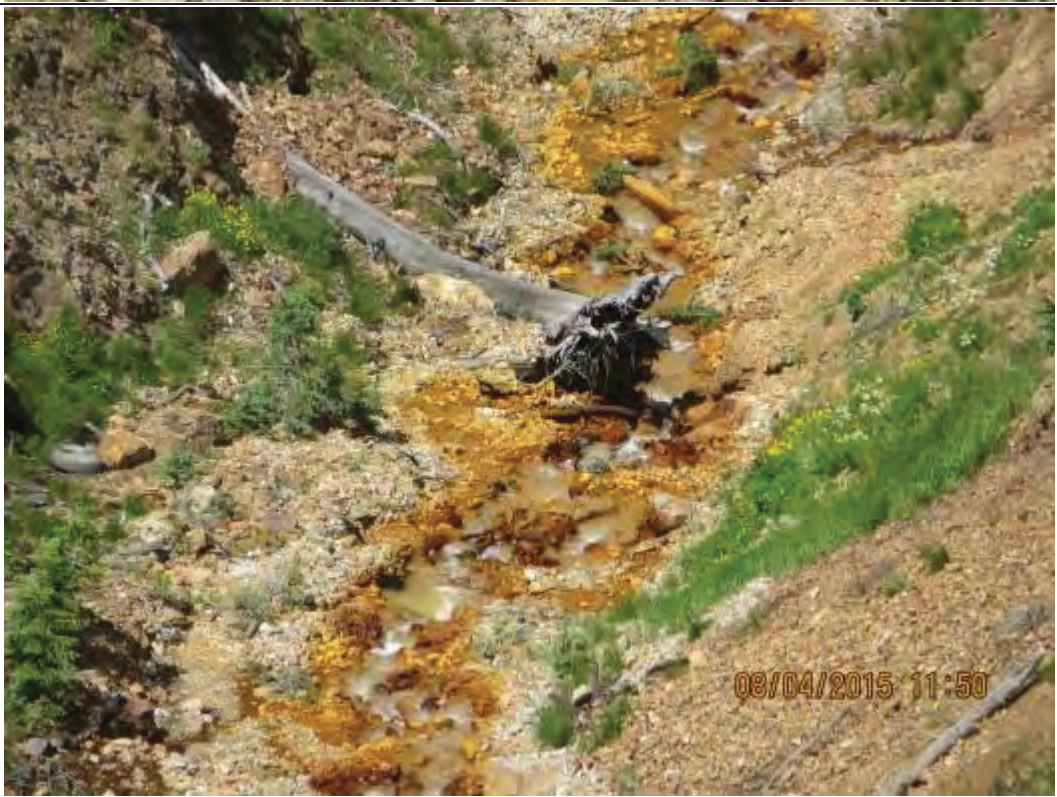
<b>Photo No.</b> <b>6</b>	<b>Date:</b> 08/04/2015
<b>Direction Photo Taken:</b>  West	
<b>Description:</b>  Water minimally murky from disturbed soil and water entering the North Fork from site.

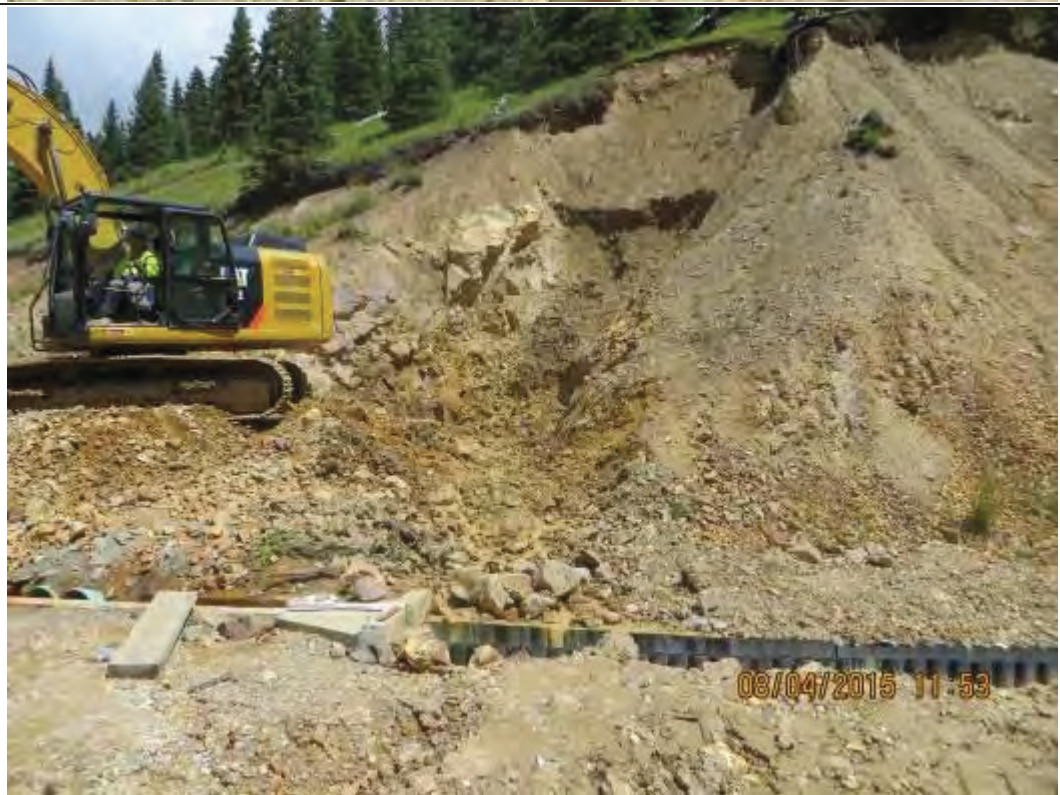
<b>Photo No.</b> <b>8</b>	<b>Date:</b> 08/04/2015
<b>Direction Photo Taken:</b>  Northwest	
<b>Description:</b> Continuing excavation at the collapsed adit, no solid bedrock found for tunnel support.

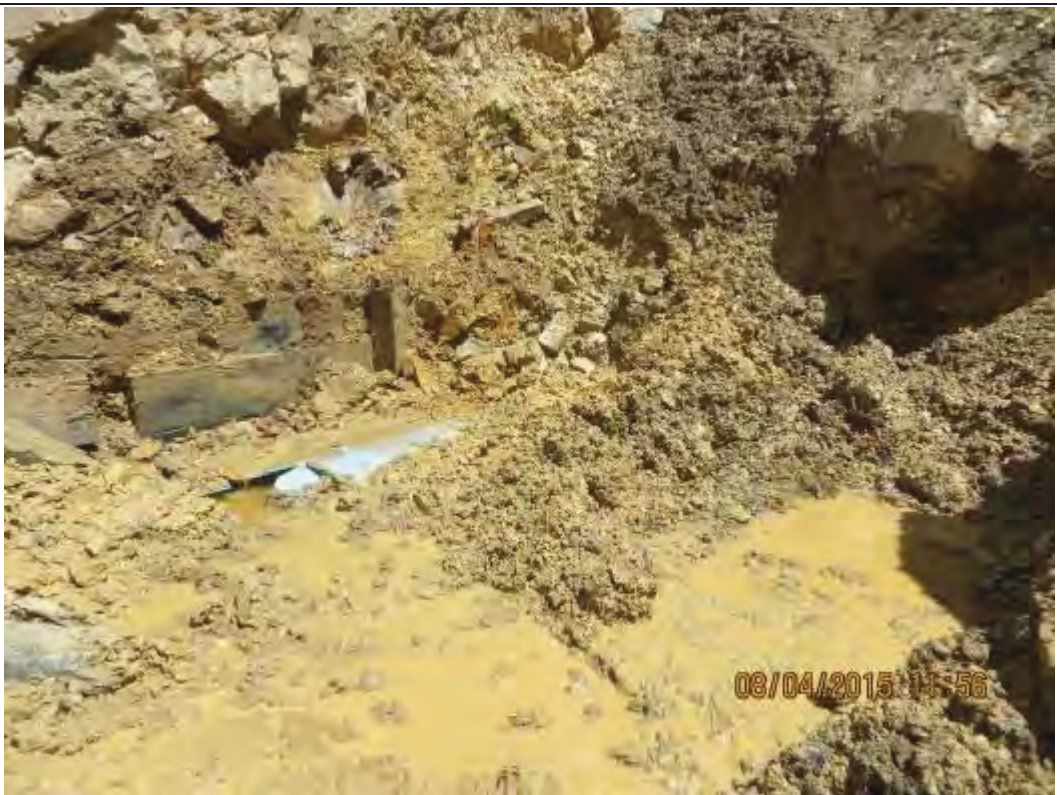
<b>Photo No.:</b> <b>9</b>	<b>Date:</b> 08/04/2015
<b>Direction Photo Taken:</b>  Northeast	
<b>Description:</b> First signs of adit, support pillar with lagging.

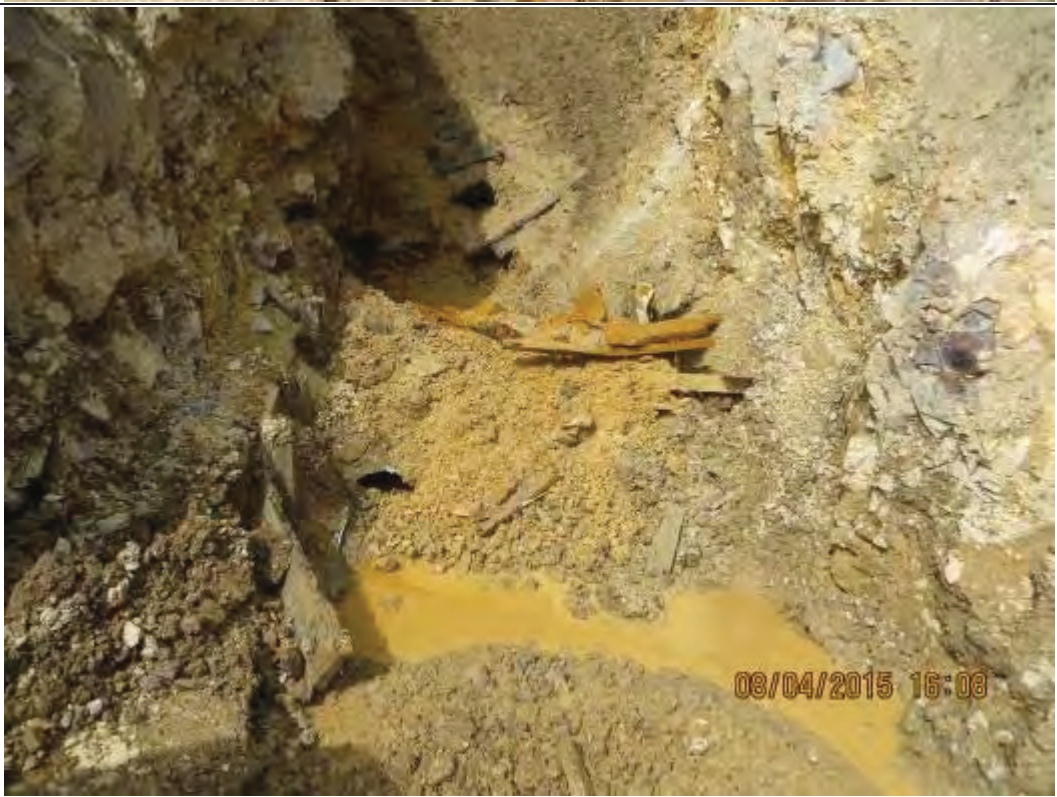
<b>Photo No.</b> <b>12</b>	<b>Date:</b> 08/04/2015
<b>Direction Photo Taken:</b>  North	
<b>Description:</b> Collapsed supports uncovered above anticipated adit, no sign of bedrock above the adit area.

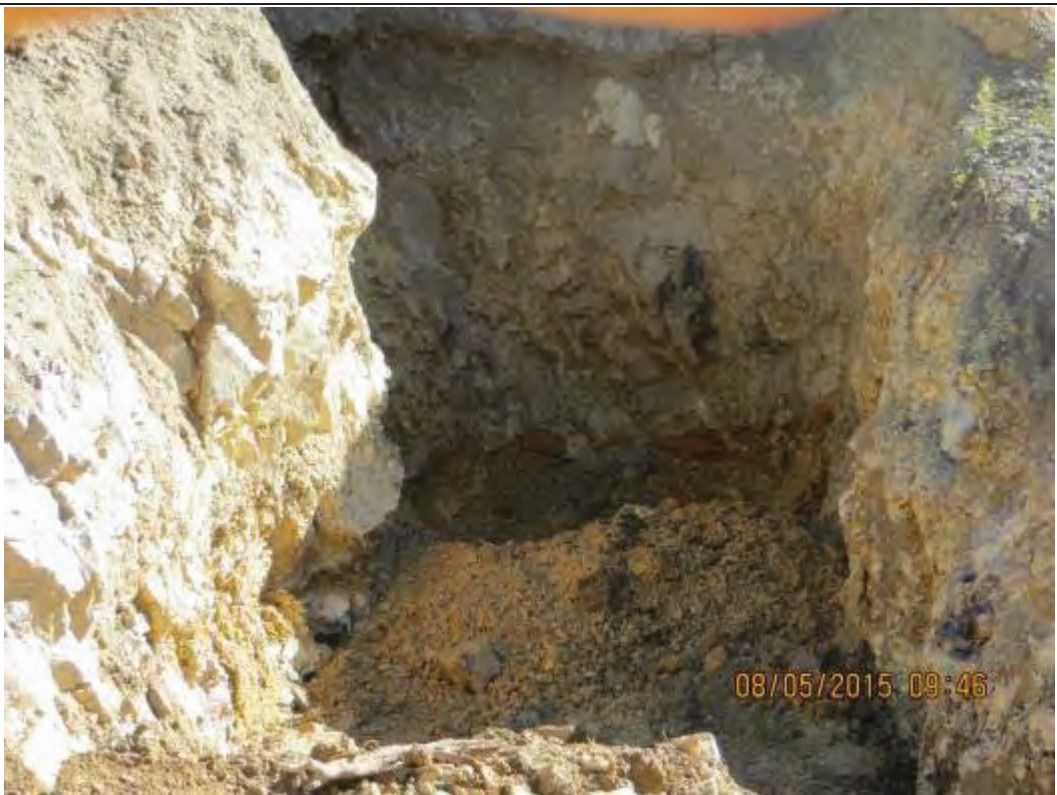
<b>Photo No.:</b> <b>15</b>	<b>Date:</b> 08/05/2015
<b>Direction Photo Taken:</b>  North	
<b>Description:</b> Bedrock found above the anticipated adit.

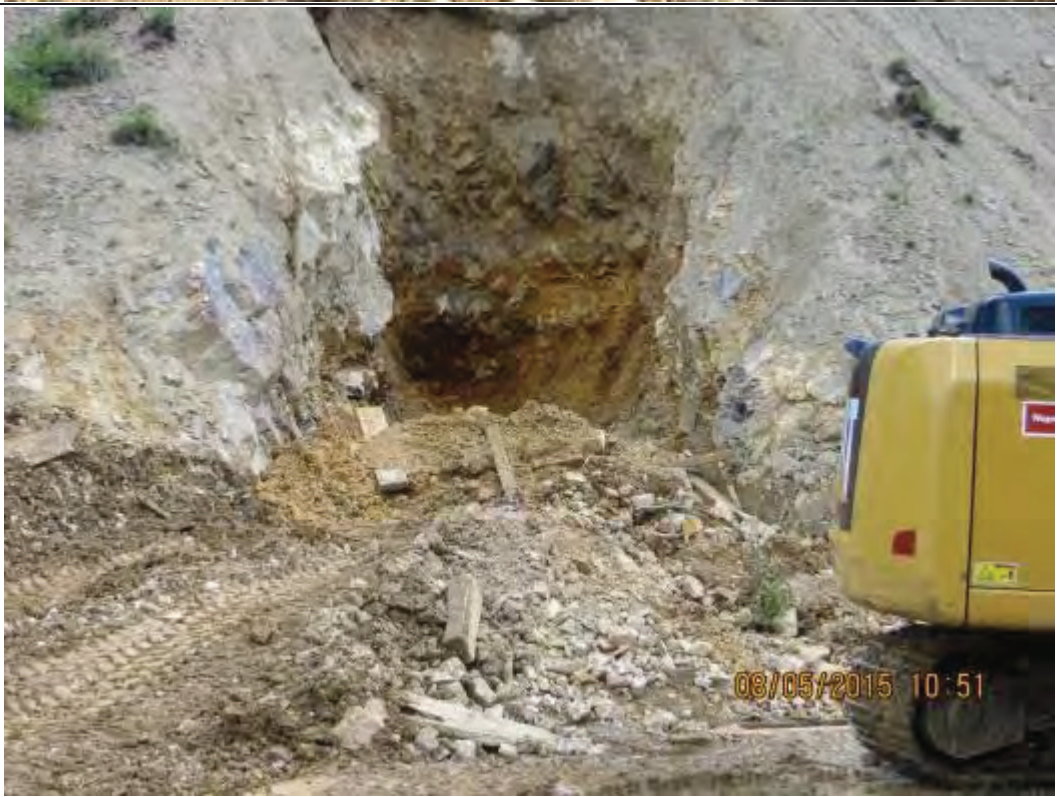
10:51 A small leak was observed approximately 15 to 20 feet above the anticipated elevation of the floor of the adit. Work stopped and the excavator moved back from the excavation area.

<b>Photo No.:</b> <b>16</b>	<b>Date:</b> 08/05/2015
<b>Direction Photo Taken:</b>  North	
<b>Description:</b> Cleaning out excavated material, small leak.

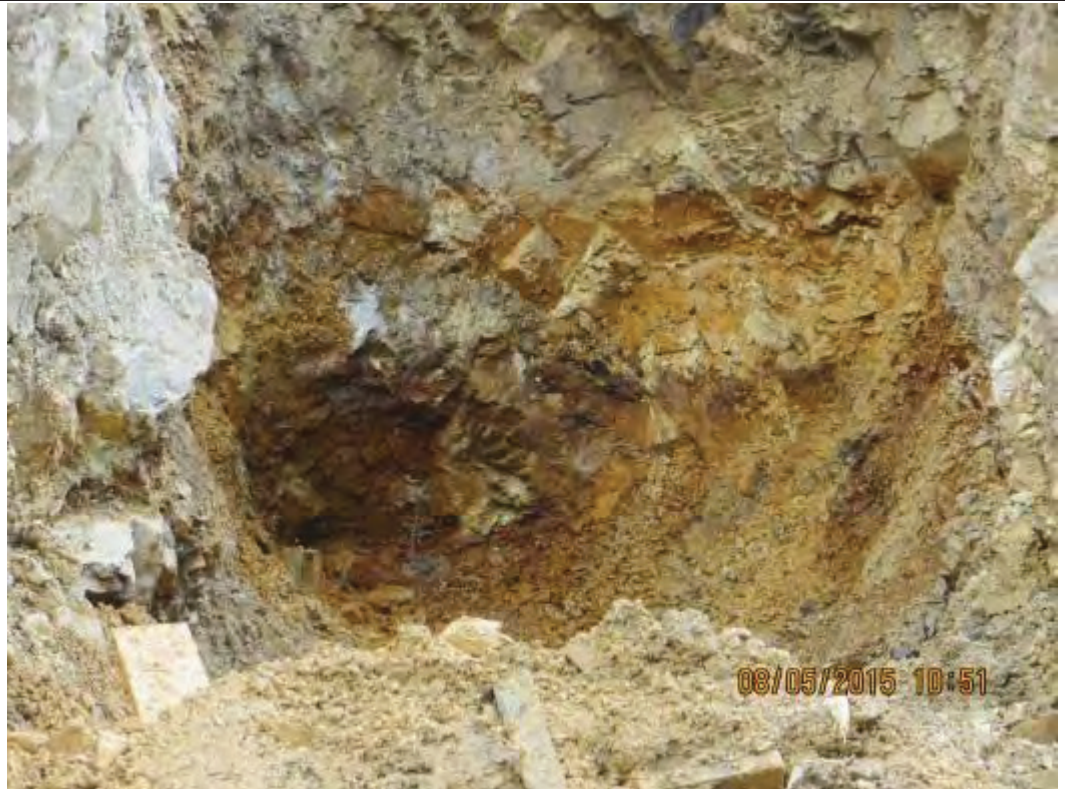
**Photo No.**  
**17**

**Description:**  
Small leak close up.

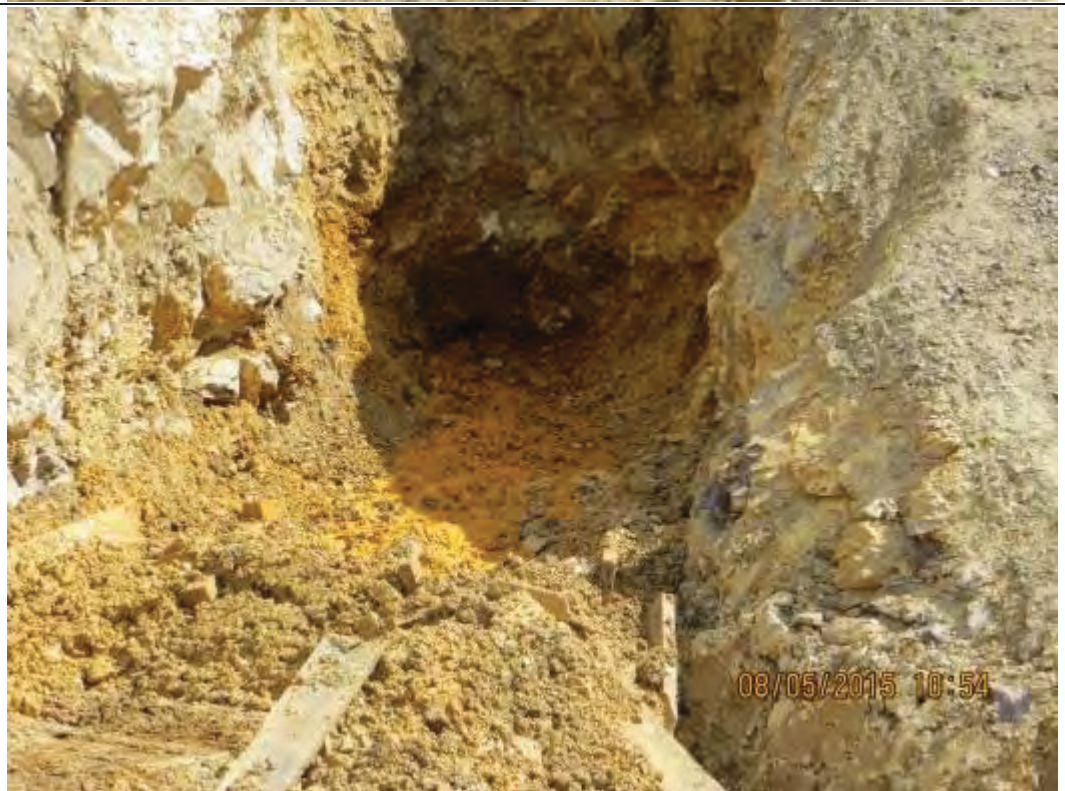
**Photo No.**  
**18**

10:54 The hole had begun to enlarge and water was pouring out.

**Description:**  
Hole starting to give way to flow.

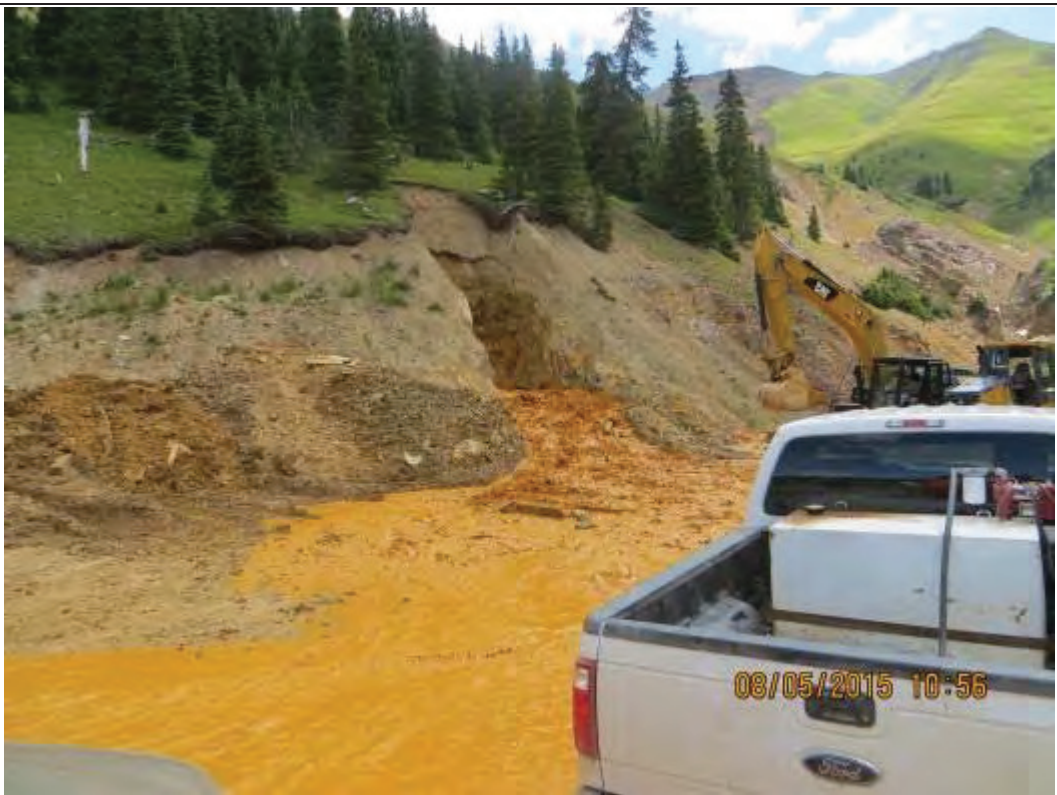
<b>Photo No.</b> <b>19</b>	<b>Date:</b> 08/05/2015
<b>Direction Photo Taken:</b>  Northeast	
<b>Description:</b>  Adit flow increasing.

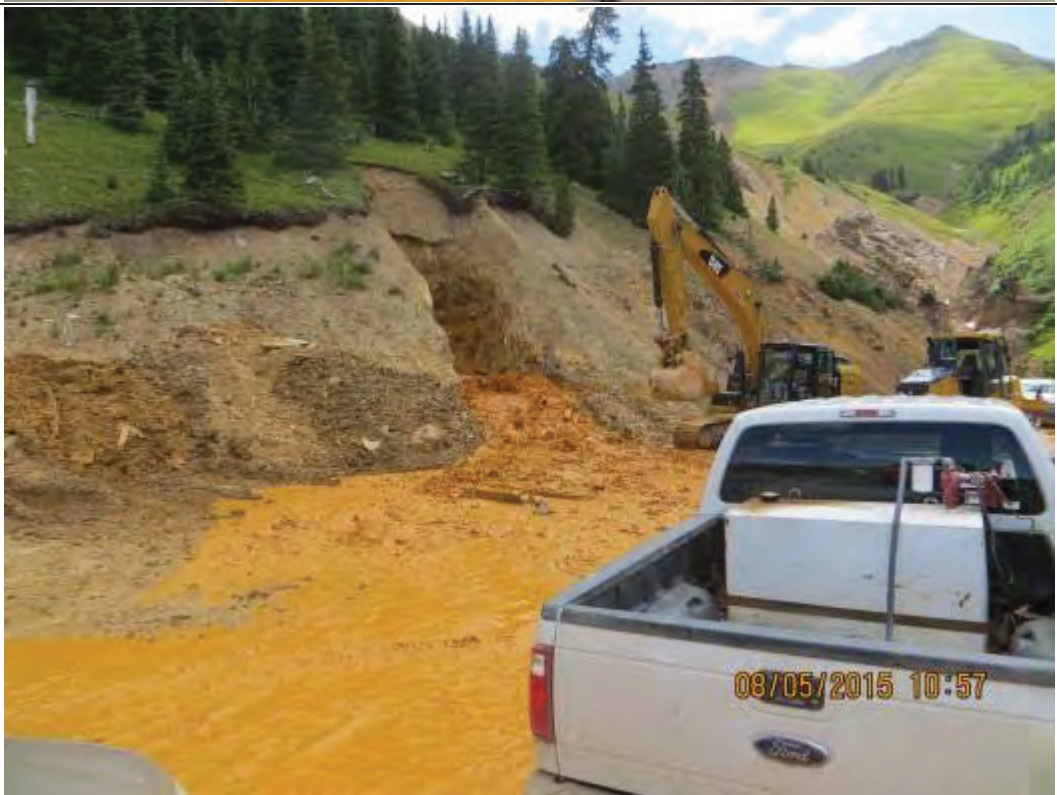
<b>Photo No.</b> <b>20</b>	<b>Date:</b> 08/05/2015
<b>Direction Photo Taken:</b>  Northeast	
<b>Description:</b>  Water flooding out at increased rate.

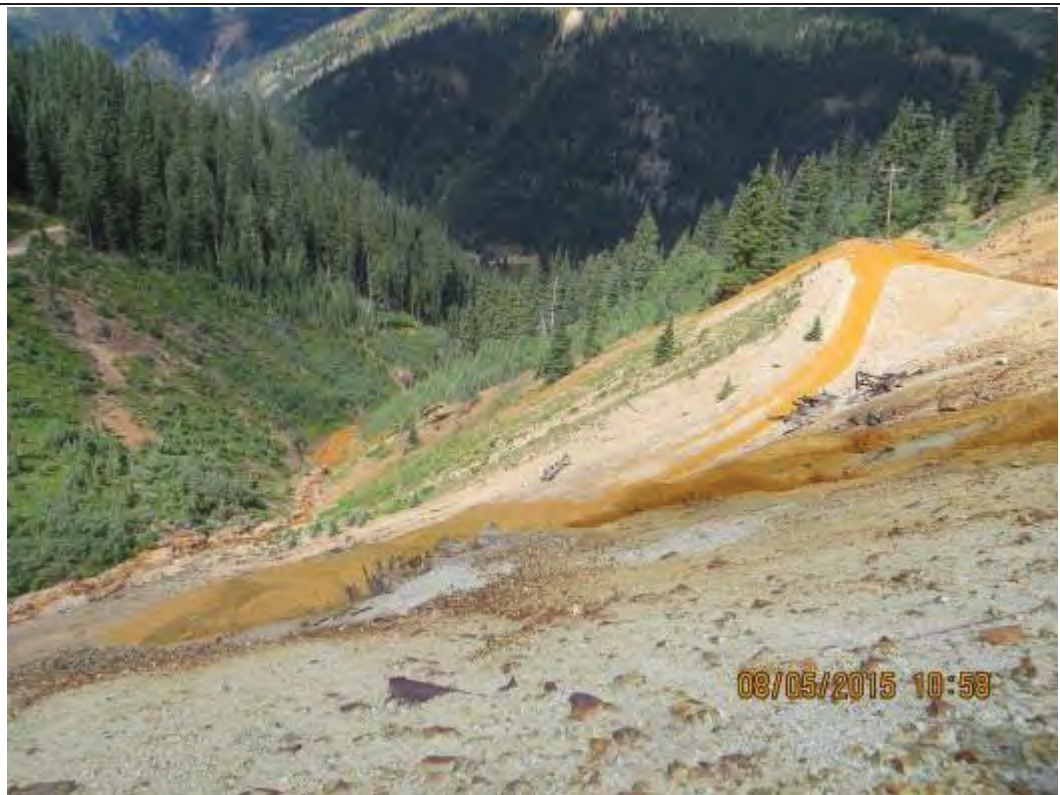
<b>Photo No.:</b> <b>21</b>	<b>Date:</b> 08/05/2015
<b>Direction Photo Taken:</b>  West	
<b>Description:</b> Water flowing along access road and across waste dump.

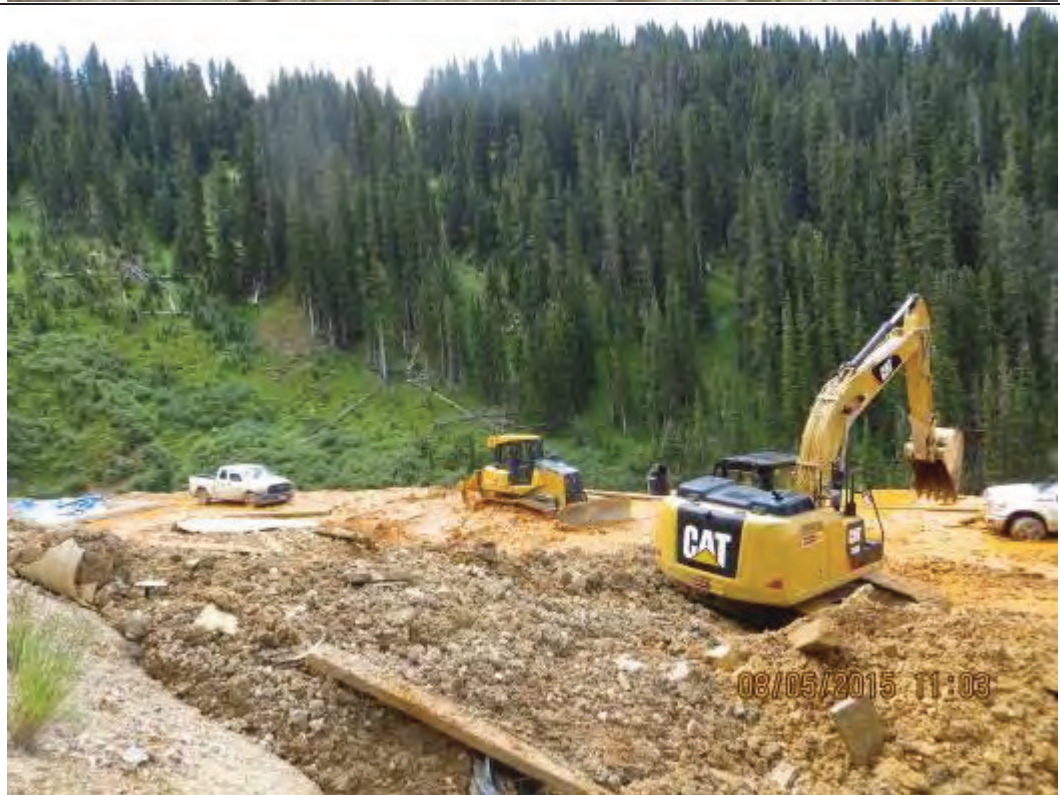
<b>Photo No.:</b> <b>22</b>	<b>Date:</b> 08/05/2015
<b>Direction Photo Taken:</b>  Southeast	
<b>Description:</b> Water flowing over the edge of the waste dump and collapsing the edge.

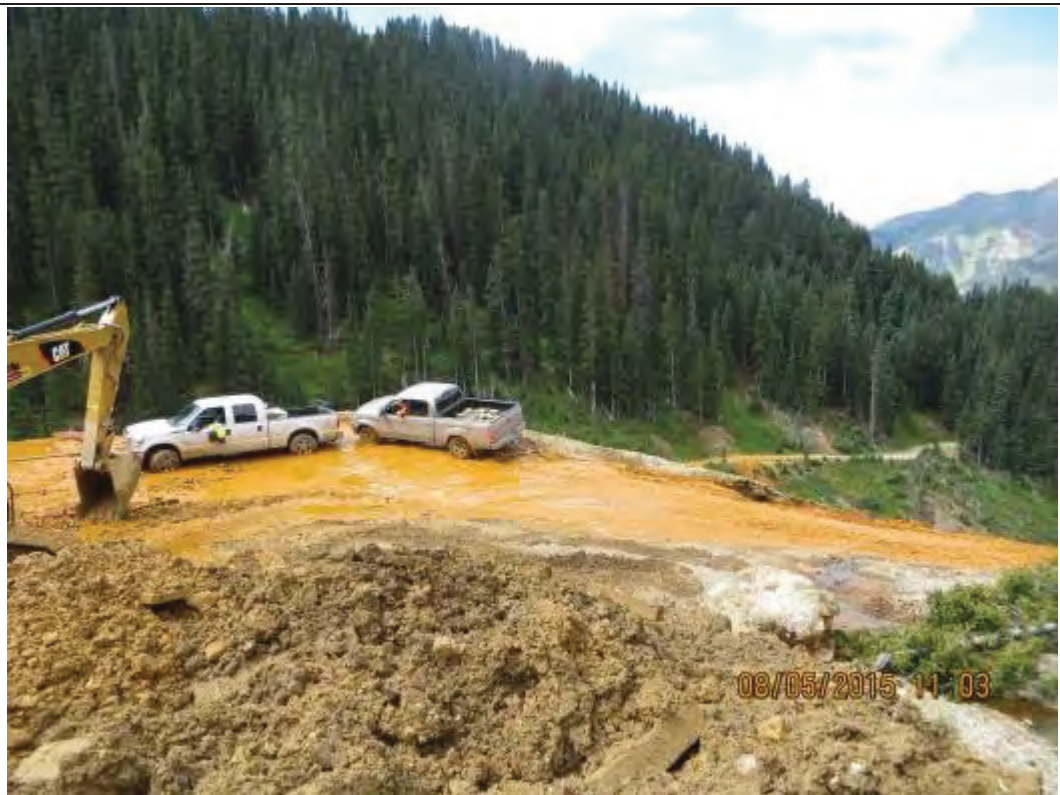
<b>Photo No.</b> <b>23</b>	<b>Date:</b> 08/05/2015
<b>Direction Photo Taken:</b>  Southwest	
<b>Description:</b> Exit route starting to collapse

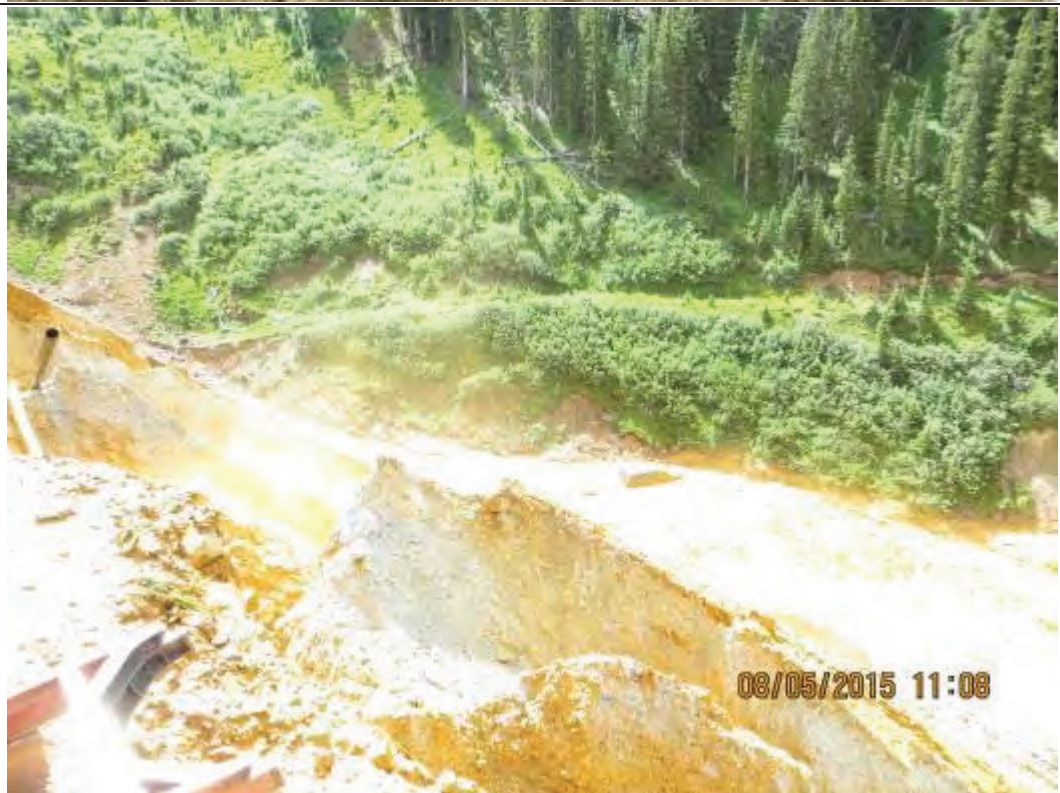
discharged water had flowed. The vehicle was later found it to be water damaged, would not start, and was un-drivable.

<b>Photo No.</b> <b>24</b>	<b>Date:</b> 08/05/2015
<b>Direction Photo Taken:</b>  Southeast/Down	
<b>Description:</b> Edge of the tailings dump collapsed, suburban trapped and half submerged in center of photo.

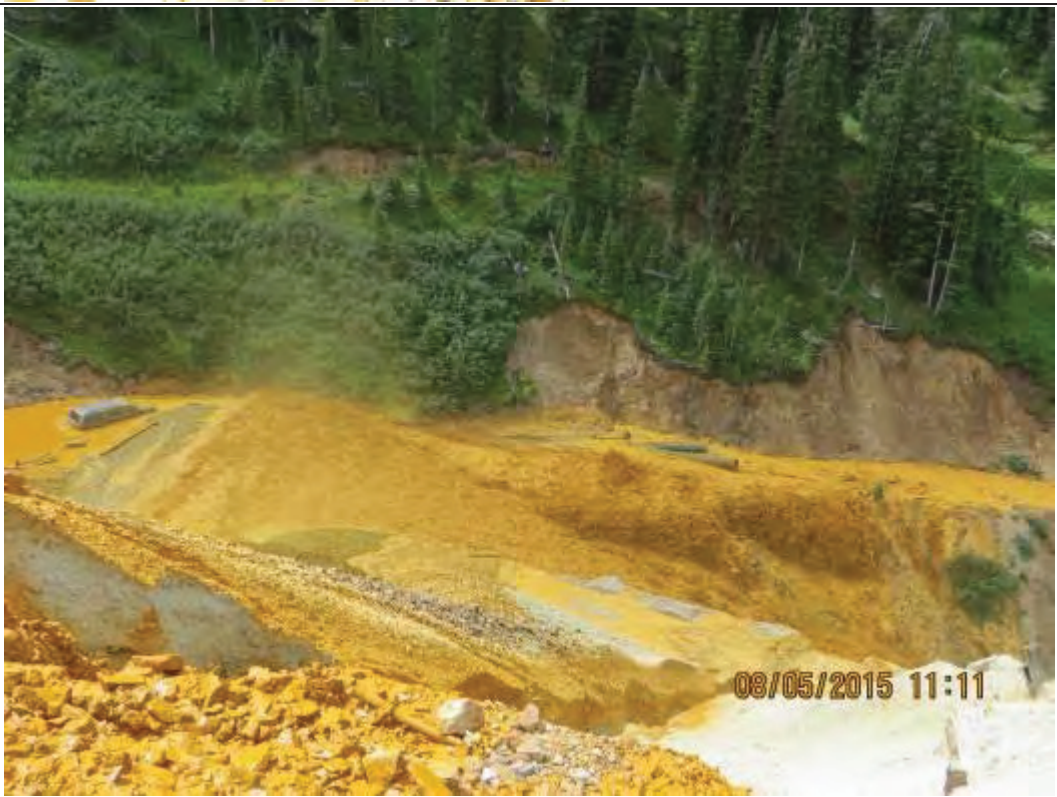
<b>Photo No.:</b> <b>26</b>	<b>Date:</b> 08/05/2015
<b>Direction Photo Taken:</b>  Southeast	
<b>Description:</b> Water flow washing out the existing road. Note Suburban in left side of photo.

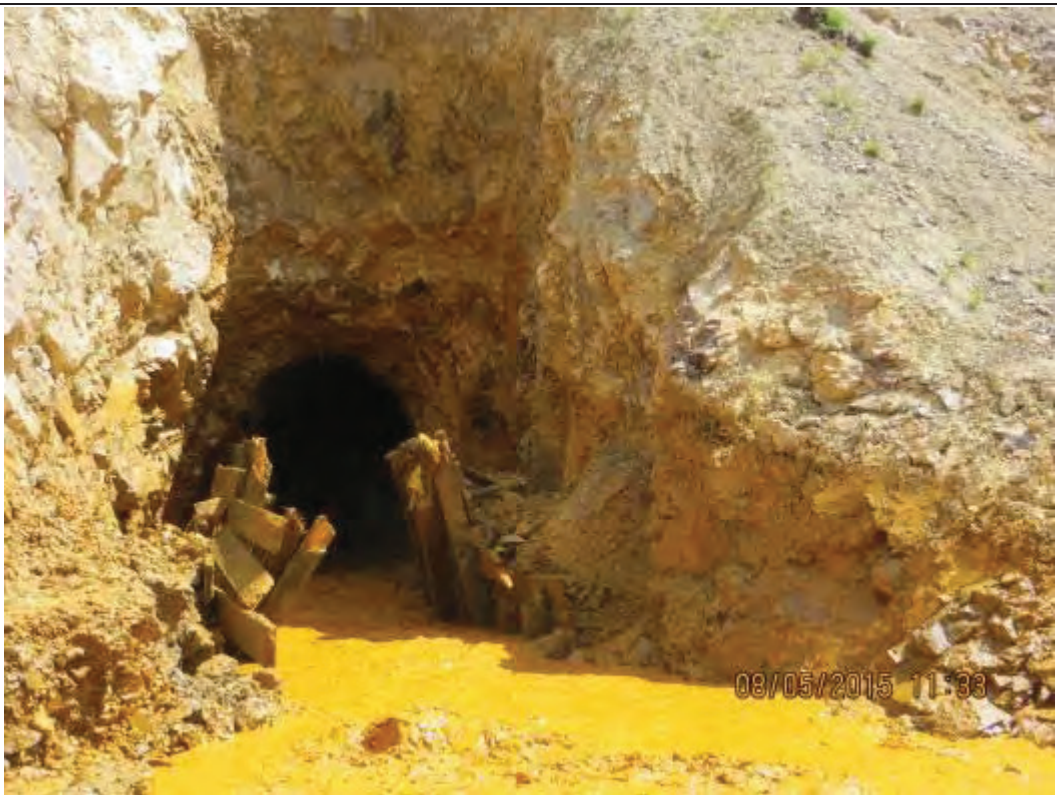
10:58 The hole had expanded significantly, later measured at about 10 feet wide by 15 feet high. Portions of the mine tailings dump and access road had begun to wash away. At this time START realized that the GSA Suburban had been parked at the toe of the mine tailings dump where much of the

<b>Photo No.</b> <b>27</b>	<b>Date:</b> 08/05/2015
<b>Direction Photo Taken:</b>  North	
<b>Description:</b> Exposed adit, roughly 10 feet wide by 15 feet high.

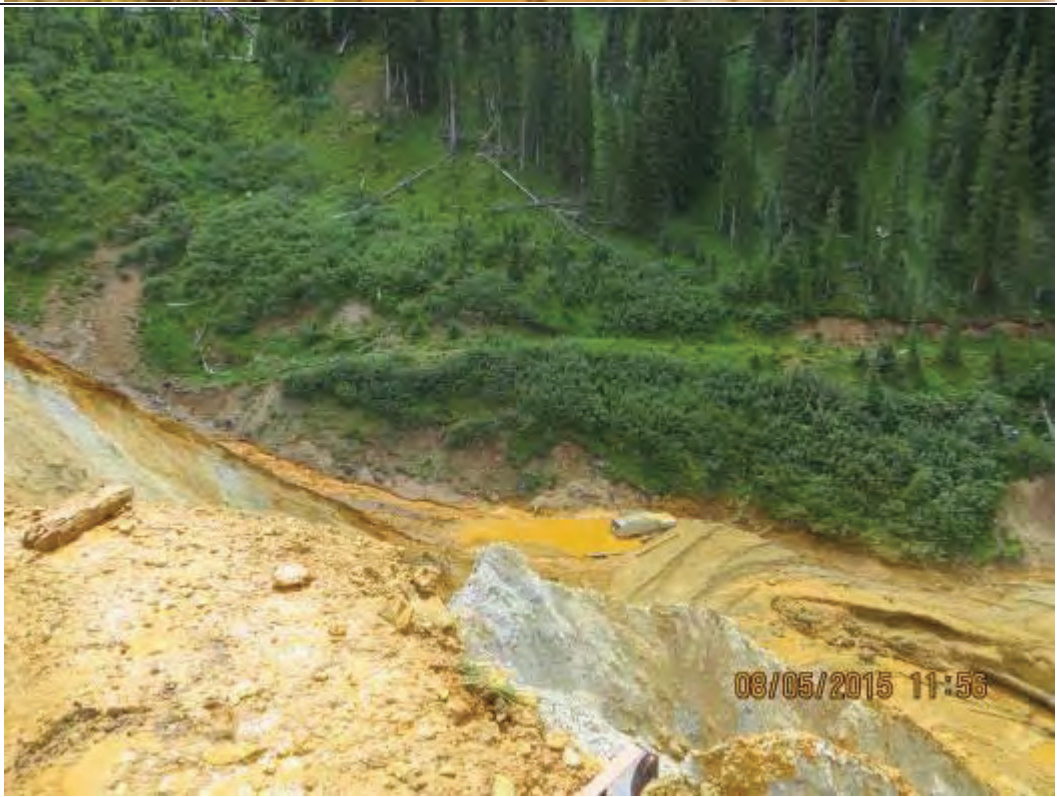
<b>Photo No.</b> <b>30</b>	<b>Date:</b> 08/05/2015
<b>Direction Photo Taken:</b>  Southeast/Down	
<b>Description:</b> Collapsed portion of waste dump and road wash out.

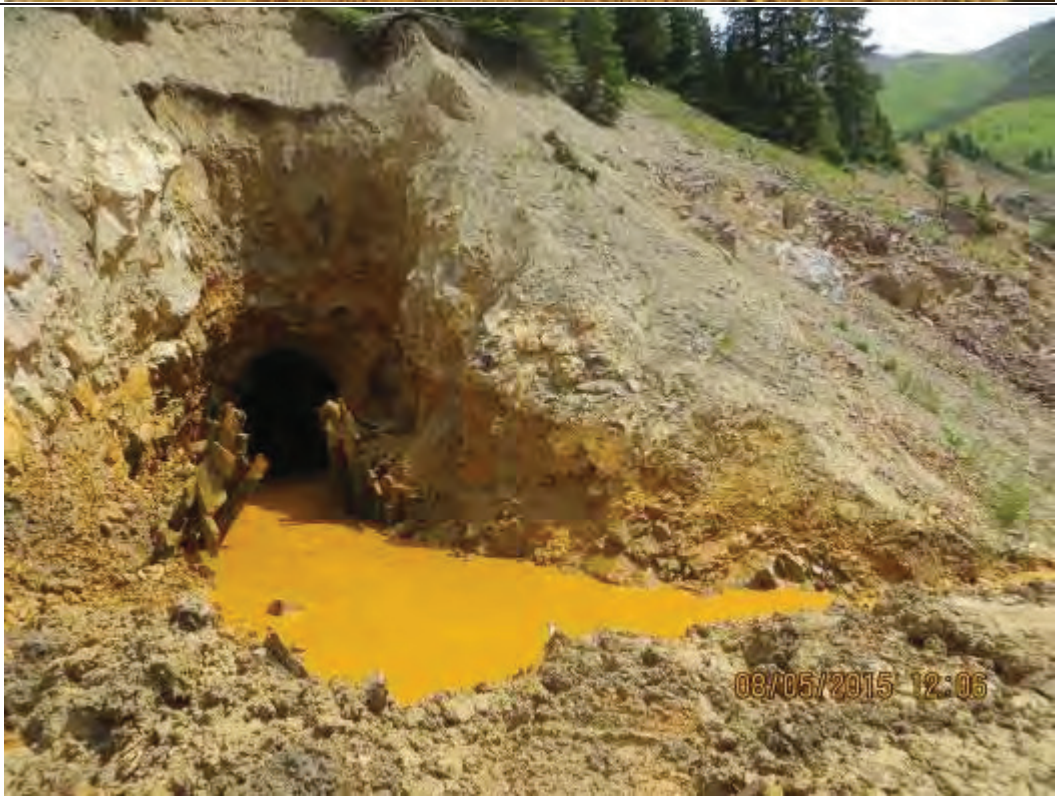
<b>Photo No.:</b> <b>32</b>	<b>Date:</b> 08/05/2015
<b>Direction Photo Taken:</b>  North	
<b>Description:</b> Exposed adit and redirected flow, flow is beginning to subside.

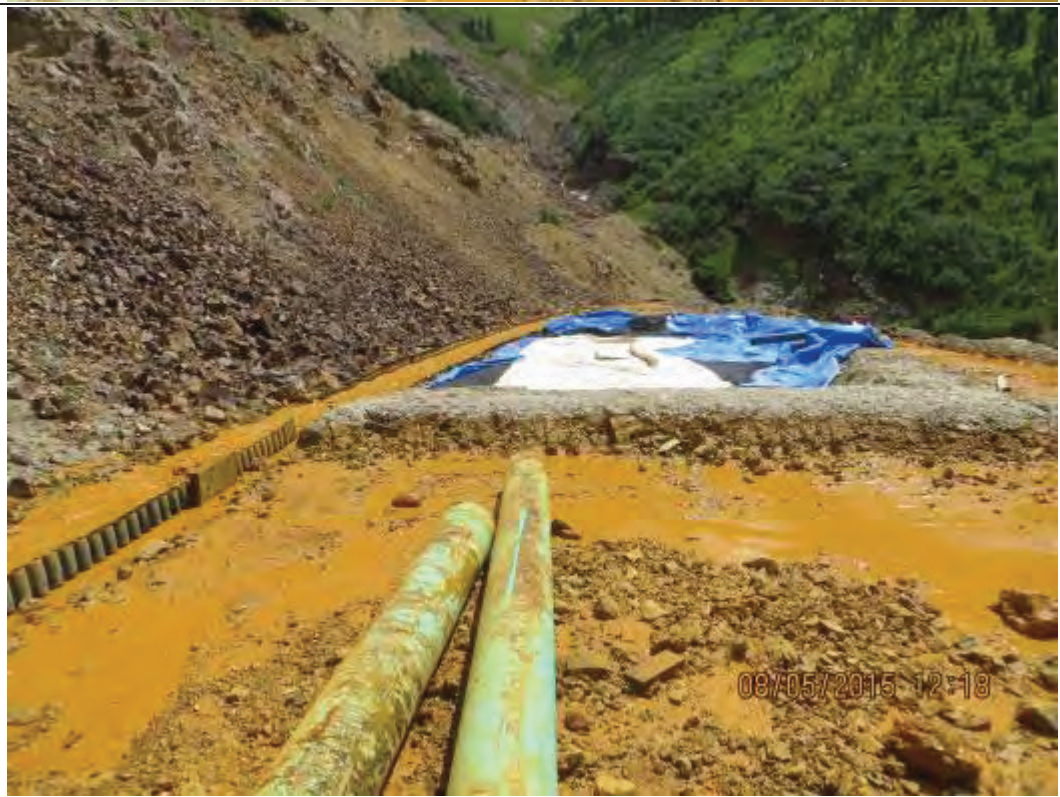
<b>Photo No.:</b> <b>36</b>	<b>Date:</b> 08/05/2015
<b>Direction Photo Taken:</b>  East	
<b>Description:</b> Existing flow channel at maximum capacity.

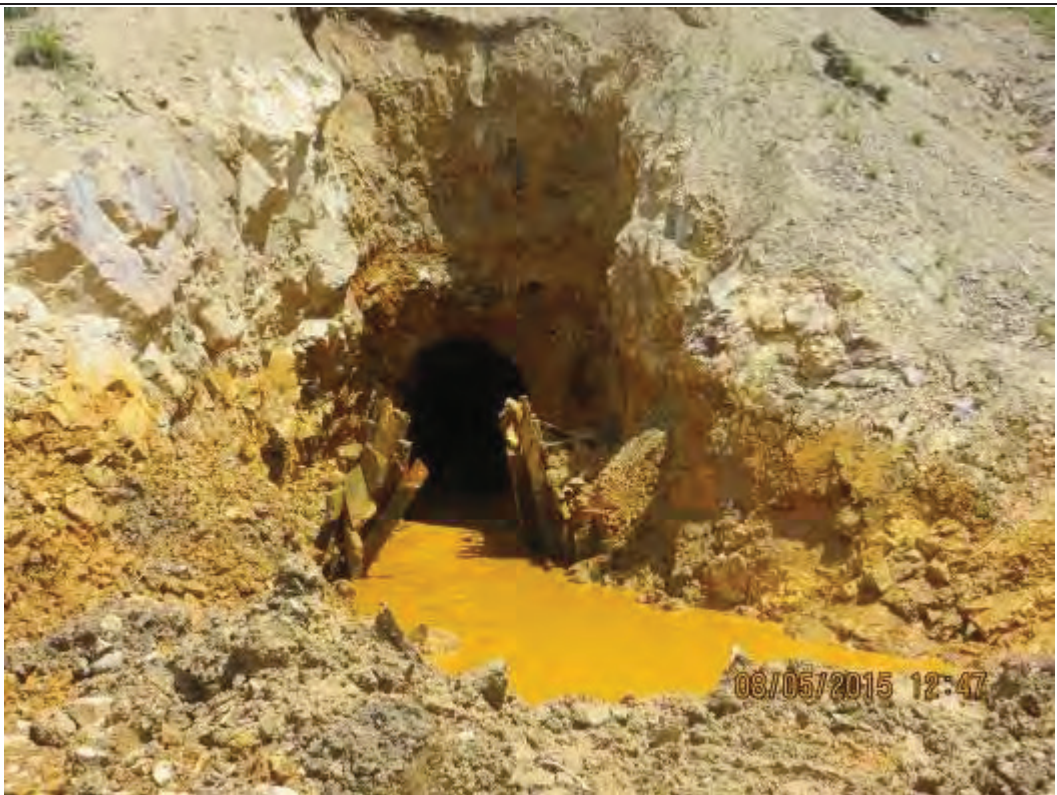
<b>Photo No.</b> <b>39</b>	<b>Date:</b> 08/05/2015
<b>Direction Photo Taken:</b>  North	
<b>Description:</b> No changes visible in adit structure or supports. Sloughing of materials inside the mine can be heard.

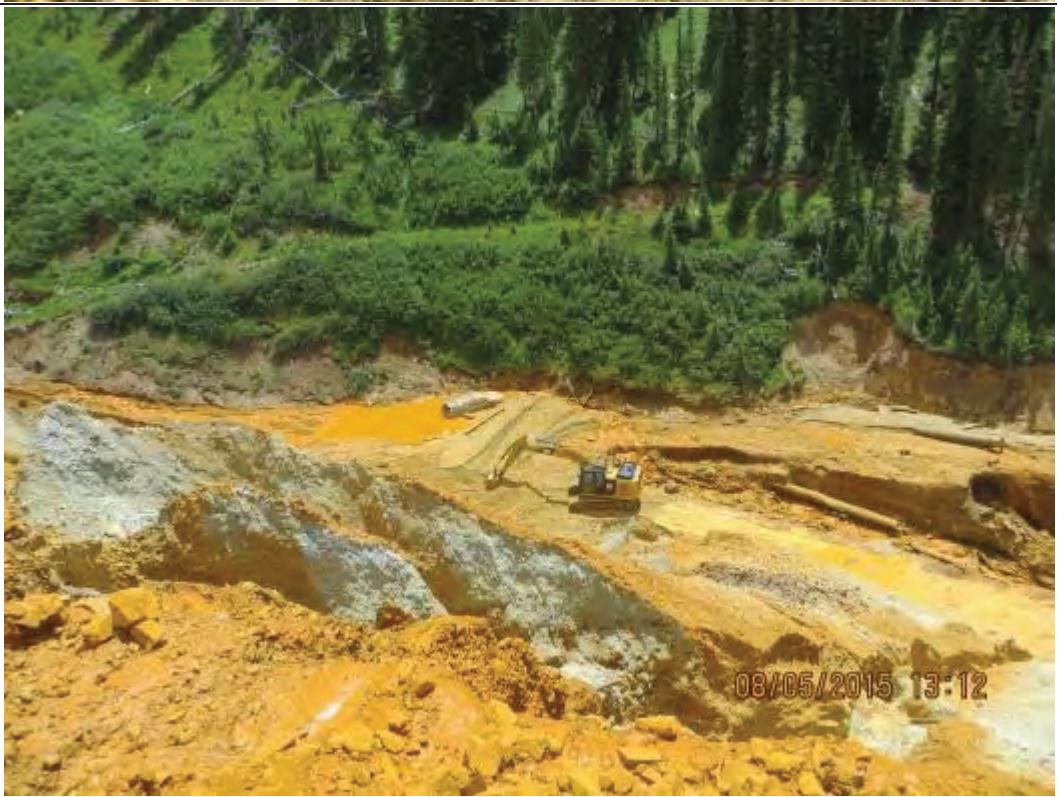
<b>Photo No.</b> <b>40</b>	<b>Date:</b> 08/05/2015
<b>Direction Photo Taken:</b>  South/Down	
<b>Description:</b> Excavator progresses to washed out North Fork crossing.
