### DRAFT TECHNICAL MEMORANDUM

**TO:** [REDACTED] EPA Region 8, On-Scene Coordinator  
**FROM:** [REDACTED], Superfund Technical Assessment and Response Team (START)  
**DATE:** August 12, 2015  
**SUBJECT:** Gold King Mine Investigation and Blowout Event

# PHOTOGRAPH LOG

<b>Project Name:</b> Gold King Mine	<b>Site Location:</b> Silverton, San Juan County, Colorado	<b>Project No.:</b> 0001/1408-01
--	---	-------------------------------------

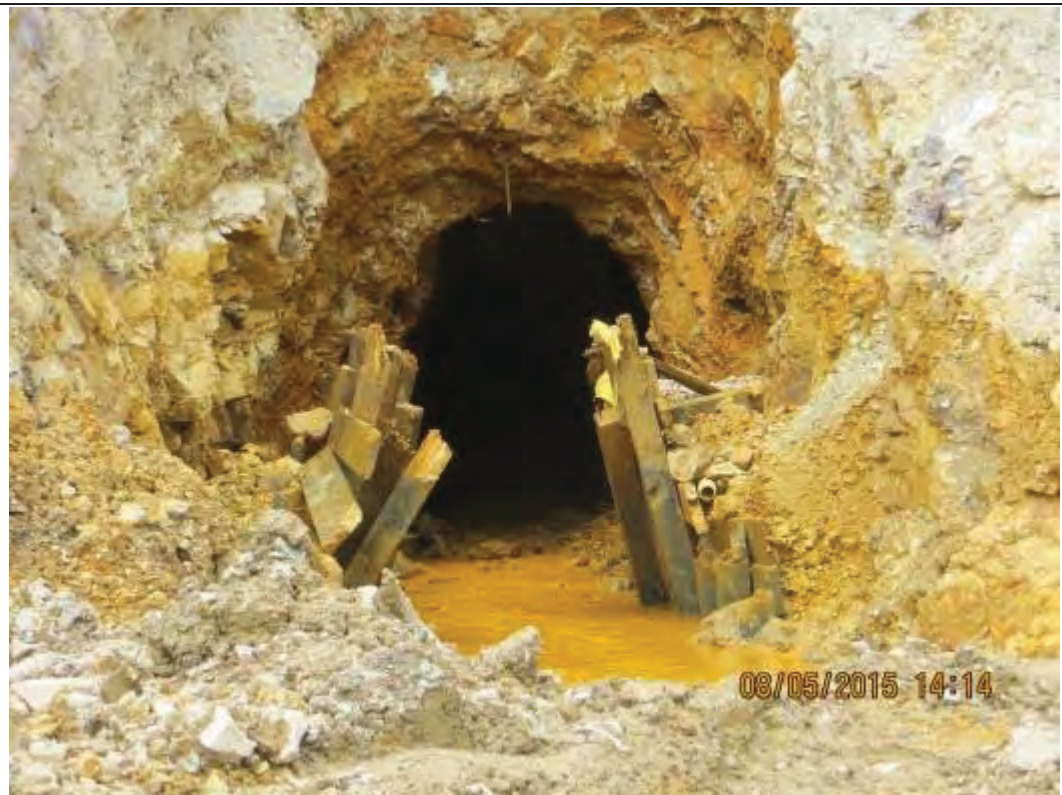
<b>Photo No.</b> <b>45</b>	<b>Date:</b> 08/05/2015
<b>Direction Photo Taken:</b>  North	
<b>Description:</b>  Water levels lowering at adit entrance, no visible changes to structure.

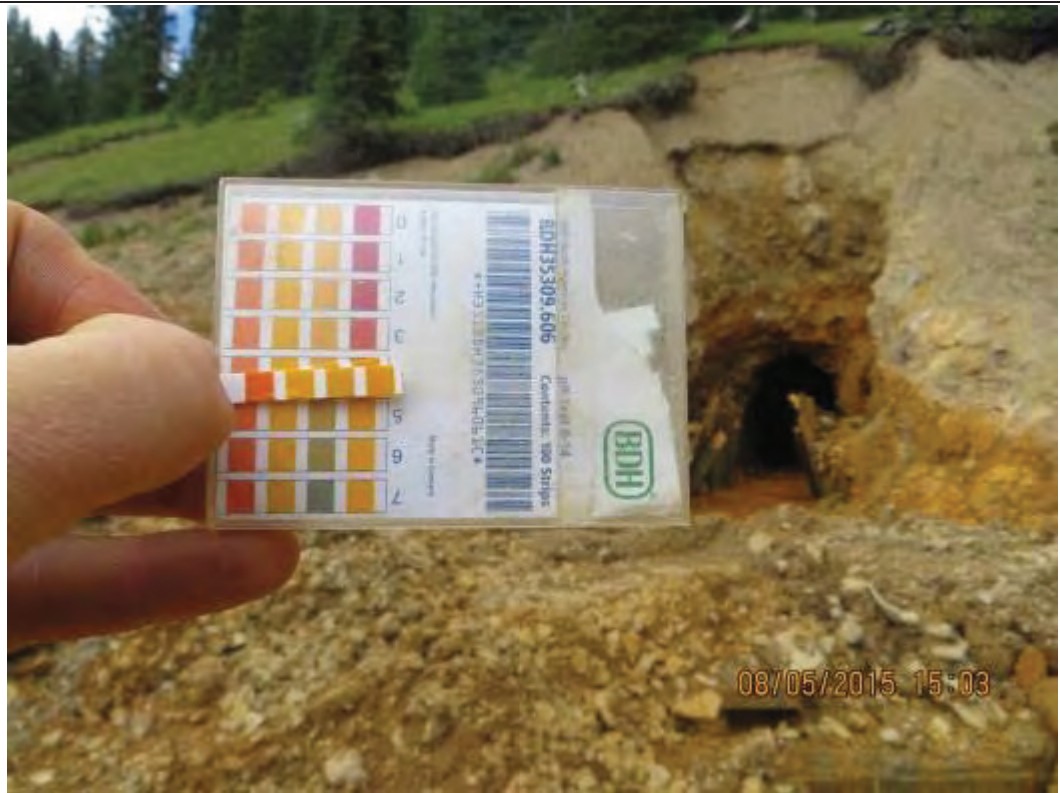
15:00 The pH of the discharge still measured approximately 4.5 on pH indicator paper.

<b>Photo No.</b> <b>49</b>	<b>Date:</b> 08/05/2015
<b>Direction Photo Taken:</b>  North	
<b>Description:</b> pH measured at approximately 4.5.

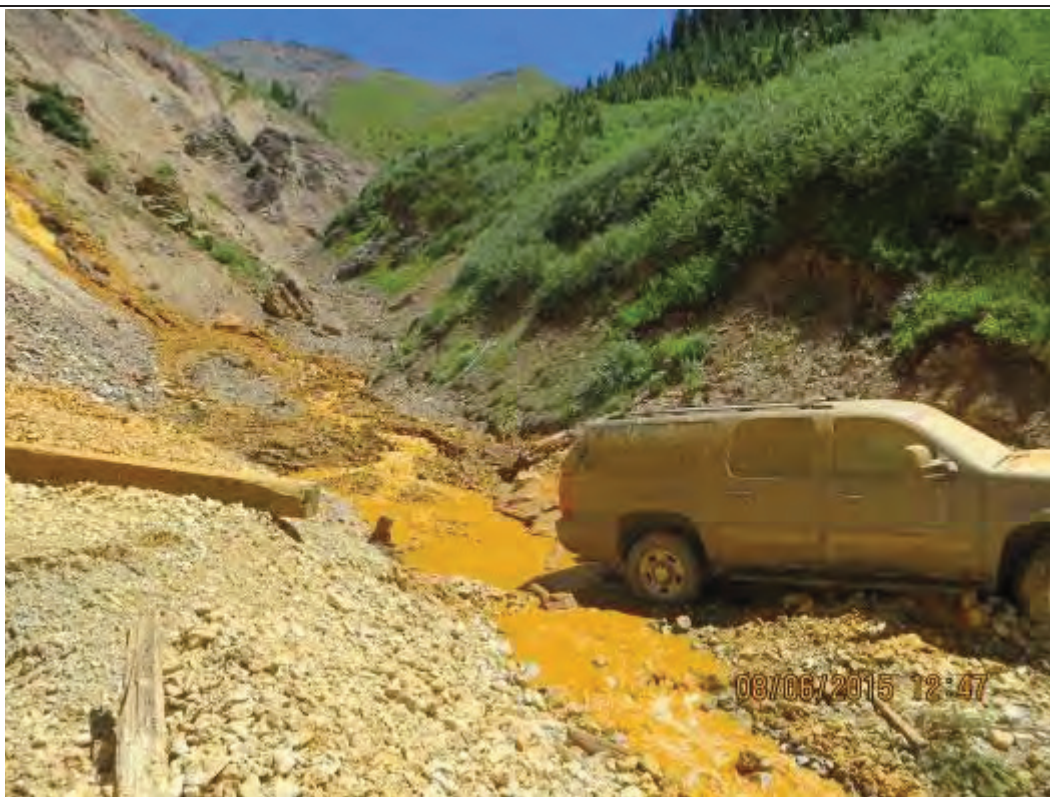
<b>Photo No.</b> <b>11</b>	<b>Date:</b> 08/06/2015
<b>Direction Photo Taken:</b>  East	
<b>Description:</b>  Damaged GSA Suburban at base of Gold King mine dump

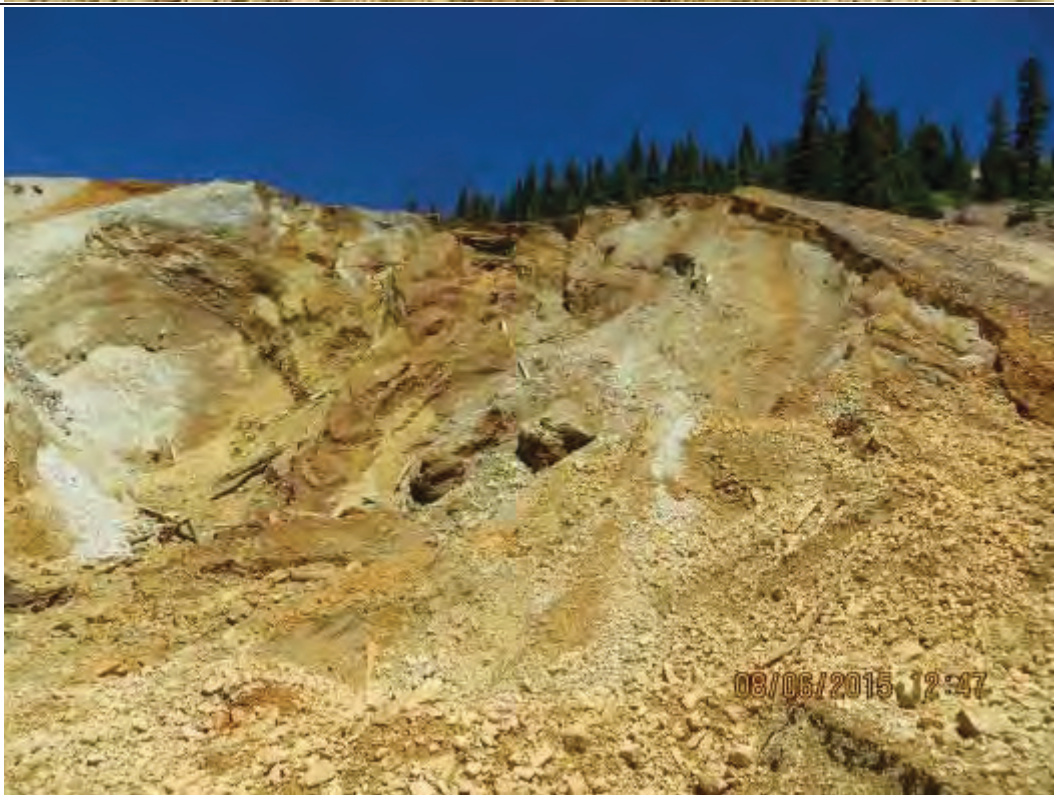
Gold King mine dump damage.

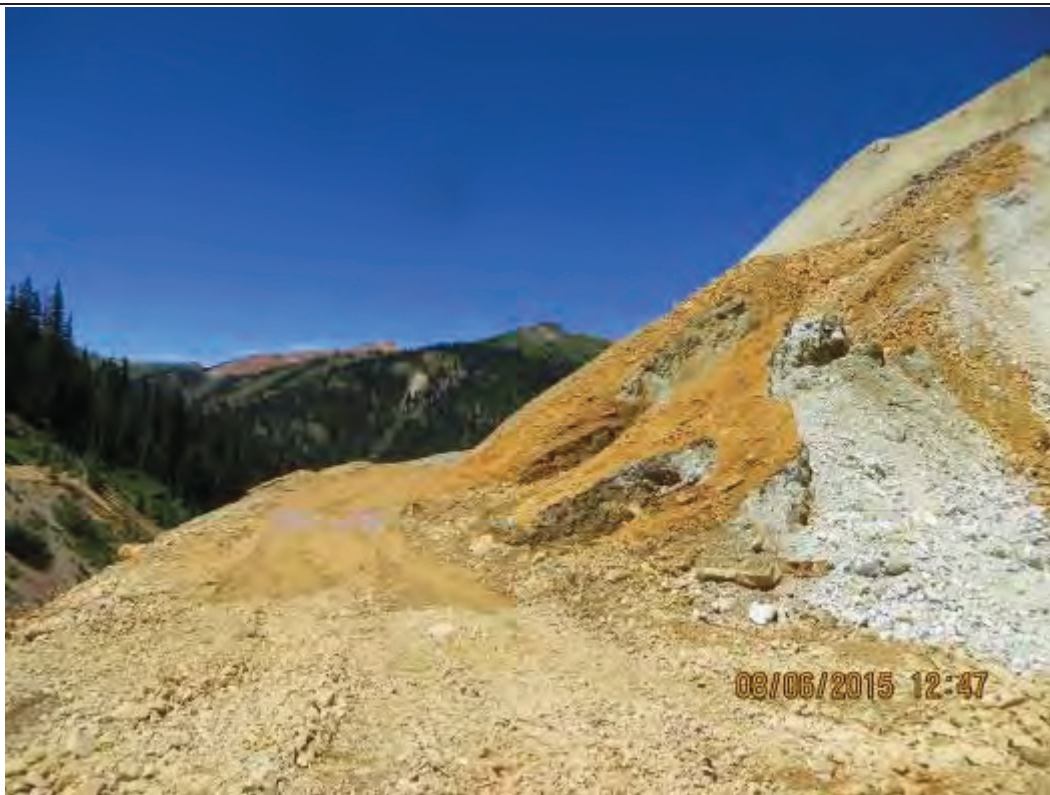
Gold King mine dump damage.

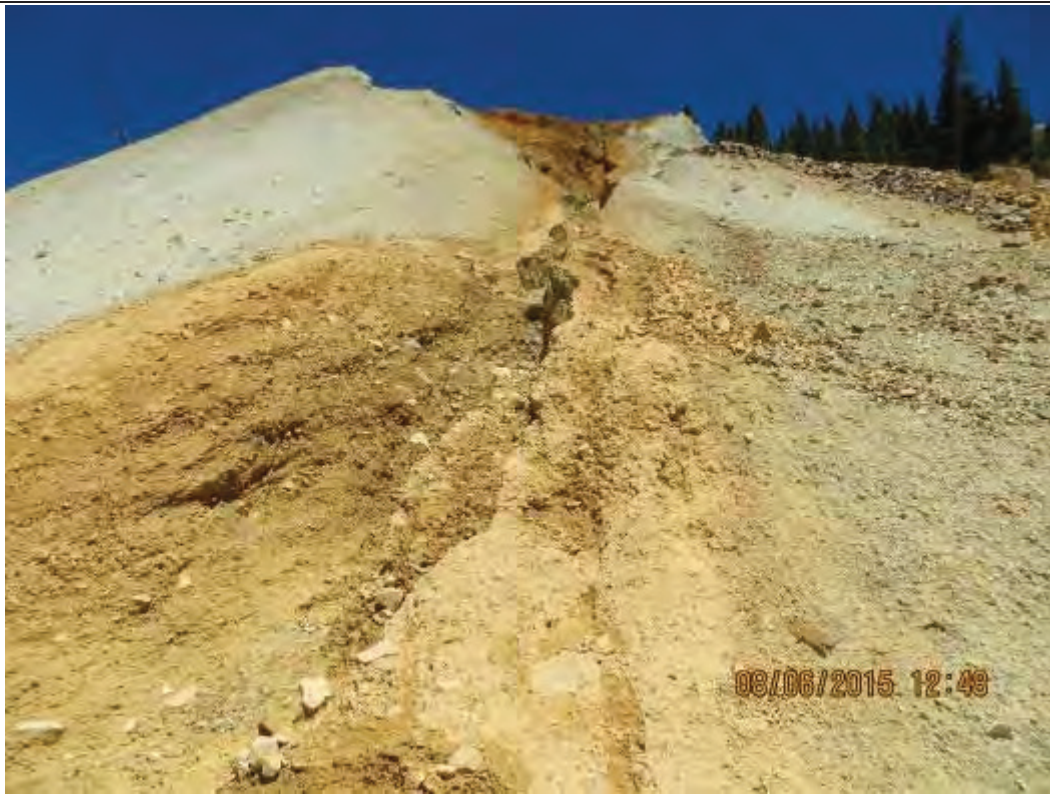
Gold King mine dump damage.

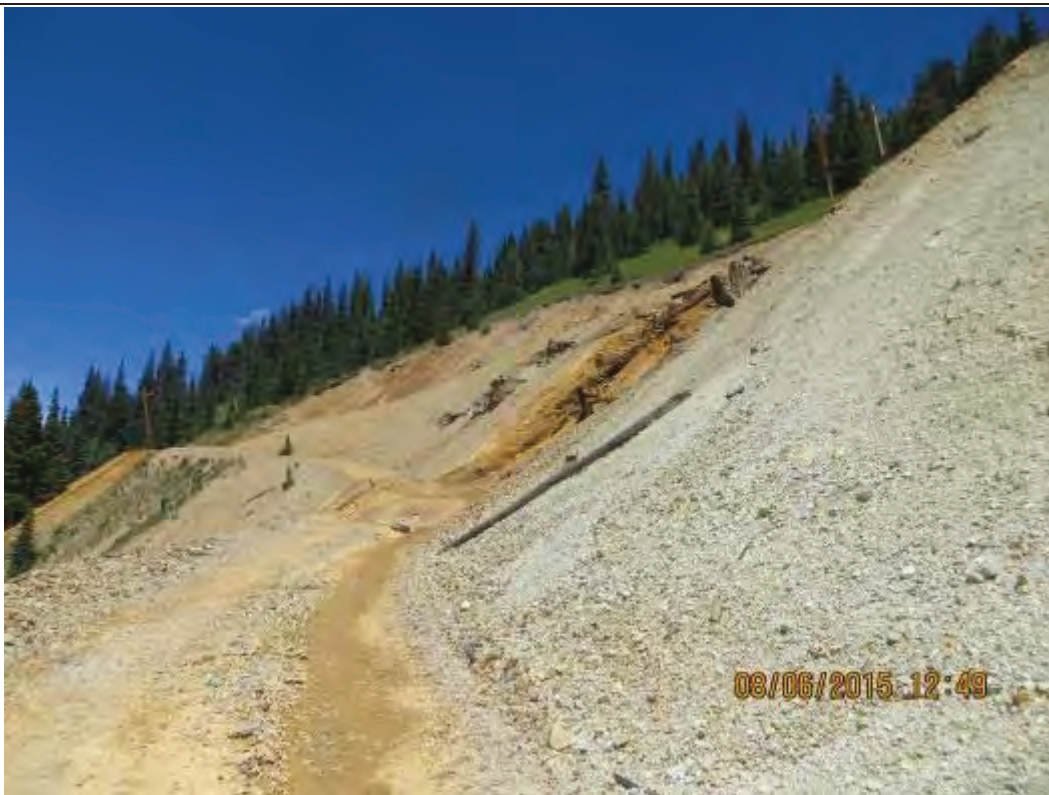
Gold King mine dump damage.

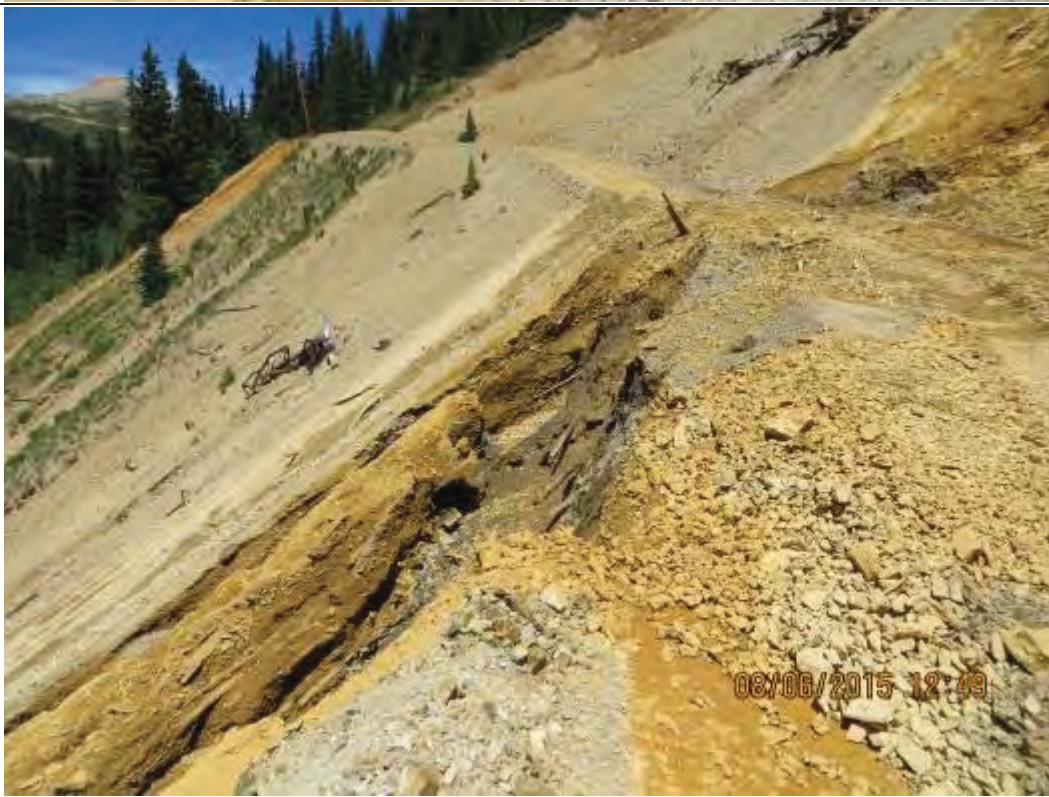
Gold King mine dump damage.

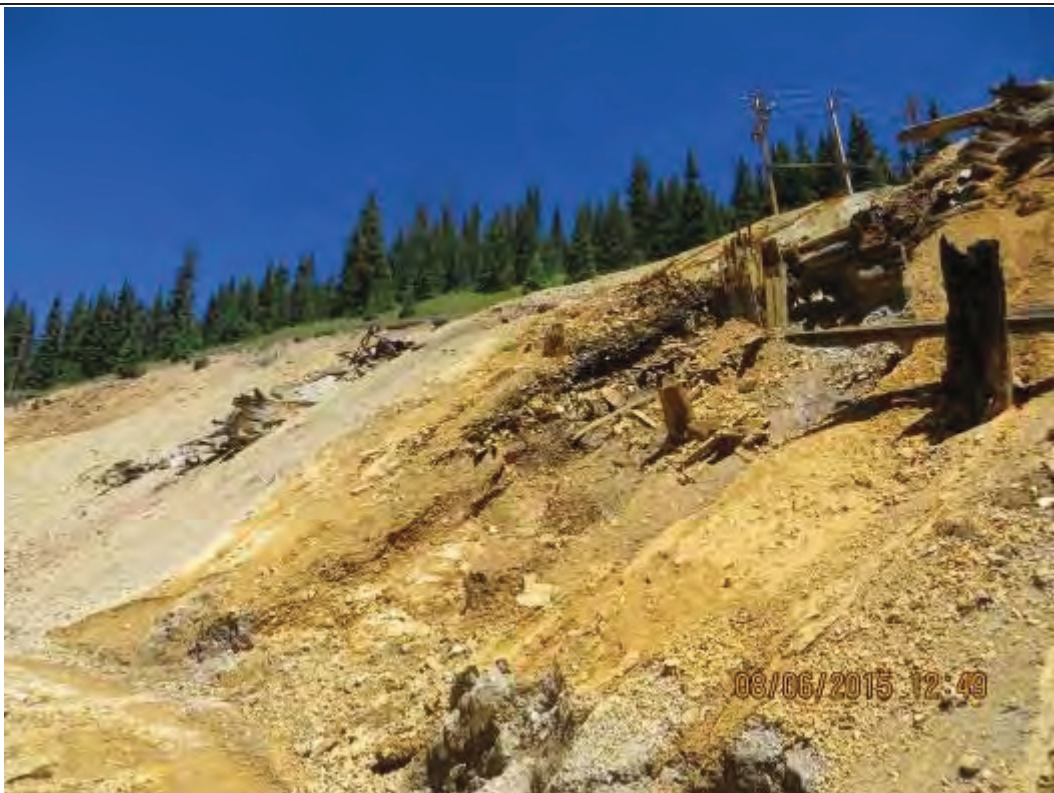
<b>Photo No.</b> <b>19</b>	<b>Date:</b> 08/06/2015
<b>Direction Photo Taken:</b>  North	
<b>Description:</b>  Gold King mine dump damage.

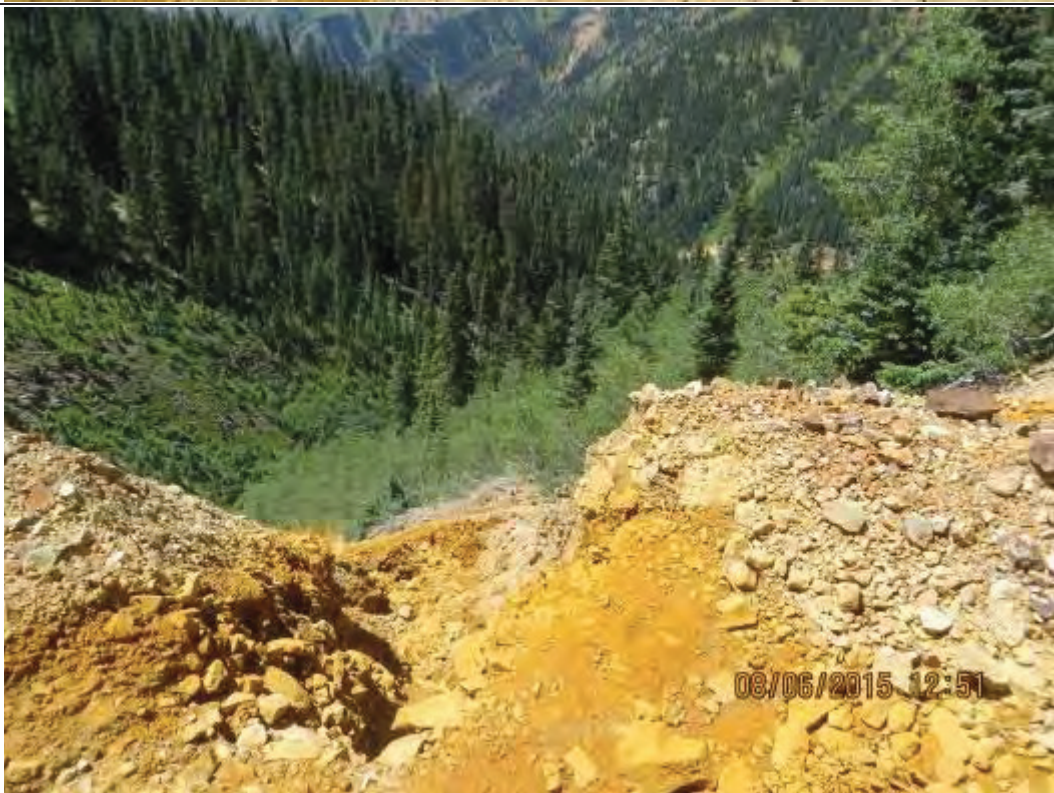
<b>Photo No.</b> <b>22</b>	<b>Date:</b> 08/06/2015
<b>Direction Photo Taken:</b>  West	
<b>Description:</b>  Gold King mine dump road damage.

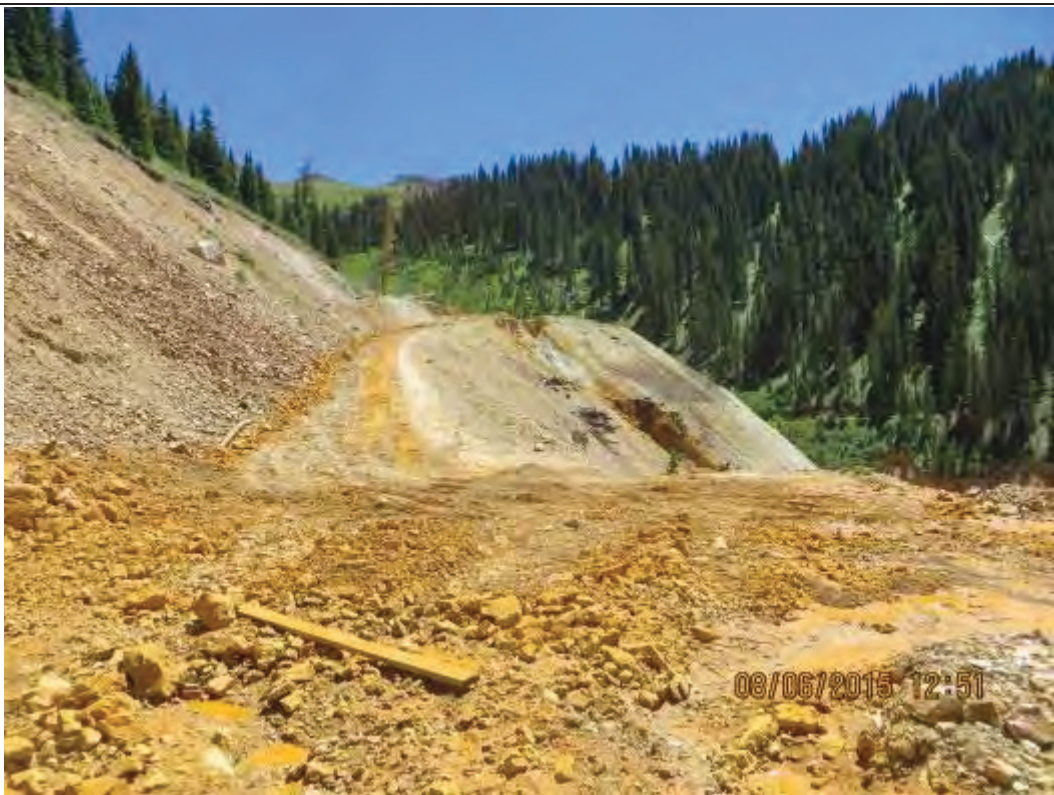
Gold King mine dump damage.

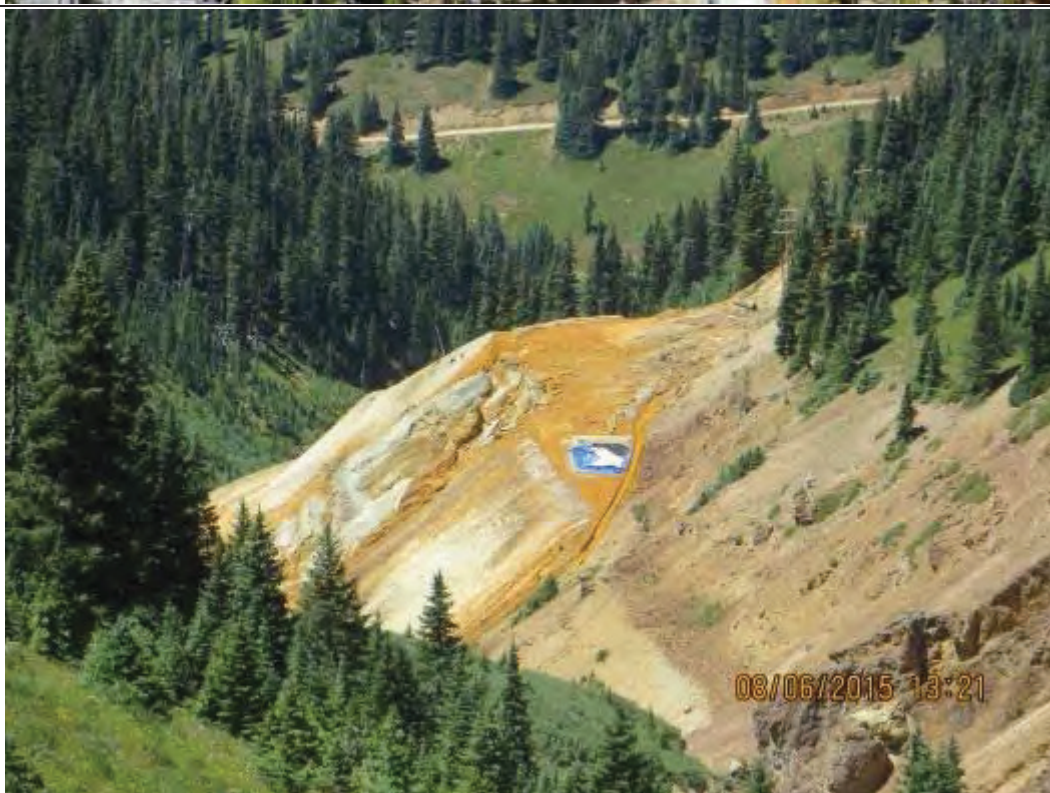
Overview of the Gold King waste dump pad after mine discharge. Note orange water in half culvert channel and damage to center of pad.

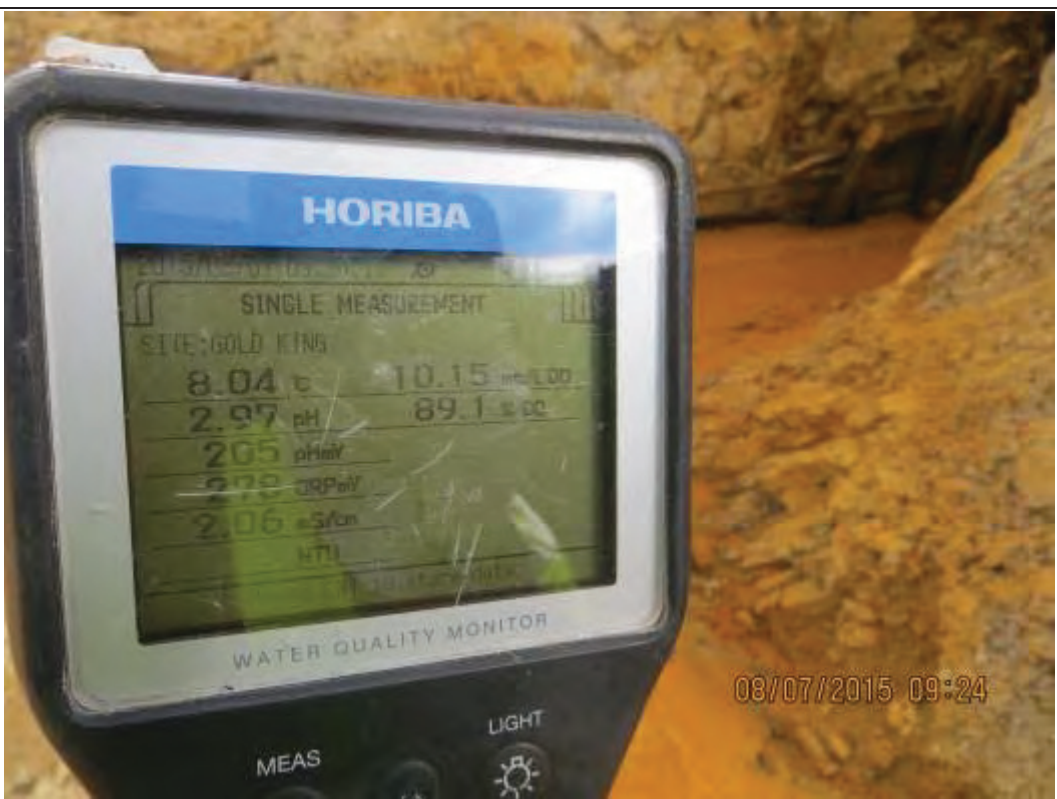
Gold King Adit pH = 2.97.

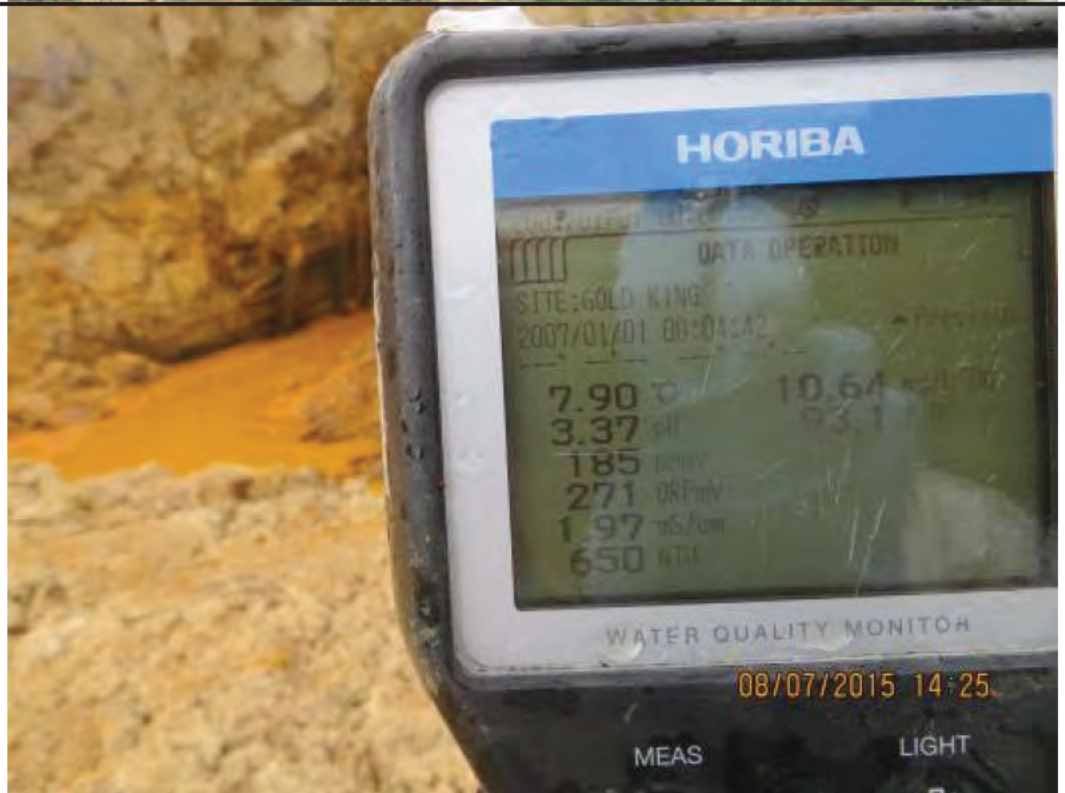
<b>Photo No.</b> <b>22</b>	<b>Date:</b> 08/07/2015
<b>Direction Photo Taken:</b>  West	
<b>Description:</b>  Adit pH = 3.37
