**Purpose:** RCRA Compliance Evaluation Inspection

**Facility:** Siemens Water Technologies Corporation

**Date of Investigation:** April 19, 2011

### Photograph Log for EPA's April 19, 2011 Siemens Water Technologies Corporation RCRA Inspection

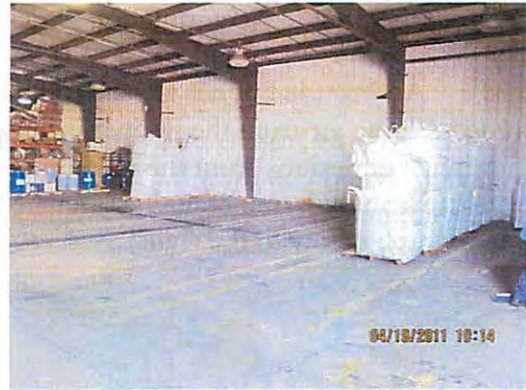
The inspectors observed approximately 13 55-gallon containers and 19 supersacks of spent carbon stored in the warehouse (see photograph to the right).

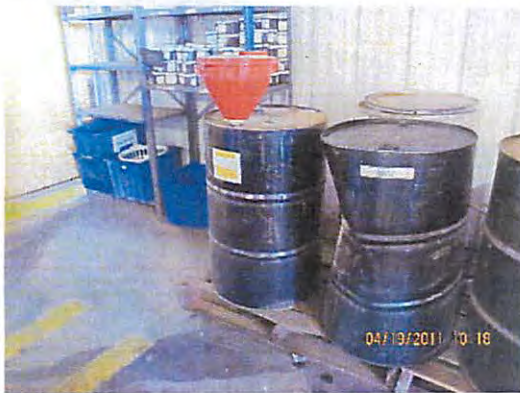
Additionally, the inspectors observed one 55-gallon container of used oil (see photograph below to the left) and one 55-gallon satellite accumulation container for warehouse debris, dated 4/18/11 (see photograph below to the right), in this area.

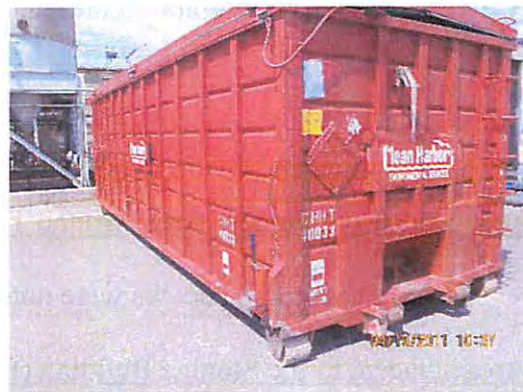
The 40-cubic yard roll-off bin containing hazardous waste generated by the facility was closed and dated March 28, 2011 (see photograph to the right). According to the facility representatives, the bin takes approximately two months to fill and is sent off-site for incineration.

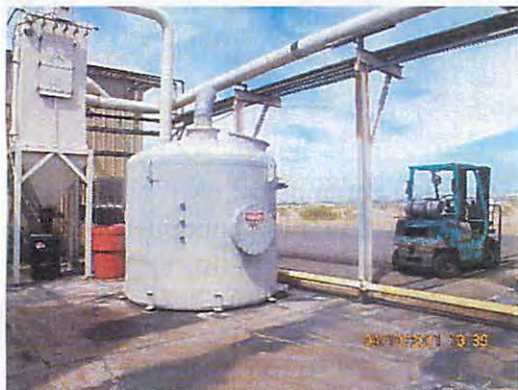
An outside hopper is used to introduce the spent carbon into the treatment process. The air from the hopper is pumped through a baghouse and a carbon bed to minimize emissions from the unloading process (see photograph below to the left). The satellite accumulation container attached to the baghouse was dated March 20, 2011 (see photograph below to the right).

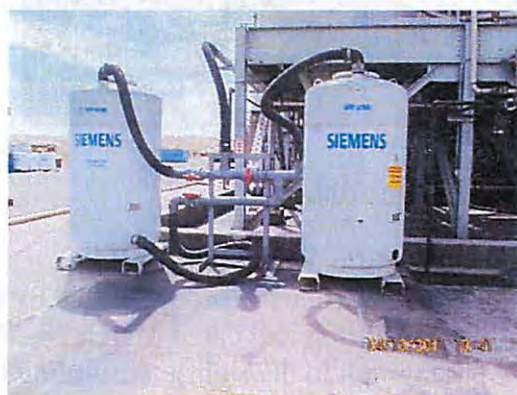
Subsequent to the 2009 U.S. EPA inspection, Siemens installed carbon beds to capture emissions from the hazardous waste storage tanks. Two carbon beds, connected in series, were located adjacent to T-1, T-2, T-5 and T-6 (see photograph to the right).

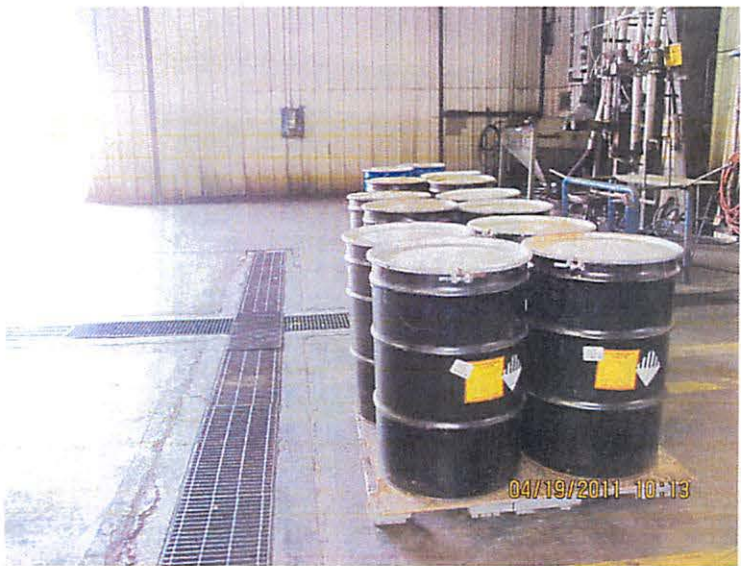
IMG\_0005.JPG  
4/19/2011

03. Sign located at the front of the facility.
04. Entrance to the facility.
05. Container Storage Warehouse: 55-gallon containers of carbon.
06. Container Storage Warehouse: Supersack containers of carbon.

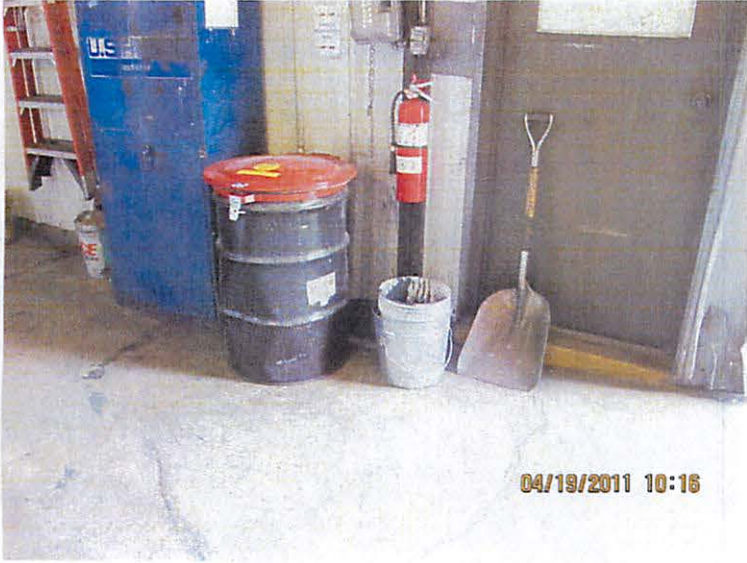
IMG\_0007.JPG  
4/19/2011

07. Container Storage Warehouse: Satellite accumulation container of warehouse debris.
08. Container Storage Warehouse: Close-up of the label on the satellite accumulation container of warehouse debris shown in photograph #07.

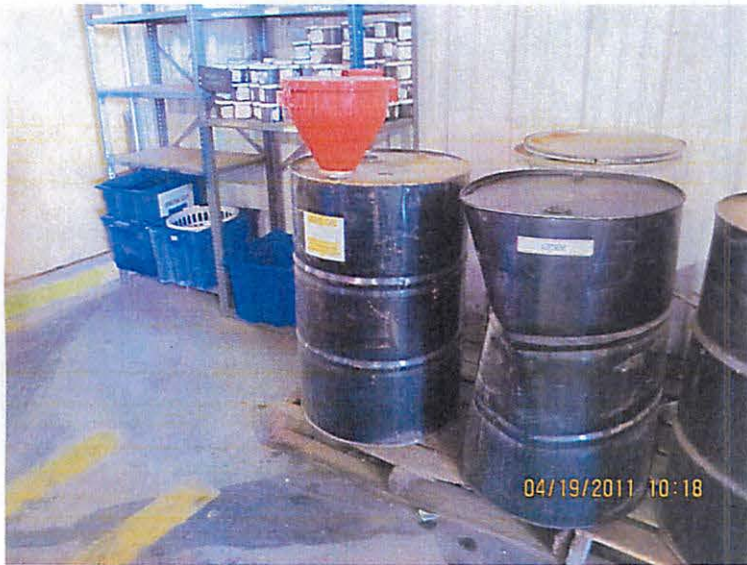
IMG\_0009.JPG  
4/19/2011

09. Container Storage Warehouse: 55-gallon container of used oil (with a red funnel).
10. Outside hopper.
11. Overview of the processing area.
12. 40-cubic yard container for hazardous waste generated by the facility.

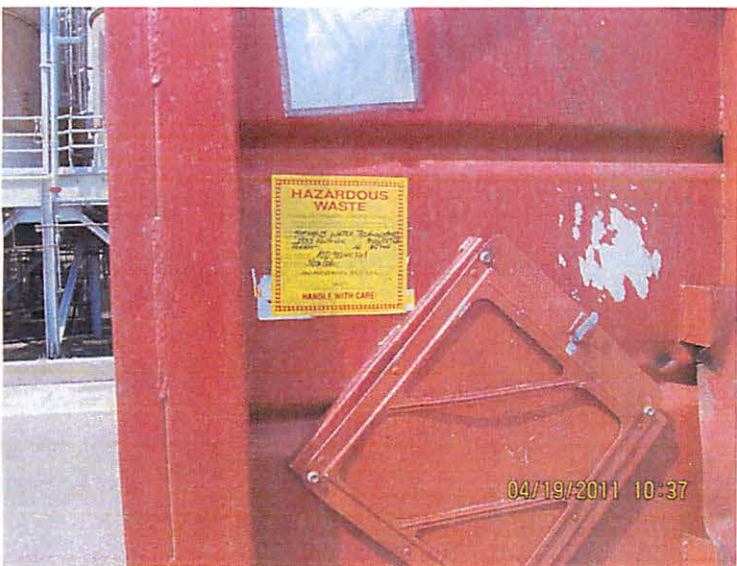
IMG\_0013.JPG  
4/19/2011

13. Close-up of the label on the 40-cubic yard container shown in photograph #12.
14. Baghouse and carbon unit for the outside hopper.
15. 55-gallon satellite accumulation container attached to the baghouse in photograph #14.

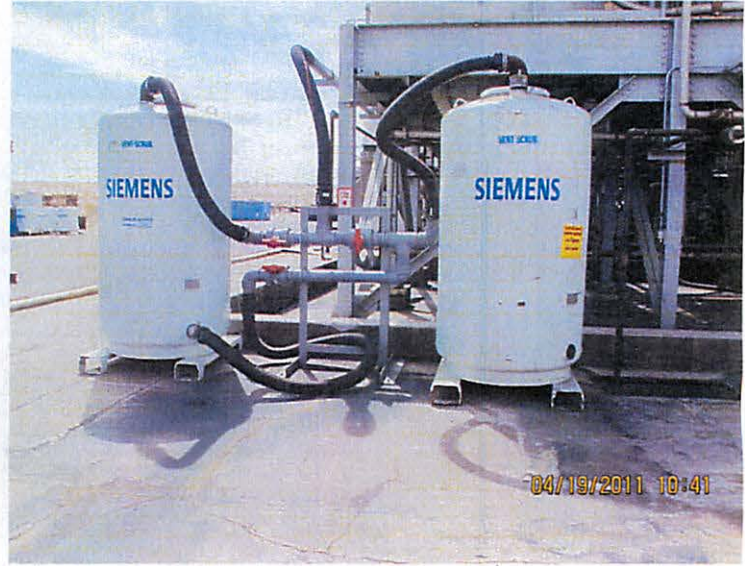
IMG\_0016.JPG  
4/19/2011

16. Carbon units used to capture emissions from the hazardous waste storage tanks.
17. Secondary containment area for the hazardous waste storage tanks.

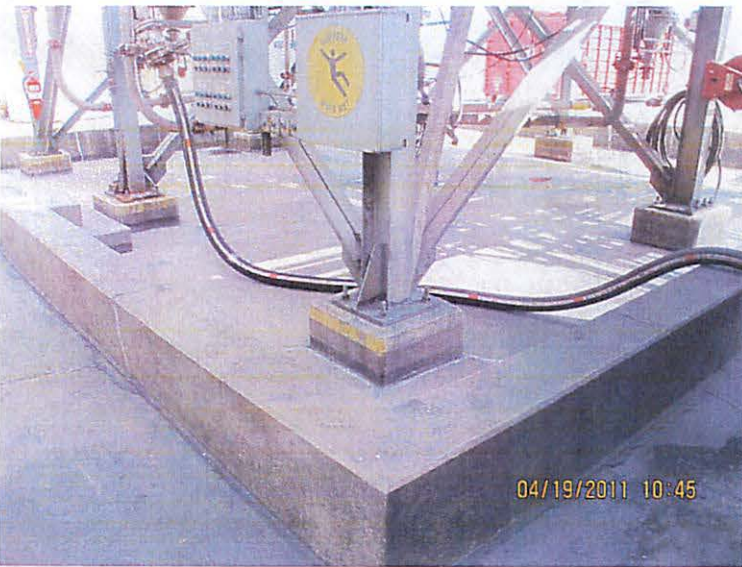
IMG\_0017.JPG  
4/19/2011

No unaddressed cracks were noted in the secondary containment area.
