# Navajo Abandoned Uranium Mine Site Screen Report

**Section 16 Deposit AUM Site**

Weston Solutions, Inc.

May 2009

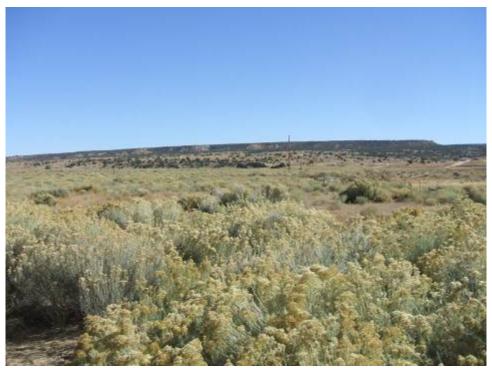
Photo 1. Section 16 Deposit site, towards the east

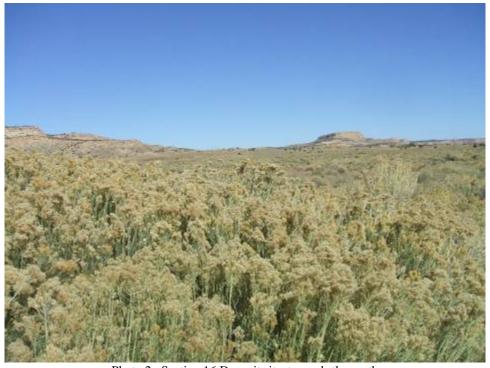
Photo 2. Section 16 Deposit site, towards the north

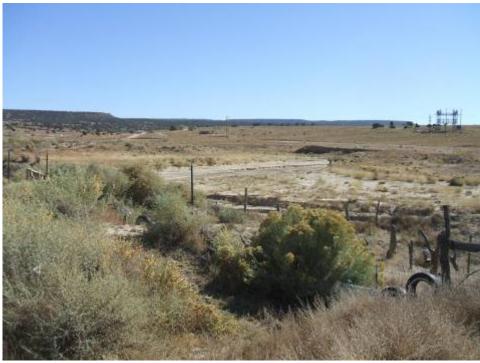
Section 16 Deposit mine consists of an area of 911,757.33 square meters. Any historical information pertaining to mining operations and historical ownership of the mine site appeared to be unclear. Two riverbeds/washes were found along the eastern and southern edges of the site (Photo 3, 5).

Photo 3. River bed / wash area along the southern edge of the site, towards the southeast

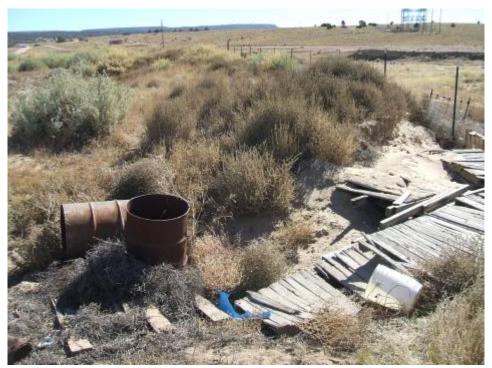
Empty drums and other waste was found along the southern portion of the site. Water pump observed in the western area of the site, likely used for livestock.

Photo 4. Empty drums and wooden boards found along the southern edge of the site, towards the south

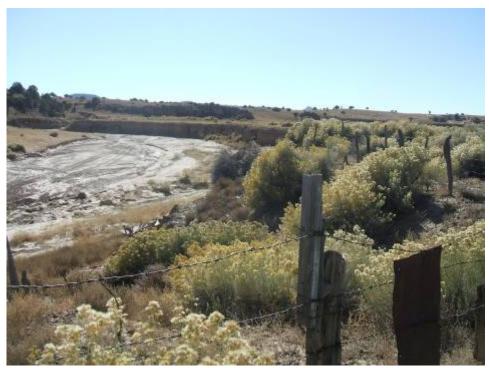
Photo 5. River bed  $\!\!\!/$  wash area along the eastern edge of the site, towards the southeast

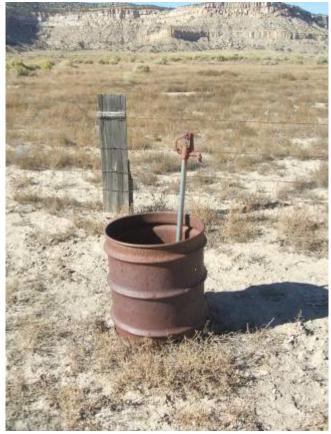
**0 to 0.25 miles:** Water pump observed in the western area of the site (Photo 9), likely used for livestock. A water tank associated with the home to the west of the site was observed. Field personnel were unable to determine the source or use of the tank.

Photo 9. Water pump found along the western edge of the site, towards the west

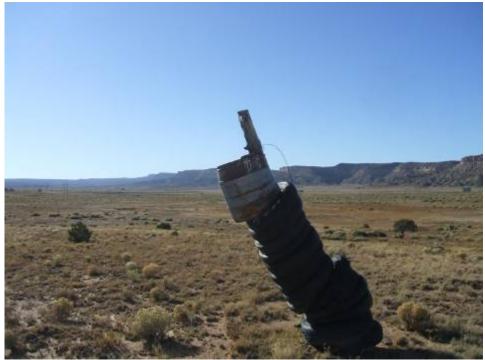
Photo 10. Wooden pole with tires and metal sheeting found in the center of the site, towards the south

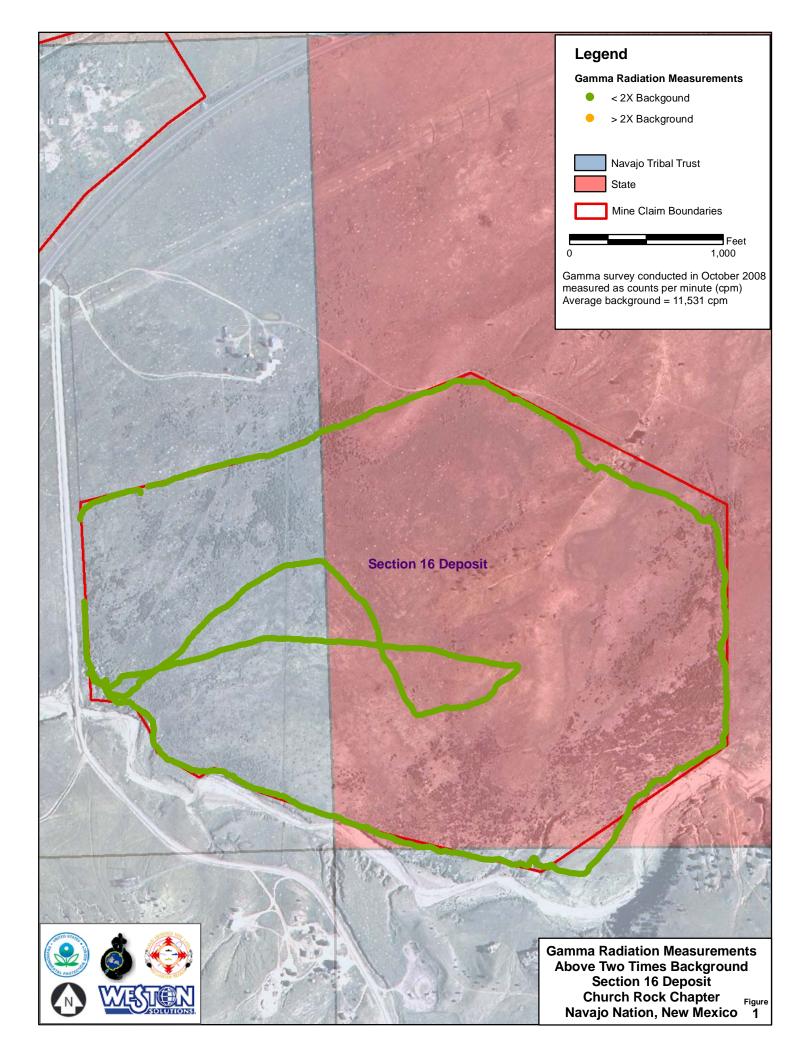
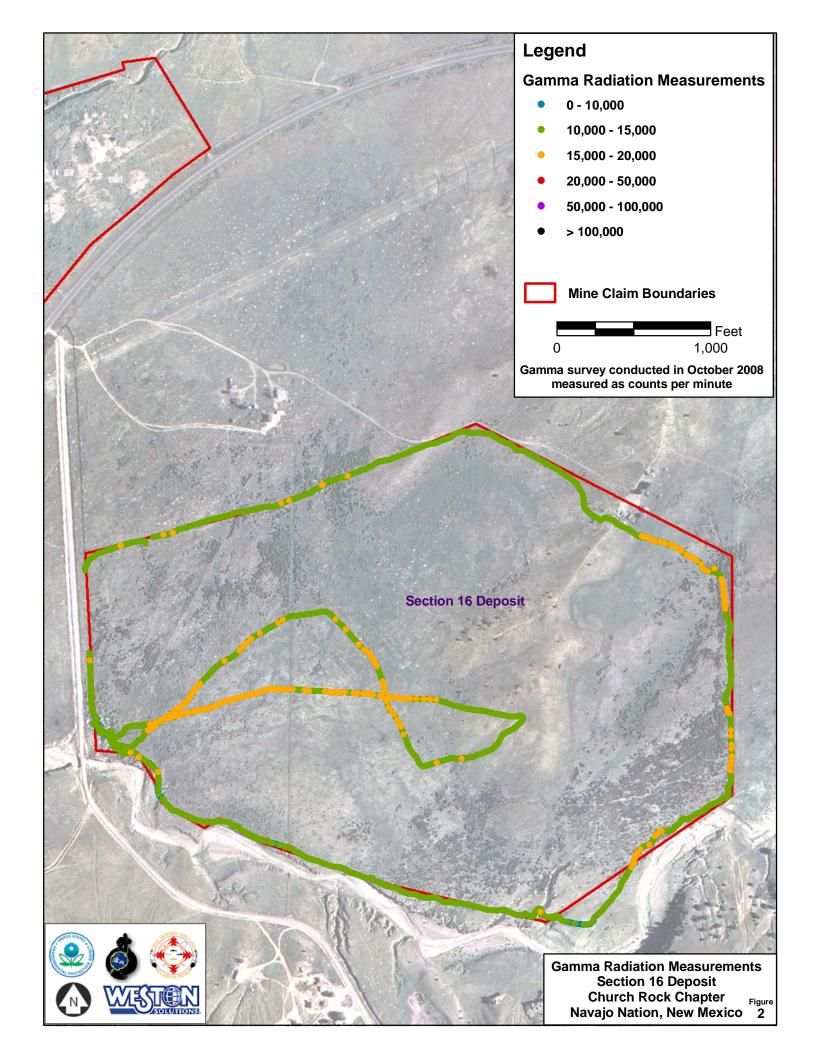
A total of 5,600 gamma radiation measurements were collected from mine sites, ranging from 7,130 cpm to 18,483 cpm. The measurements are represented in Figures 1 and 2.
