Navajo Abandoned Uranium Mine Site Screen Report

Bibo Trespass AUM Site

Navajo AUM Eastern Region

May 2009

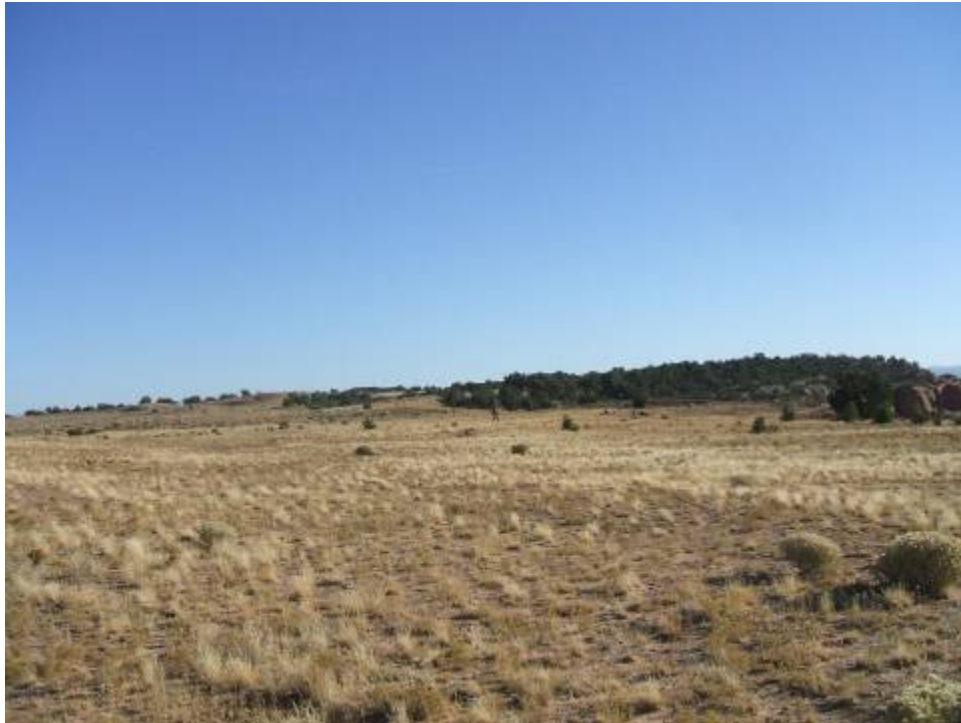
Reclamation status of the mine site is currently unknown. The mine appears to have been reclaimed by dirt covering waste piles. Signs were posted warning of underground radiological hazards. The signs were faded and nearly illegible. No adits or other mine features were observed during the site visit.

Photo 1. Bibo Trespass mine site, towards the south

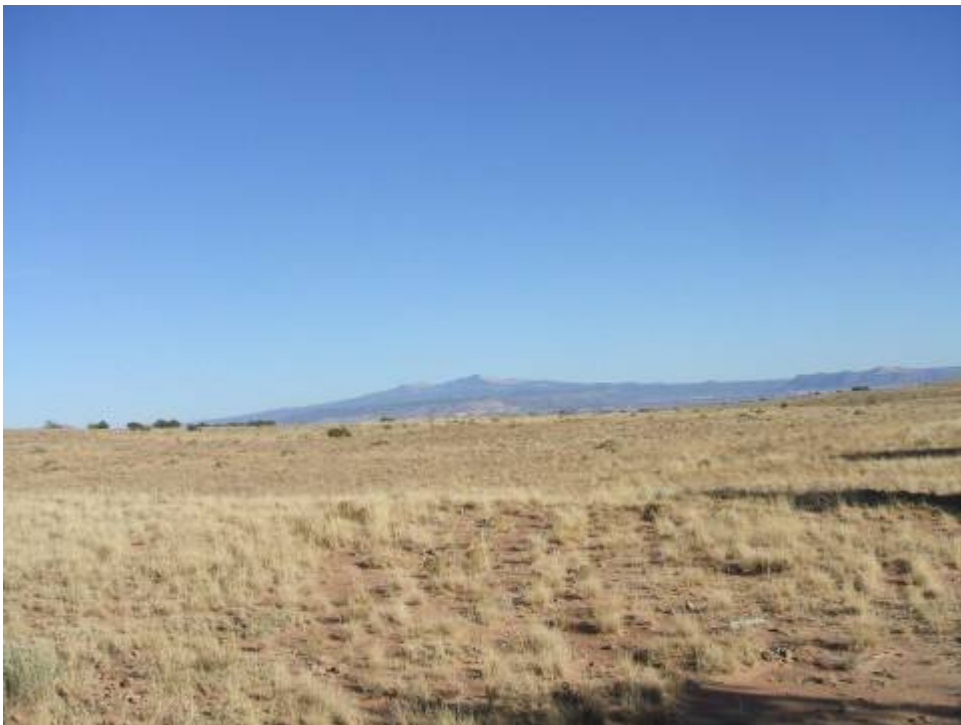
Photo 2. Bibo Trespass mine site, towards the east

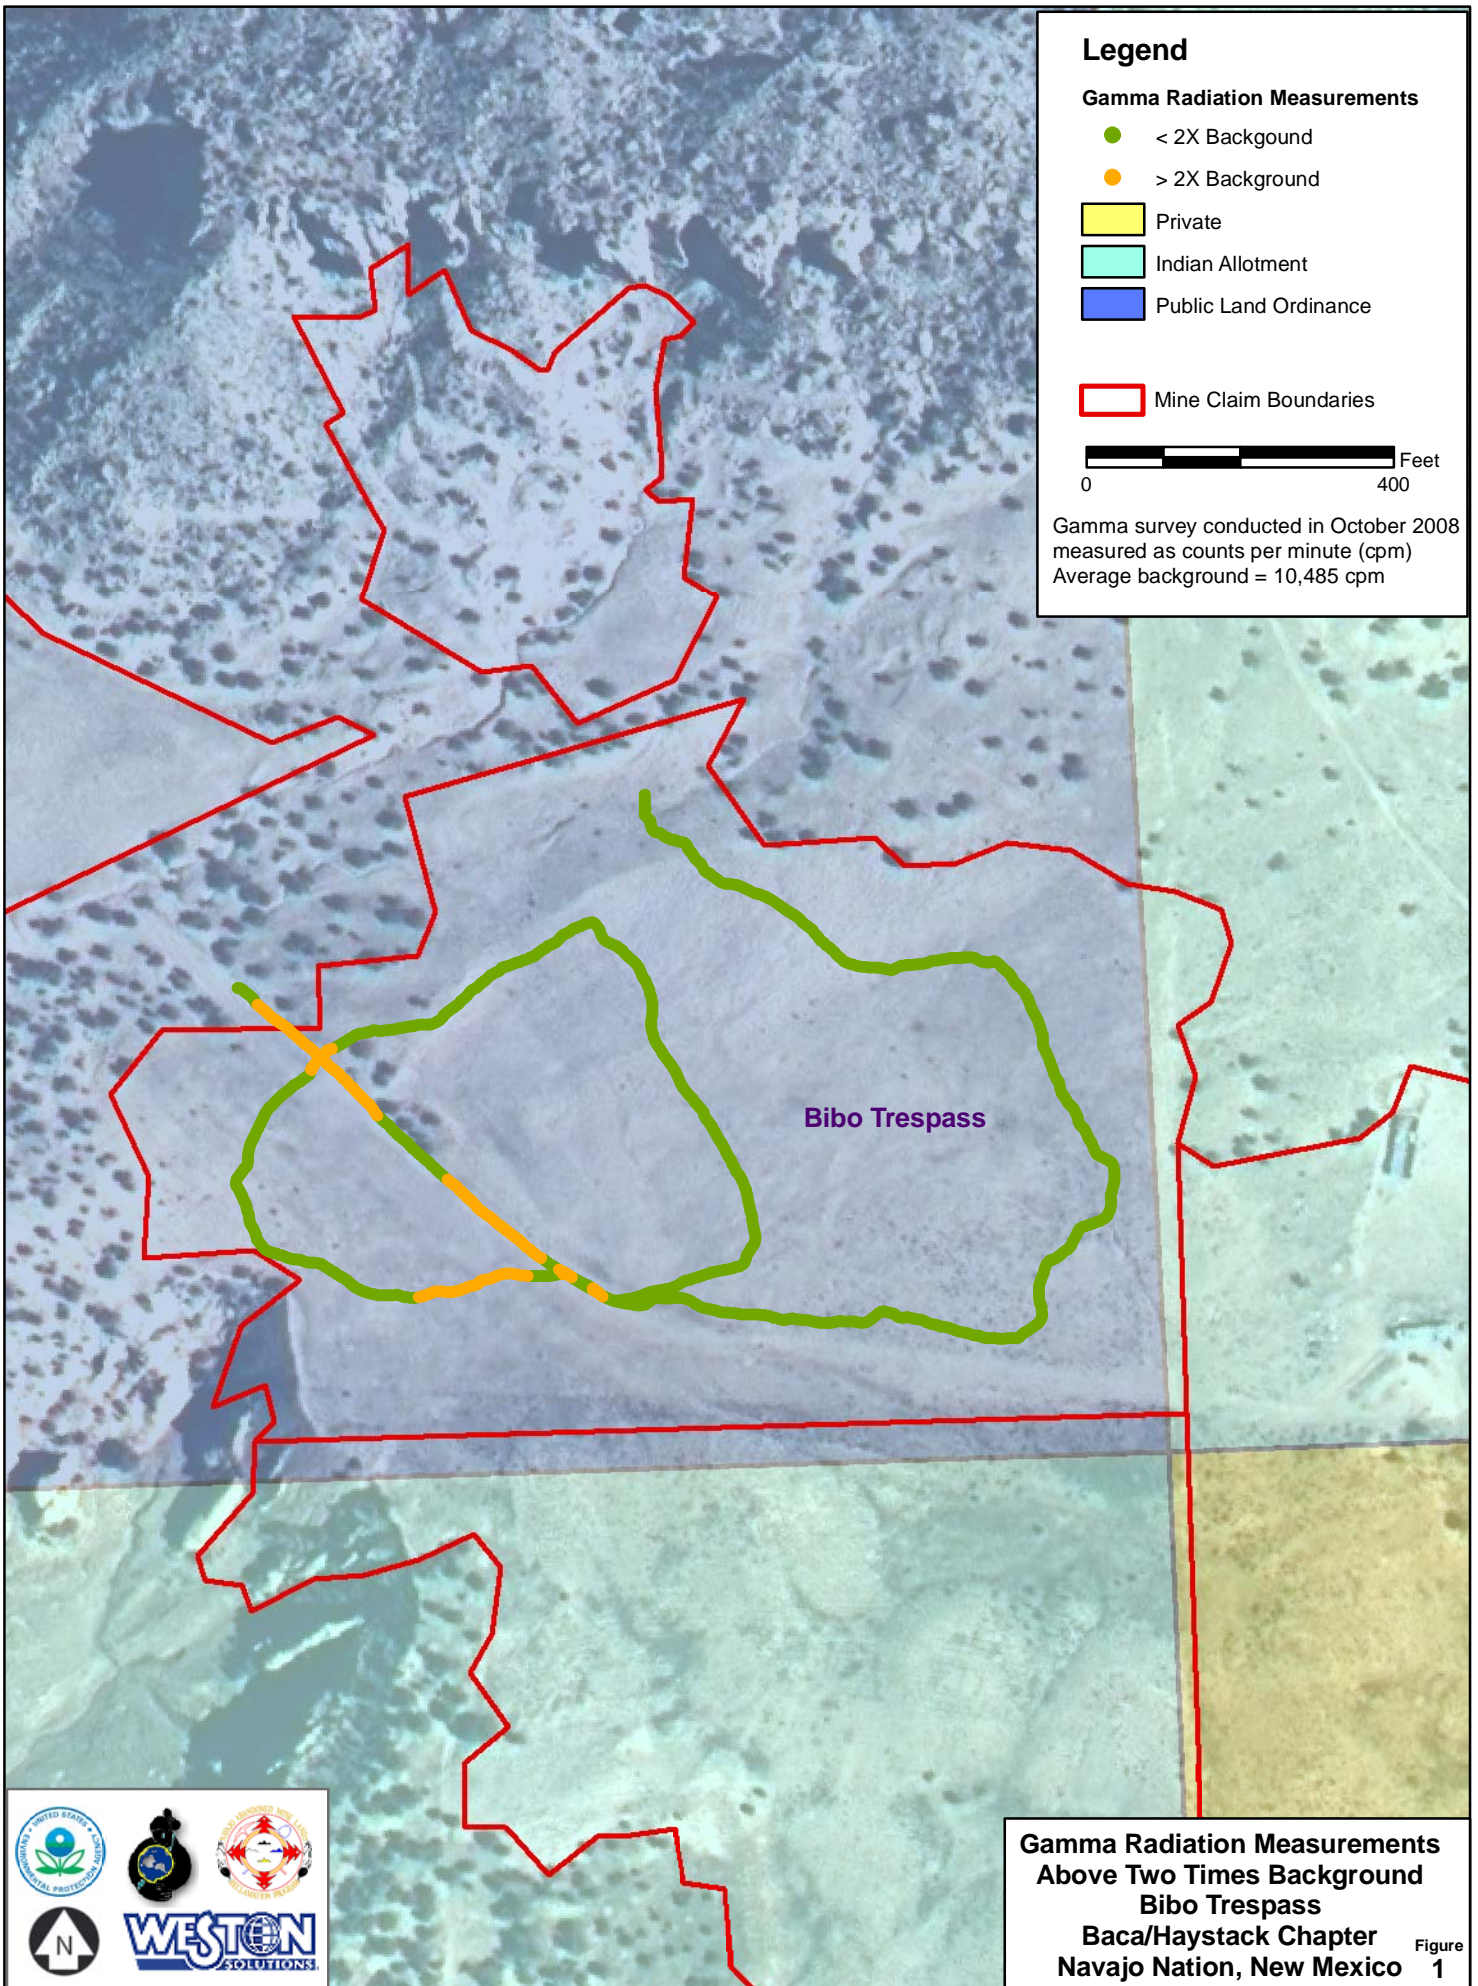
Gamma Radiation Measurements Above Two Times Background Bibo Trespass
Baca/Haystack Chapter Navajo Nation, New Mexico Figure 1

1,095 gamma radiation measurements were collected from mine sites, ranging from 6,552 cpm to 89,750 cpm. Measurements were found at their highest along the dirt road transecting the site.
