Navajo Abandoned Uranium Mine Site Screen Report

Christensen AUM Site

Navajo AUM Eastern Region

May 2009

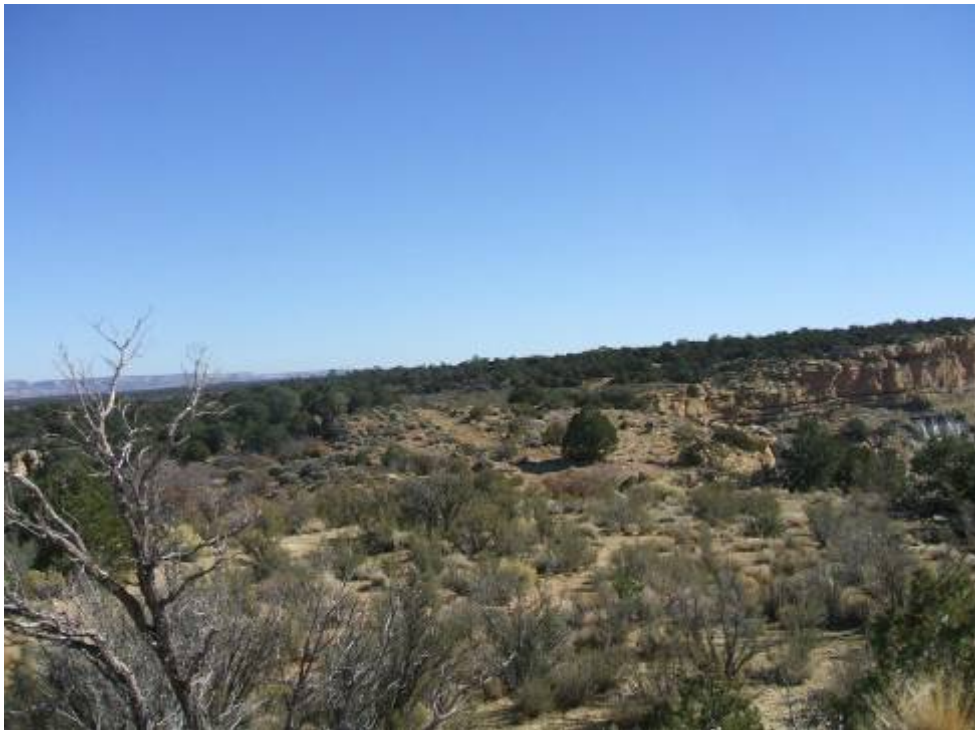
Photo 1. Mine site, from background location, towards the northeast

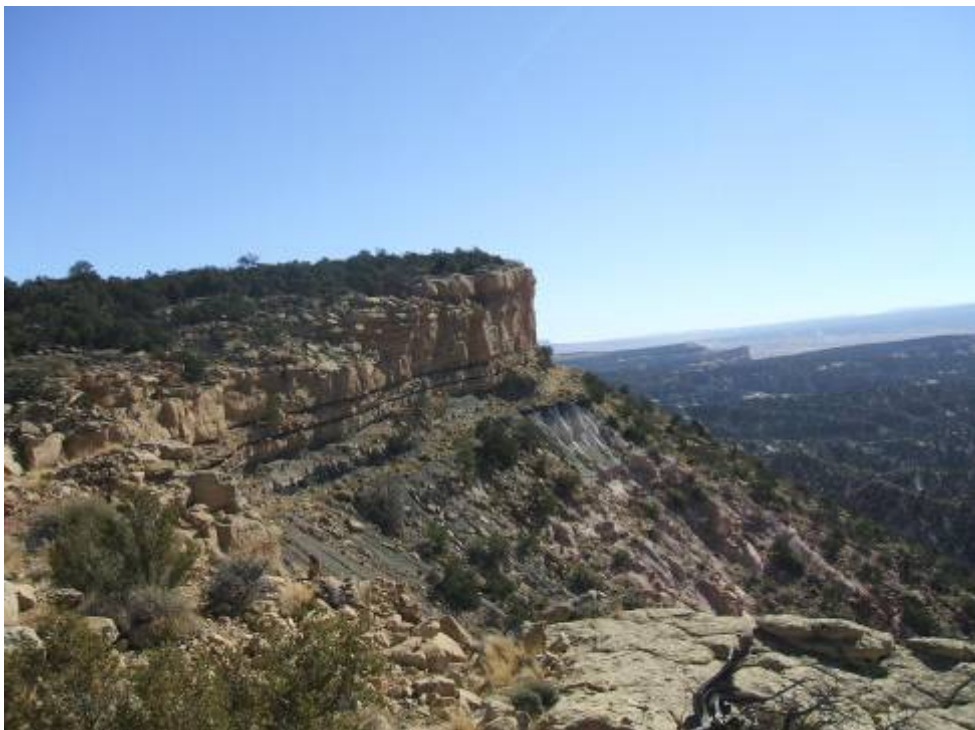
Photo 2. Mine site cliff area, towards the east/northeast

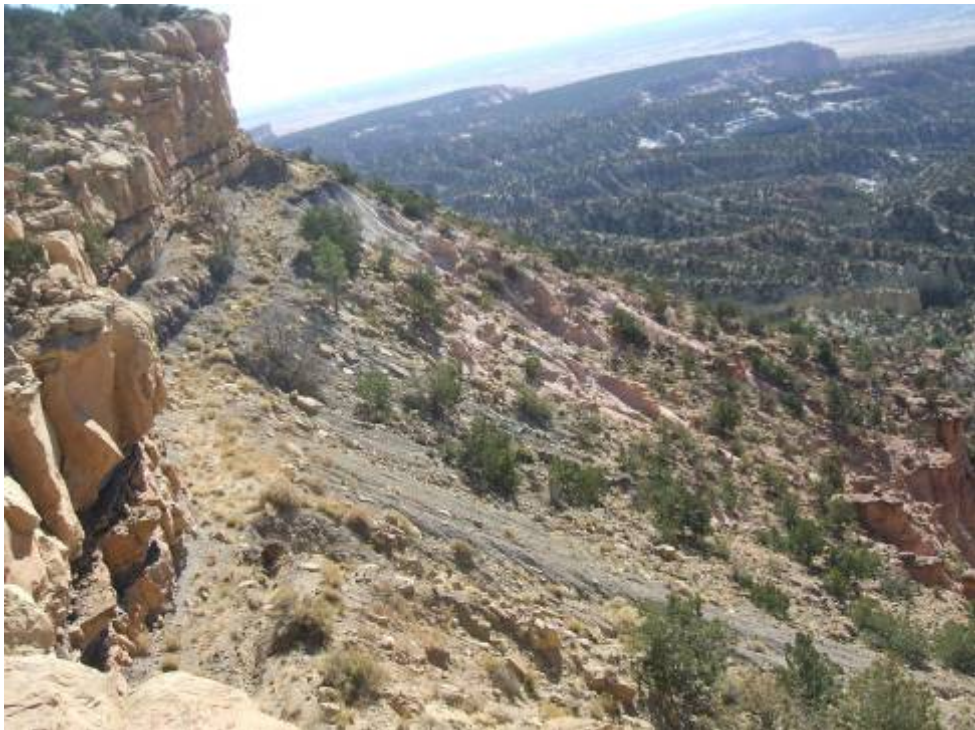
Photo 3. Mine site and cliff face area, towards the east

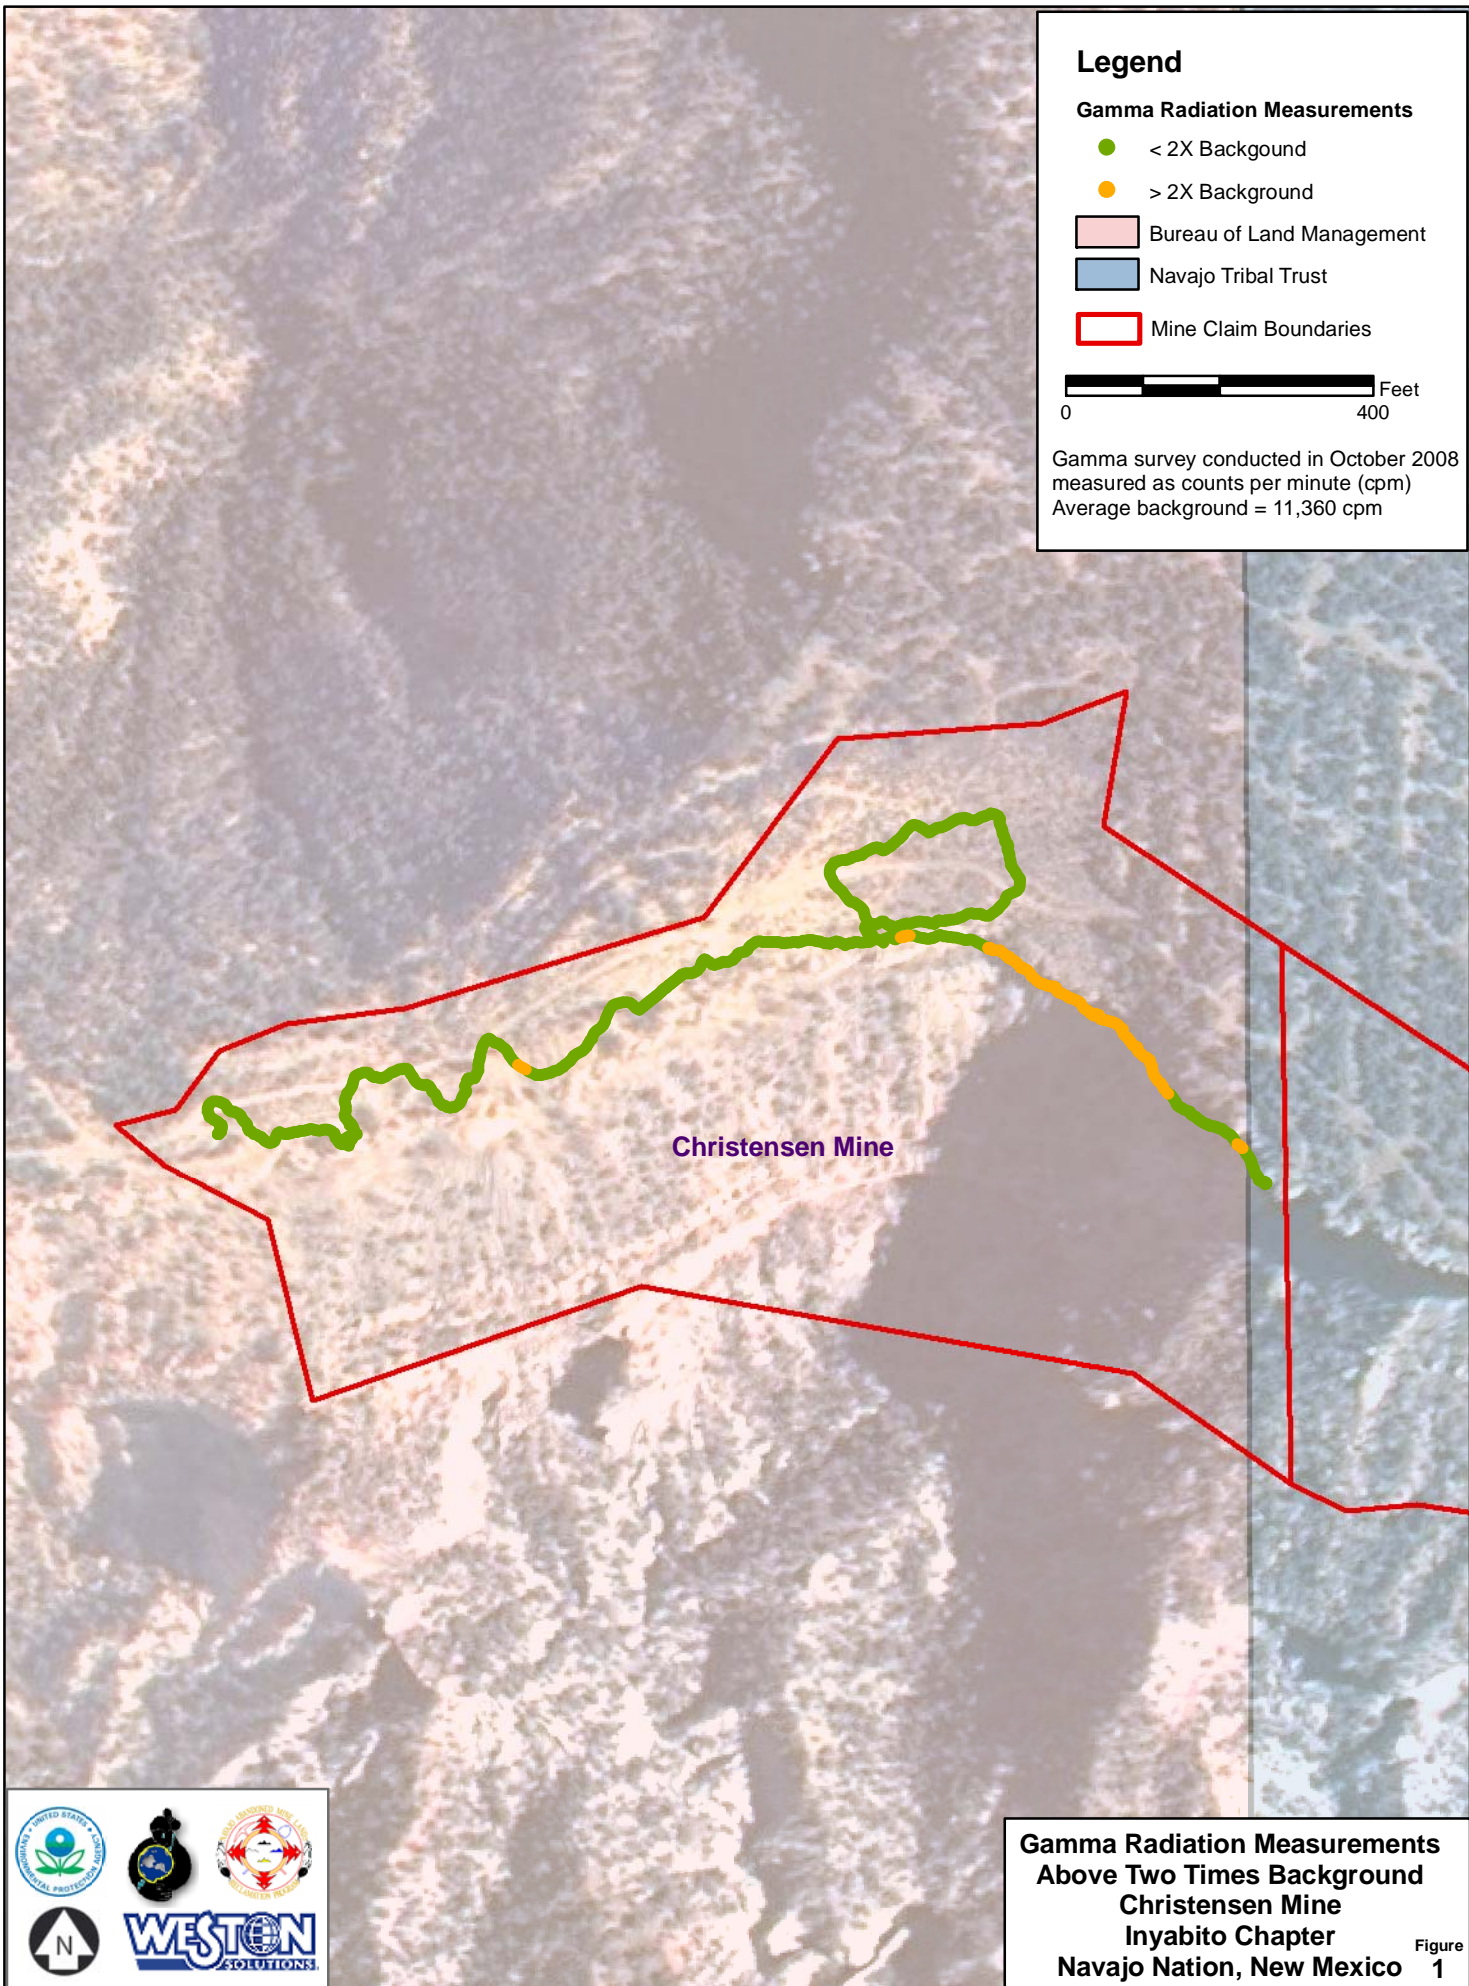
Gamma Radiation Measurements Above Two Times Background Christensen Mine Inyabito Chapter Navajo Nation, New Mexico Figure 1

A total of 949 gamma radiation measurements were collected from mine sites, ranging from 7,342 cpm to 105,360 cpm. The measurements are represented in Figures 1 and 2.

Gamma survey conducted in October 2008
 measured as counts per minute (cpm)
 Average background = 11,360 cpm
