Navajo Abandoned Uranium Mine

Site Screen Report

Boyd Tisi No. 1 AUM Site

January 2011

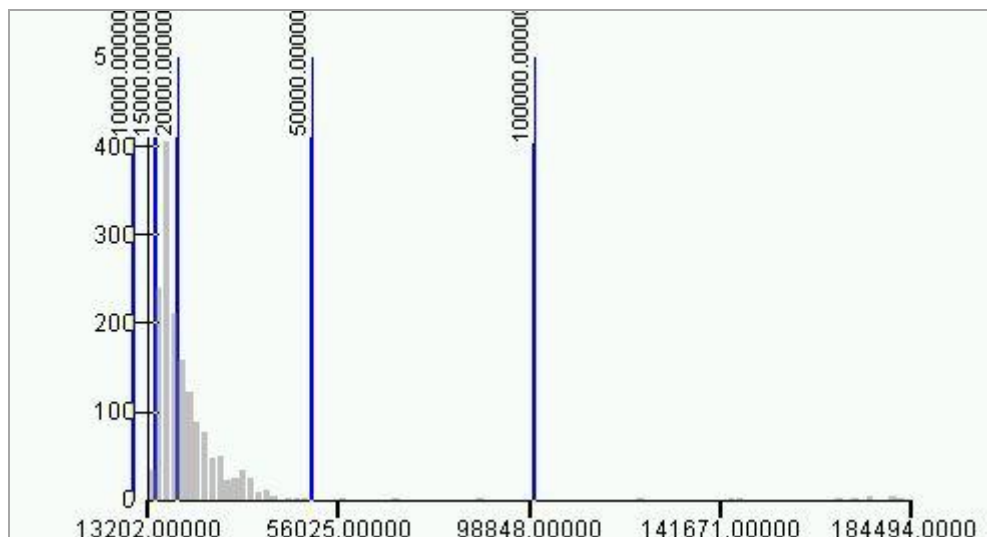
Count:	1614
Minimum:	13202.00000
Maximum:	184494.00000
Sum:	39628055.00000
Mean:	24552.69827
Median:	19321.00000
Standard Deviation:	21626.85980

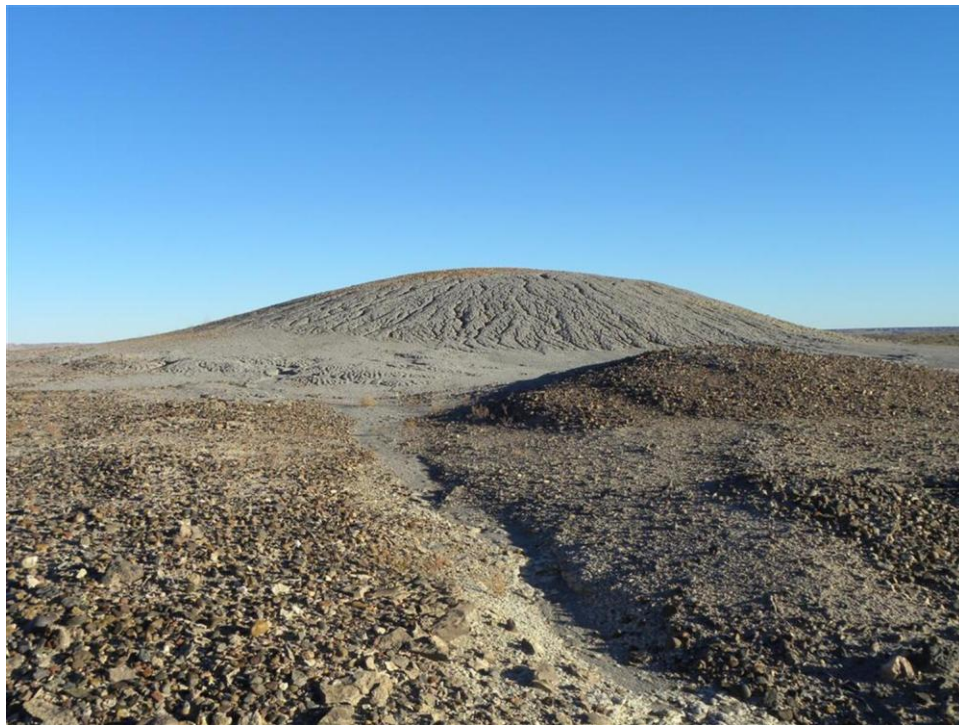
Reclamation cap in center of site, grey mound with red-brown soil on top, 200' x 100' x 8'

Photo 2. Boyd Tisi No. 1 mine site, reclamation cap

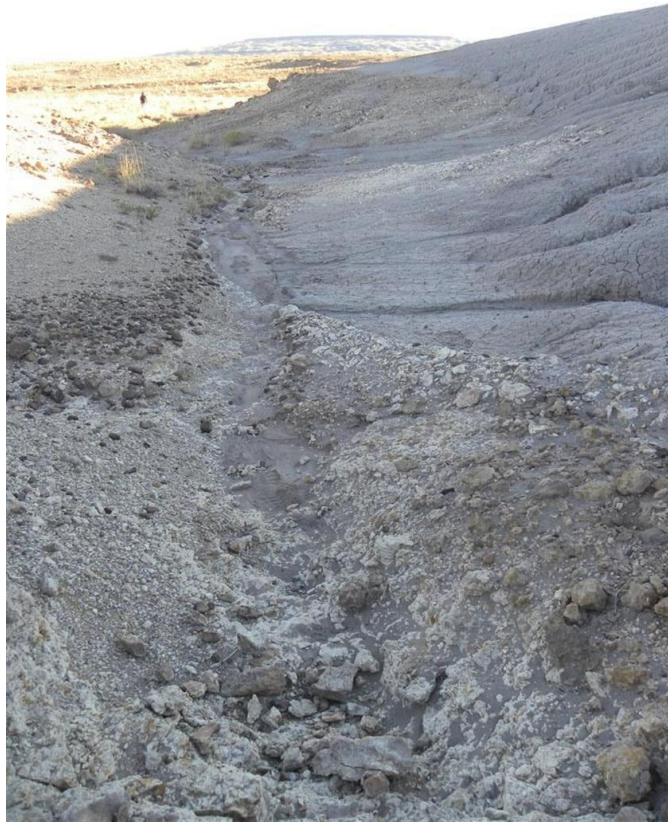
Photo 3. Boyd Tisi No. 1 mine site, drainage

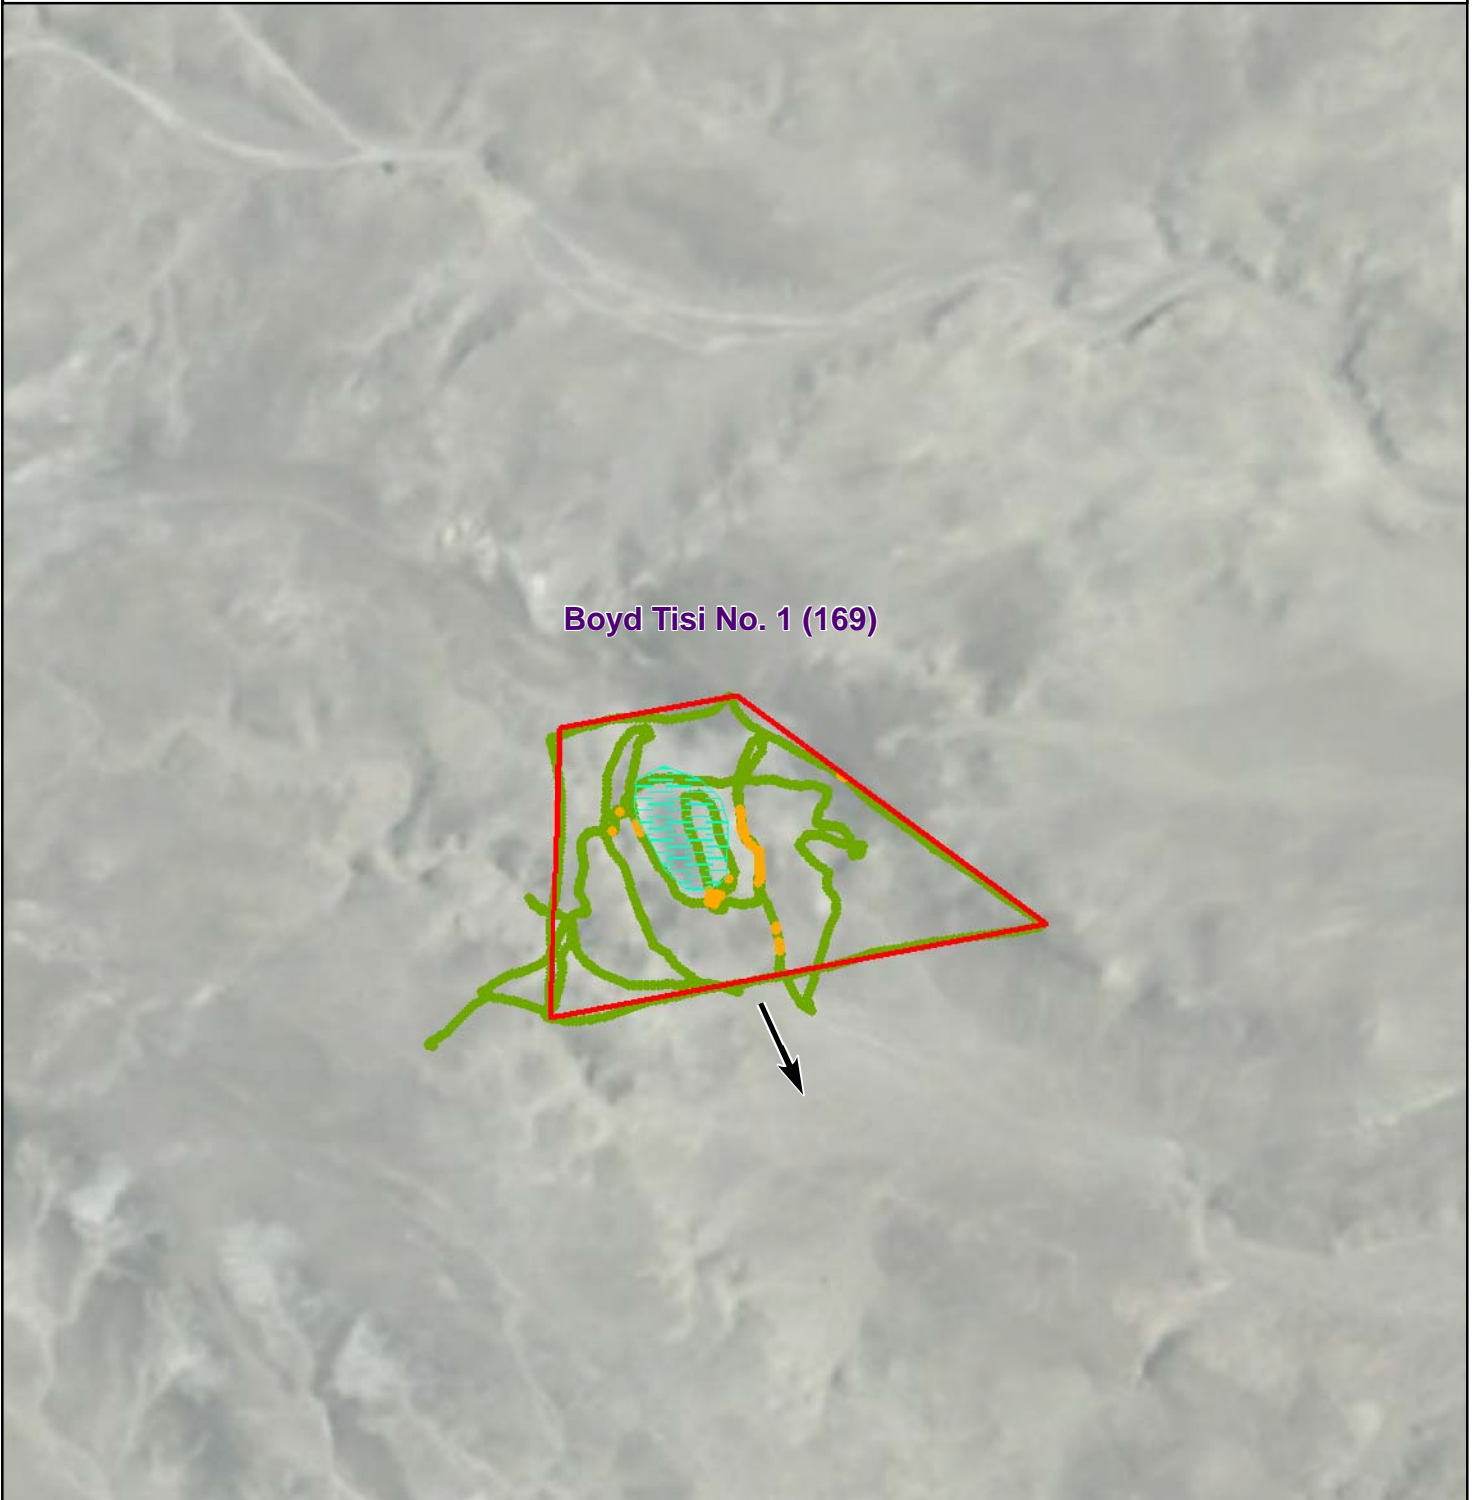
**Figure 1 - Gamma Radiation Measurements, Above Two Times Background
Boyd Tisi No. 1 (169)
Cameron Chapter, Navajo Nation**

A total of 1,614 gamma radiation measurements were collected from the mine site, ranging from 13,202 cpm to 184,494 cpm. The measurements collected throughout the site at an average level of approximately 30,000 cpm, with a few isolated hot spots with maximum levels of 185,000 cpm. The measurements are represented in Figures 1 and 2.
