Navajo Abandoned Uranium Mine Site Screen Report

Westwater #1 AUM Site

Navajo AUM Eastern Region

May 2009

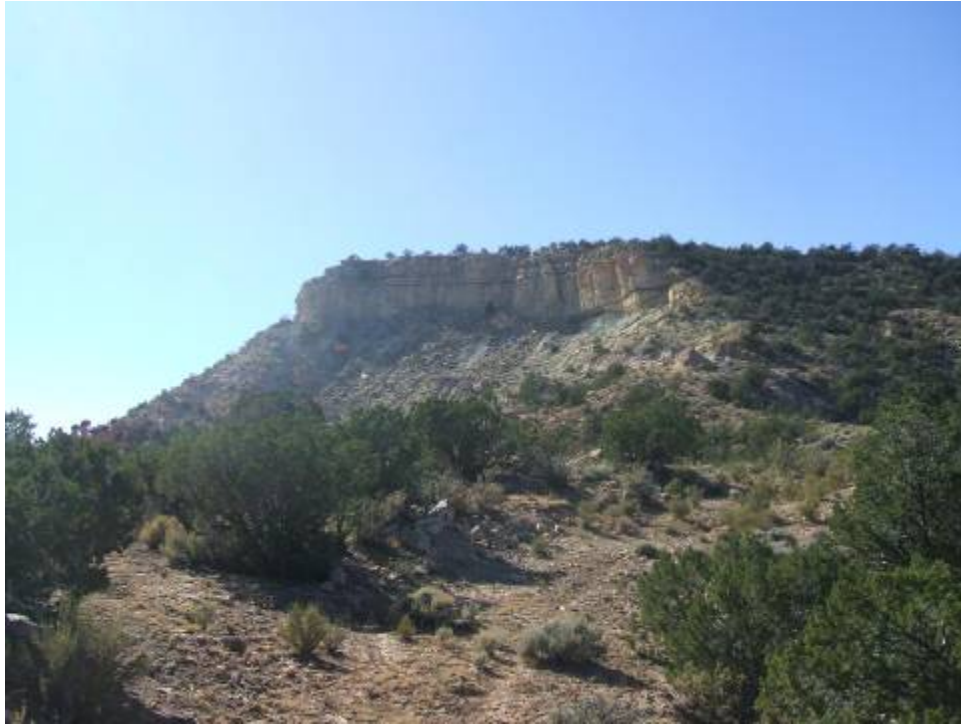
Photo 1. Westwater # 1 mine site, towards the southwest

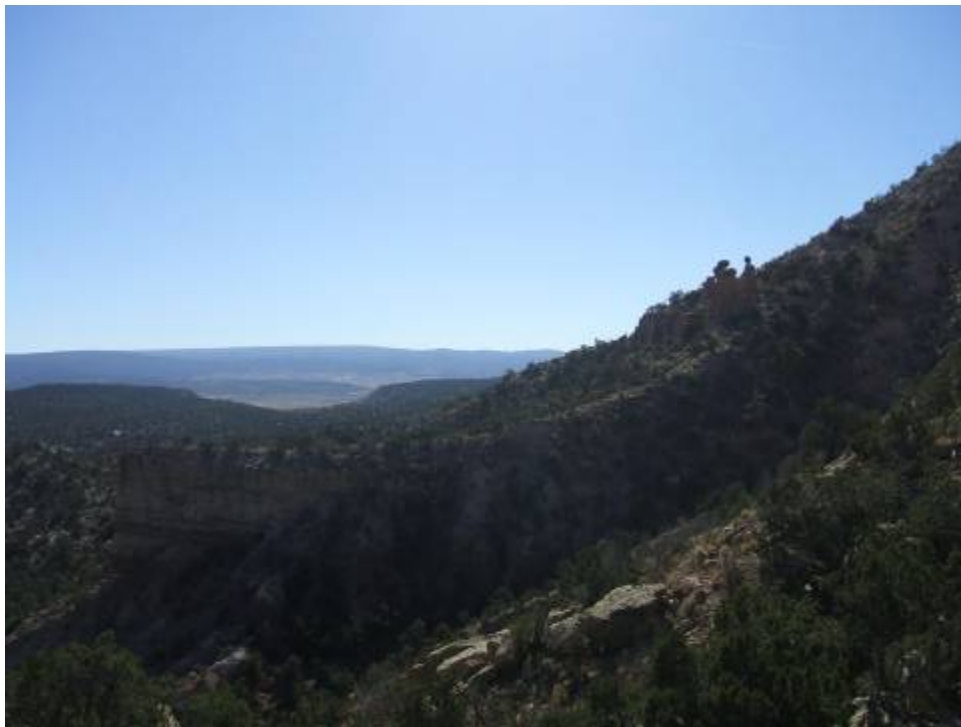
Photo 2. Westwater # 1 mine site ridge down-slope, east of cliff area, towards the southwest

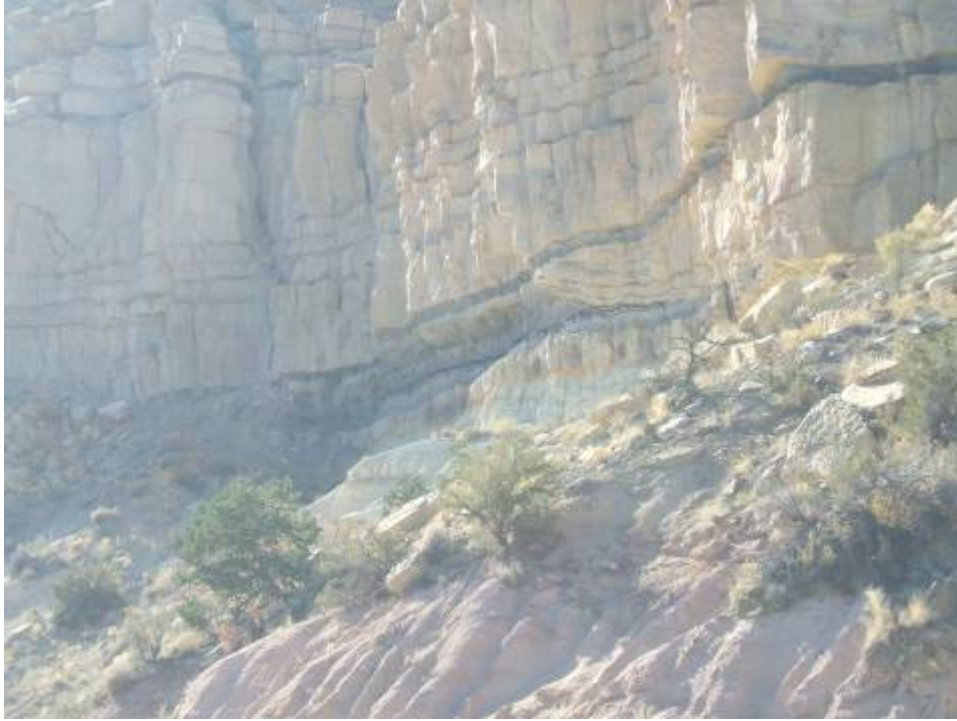
Photo 3. Westwater # 1 mine site cliff face, towards the south

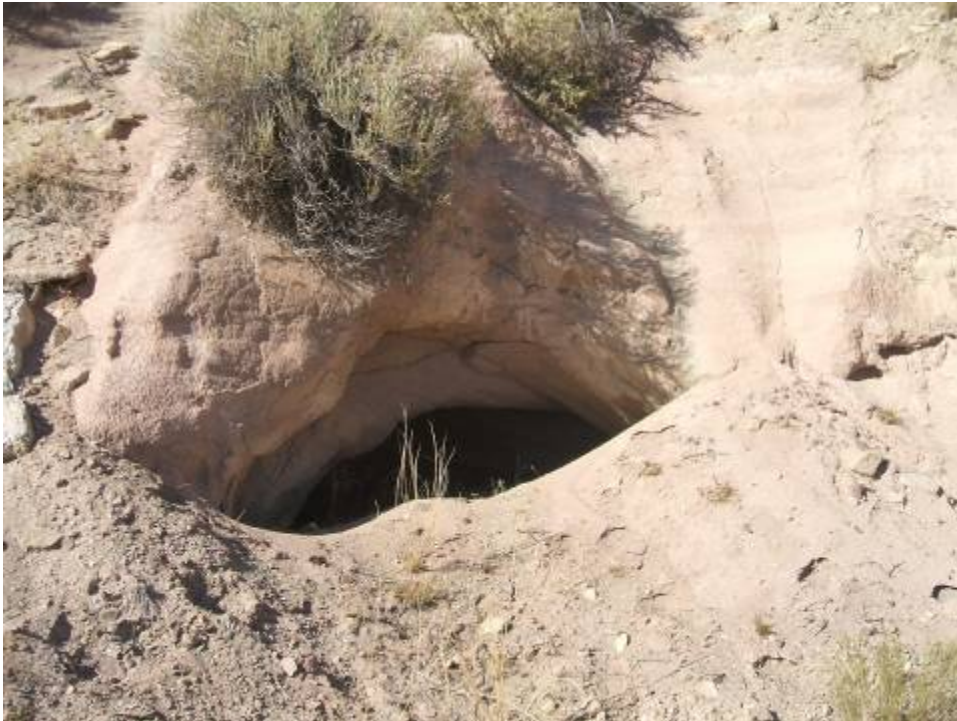
Reclamation status of the mine site is currently unknown. No visible signs of reclamation were observed. A monitoring well was observed within the northern portion of the site. One adit / shaft entrance was observed in the center of the site (Photo 4). No waste piles, or other mine features were observed during the site visit. Due to steep grades, the only accessible portion of the site was a narrow pass running through the center of the site.

Photo 4. Westwater # 1 mine site shaft/adit along cliff face, towards the northwest

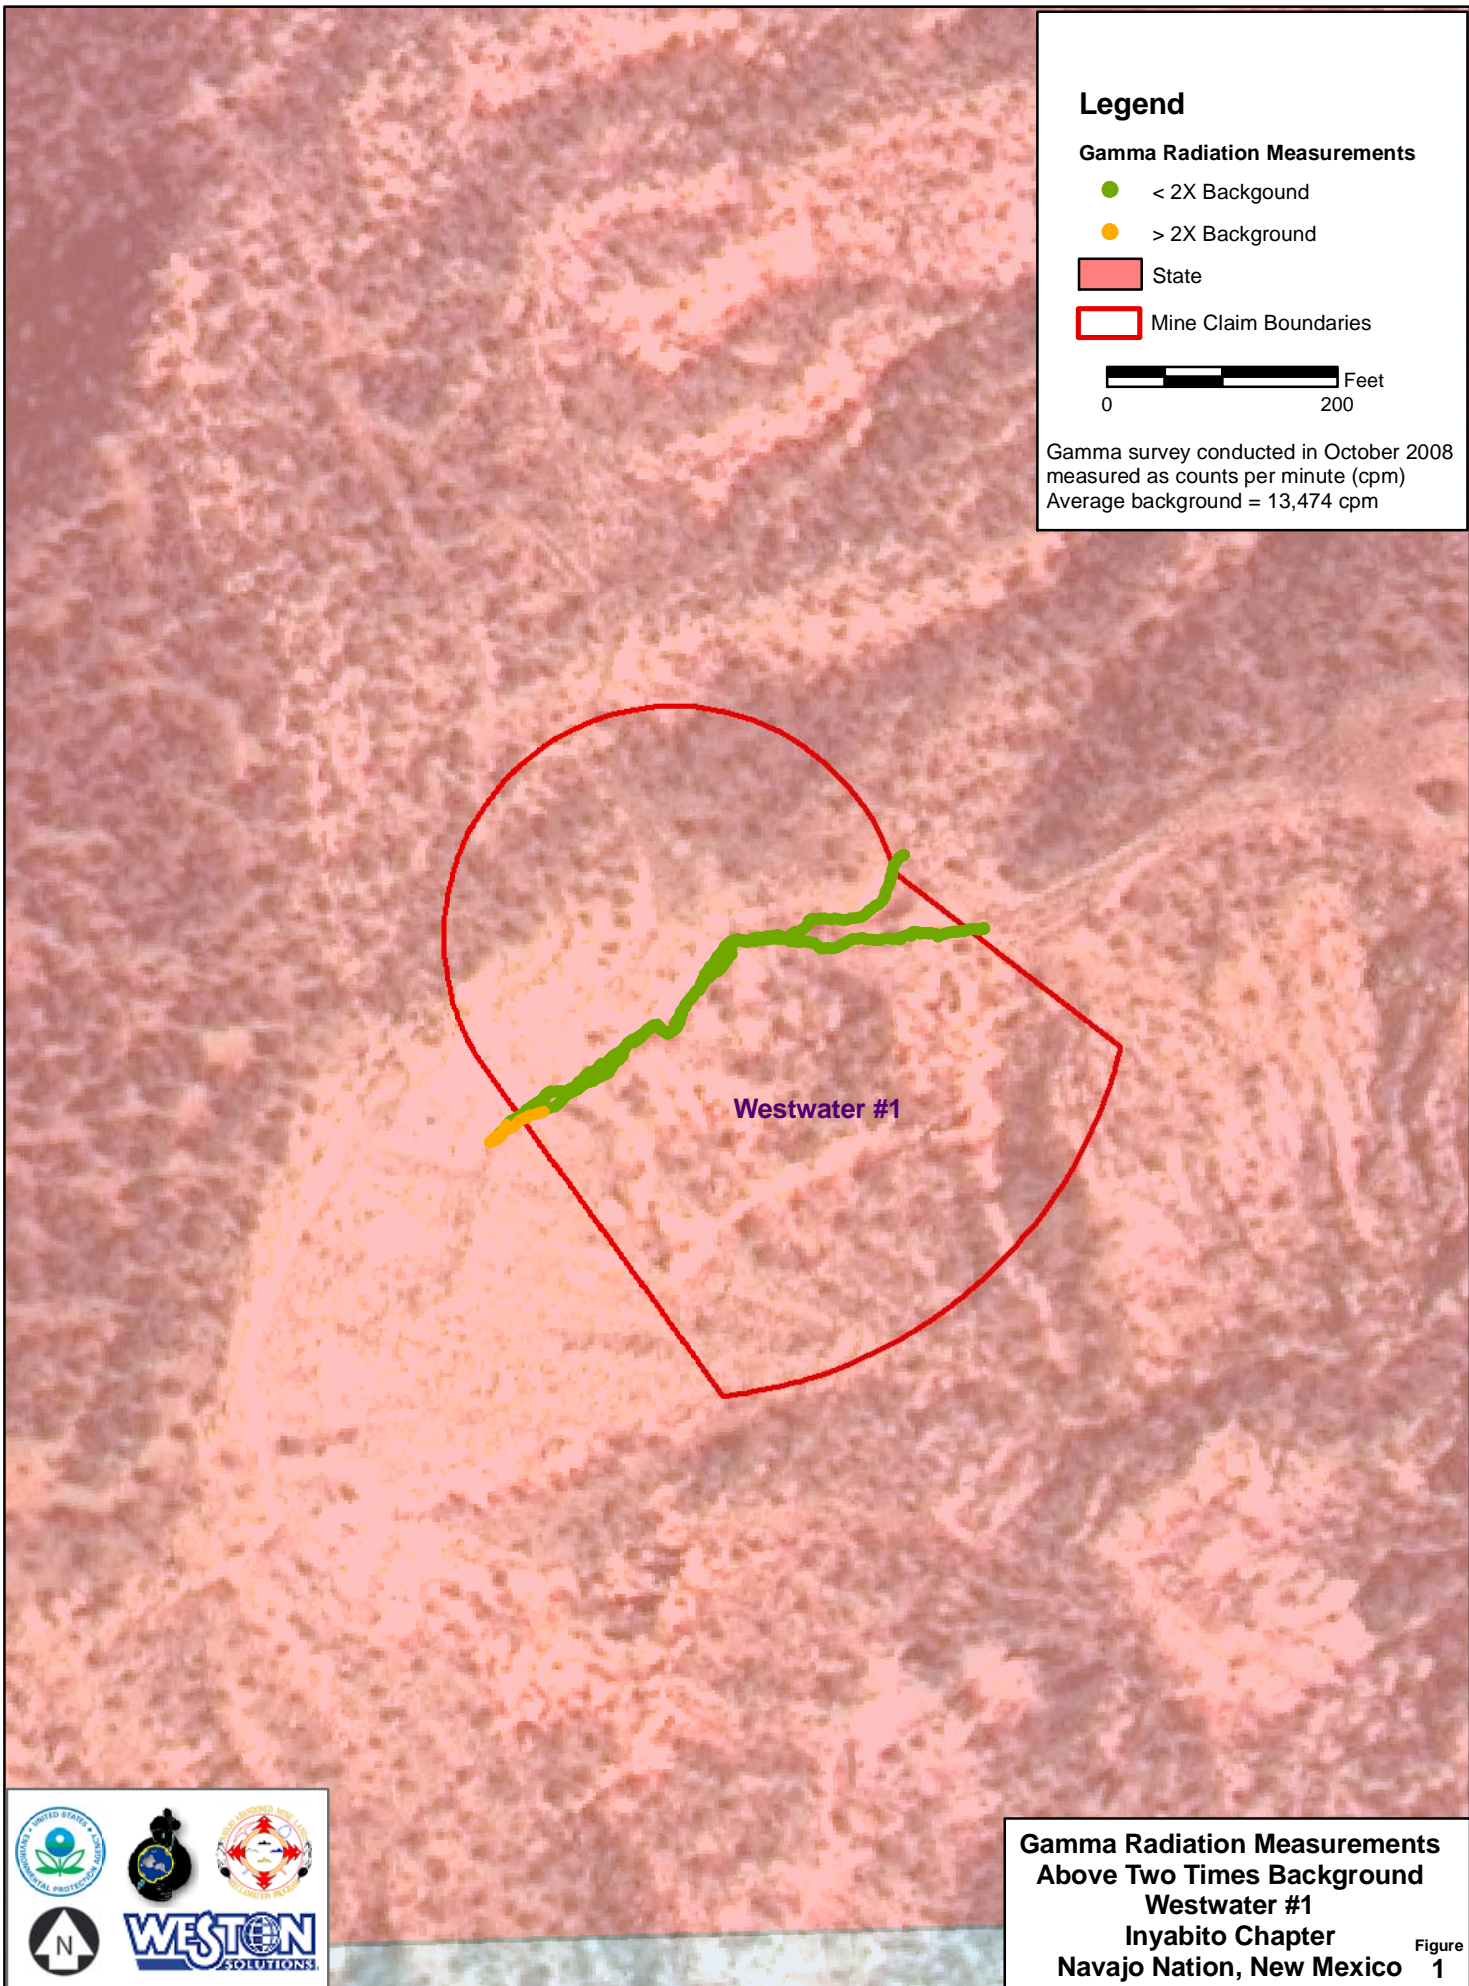
**Gamma Radiation Measurements
 Above Two Times Background
 Westwater #1
 Inyabito Chapter
 Navajo Nation, New Mexico** Figure 1

A total of 445 gamma radiation measurements were collected from mine sites, ranging from 10,119 cpm to 39,985 cpm. The measurements are represented in Figures 1 and 2.

Gamma survey conducted in October 2008
 measured as counts per minute (cpm)
 Average background = 13,474 cpm
