Navajo Abandoned Uranium Mine Site Screen Report

Haven AUM Site

Navajo AUM Eastern Region

Weston Solutions, Inc.

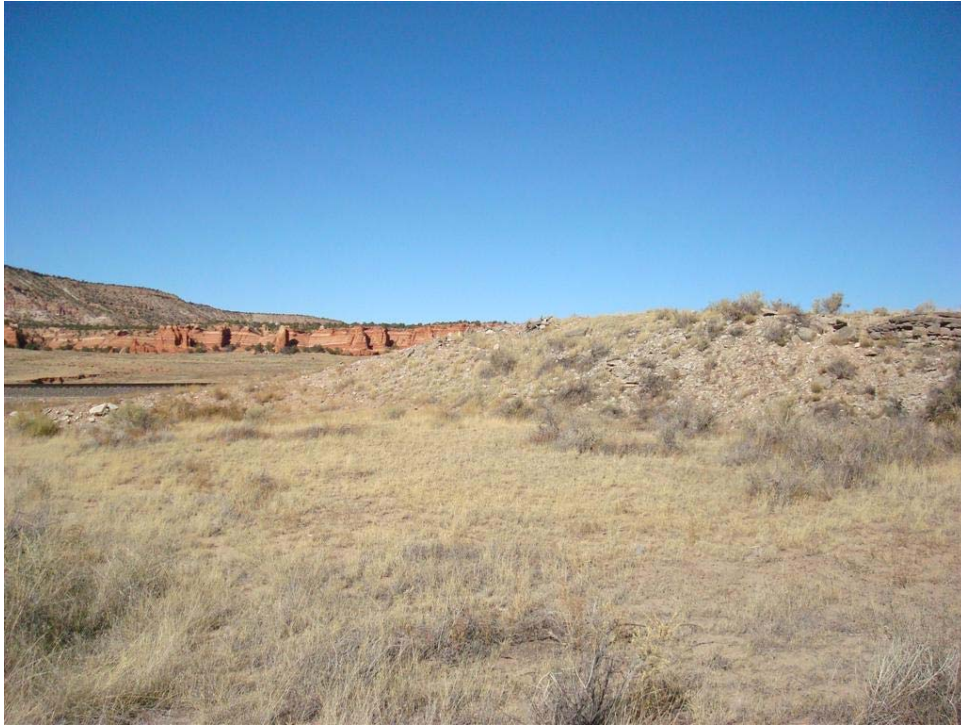
Photo 1. Haven Mine site, towards the north. Railroad in background.

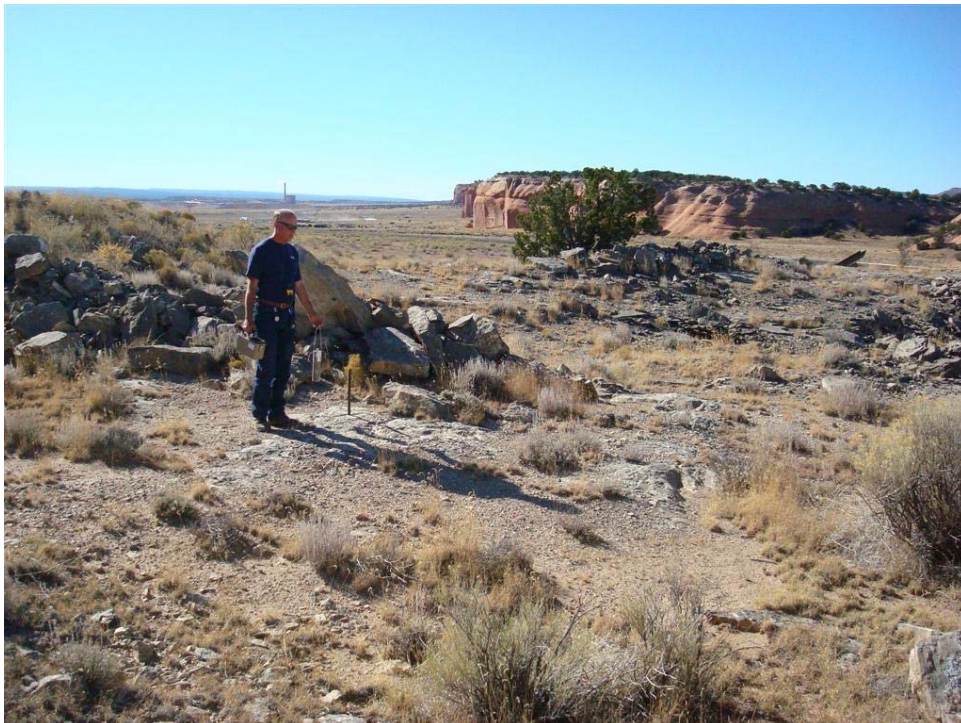
Reclamation status of the mine site is currently unknown. No visible signs of reclamation were observed. Numerous waste rock piles are found throughout the site. The mining appears to have been conducted from exposed bedrock at the surface. A wooden chute remains at the southern edge of the mine. Blast holes were found in some areas. No adits or other mine features were observed during the site visit.

Photo 2. Haven Mine site, towards the northwest
Waste rock piles and drill steel in bedrock

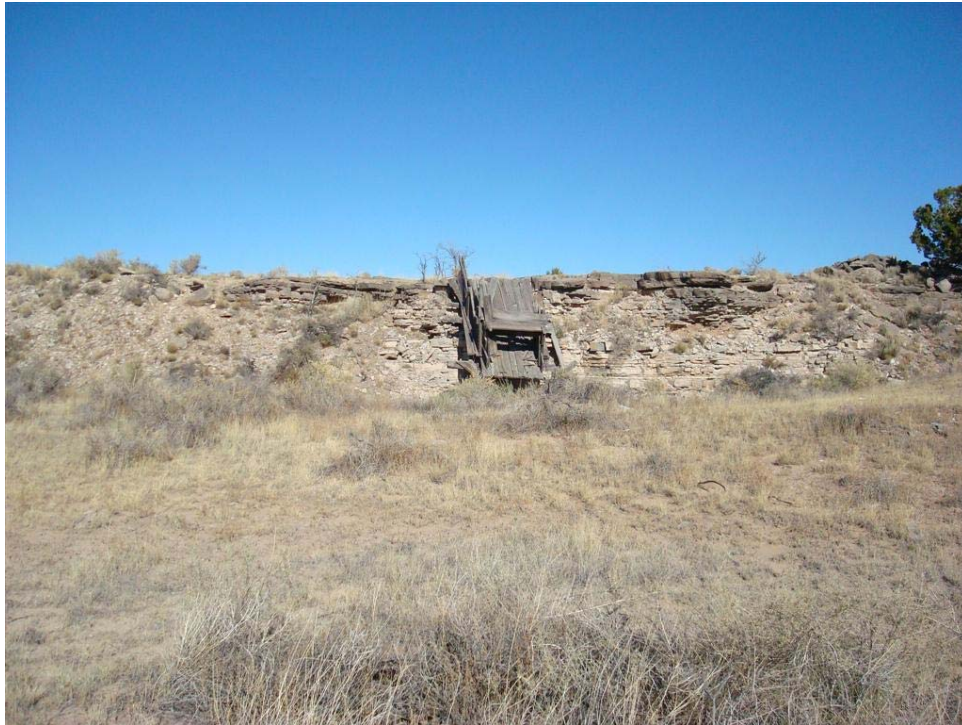
Photo 3. Haven Mine site with wooden chute at west end of mine

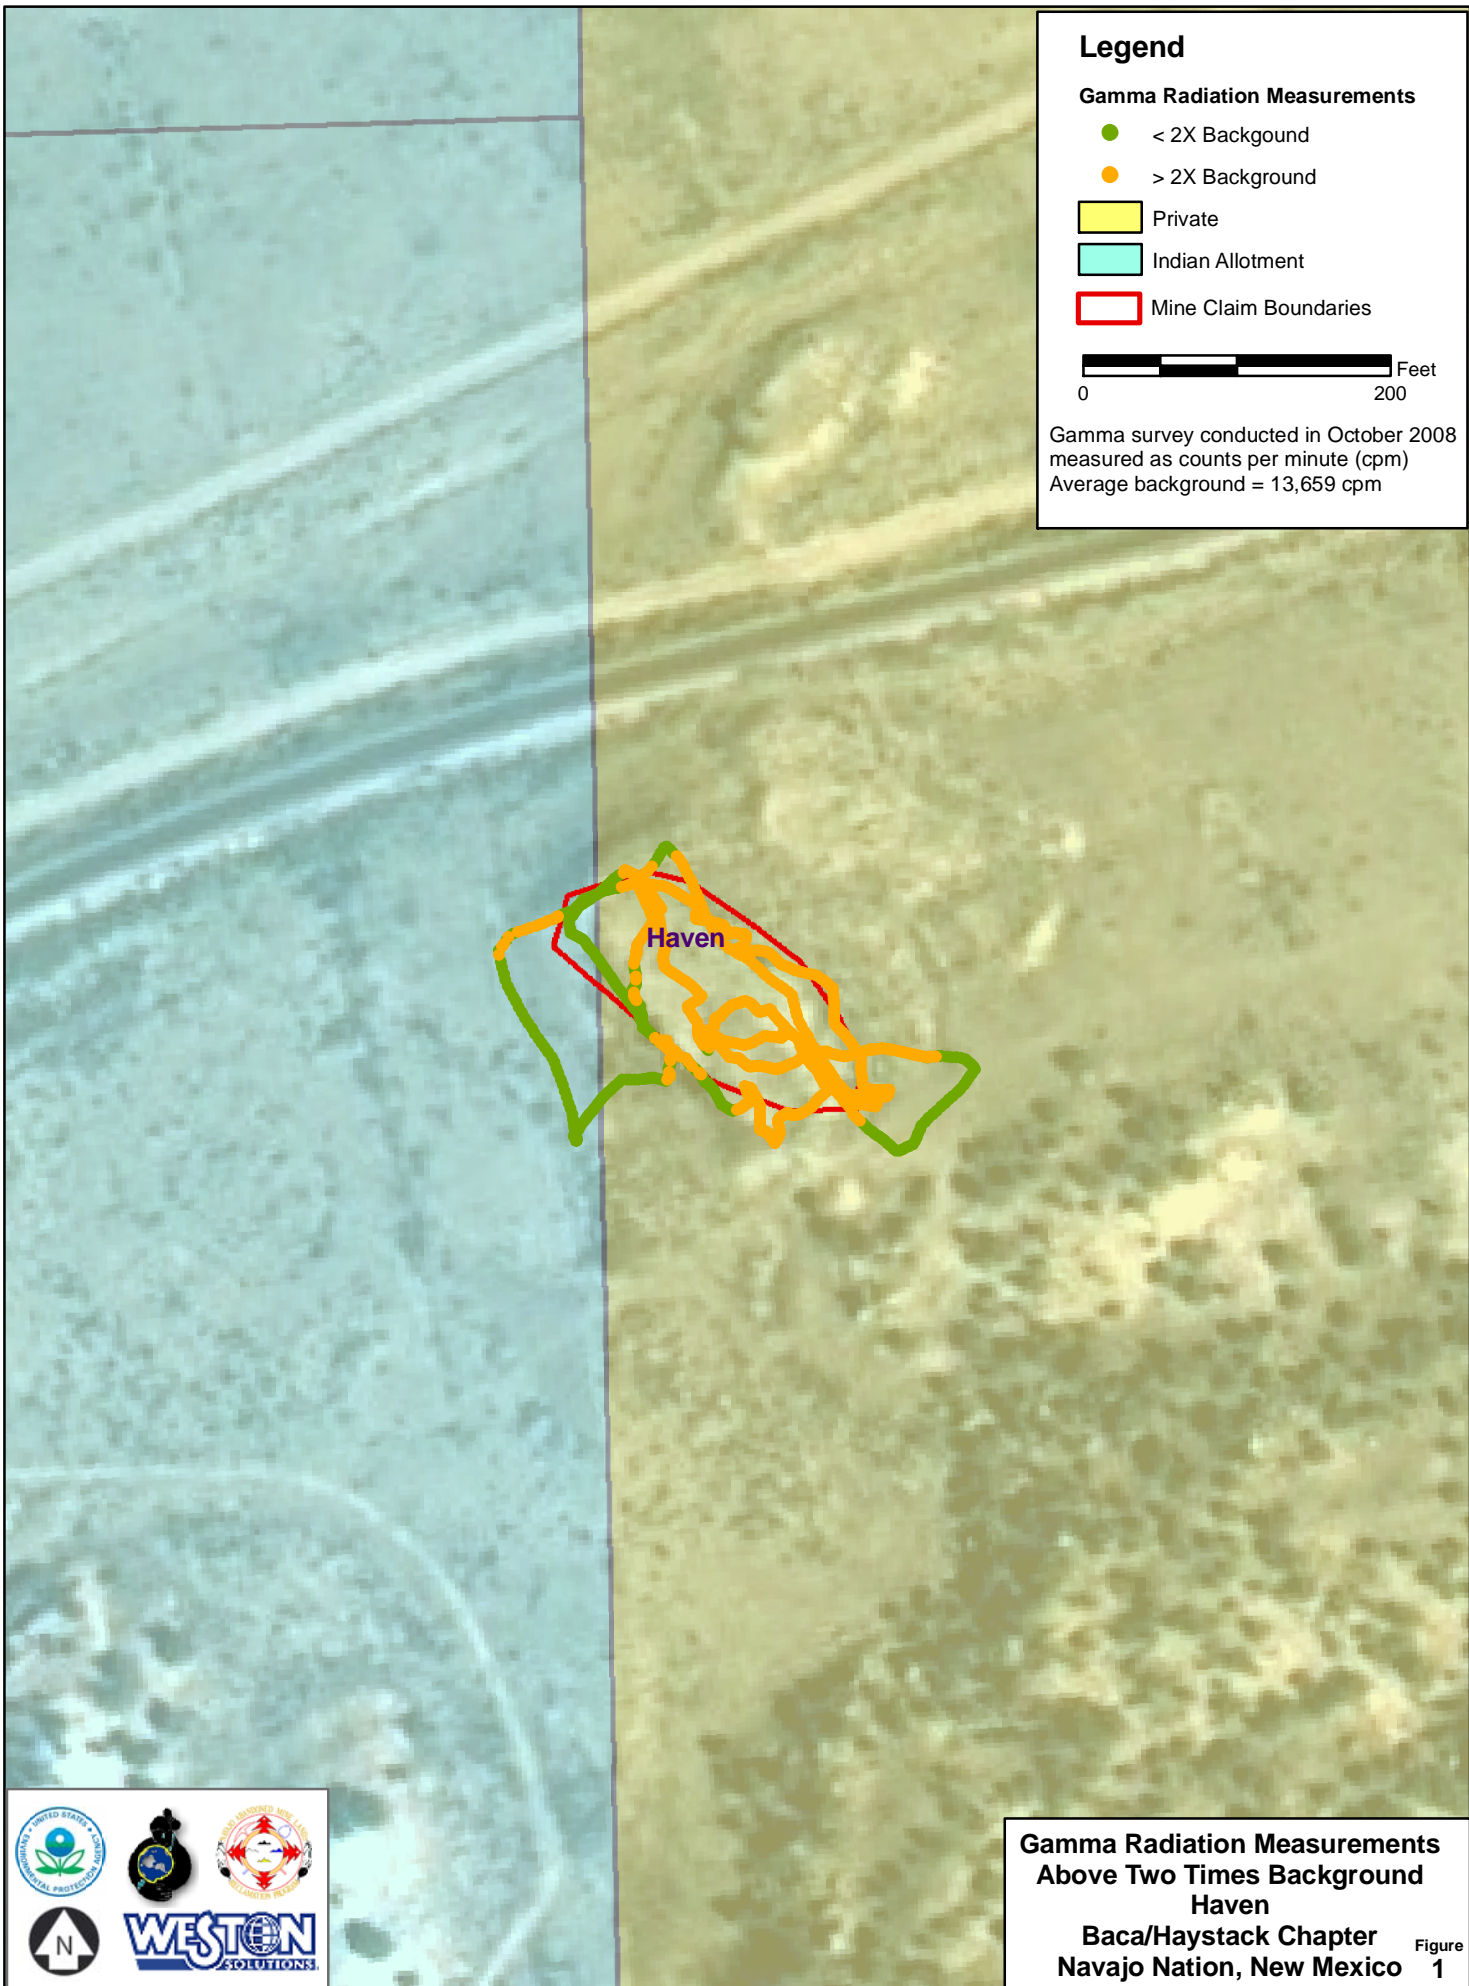
**Gamma Radiation Measurements
 Above Two Times Background
 Haven
 Baca/Haystack Chapter
 Navajo Nation, New Mexico** Figure 1

A total of 1,348 gamma radiation measurements were collected from mine sites, ranging from 10,670 cpm to 356,709 cpm. The measurements are represented in Figures 1 and 2.

Gamma survey conducted in October 2008
 measured as counts per minute (cpm)
 Average background = 13,659 cpm

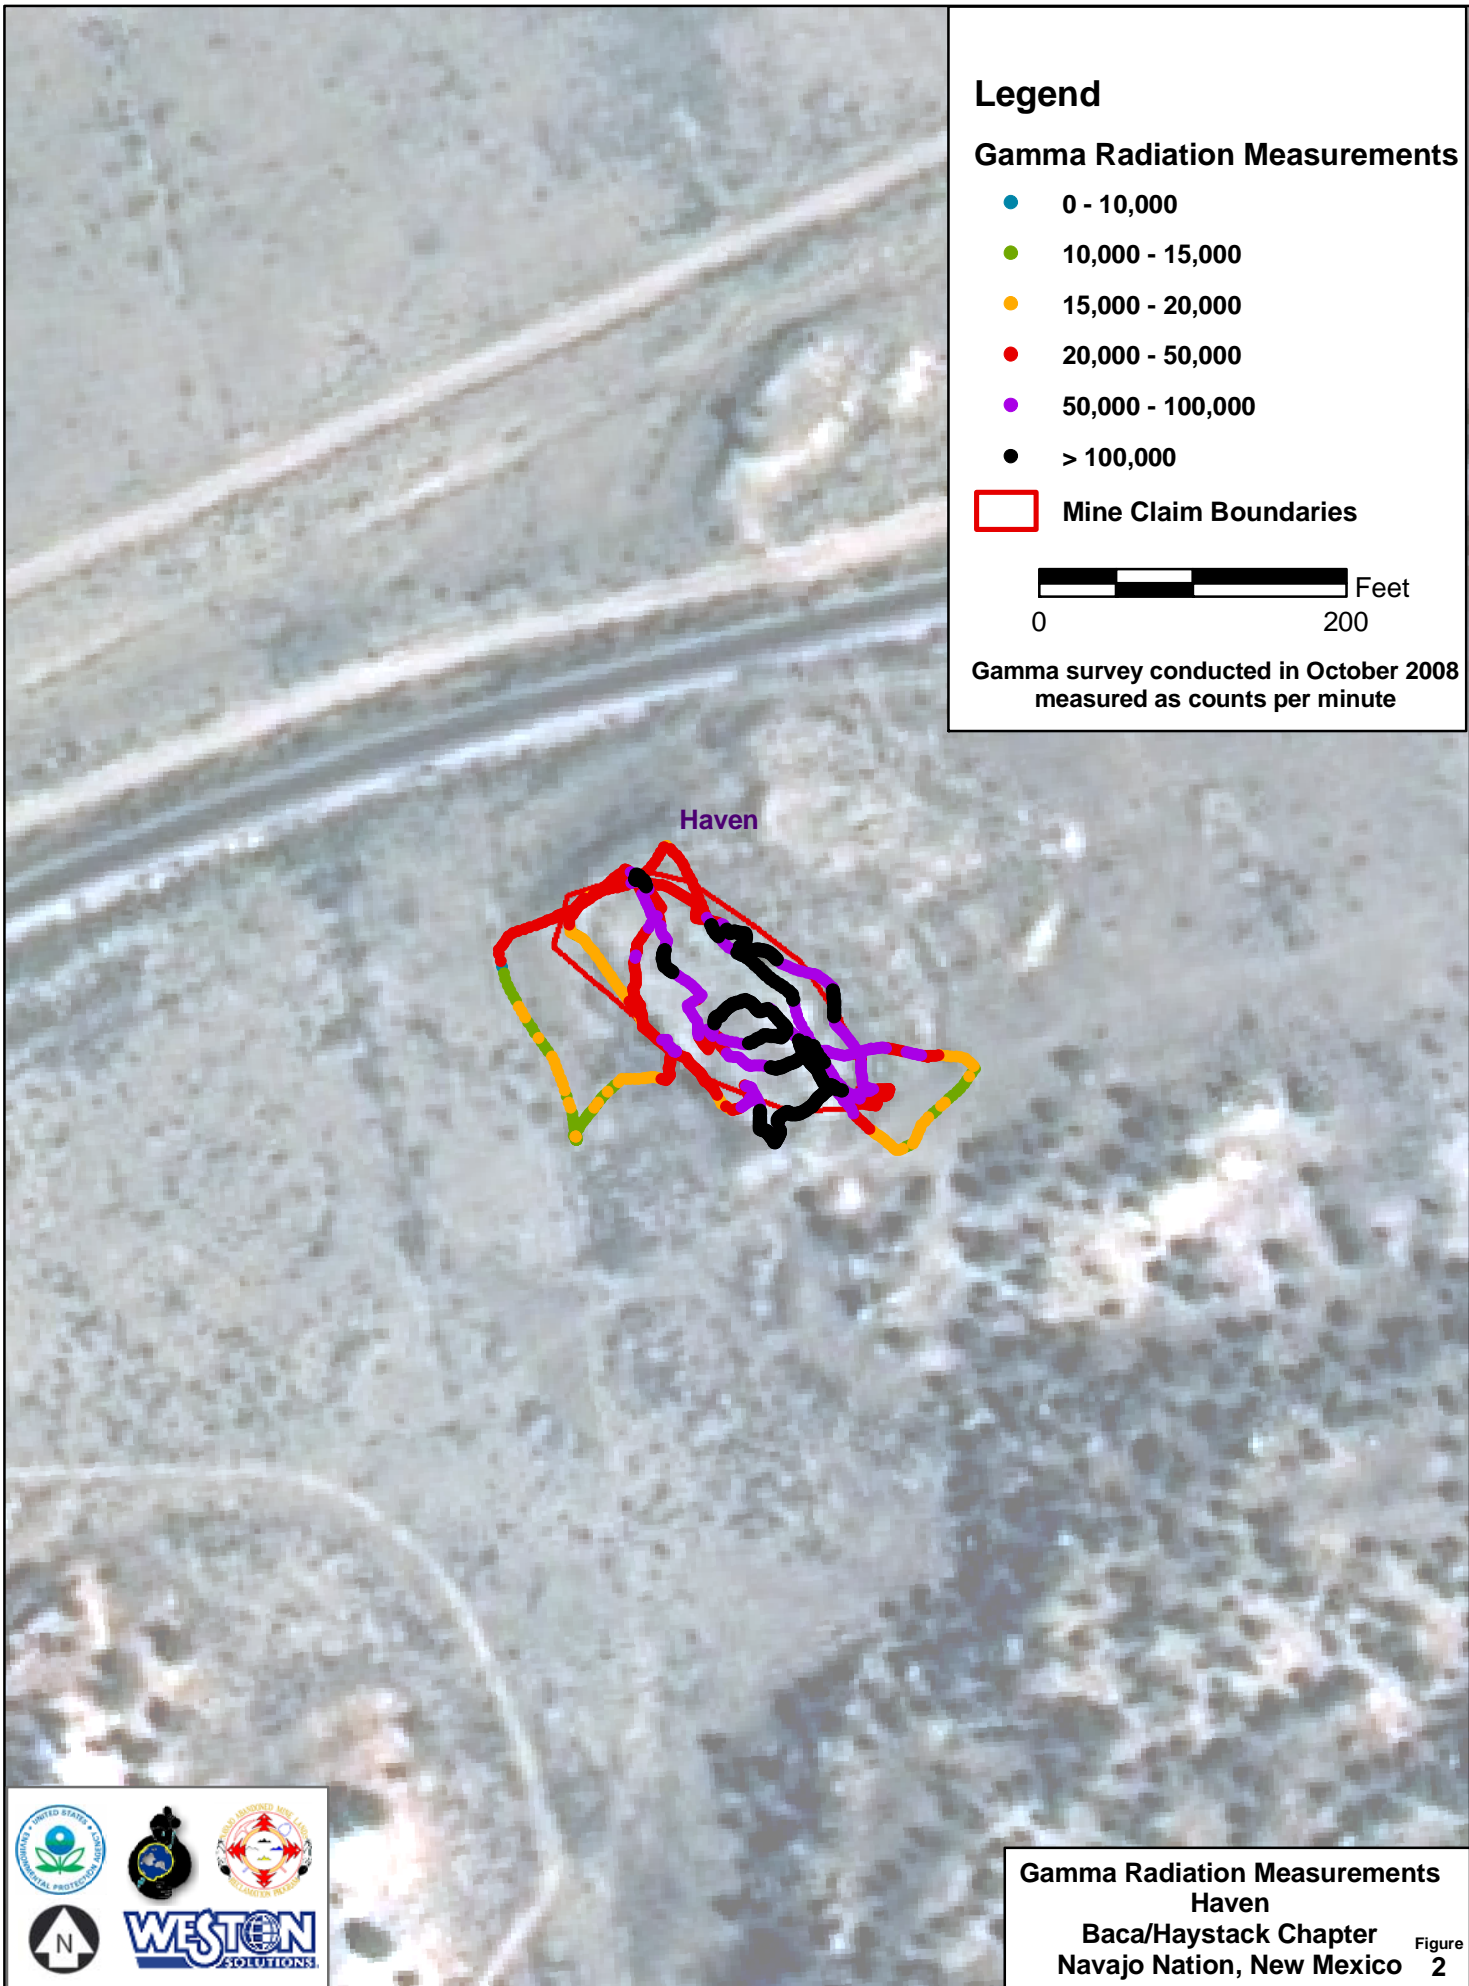
**Gamma Radiation Measurements
Haven
Baca/Haystack Chapter
Navajo Nation, New Mexico** Figure 2

Gamma survey conducted in October 2008
measured as counts per minute
