# Navajo Abandoned Uranium Mine Site Screen Report

# Alta AUM Site

# Weston Solutions, Inc.

# May 2009

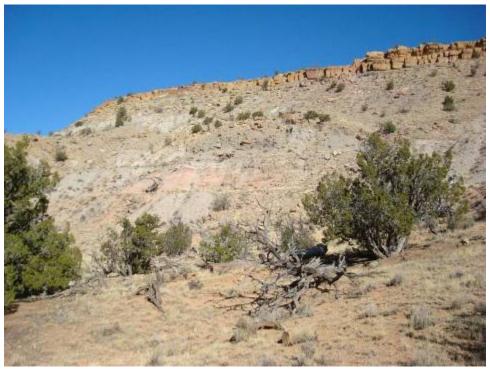
Photo 1. Alta Mine site on hillside, towards the north

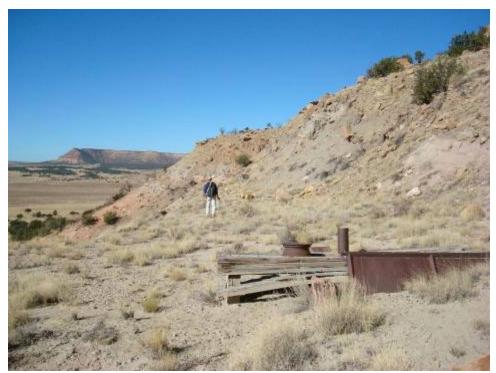
Photo 2. Alta Mine site on hillside, towards the west

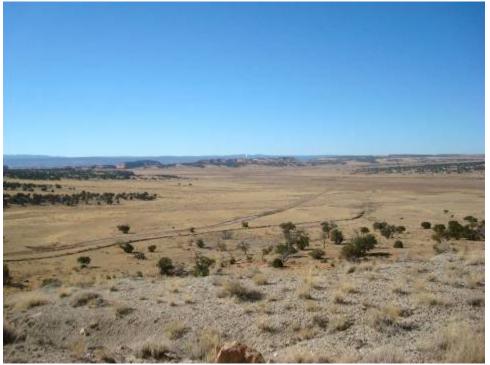
Photo 3. View from Alta Mine site, towards the southwest

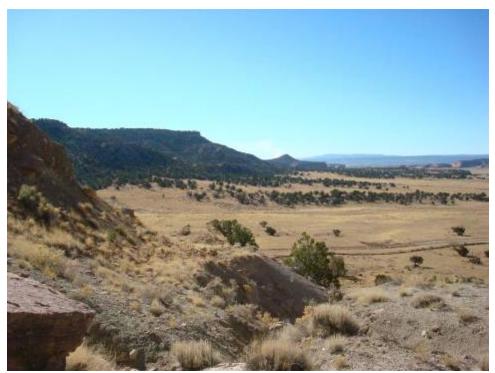
Photo 4. View from Alta Mine site, towards the south

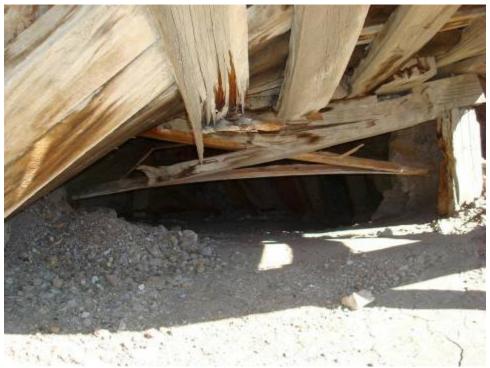
Reclamation status of the mine site is currently unknown. No visible signs of reclamation were observed. The mining operations appear to have been conducted in the hillside. Waste rock appears to have deposited below the mine adits. Three adits were observed in the hillside and were partially collapsed. Some unidentified remnants of the former mine workings were observed at the site. No other mine features were observed during the site visit.

Photo 5. Alta Mine site, collapsed adit

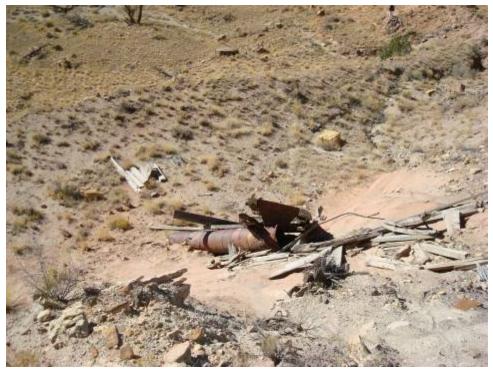
Photo 6. Alta Mine site, former workings

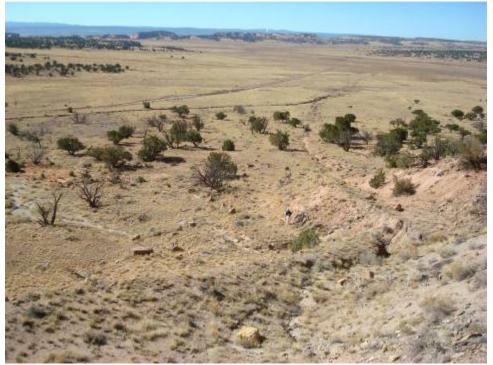
Photo 7. Alta Mine site, access road

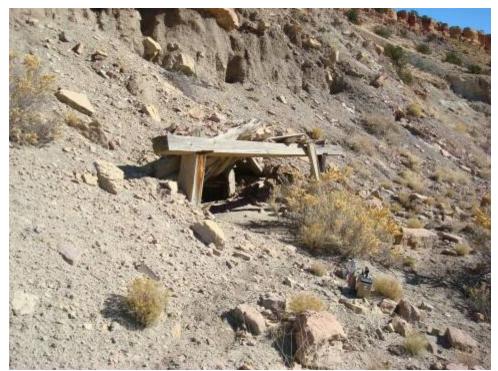
Photo 8. Alta Mine site, two adits

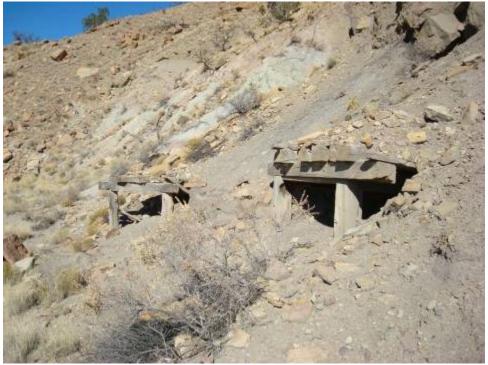
Photo 9. Alta Mine site, two adits

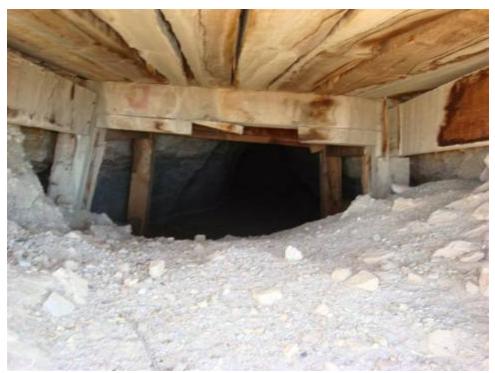
Photo 10. Alta Mine site, adit

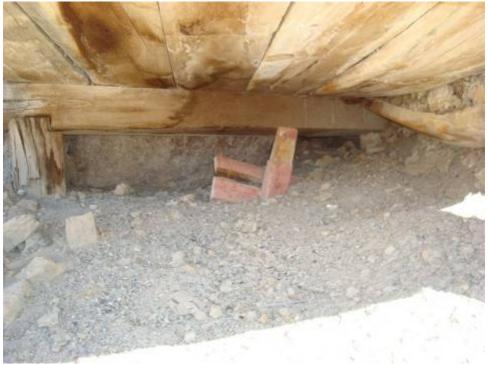
Photo 11. Alta Mine site, adit

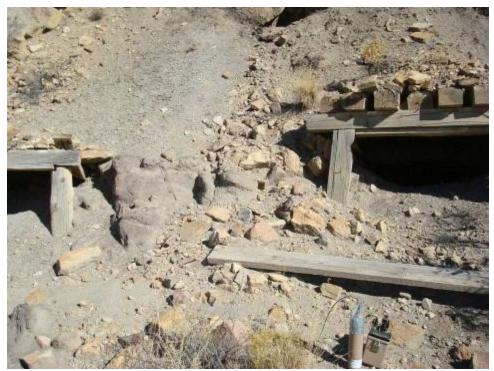
Photo 12. Alta Mine site, two adits

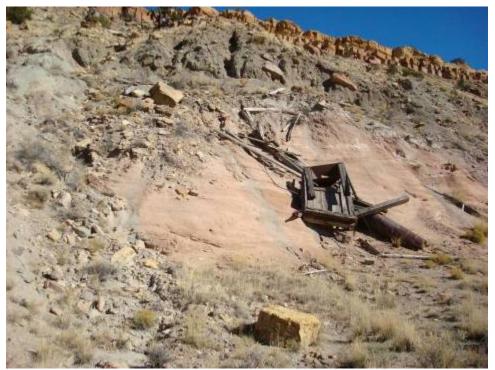
Photo 13. Alta Mine site, collapsed wood structure

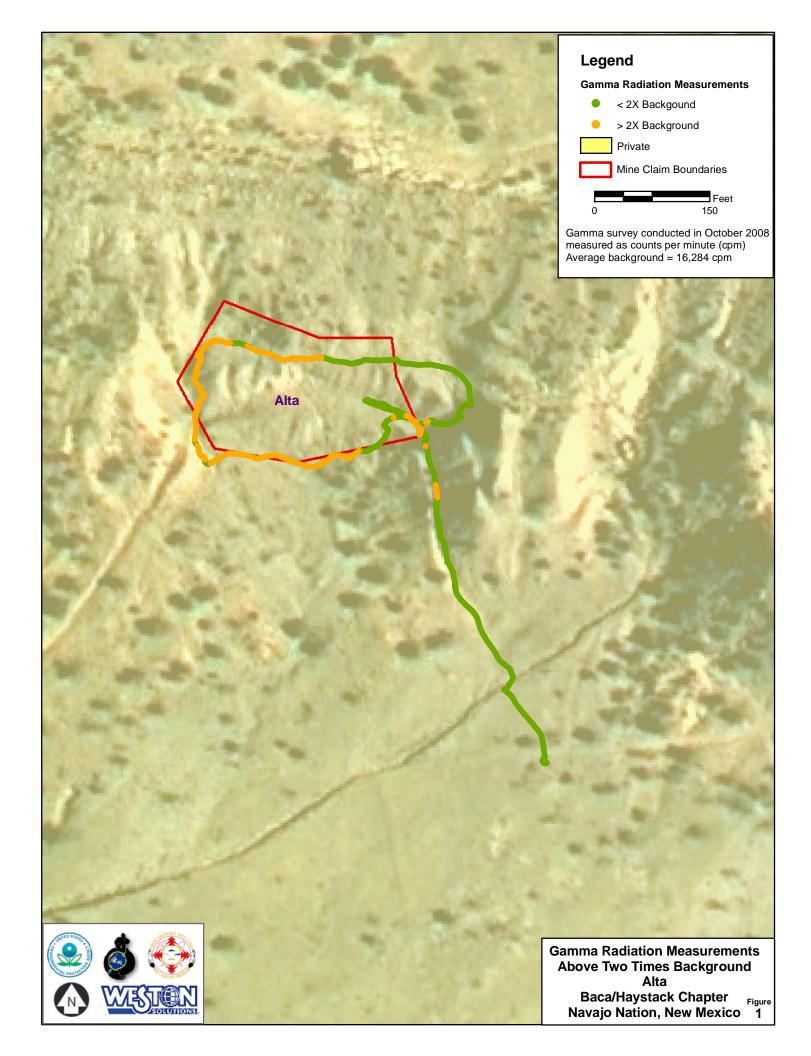
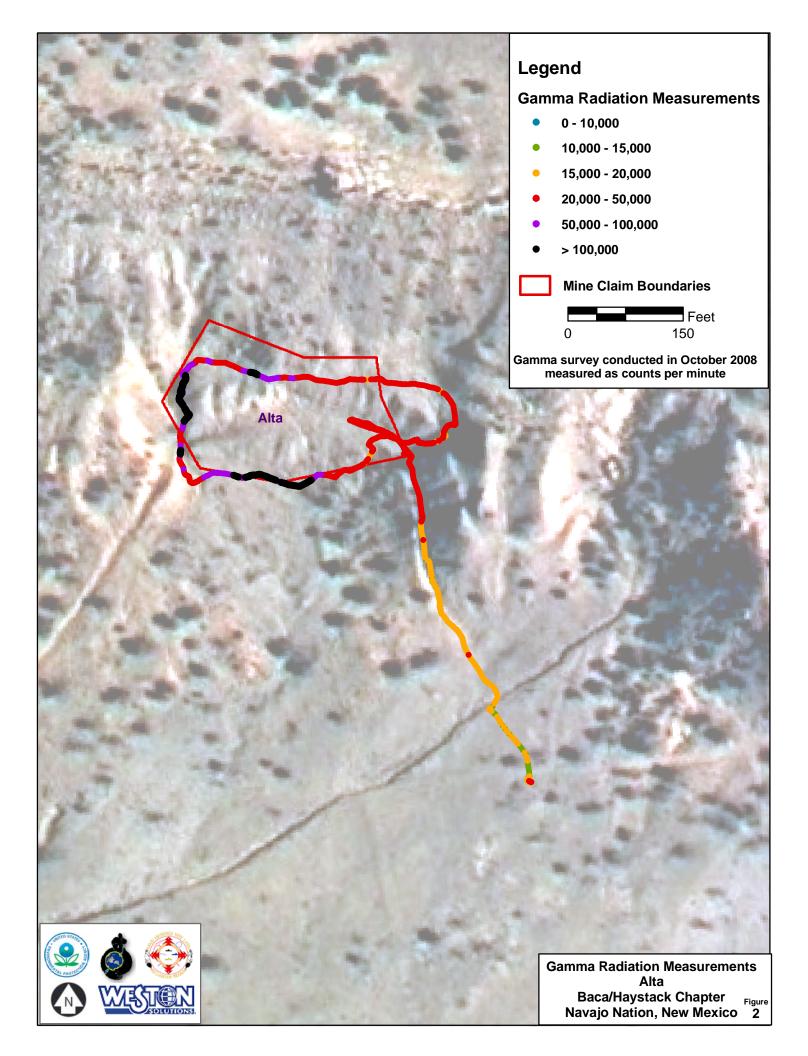
A total of 1,164 gamma radiation measurements were collected from the mine site, ranging from 12,862 cpm to 286,622 cpm. The measurements are represented in Figures 1 and 2.
