Navajo Abandoned Uranium Mine Site Screen Report

Silver Spur AUM Site

Navajo AUM Eastern Region

May 2009

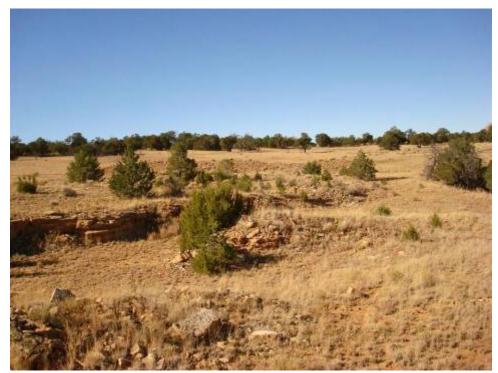
Reclamation status of the mine site is currently unknown. No visible signs of reclamation were observed. The mining operations appear to be a shallow pit dug into bedrock with underground operations through an adit observed at the north edge of the mine. Numerous waste rock piles remain around the mine and a tri-cone drill bit were observed during the site visit.

Photo 1. Silver Spur Mine site, towards the northwest. Open pit and waste rock piles

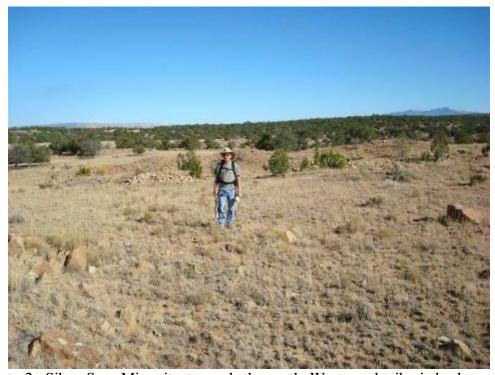
Photo 2. Silver Spur Mine site, towards the south. Waste rock piles in background.

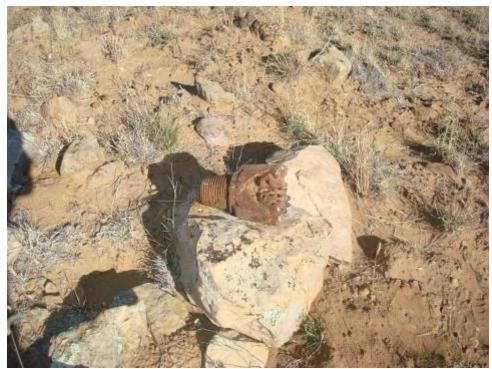
Photo 3. Silver Spur Mine site, tri-cone drill bit observed at site

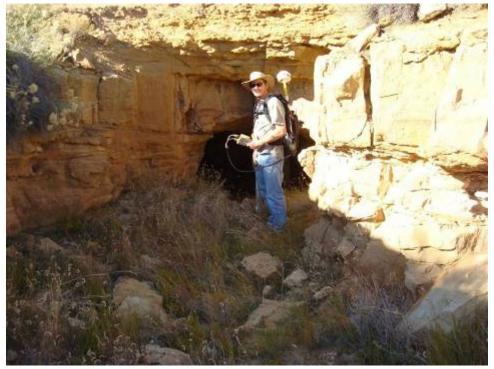
Photo 4. Silver Spur Mine site, adit located at northern edge of mine

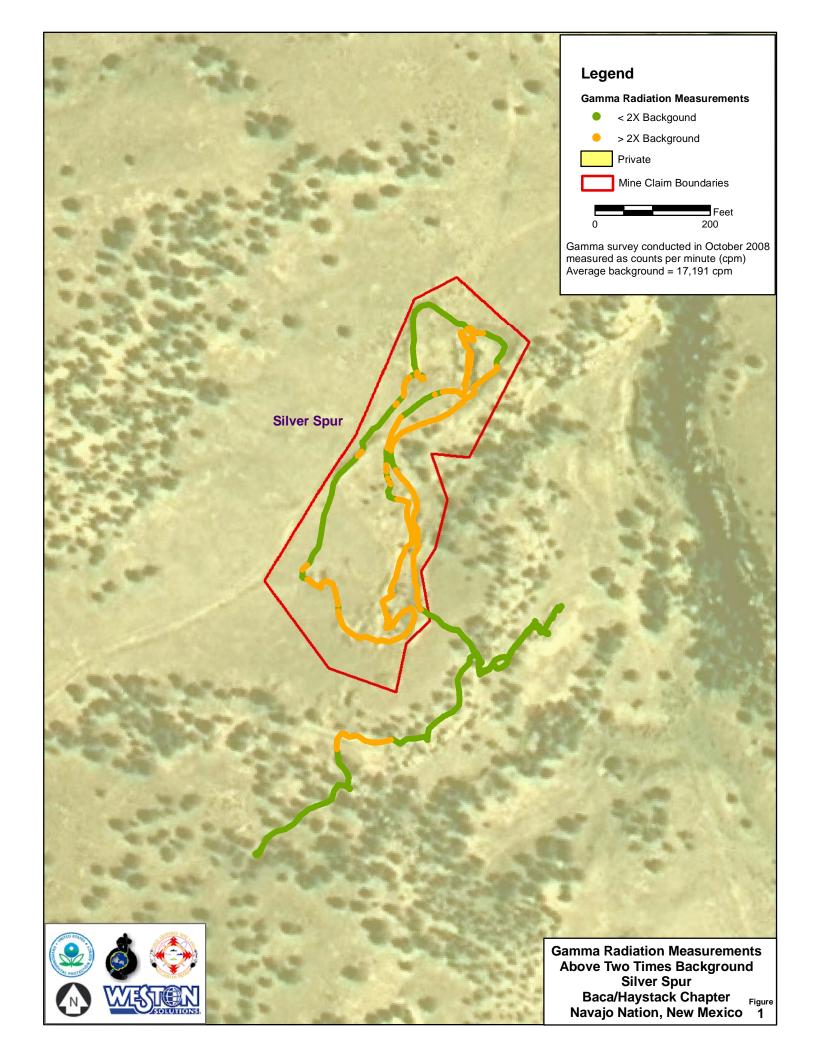
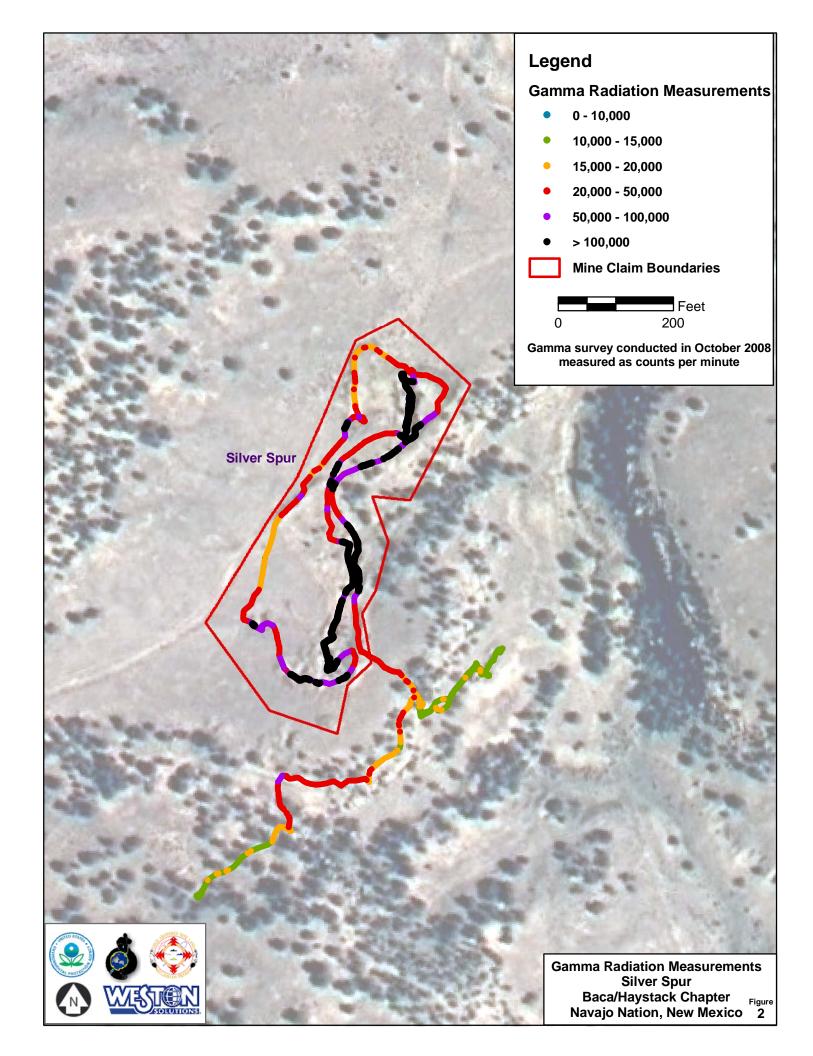
A total of 2,144 gamma radiation measurements were collected from mine sites, ranging from 9,538 cpm to 587,385 cpm. The measurements are represented in Figures 1 and 2. The New Mexico Mining and Minerals Division identified radiological measurements with level in the pits as 1,800-2,000 counts per second (cps); and the dump as 900 cps.
