Navajo Abandoned Uranium Mine Site Screen Report

Haystack No. 2 AUM Site

Navajo AUM Eastern Region

May 2009

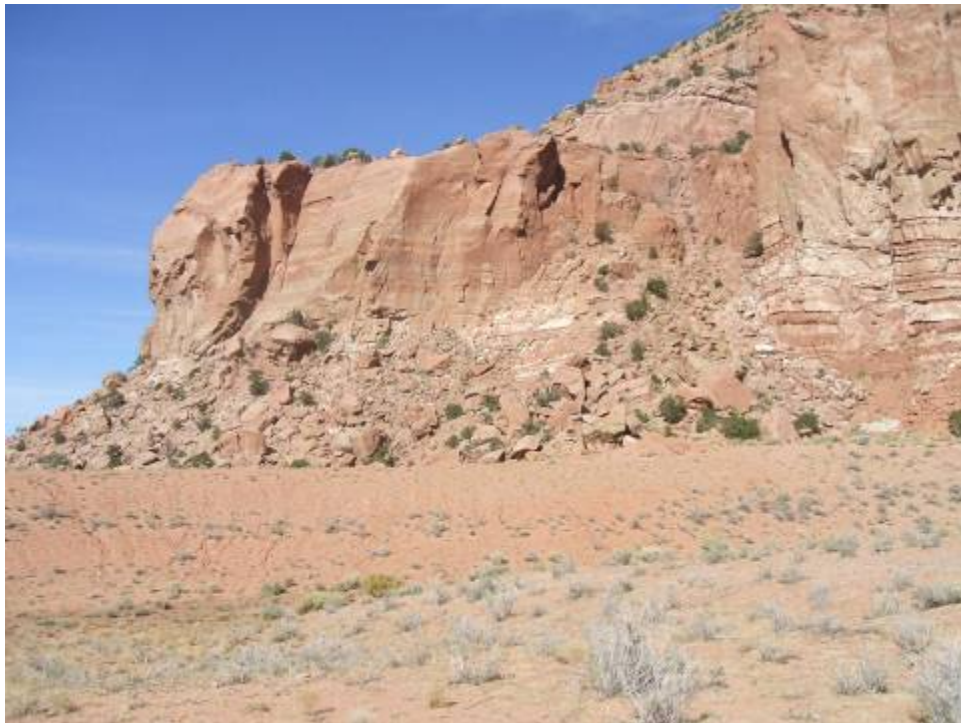
Reclamation status of the mine sites are currently unknown. No visible signs of reclamation were observed. A large recessed area in the center of the site may have been used as an open pit (Photo 2). No waste piles, adits, or other mine features were observed during the site visit.

Photo 2. Haystack No 2 mine site and open recessed area, towards the north

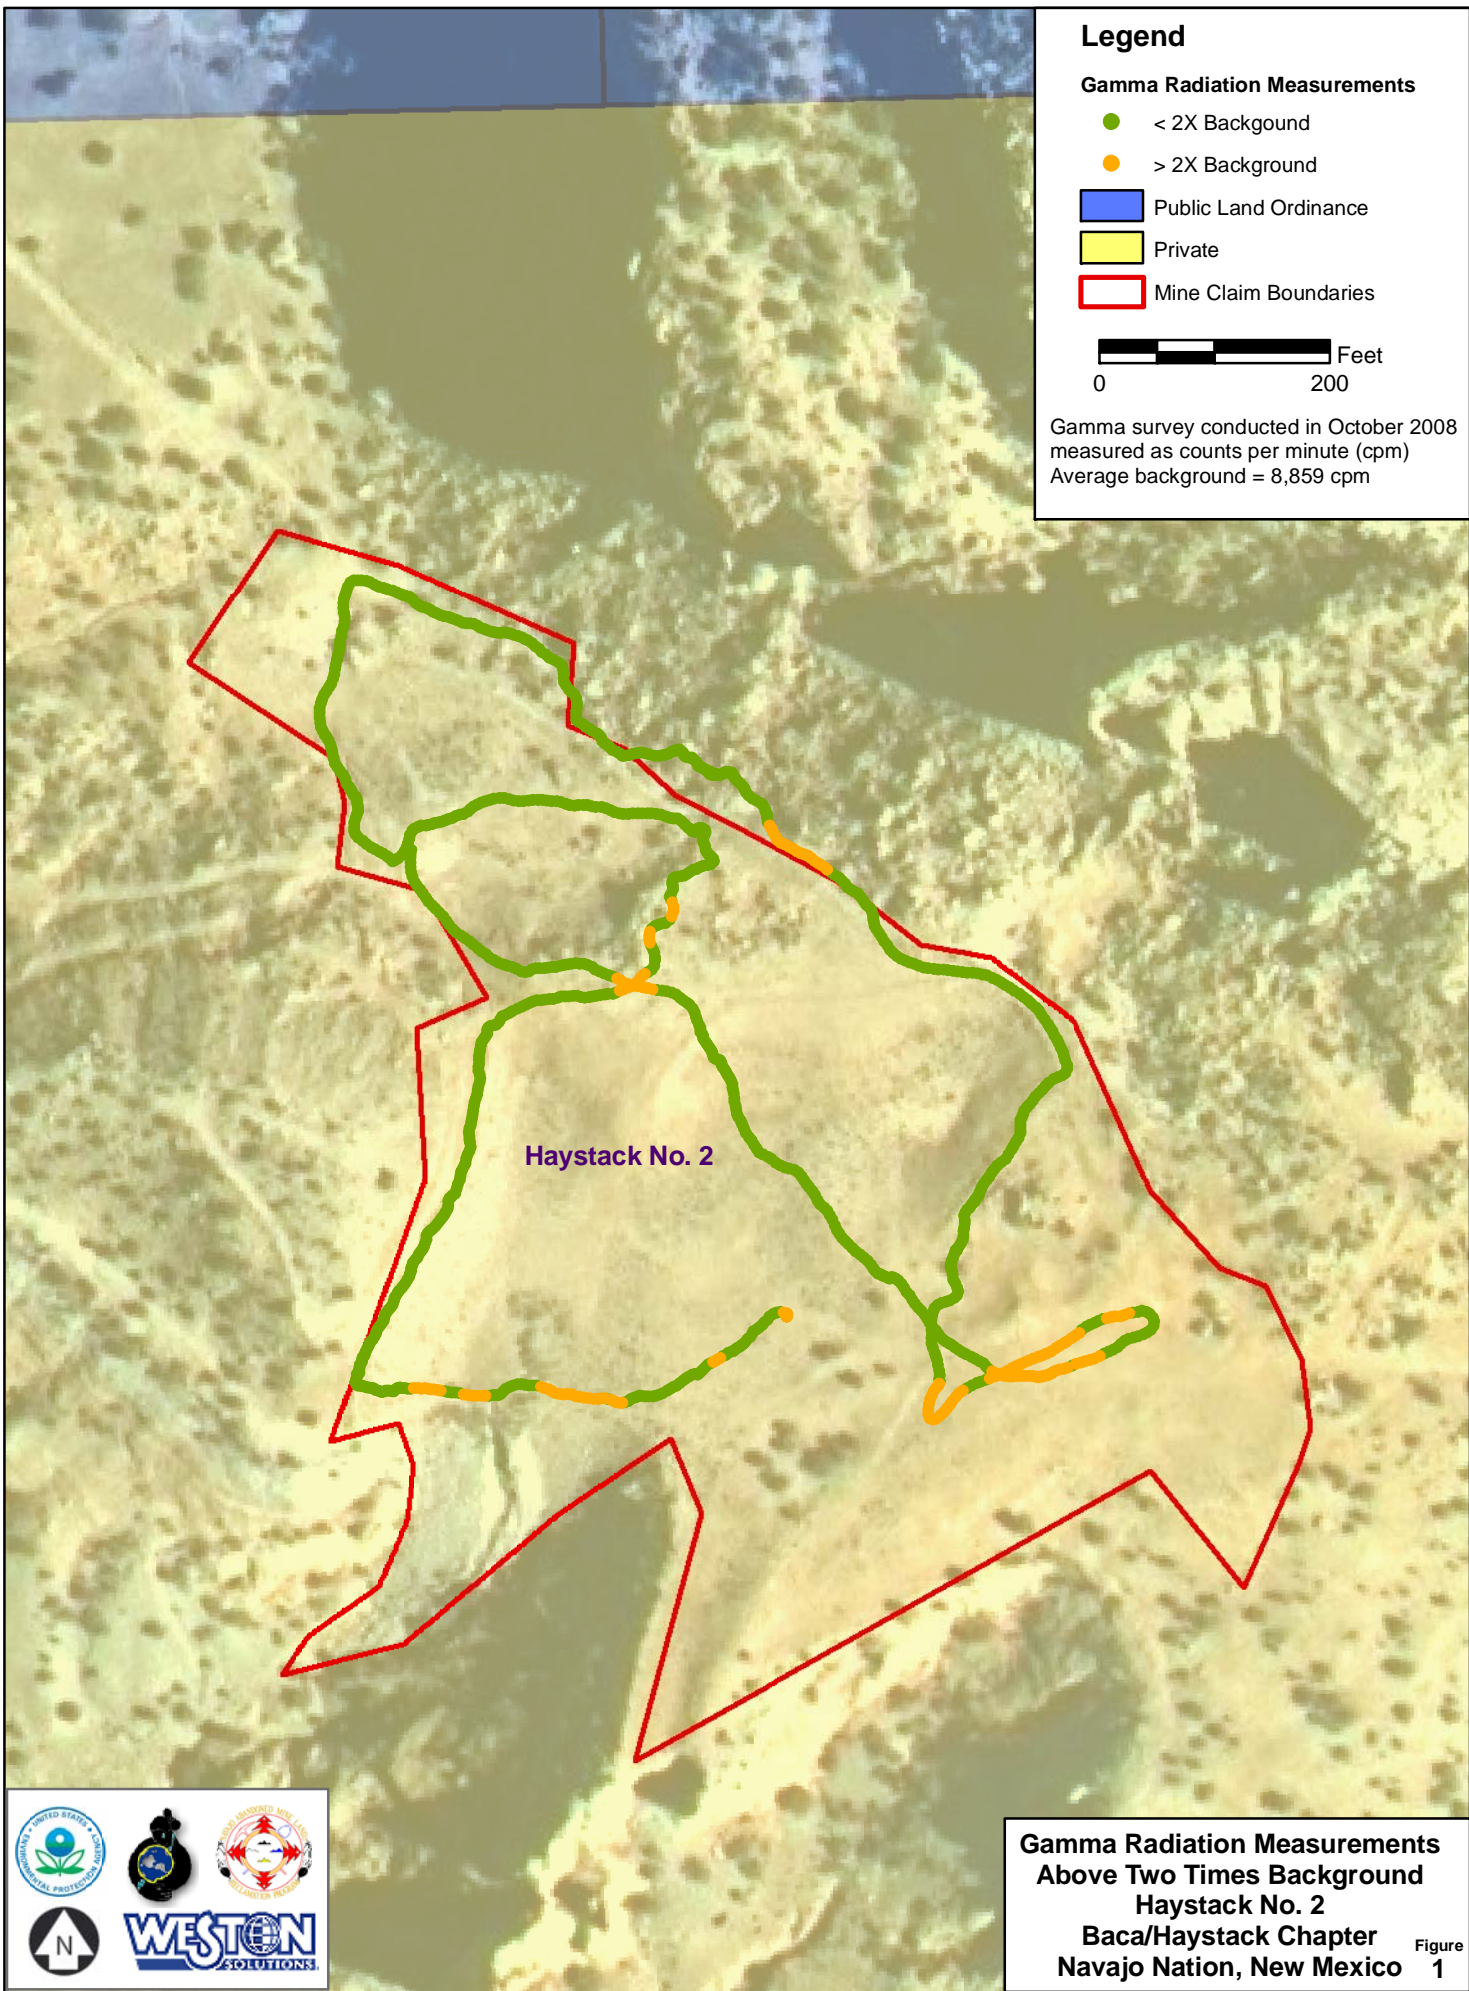
**Gamma Radiation Measurements
 Above Two Times Background
 Haystack No. 2
 Baca/Haystack Chapter
 Navajo Nation, New Mexico** Figure 1

A total of 1,210 gamma radiation measurements were collected from the mine site, ranging from 6,155 cpm to 32,732 cpm. The measurements are represented in Figures 1 and 2. Radiological measurements collected for the New Mexico Mining and Minerals Division during a 2008 field screening survey found gamma radiation levels near the ground surface with a maximum of 90 micro Roentgen per hour ($\mu\text{R/hr}$) and a minimum of 10 $\mu\text{R/hr}$, levels at the 4-foot elevation with a maximum of 60 $\mu\text{R/hr}$ and a minimum of 9 $\mu\text{R/hr}$, and background levels of 10 $\mu\text{R/hr}$.

Gamma survey conducted in October 2008
 measured as counts per minute (cpm)
 Average background = 8,859 cpm

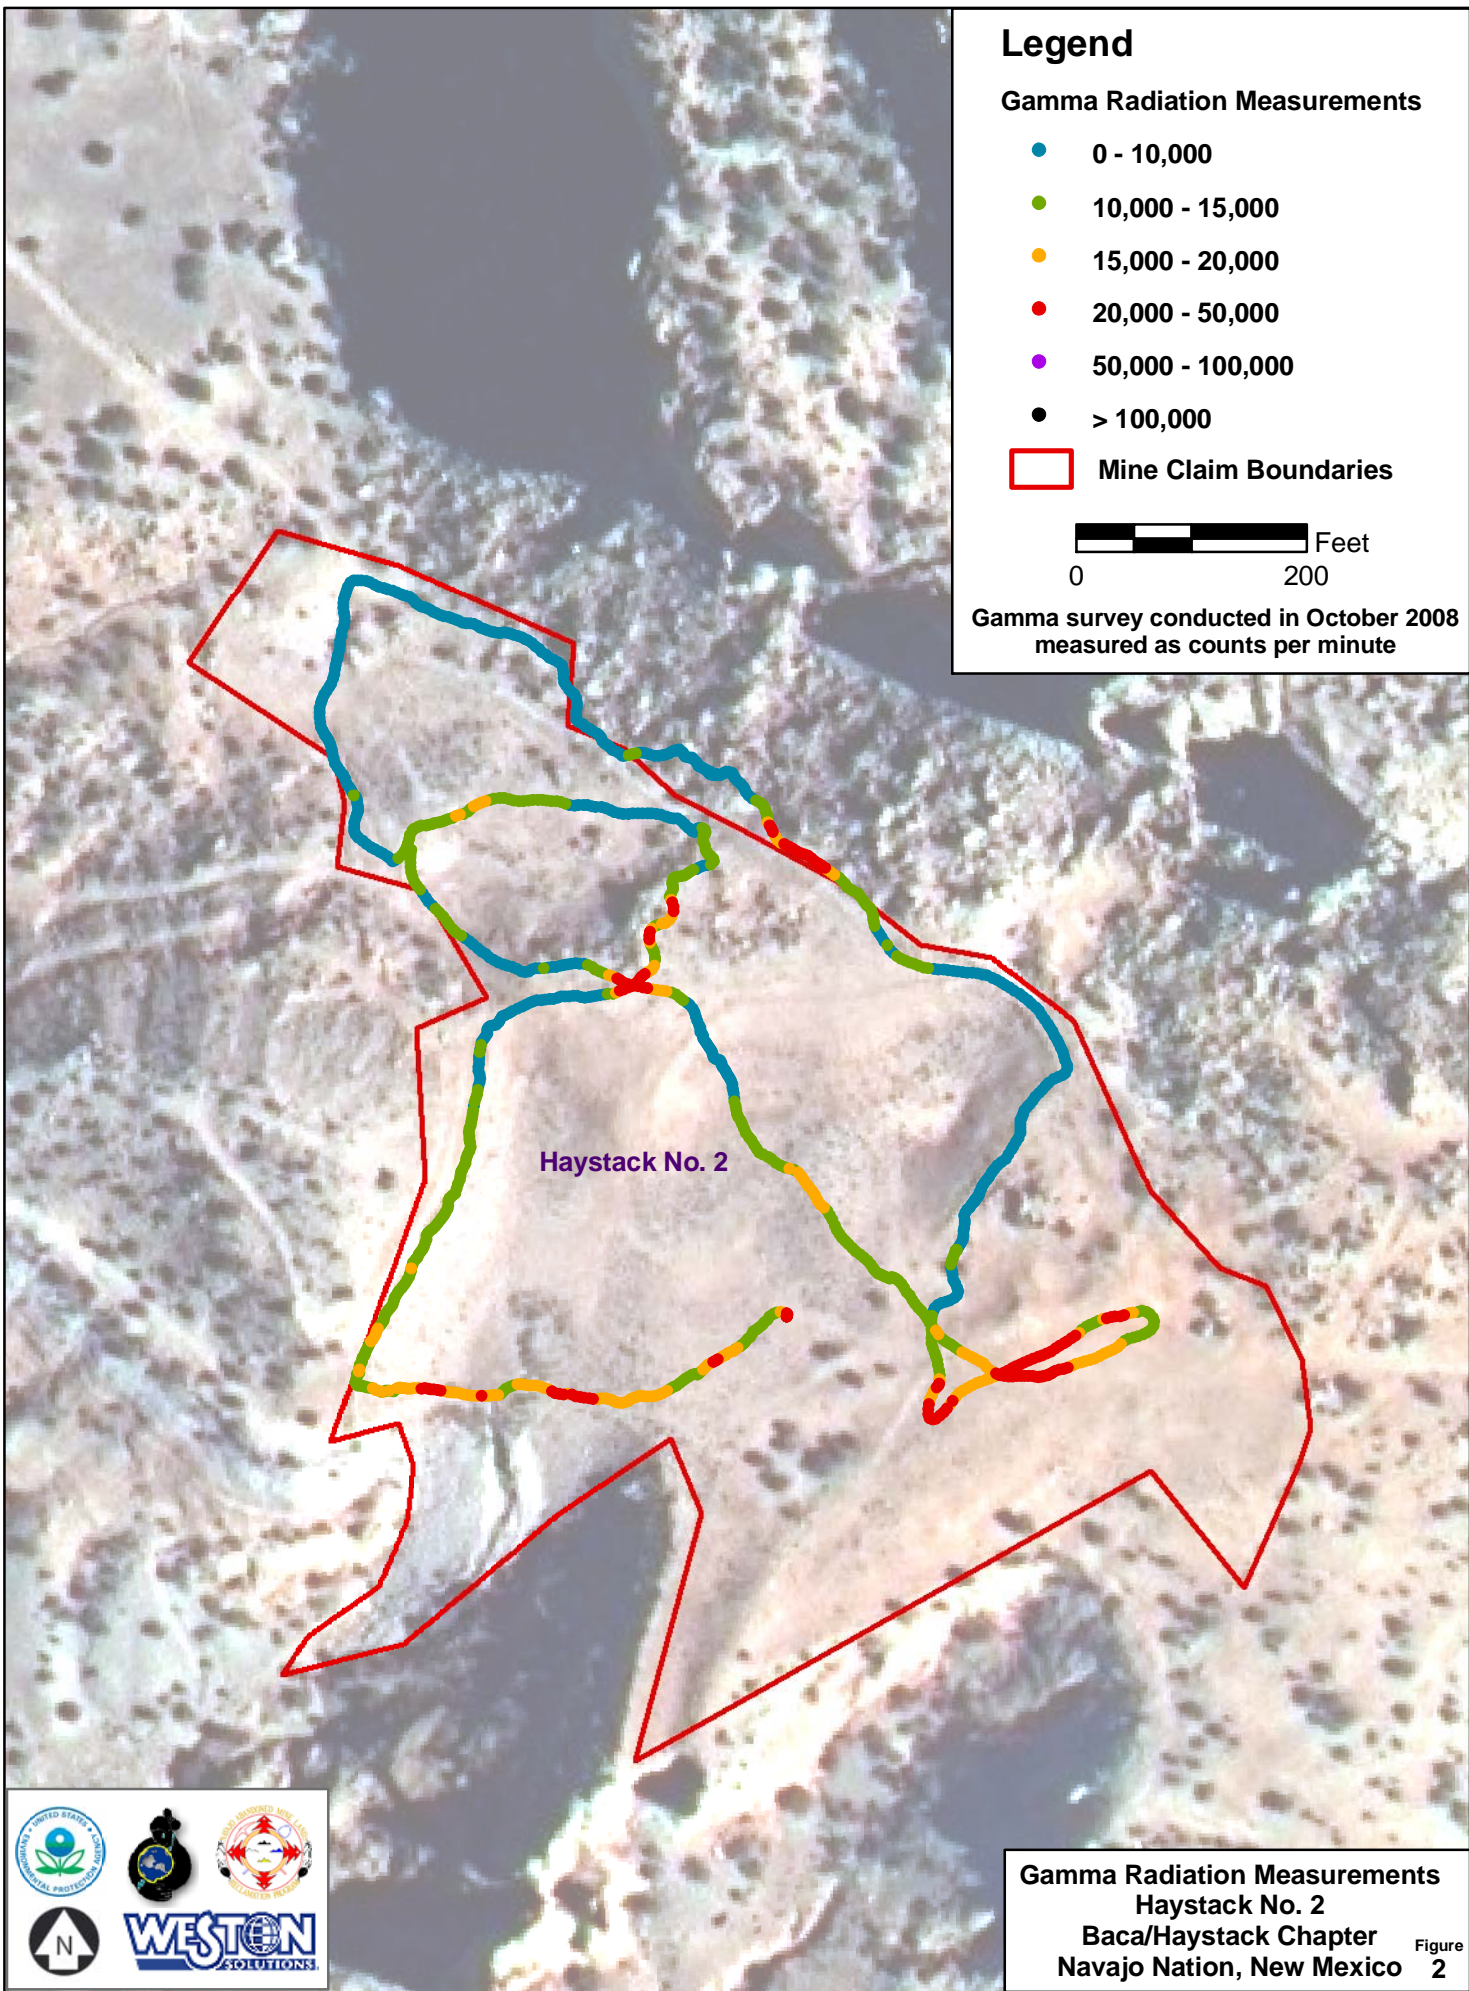
**Gamma Radiation Measurements
Haystack No. 2
Baca/Haystack Chapter
Navajo Nation, New Mexico** Figure 2

Gamma survey conducted in October 2008
measured as counts per minute
