Navajo Abandoned Uranium Mine Site Screen Report

Red Point Lode AUM Site

Weston Solutions, Inc.

May 2009

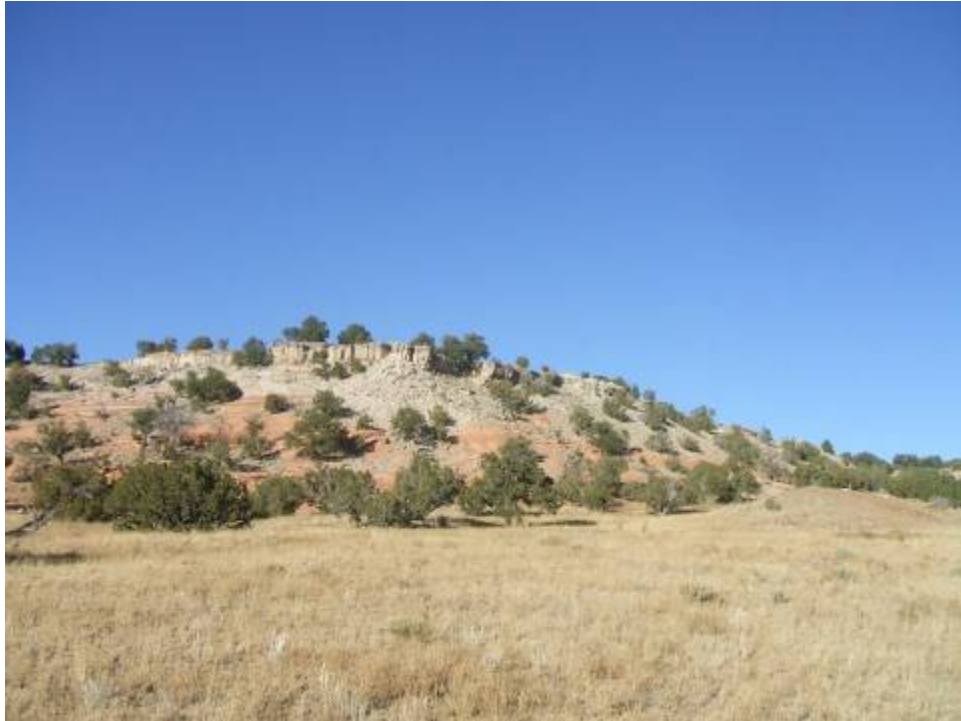
Photo 1. Red Point Lode mine site, to the north

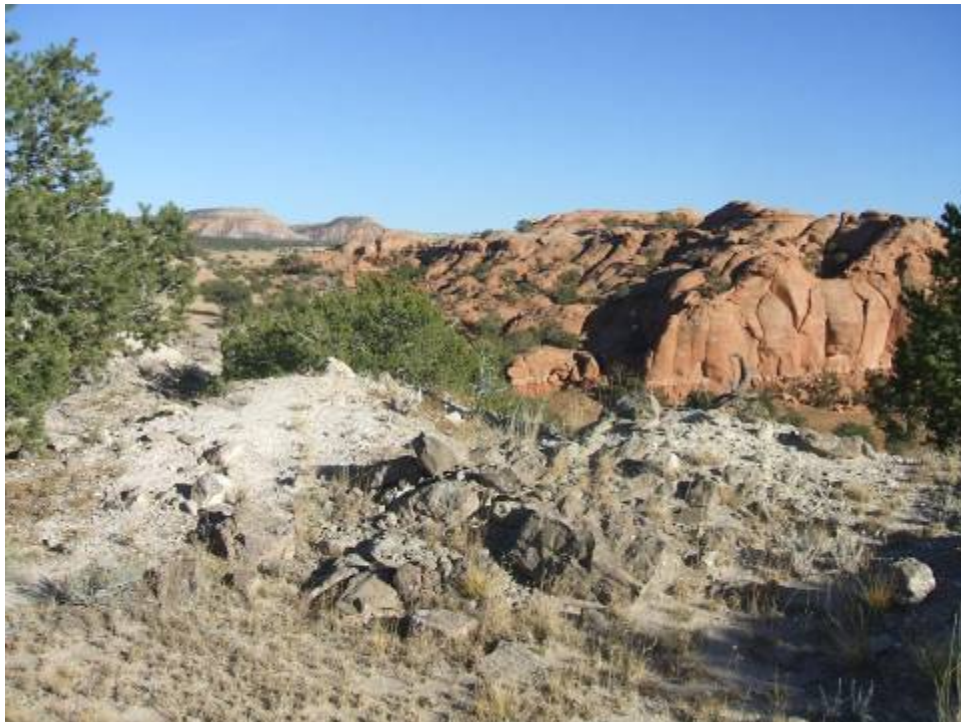
Reclamation status of the mine site is currently unknown. Small gravel/rock piles and pits were observed throughout the site property (Photo 2, 3). No adits or other mine features were observed during the site visit.

Photo 2. Red Point Lode mine site rock piles, to the east

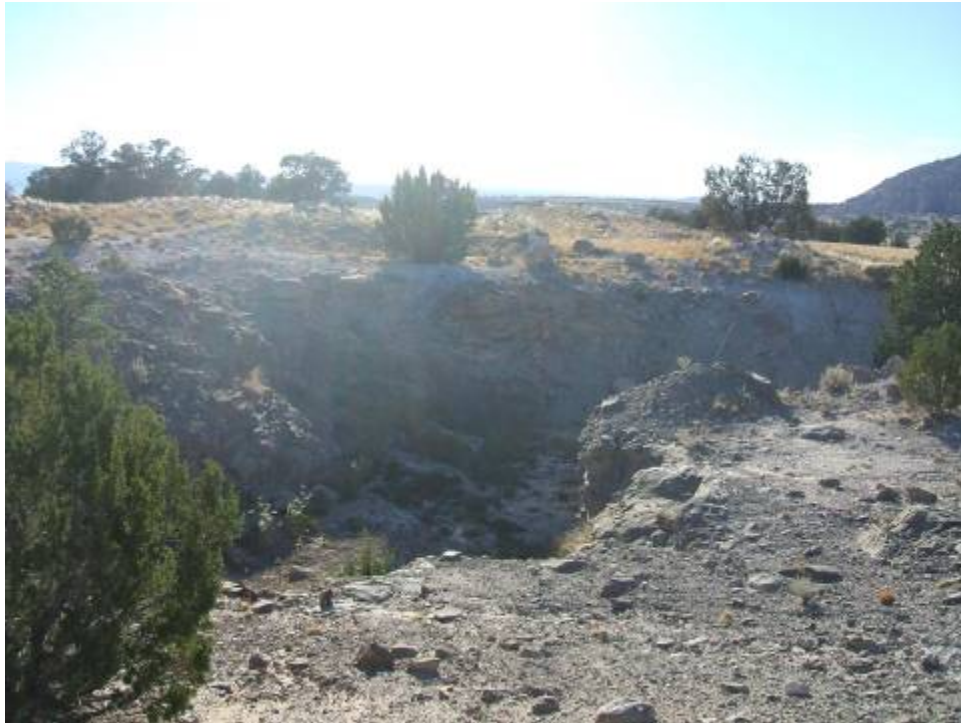
Photo 3. Red Point Lode mine site rock piles and ditch, to the southwest

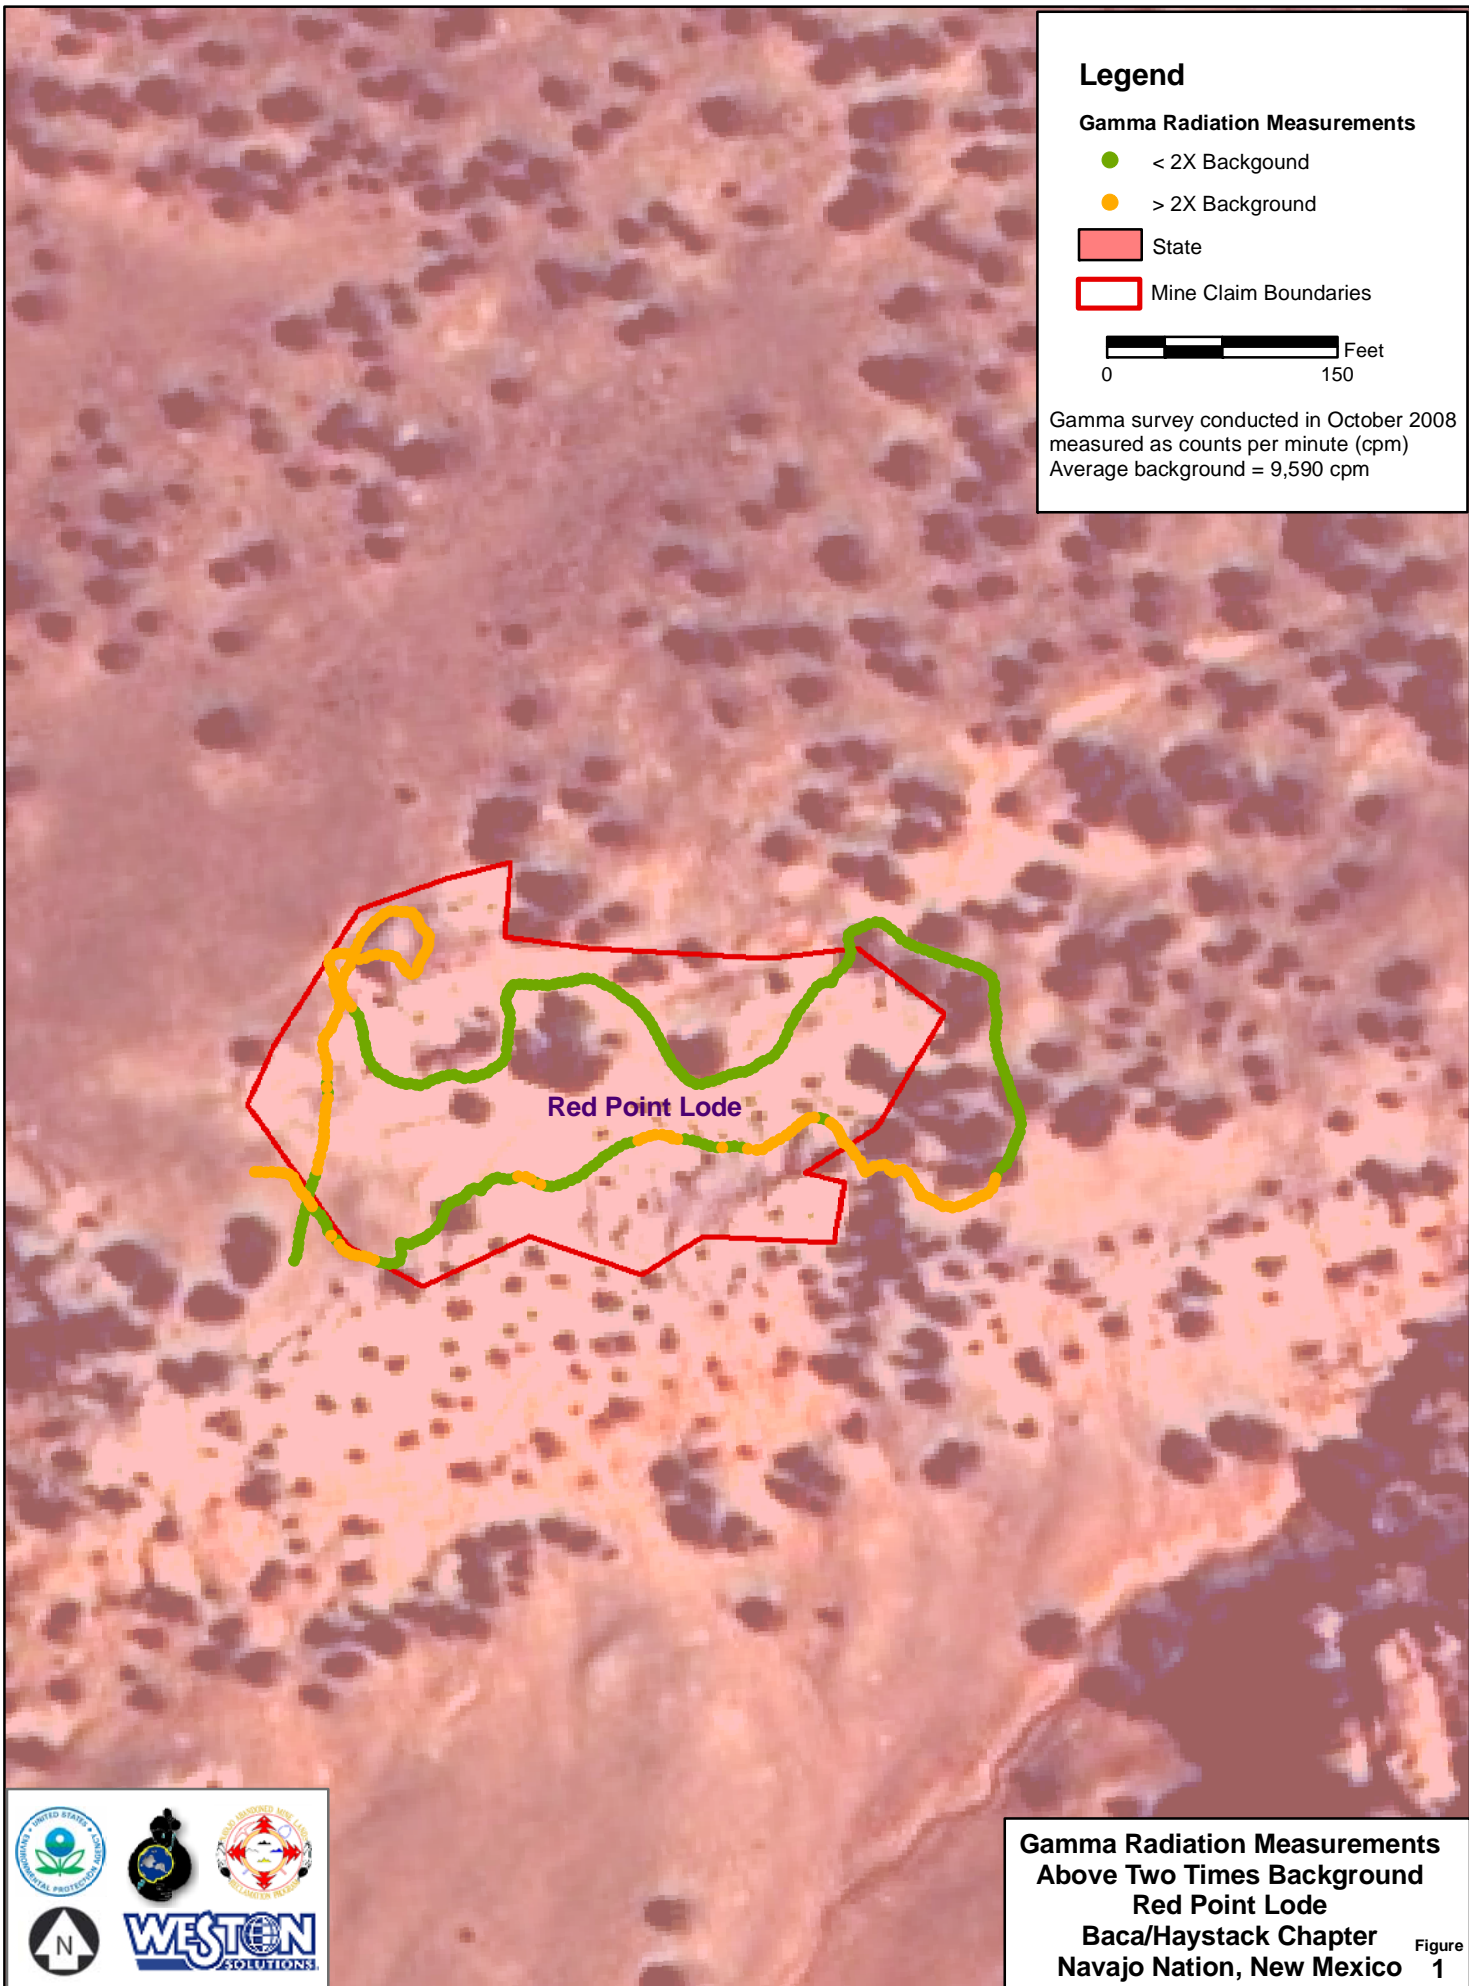
**Gamma Radiation Measurements
 Above Two Times Background
 Red Point Lode
 Baca/Haystack Chapter
 Navajo Nation, New Mexico** Figure 1

A total of 565 gamma radiation measurements were collected from mine sites, ranging from 6,195 cpm to 149,417 cpm. The measurements are represented in Figures 1 and 2. The New Mexico Mining and Minerals Division identified radiological measurements with background levels 50 counts per second (cps); pits 3,800 cps, and dumps 1,500 cps. Radiological measurements collected for the New Mexico Mining and Minerals Division during a 2008 field screening survey found gamma radiation levels near the ground surface with a maximum of 420 micro Roentgen per hour ($\mu\text{R/hr}$) and a minimum of 12 $\mu\text{R/hr}$, levels at the 4-foot elevation with a maximum of 200 $\mu\text{R/hr}$ and a minimum of 12 $\mu\text{R/hr}$, and background levels of 12 $\mu\text{R/hr}$.

Gamma survey conducted in October 2008
 measured as counts per minute (cpm)
 Average background = 9,590 cpm
