# Navajo Abandoned Uranium Mine Site Screen Report

## **Kermac No. 22 AUM Site**

### **Navajo AUM Eastern Region**

**May 2009**

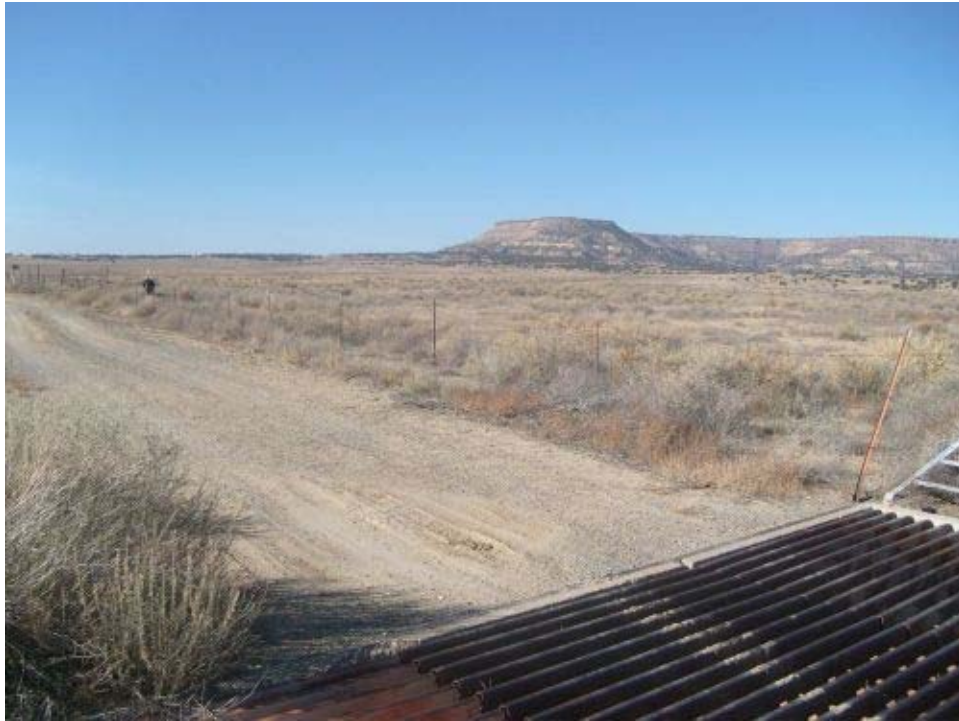
Photo 1. Kermac 22 mine site, towards west/southwest from road at northeast corner of site

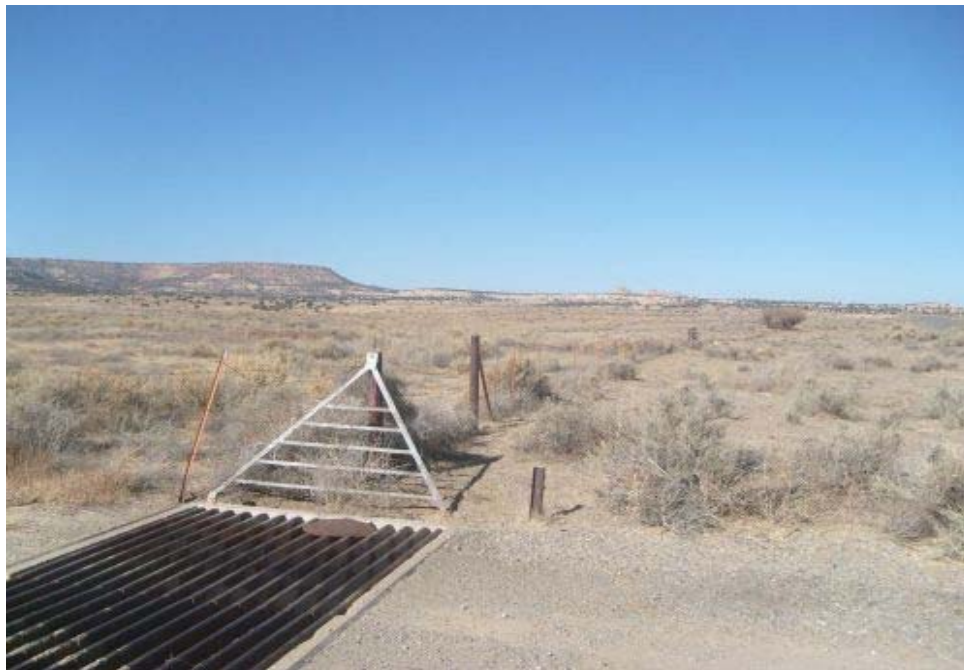
Photo 2. Kermac 22 mine site, towards west/southwest from road at northeast corner of site

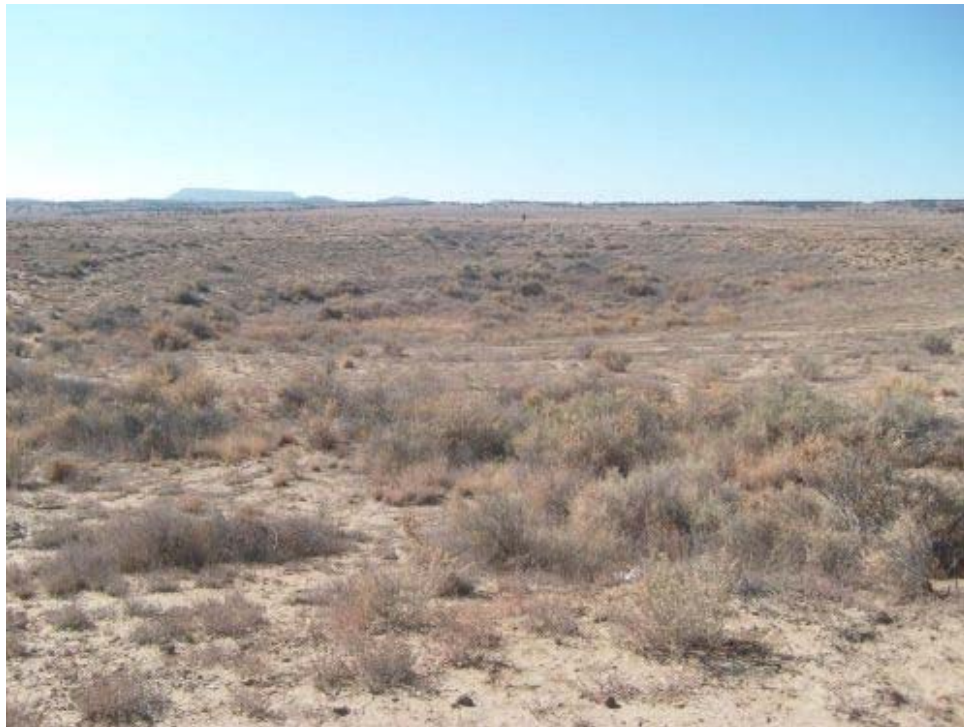
A total of 4,842 gamma radiation measurements were collected from the mine site, ranging from 11,268 cpm to 227,145 cpm. An area of depression within the site was measured at approximately 20,000 cpm. The measurements are represented in Figures 1 and 2.

Photo 4. Large depression south of road

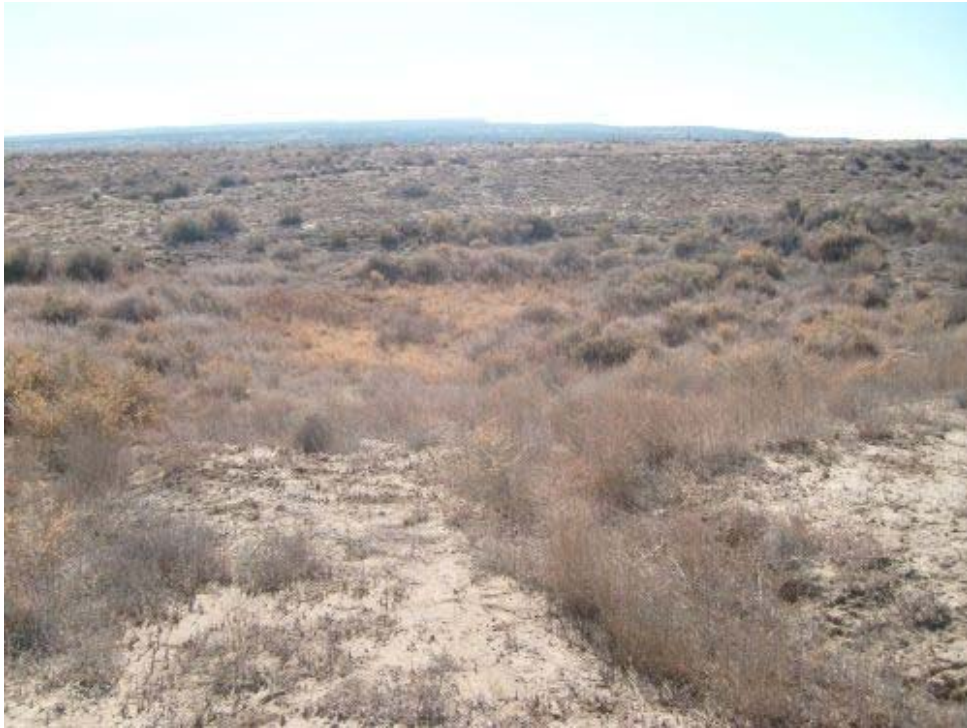
Photo 5. Large depression south of road
