Navajo Abandoned Uranium Mine Site Screen Report

Homestake Sapin No. 15

Navajo AUM Eastern Region

May 2009

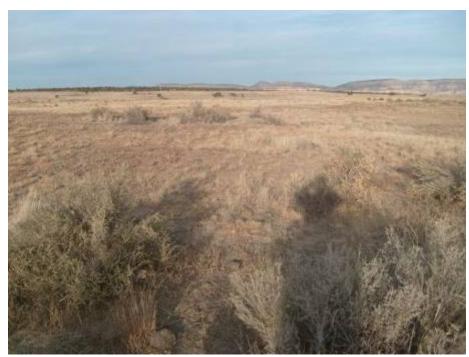
Photo 1. Homestake Sapin 15 mine site, towards the northeast from southwest corner

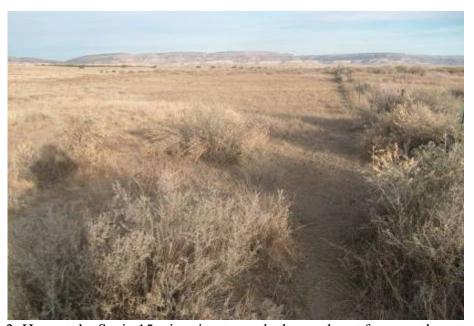
Photo 2. Homestake Sapin 15 mine site, towards the northeast from southwest corner

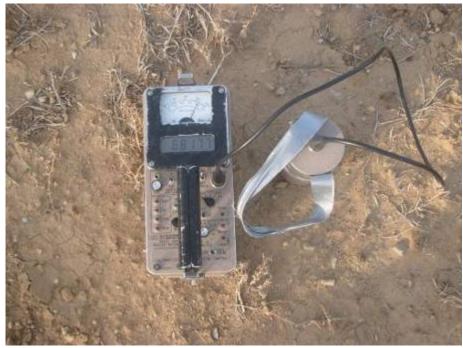
Photo 3. Reading taken at hot area around southwest corner of site

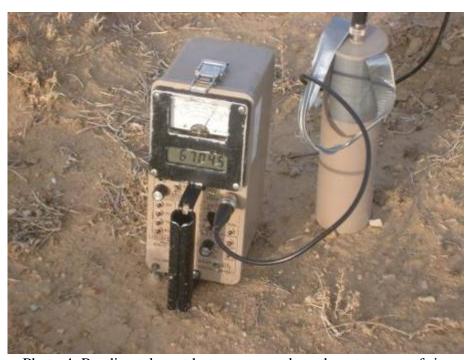
Photo 4. Reading taken at hot area around southwest corner of site

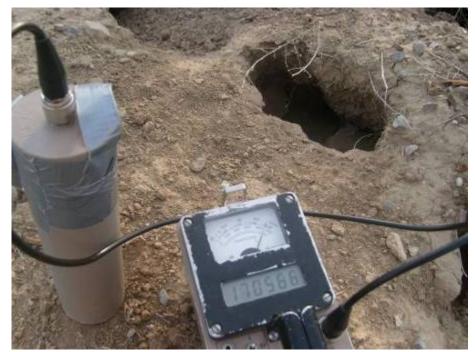
A total of 3,256 gamma radiation measurements were collected from the mine site, ranging from 13,634 cpm to 134,881 cpm. There are animal burrows along the fence at the southern end of the site. It is possible that ore was brought to the surface this way. Readings were approximately 170,000 cpm. There is a concrete vault along the southern fenceline, approximately 6' x 12'. Readings were approximately 135,000 cpm. The general range along the southern fenceline was ~40,000 to 170,000 cpm. The measurements are represented in Figures 1 and 2.

Photo 5. Reading taken at animal burrows along fence at southern end of site

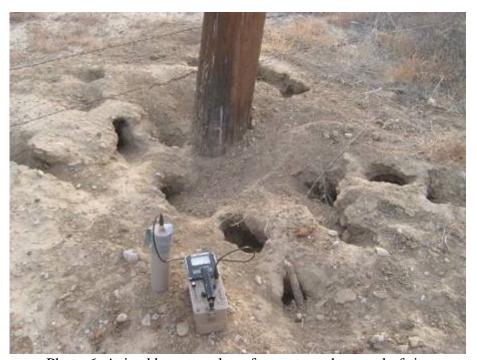
Photo 6. Animal burrows along fence at southern end of site

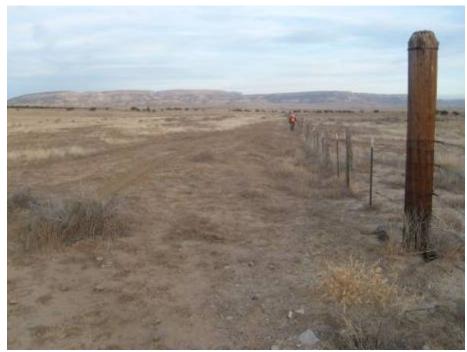
Photo 7. GPS walking west along southern fence

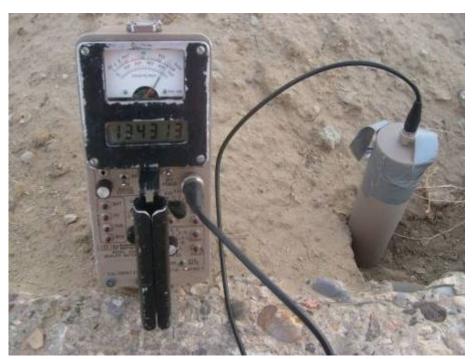
Photo 8. Reading taken at concrete vault along south fence

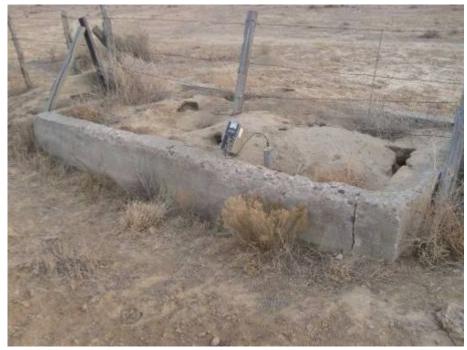
Photo 9. Concrete vault along south fence

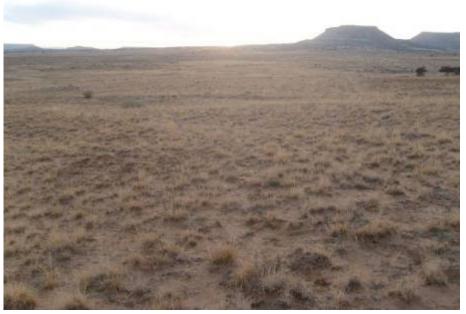
Photo 10. View from atop a hill at northeast corner of site, towards the southwest Note: Field vehicle in distance showing size/length of site
