# Navajo Abandoned Uranium Mine Site Screen Report

## Section 25

### Navajo AUM Eastern Region

**May 2009**

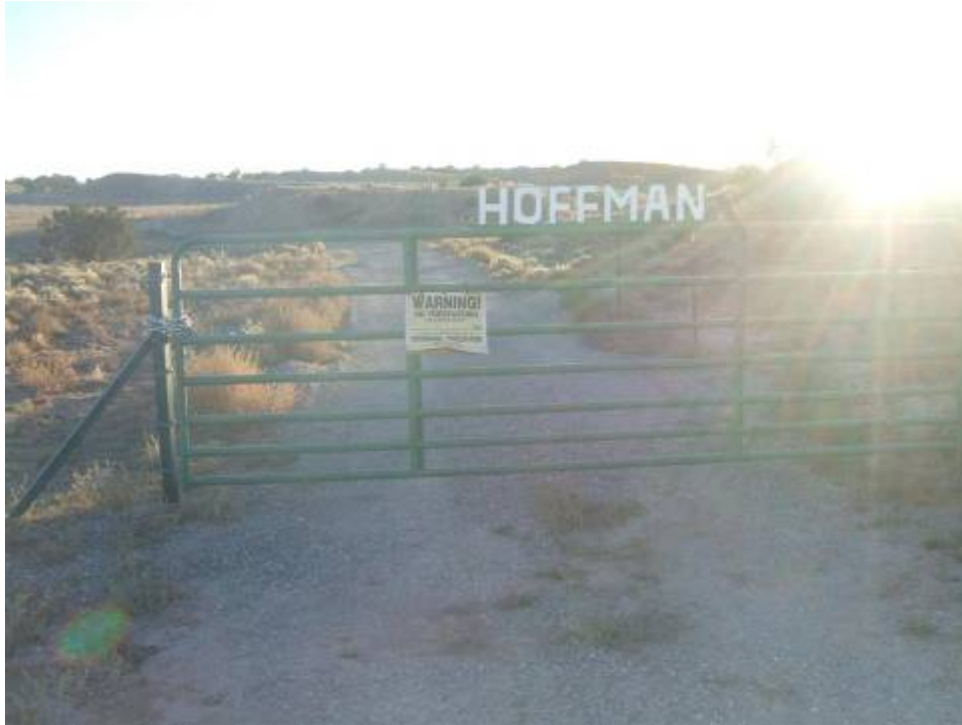
Photo 1. Locked gate on road leading towards Section 25 mine site

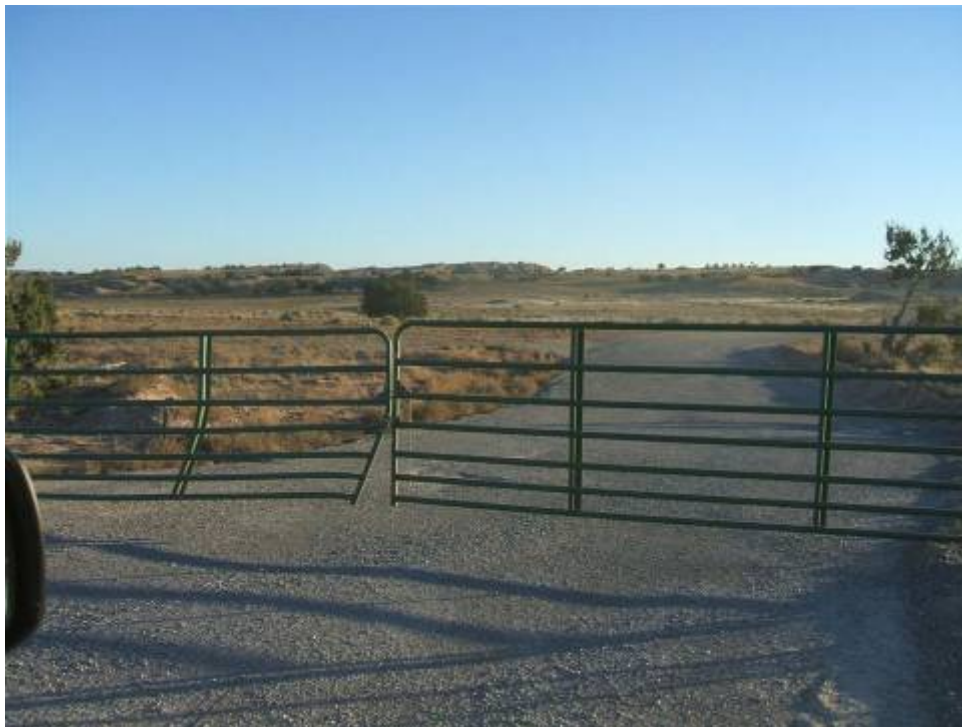
Photo 2. Locked gate leading towards Section 25 mine site

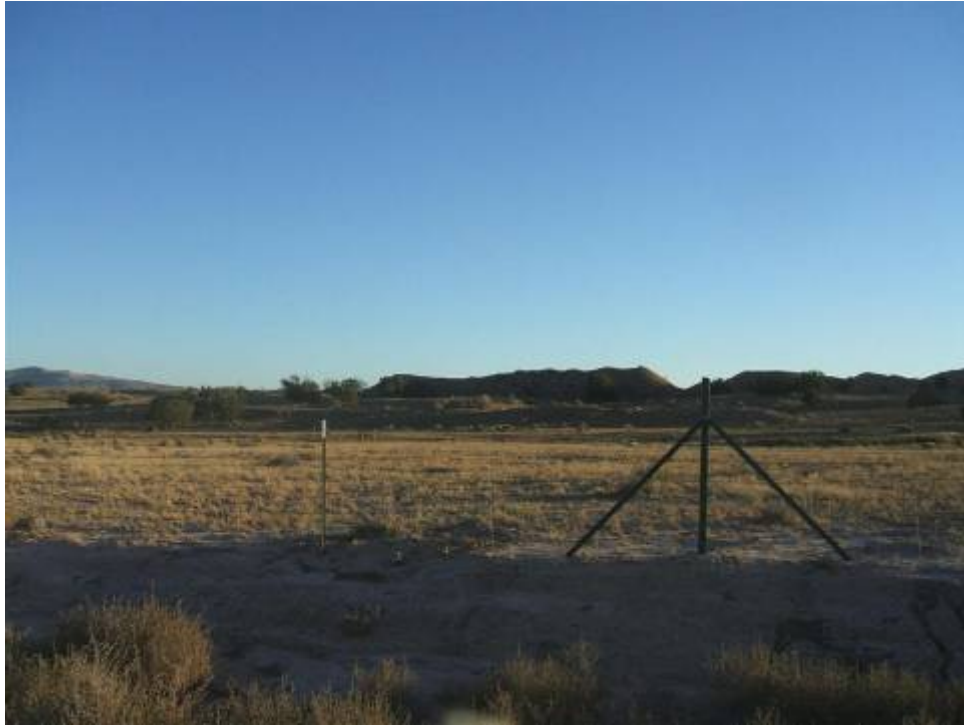
Photo 3. Fenced area leading towards Section 25 mine site

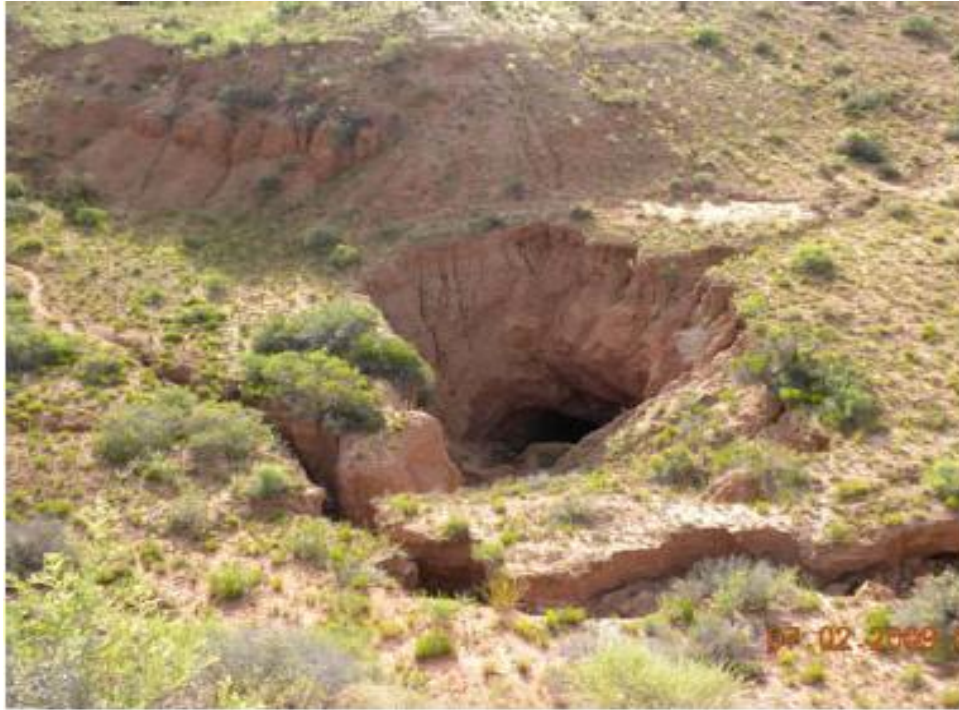
Open pit area (Section 25 #363) adit

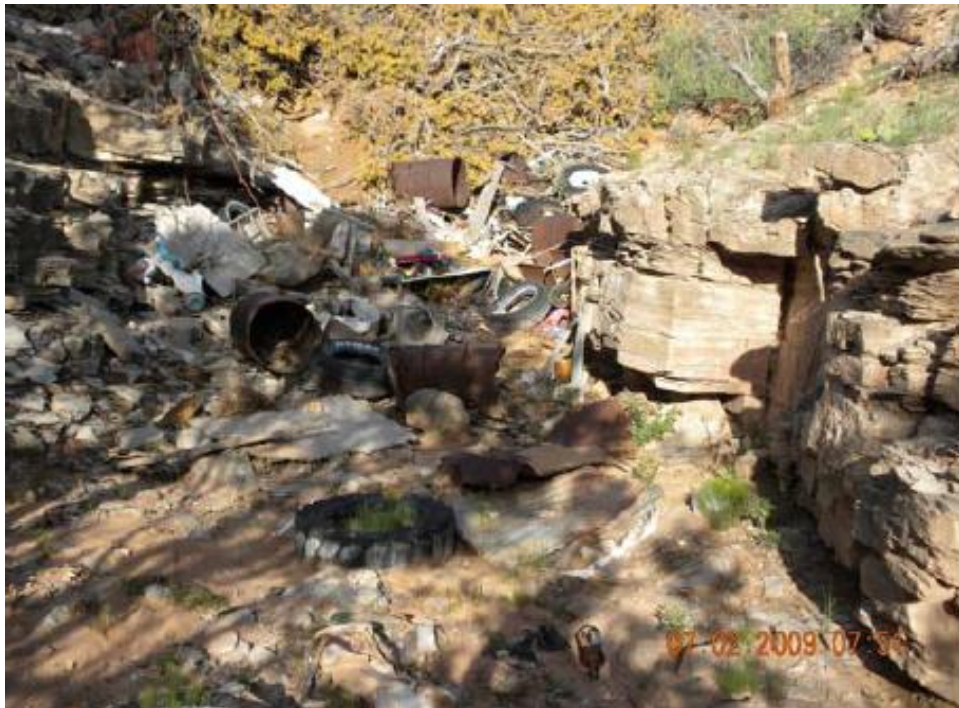
Open pit area (Section 25 #363) bulldozer cut into limestone, current trash dump area

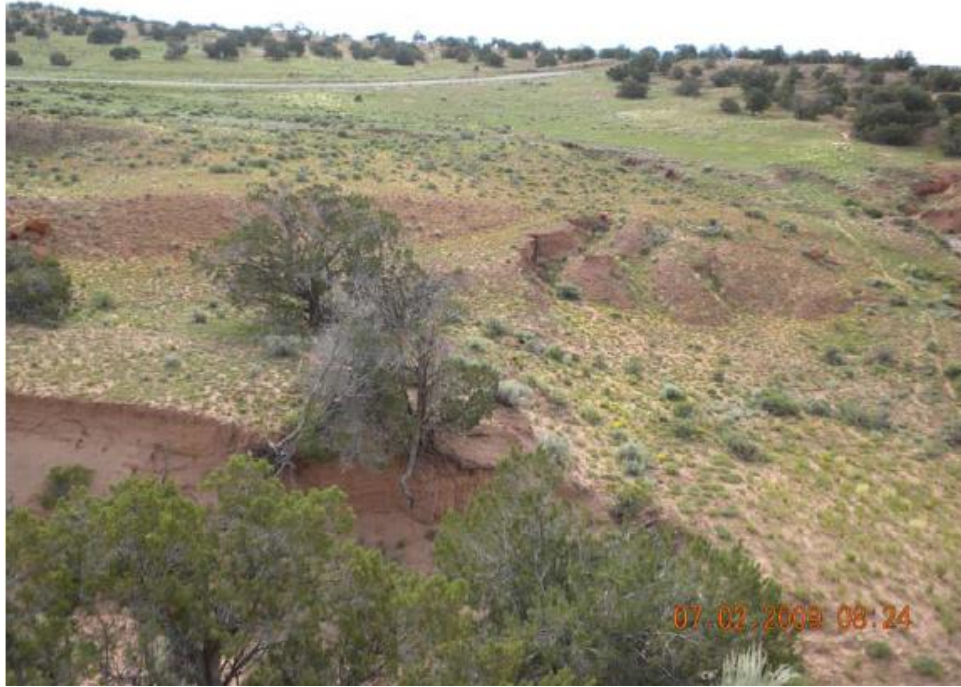
Open pit area (Section 25 #363) facing east towards possible reclaimed area

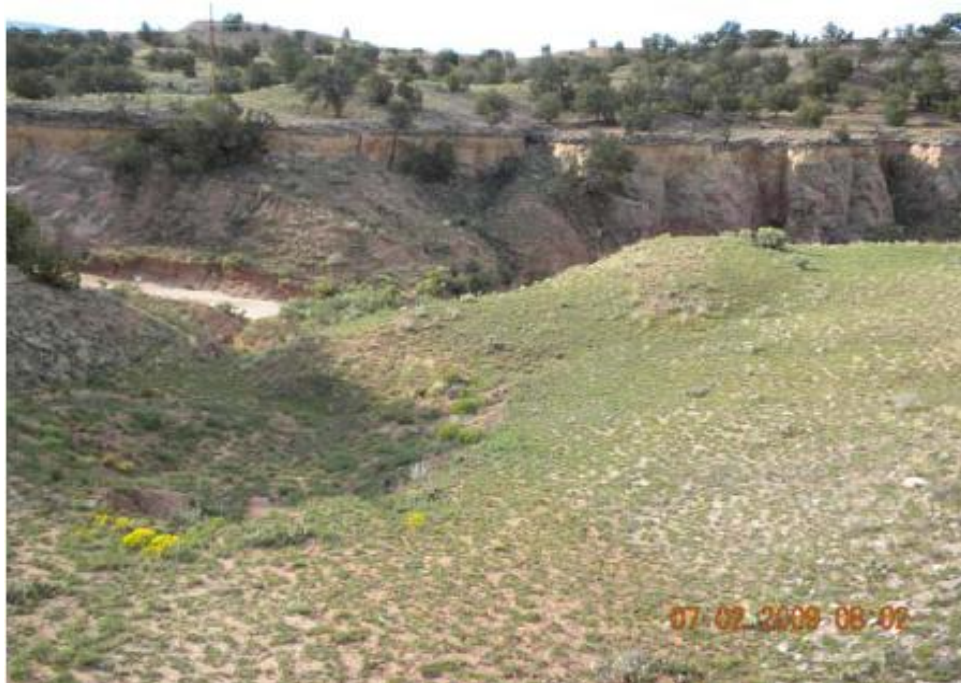
Open pit area (Section 25 #363) facing southeast, overlooking mined area

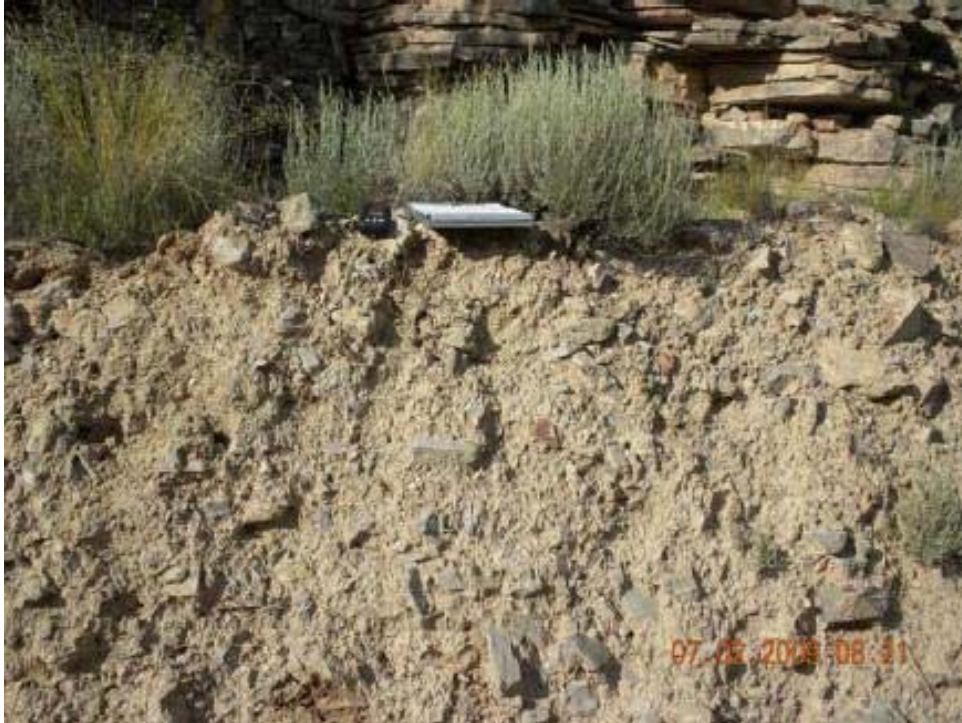
Open pit area (Section 25 #363) waste rock near drainage

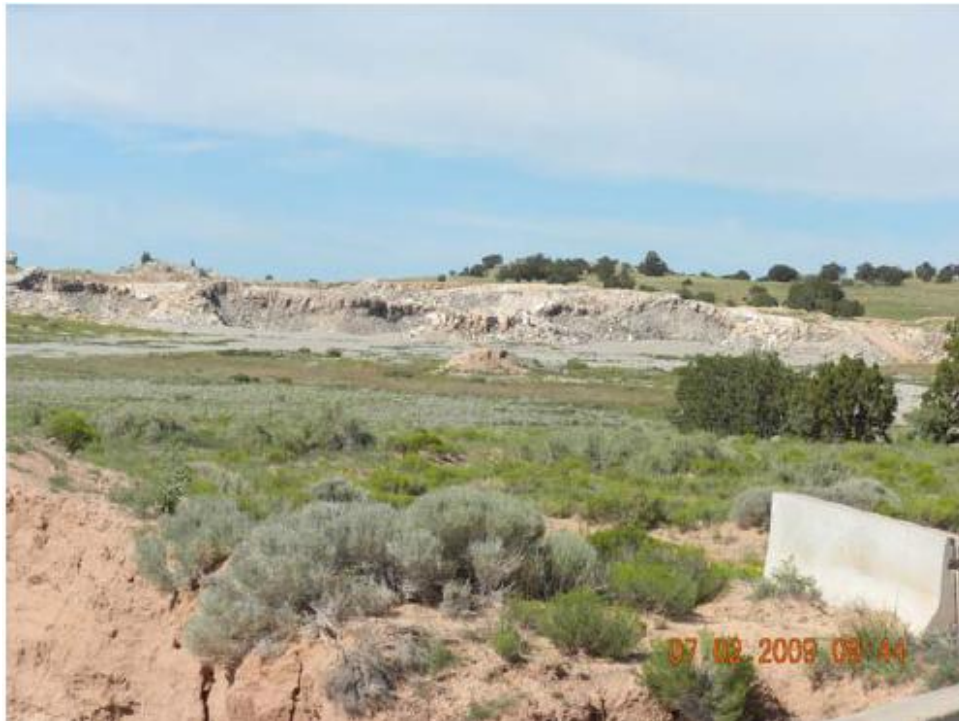
Aggregate pit area (Section 25 #366) facing the southwest

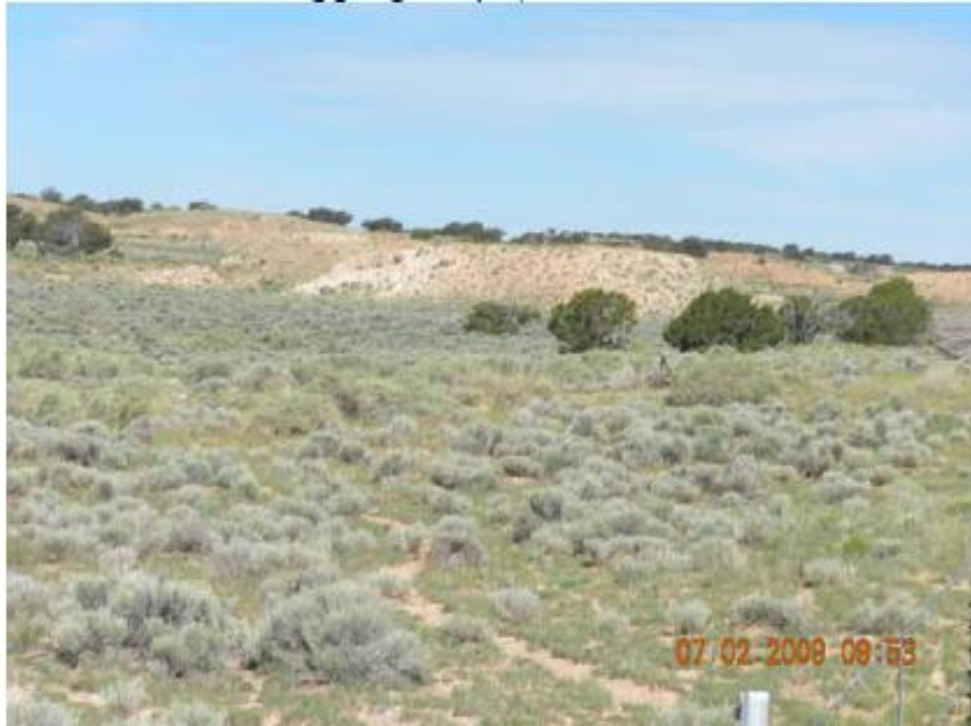
SEQ area (northwest corner of Section 25 #366) facing the west
