Navajo Abandoned Uranium Mine Site Screen Report

Section 2

Navajo AUM Eastern Region

Weston Solutions, Inc.

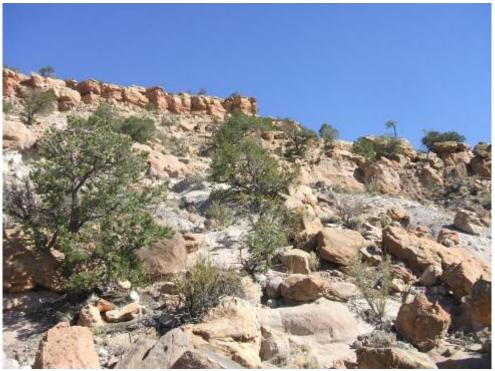
Photo 1. Mine site, towards the north

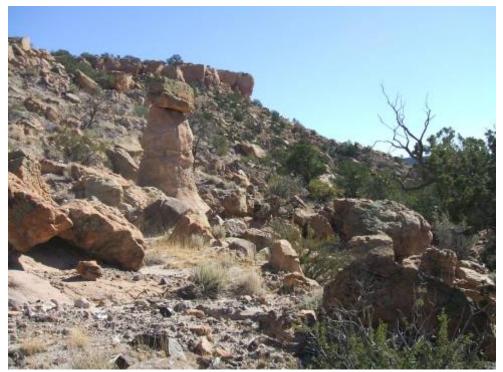
Photo 2. Mine site, towards the east

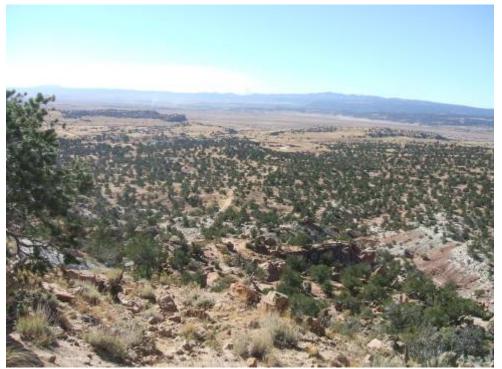
Photo 3. Mine site and surrounding vicinity, towards the south

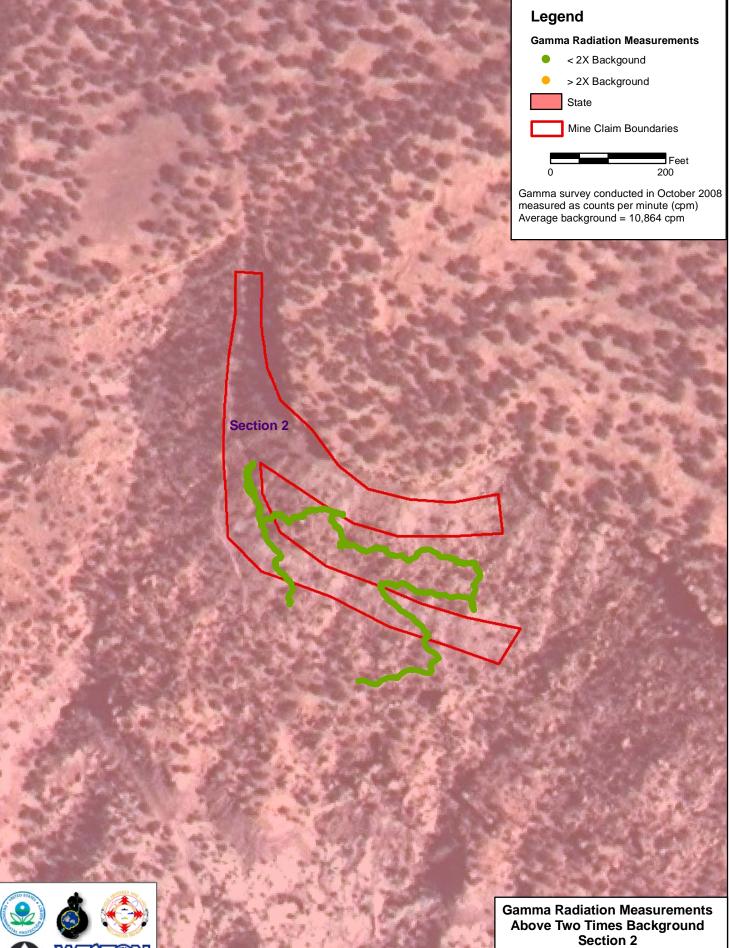
Baca/Haystack Chapter Figure Navajo Nation, New Mexico 1

A total of 982 gamma radiation measurements were collected from mine sites, ranging from 5,752 cpm to 16,985 cpm. The measurements are represented in Figures 1 and 2.
