Project: 150557-01.01

Re: Post-TCRA Quarterly Inspection Report – April 2016

This document reports the results of the April 2016 inspections of the armored cap cover, fencing, and signage installed for the Time Critical Removal Action (TCRA) at the San Jacinto River Waste Pits Superfund Site (TCRA Site).

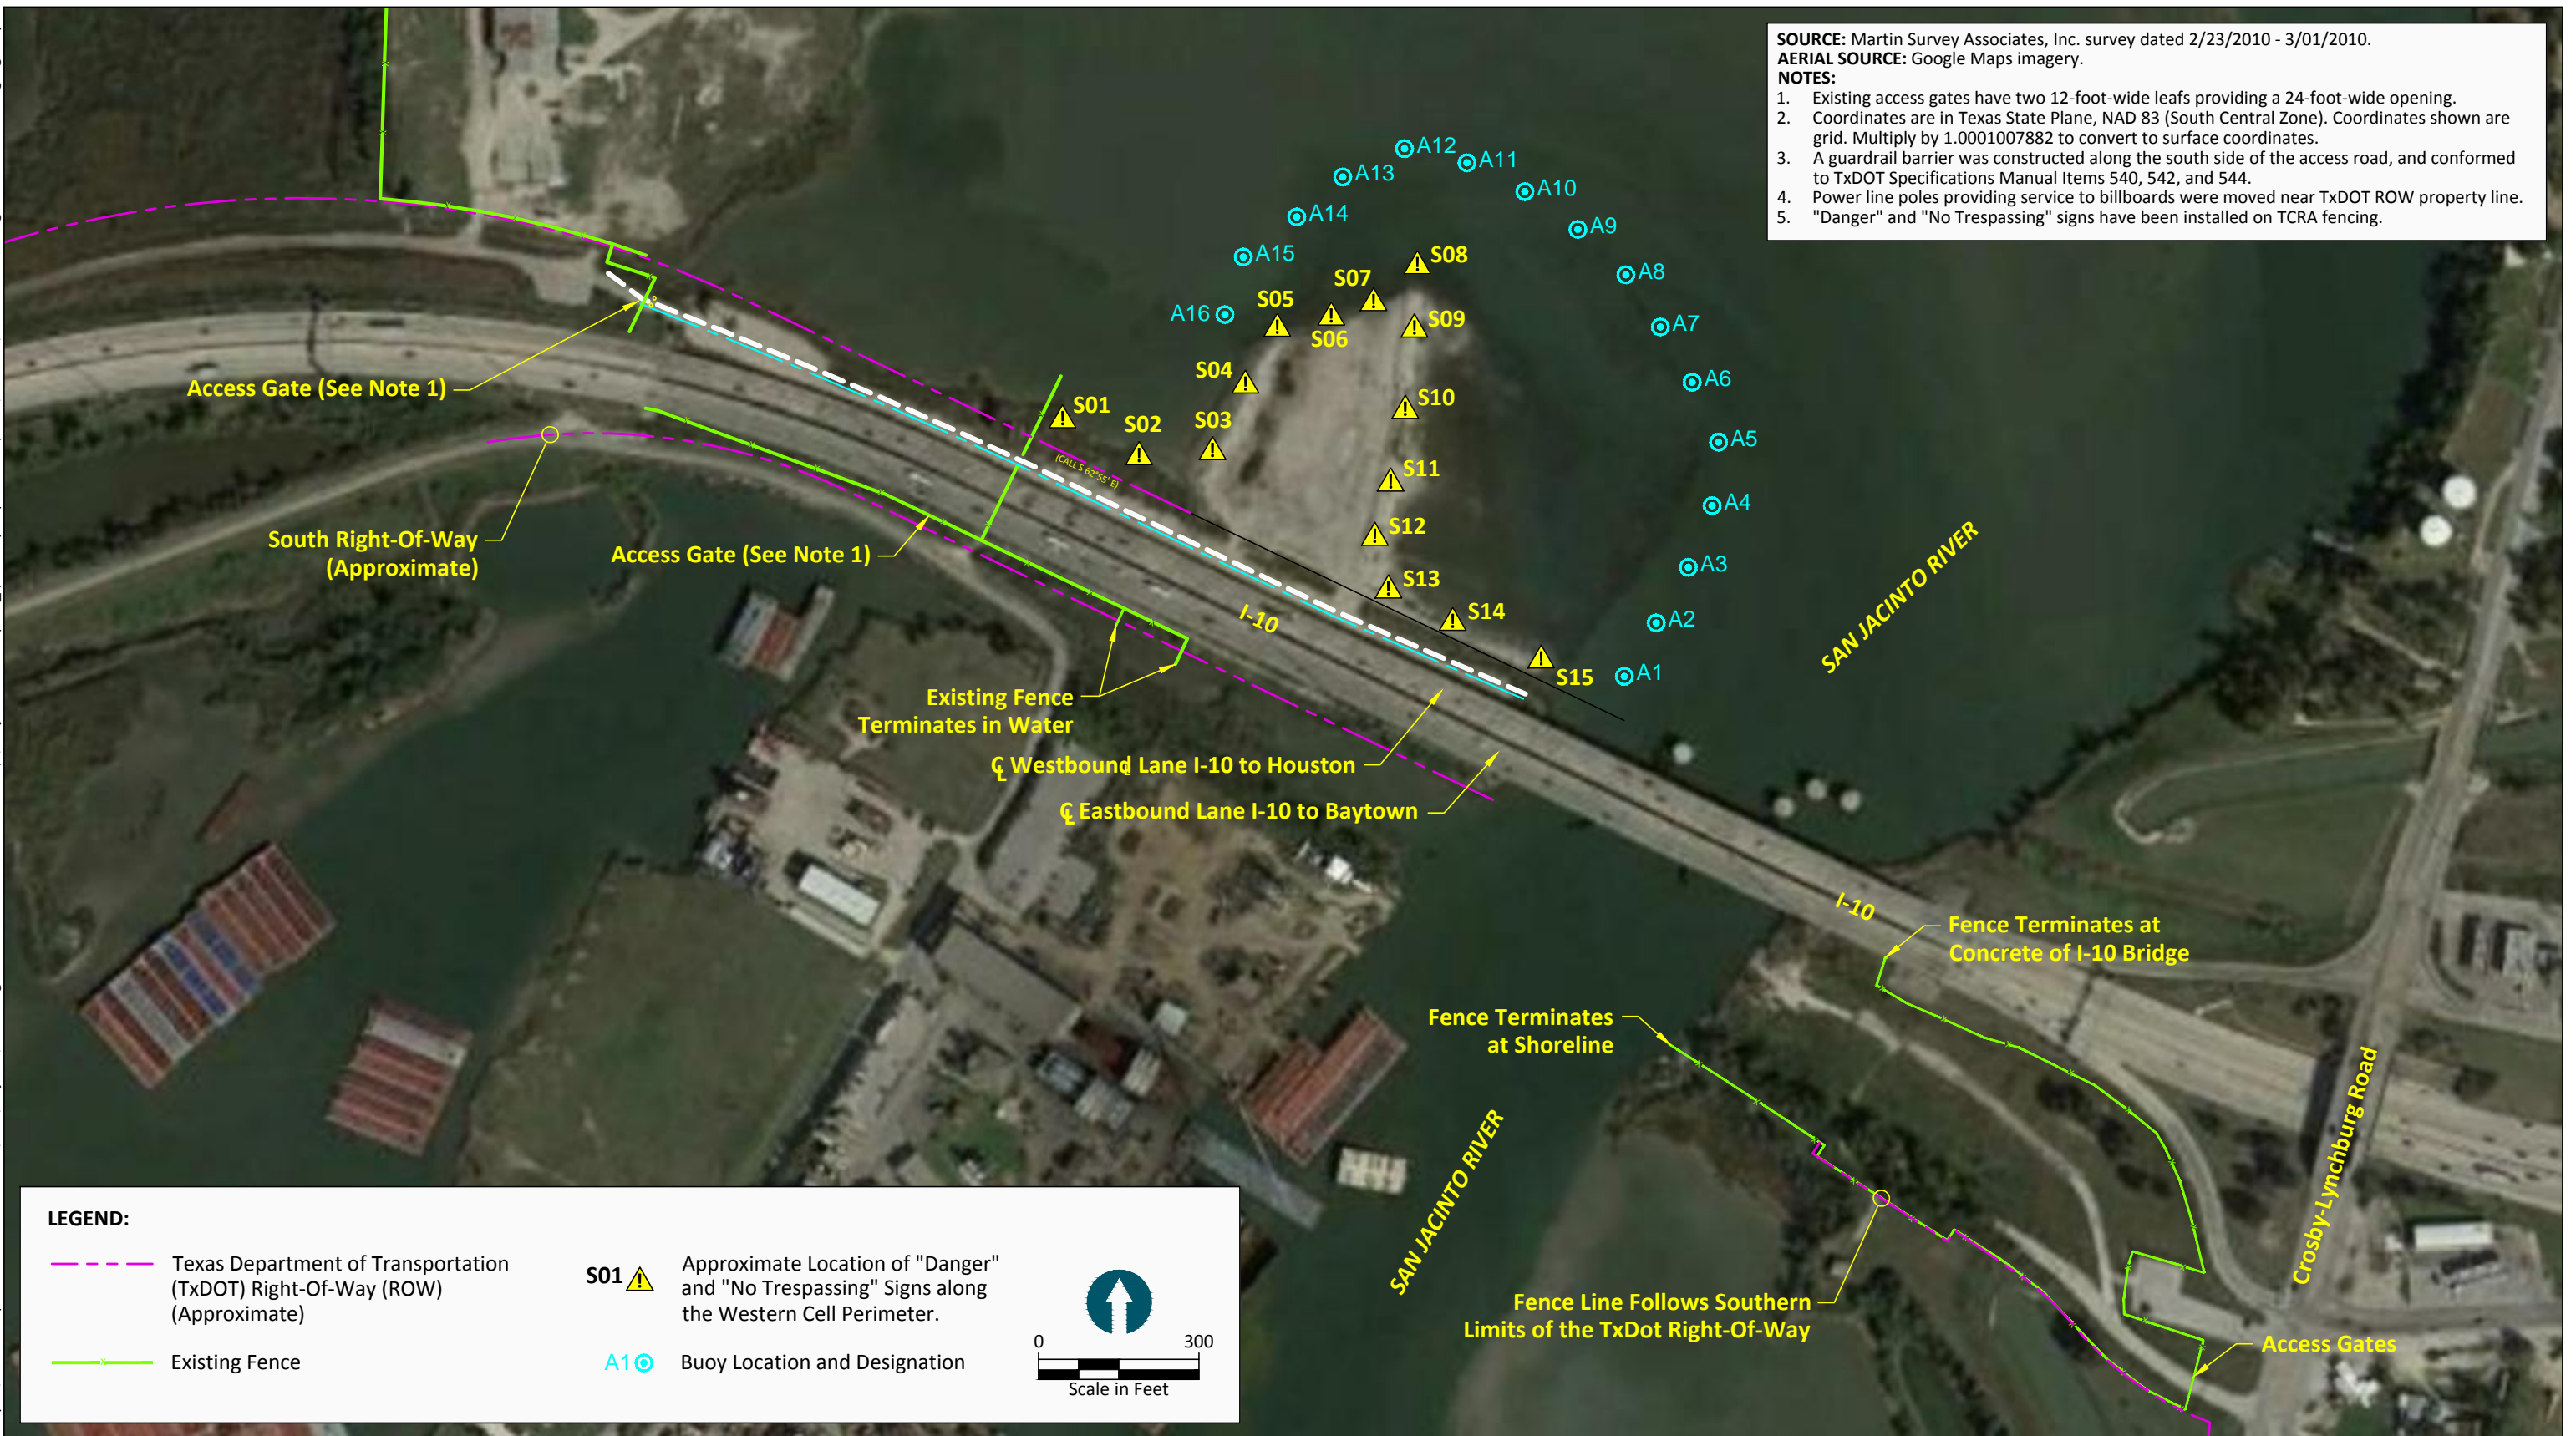
Figure 2
 Fence and Warning Sign Layout
 Post-TCRA Quarterly Inspection (April 2016)
 San Jacinto River Waste Pits Superfund Site

The perimeter fencing (Figure 2) on the west and east banks of the San Jacinto River was visually inspected for breaches or other signs of damage on April 11, 2016. A breach roughly 3 feet by 1.5 feet in size was discovered in the fencing on the west bank on the south side of I-10. National Fence replaced the damaged portion of the fence panel on April 14, 2016. Photographs 13 and 14 in Appendix A show the damaged and repaired fence. No other breaches or other signs of fence damage were observed during the inspection of the perimeter fencing on either the east bank or on the west bank north of I-10. For examples, see Photographs 10 through 12, 16, and 17 in Appendix A.

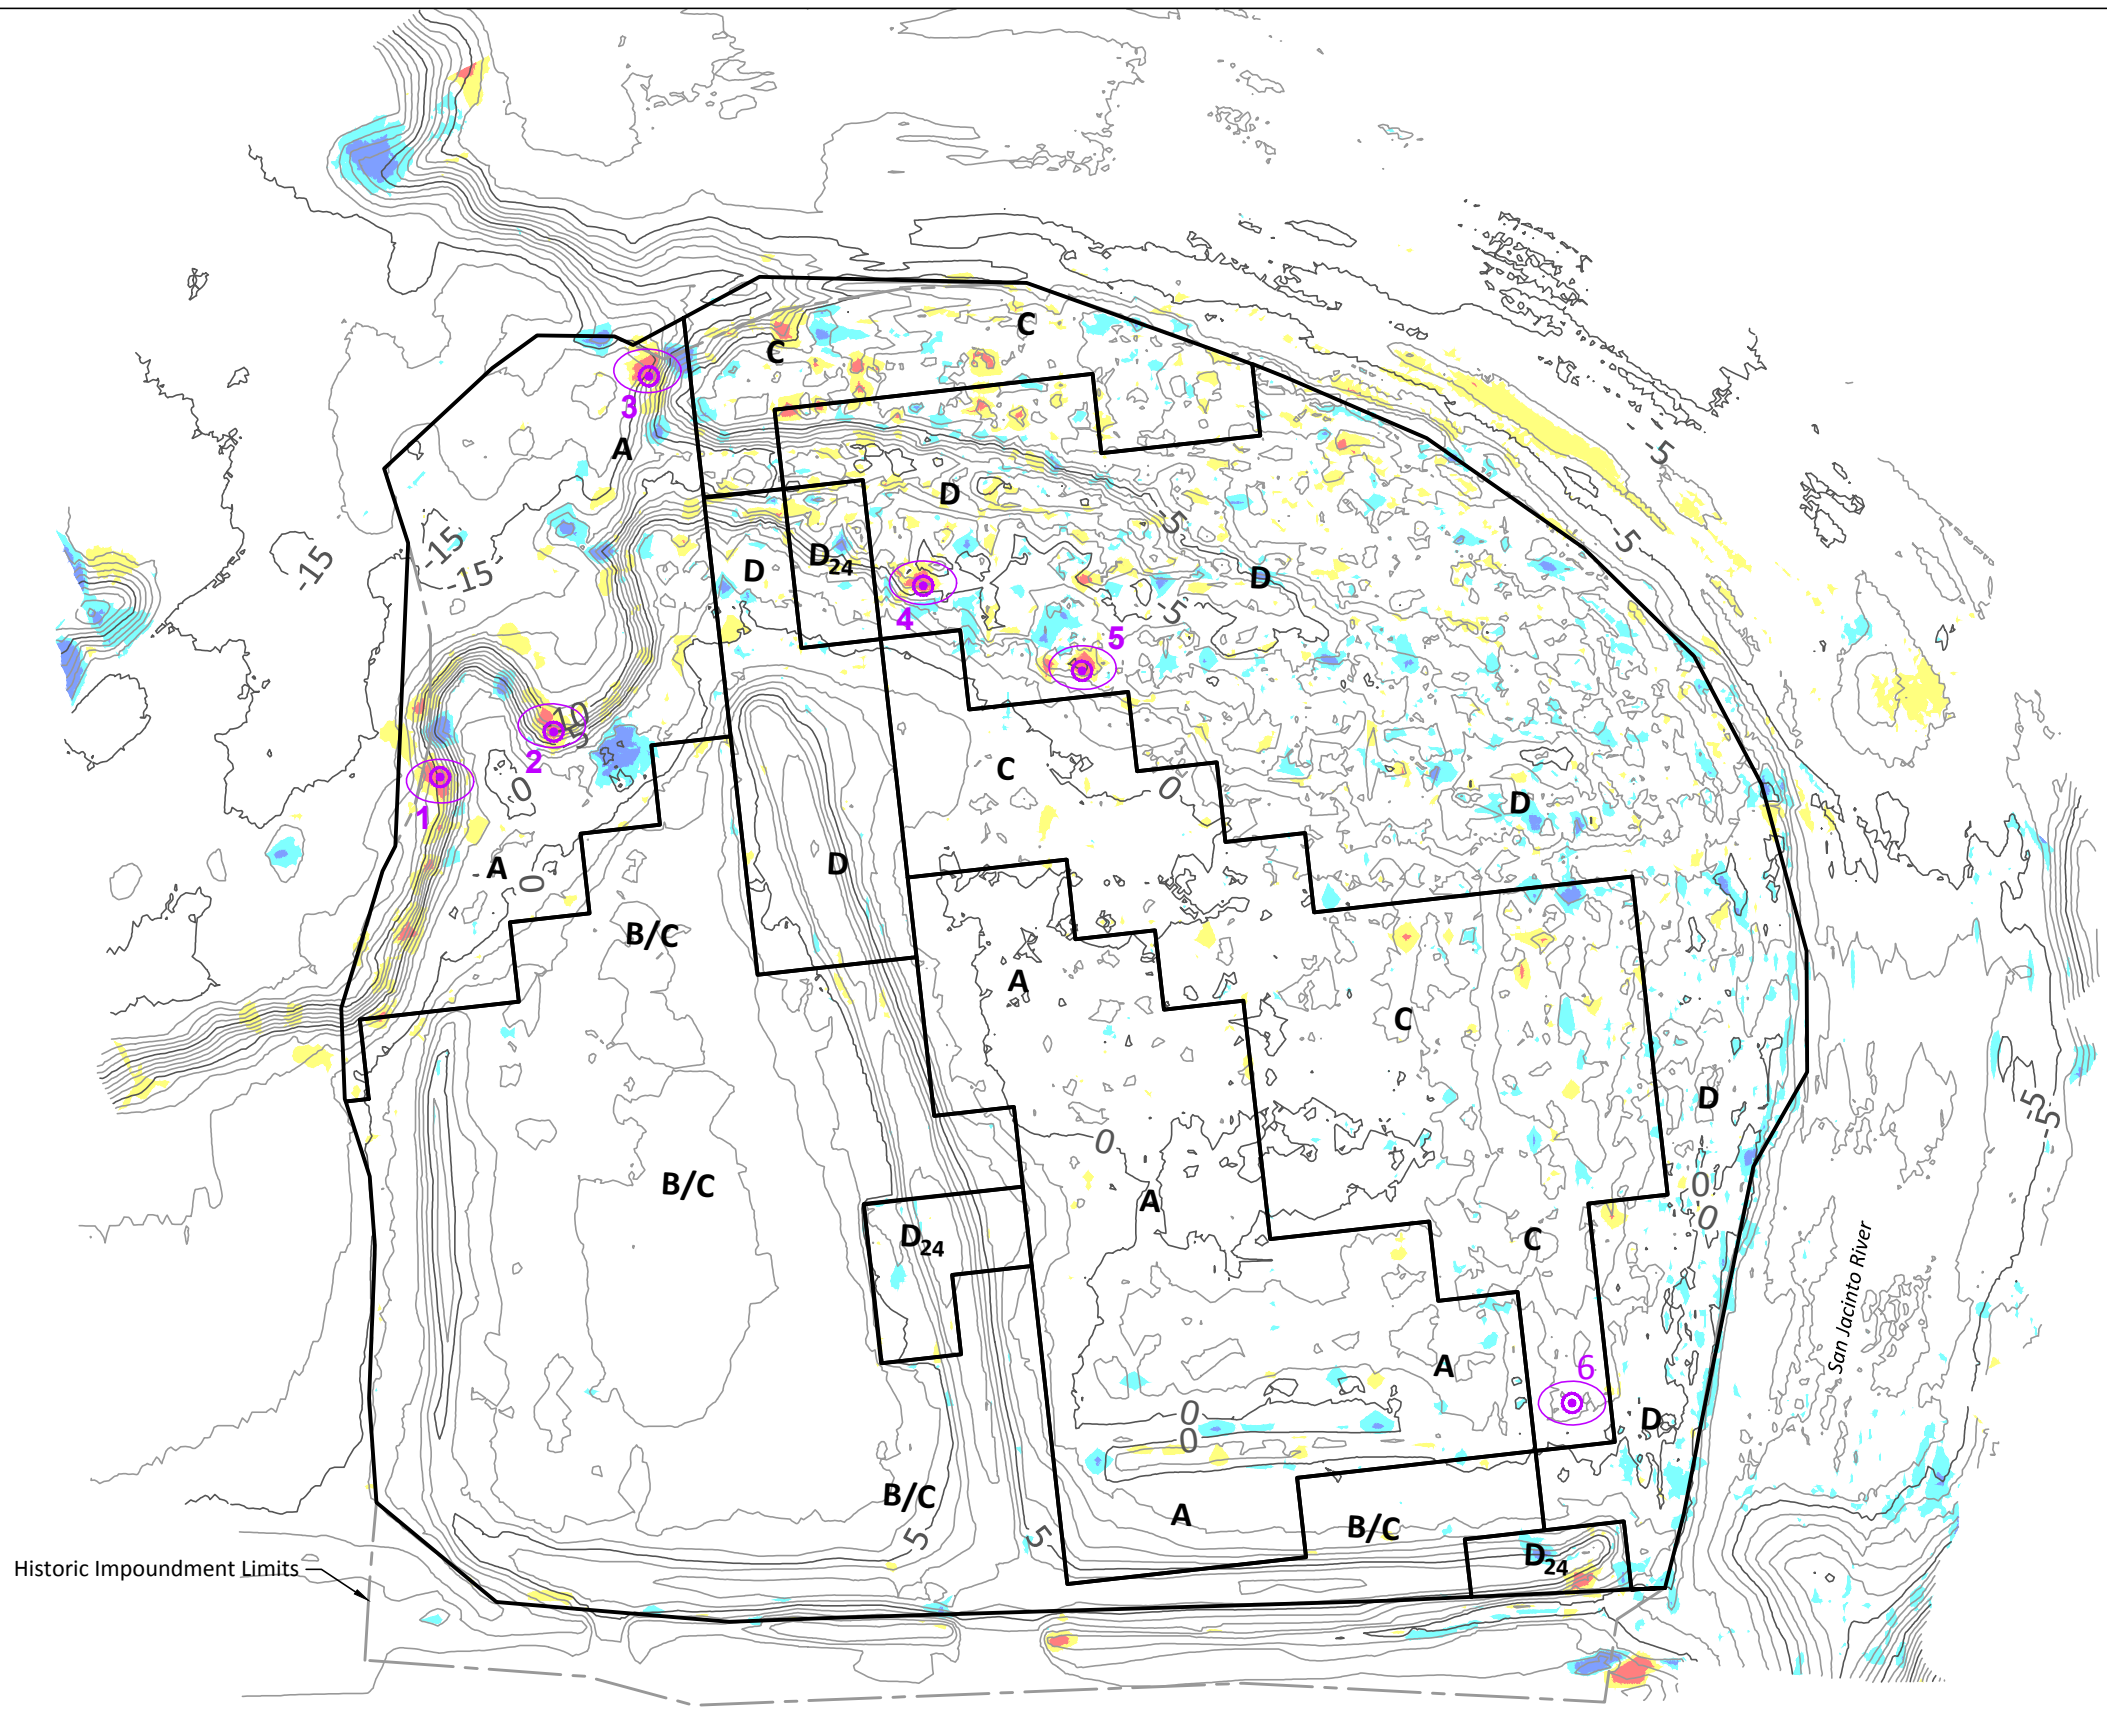
The survey data from the April 2016 survey and the October 2015 survey were compared to evaluate the differences in the top of the armored cap elevation. These differences are shaded and shown on Figure 3. The survey results indicate continued sedimentation/deposition, some scour of prior alluvial deposition and the presence of maintenance areas at which work was completed in December 2015 and April 2016.

2015 surveys were compared, the results indicated that there were 5 areas of interest indicating potential changes of greater than one foot. Respondents elected to probe these areas although they were all smaller than 30 feet by 30 feet. The 5 areas were probed on May 13, 2016, with 1 location (location 5 on Figure 3) being identified as requiring maintenance (Table 2). Location 5 had exposed geotextile and some but not the specified thickness cap material of over an area of approximately 4 foot by 3 foot.

As with location 5, the 4 other small areas identified as increases and decreases in elevation were probed at the centroid and to their extent in all principal directions (north, south, east and west) using a steel rod, steel tube and plastic tube. The probes at these 4 locations indicated that the cap was intact and armor rock was present at the required thickness. These survey differences can be attributed to the horizontal and vertical limitations of the survey, shifts in track line location from the baseline survey that were taken in a higher than normal flow event, shifts in alluvial deposits since construction and elevation data recorded in the crevices between rock surfaces, atop shellfish growth or on the surface of the maintenance areas completed in March and April 2016. The potential for these types of variations between the two datasets to exist was confirmed by the surveyor after reviewing the data collected during this inspection.

On May 18, 2016, in the course of the USEPA Dive Team’s installation of porewater monitors, a second location that required maintenance was identified. Maintenance was performed in this area on May 20, 2016, and is shown on Figure 3 and identified as area of interest 6. The area was delineated as an area of 2 foot by 3 foot in which there was exposed geotextile and some but not the specified thickness of cap material.

As noted above, one area of the TCRA armored cap that required maintenance was identified through probing conducted on May 13, 2016 (i.e., location 5 on Figure 3). The USEPA was notified of the TCRA armored cap issue and a maintenance event was planned. USEPA provided approval to perform the maintenance activity by email on May 17, 2016. The maintenance activity consisted of installing the prescribed “D” rock to a thickness of 1.5 feet in that area, and that took place on May 20, 2016.

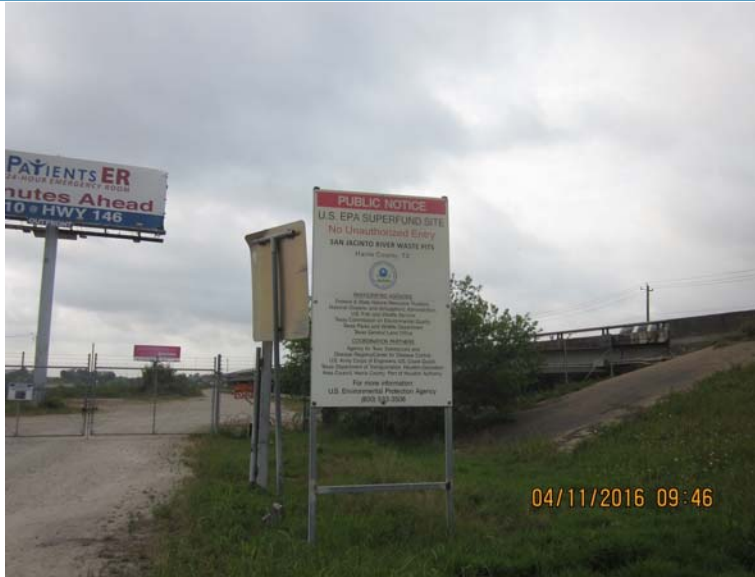
3) at the end of the TxDOT right-of-way north of I-10 near the San Jacinto River. For examples, see Photographs 1 and 12 in Appendix A. These three signs were observed to be in place and undamaged.

Photograph 01: USEPA Public Notice Sign located outside access gate north of I-10 (view east)

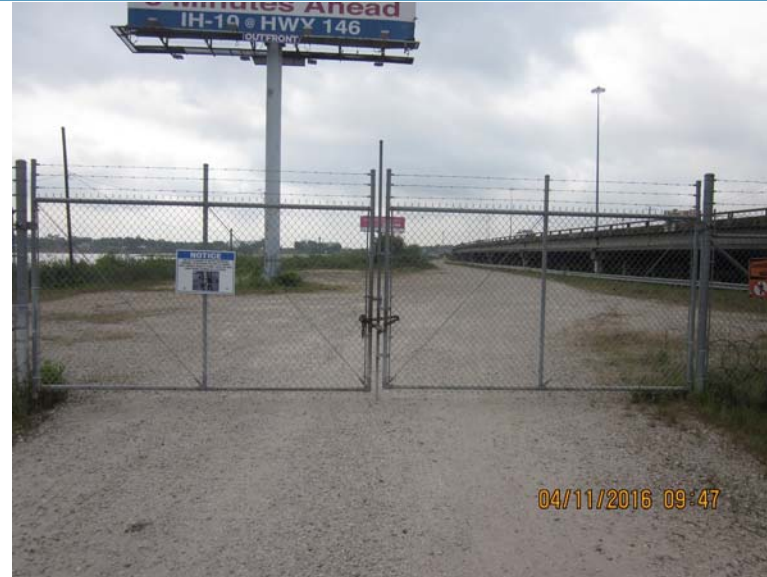
Signage on all locked gates reminds entrants to “daisy chain” the locks properly prior to leaving the TCRA Site, as seen in Photograph 2. These signs were observed to be in place and undamaged.

Photograph 02: Access gate north of I-10 (view east)

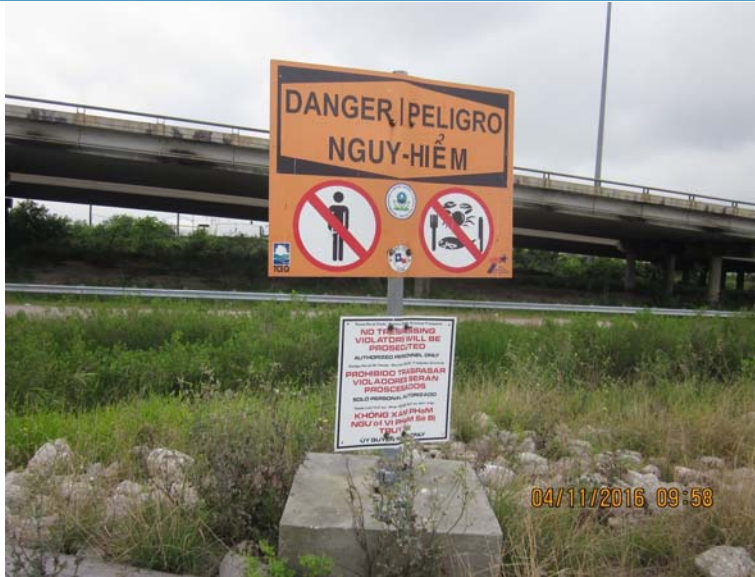
A total of 15 signs were installed at the TCRA Site around the perimeter of the land portion of the TCRA Site; the signs are mounted on steel posts and set in concrete pads. For examples, see Photographs 5 and 7 in Appendix A. These signs are intended to face the San Jacinto River to deter water-based entry to the TCRA Site. A few of these signs had rotated out of proper alignment due to the wind, and the affected signs were re-aligned to the intended viewing perspective.

Photograph 05: Warning sign along southern berm (view south)

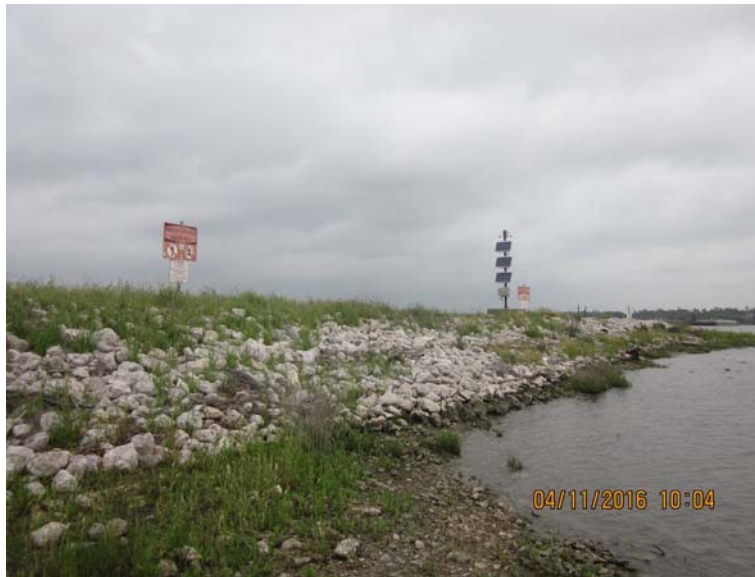
Photograph 07: Warning signs and security camera system along central berm (view northwest)

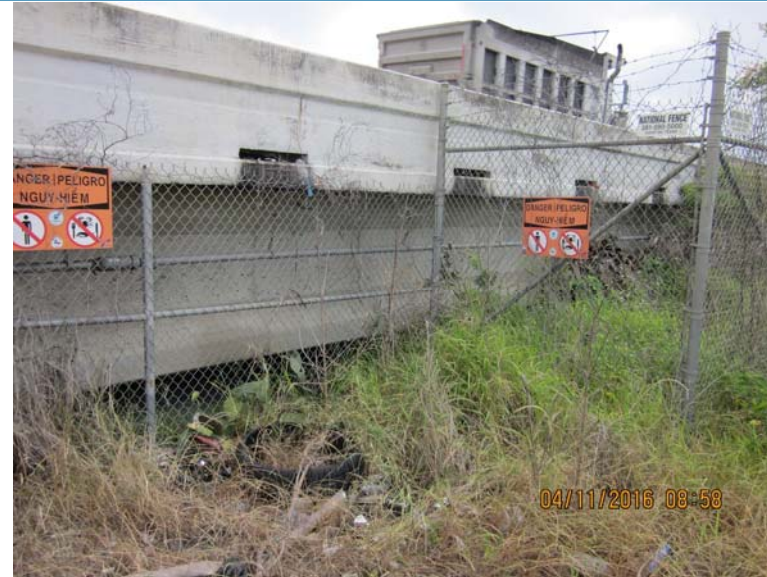
“Danger” and “No Trespassing” signs are posted at regular intervals on the perimeter fencing surrounding the TCRA Site. For examples, see Photographs 10 and 11 in Appendix A. These signs were observed to be in place during the April 11, 2016 inspection.

Photograph 10: Signage and perimeter fencing on west bank south of I-10 (view northeast)

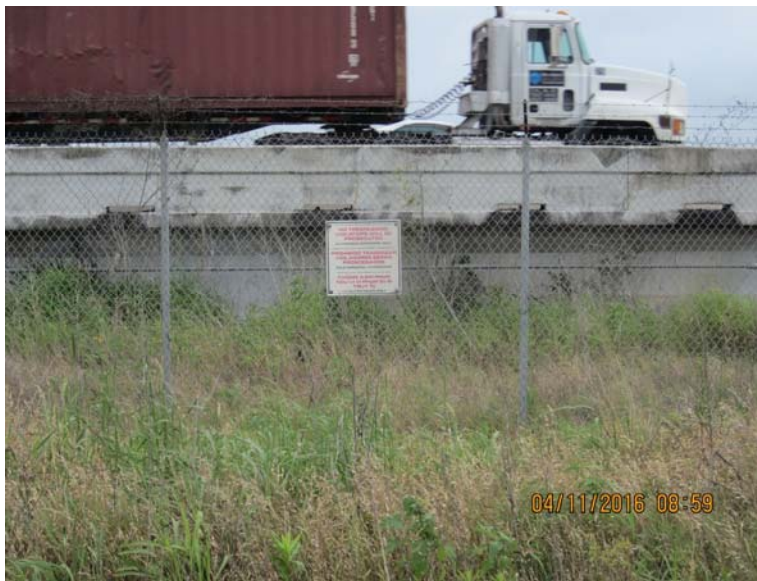
Photograph 11: Signage and perimeter fencing on west bank south of I-10 (view north)

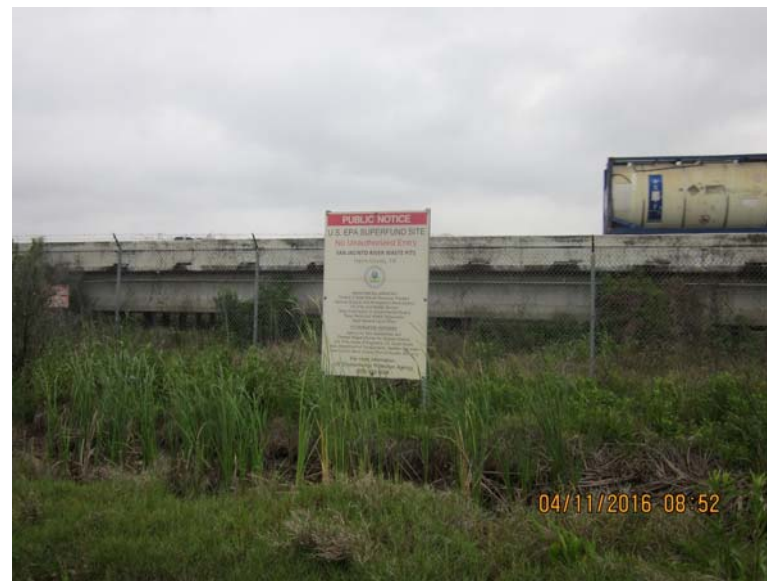
Photograph 12: USEPA Public Notice Sign on west bank south of I-10 (view north)

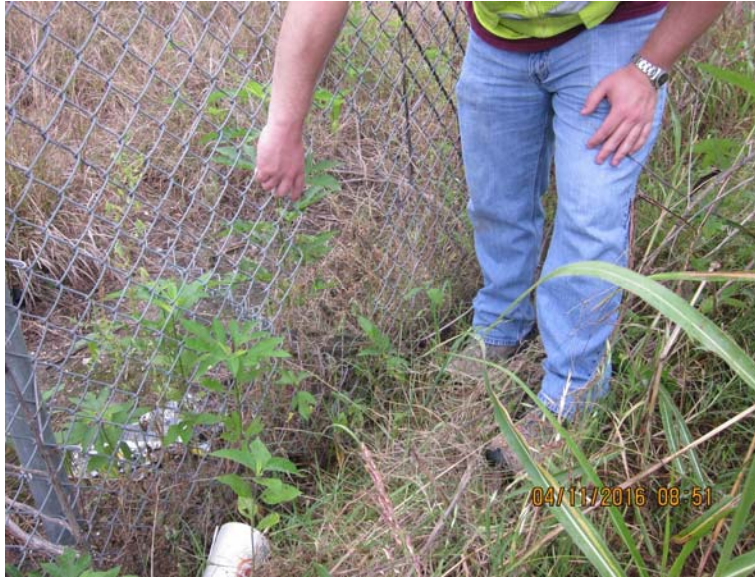
Photograph 13: Breach in the perimeter fencing on the west bank south of I-10 (view northeast)

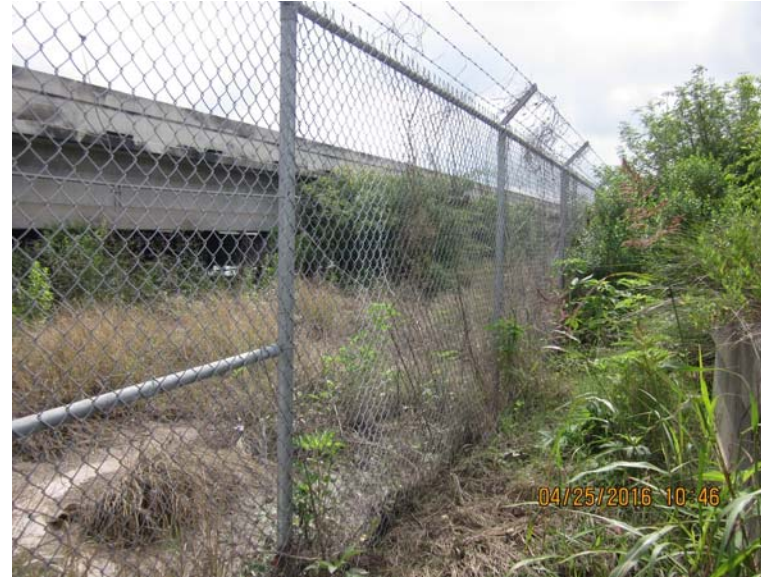
Photograph 14: Repaired perimeter fencing on west bank south of I-10 (view northeast)

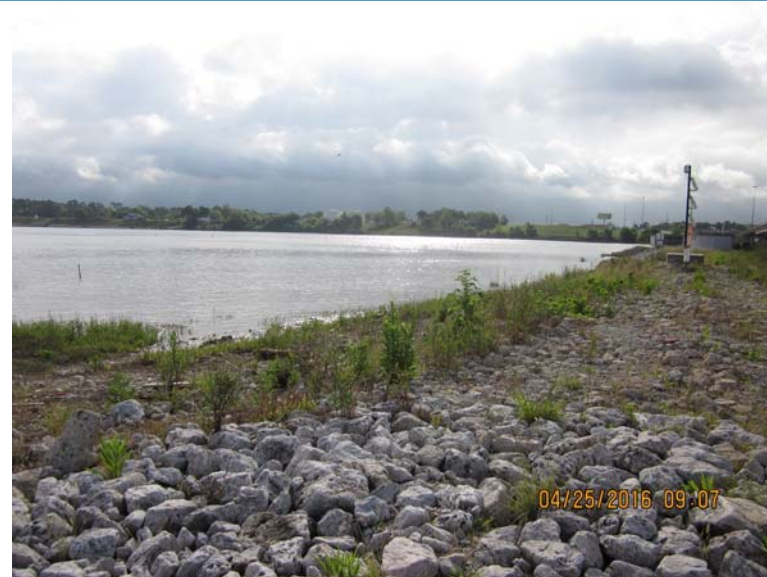
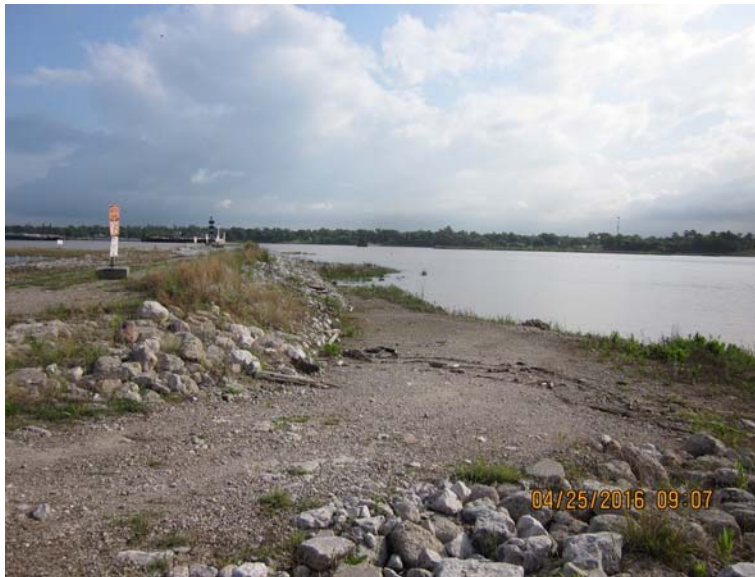
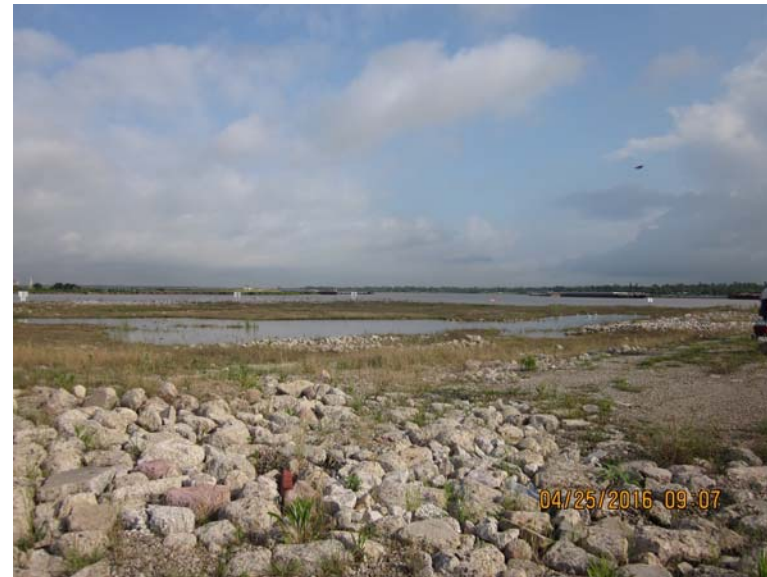
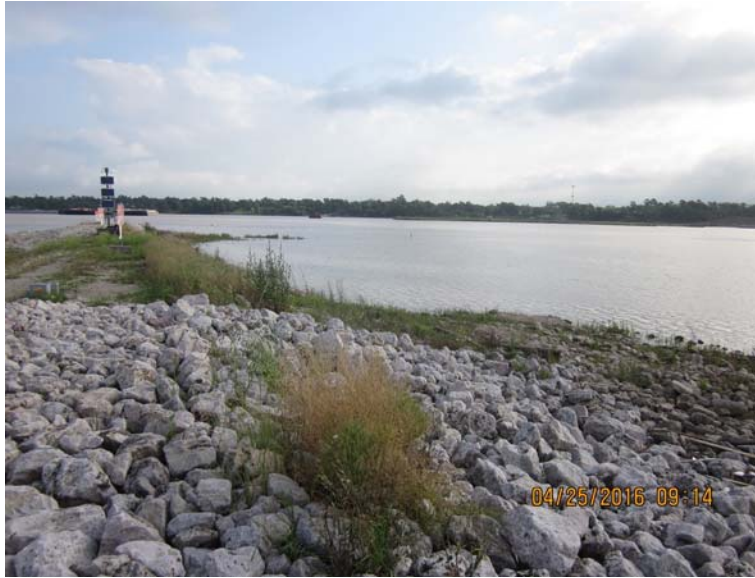
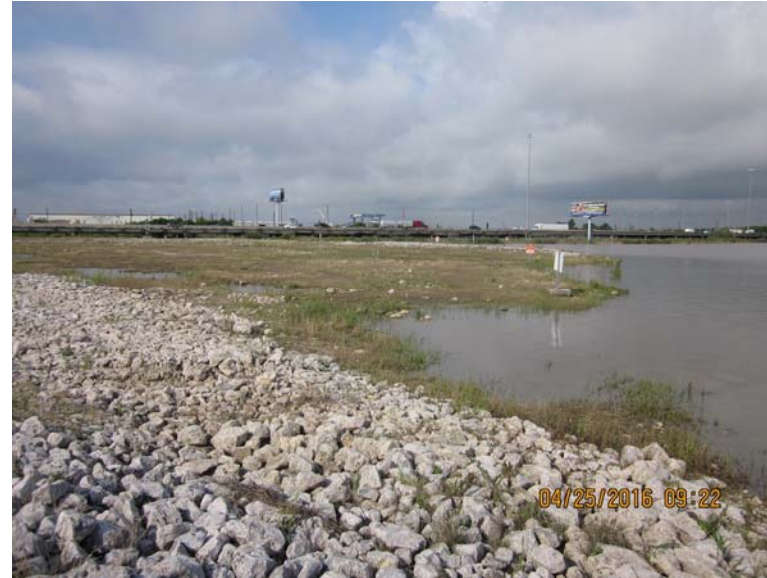
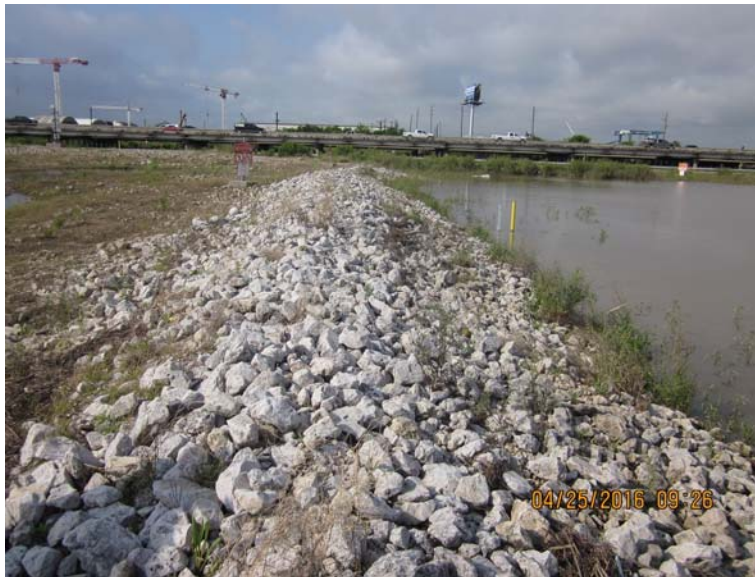
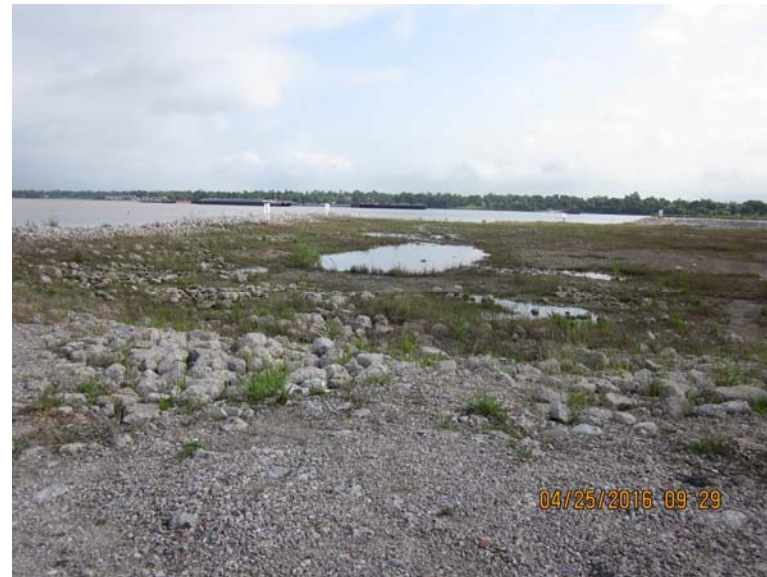
Heavy rainfall and flooding occurred in the area of the TCRA Site during the week of April 18, 2016. Three inches of rain fell between April 18 and April 22, 2016. The stage heights at Lake Houston and the U.S. 90 gauge peaked at or above the 10-year flood level. At the request of USEPA, daily visual inspections were performed April 19 through April 22, 2016. On these dates, the TCRA Site was not accessible due to flooding on the access roads, so conditions were observed from the I-10 Bridge and from the east bank. The majority of the armored cap was under water during this time. Additional visual inspections were performed on April 25, 2016, and again, after the water subsided, on May 4, 2016. The USEPA was present at the May 4, 2016 inspection when the water receded and the TCRA Site was accessible by automobile and on foot. No movement of cap material was observed in connection with these inspections. See Photographs 18 through 24 for Site conditions after the flooding.

Photograph 18: Southern berm after heavy rainfall the week of April 18, 2016 (view northeast)

Photograph 19: Central berm after heavy rainfall the week of April 18, 2016 (view north)

Photograph 20: Interior of Western Cell after heavy rainfall the week of April 18, 2016 (view northwest)

Photograph 21: Central berm after heavy rainfall the week of April 18, 2016 (view north)

Photograph 22: Interior of Western Cell after heavy rainfall the week of April 18, 2016 (view southwest)

Photograph 23: Western berm after heavy rainfall the week of April 18, 2016 (view south)

Photograph 24: Interior of Western Cell after heavy rainfall the week of April 18, 2016 (view north)

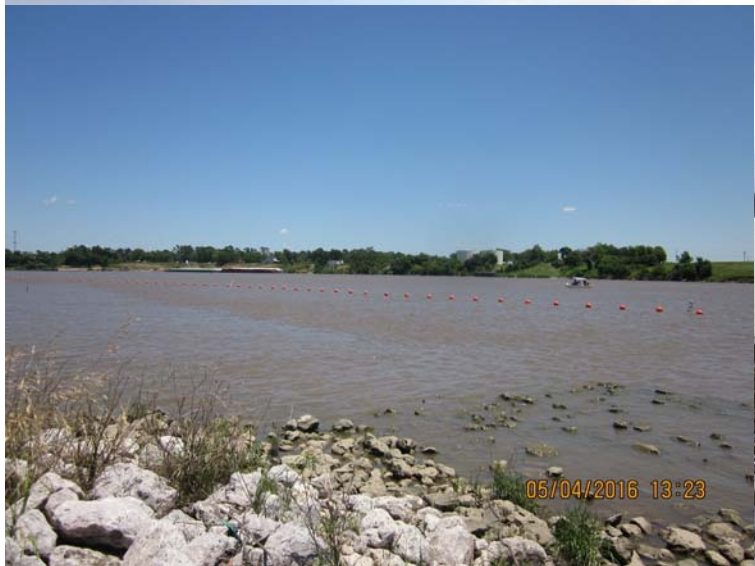
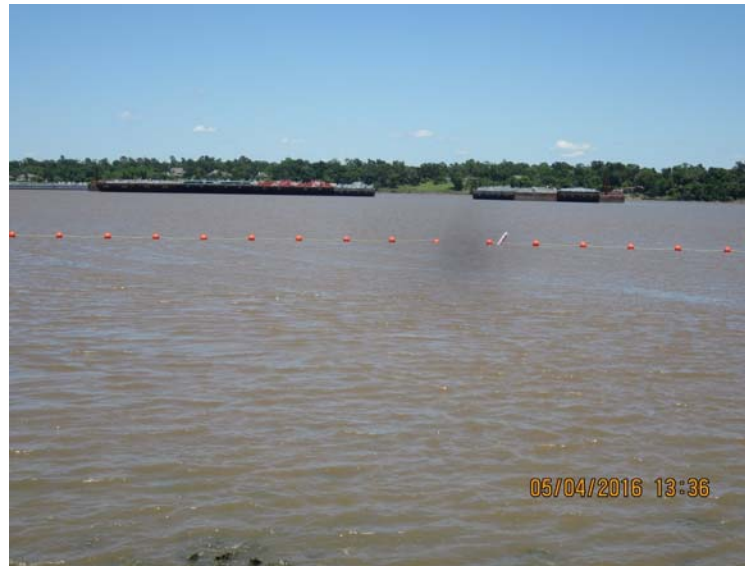
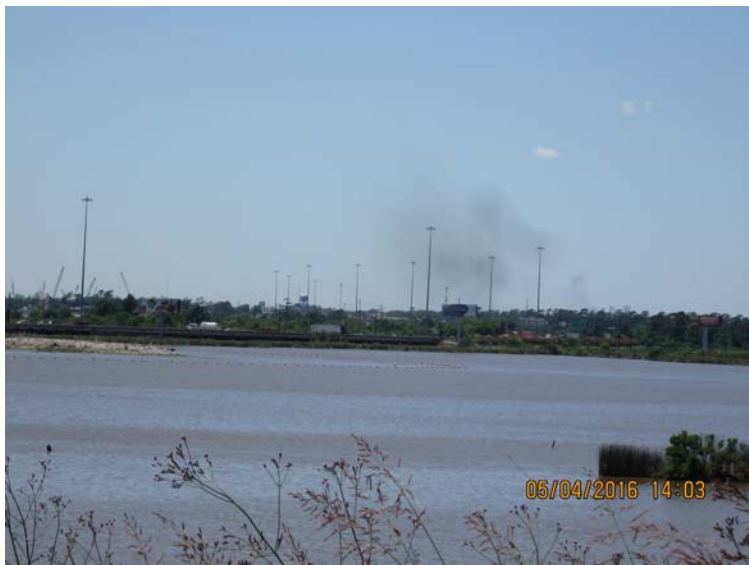
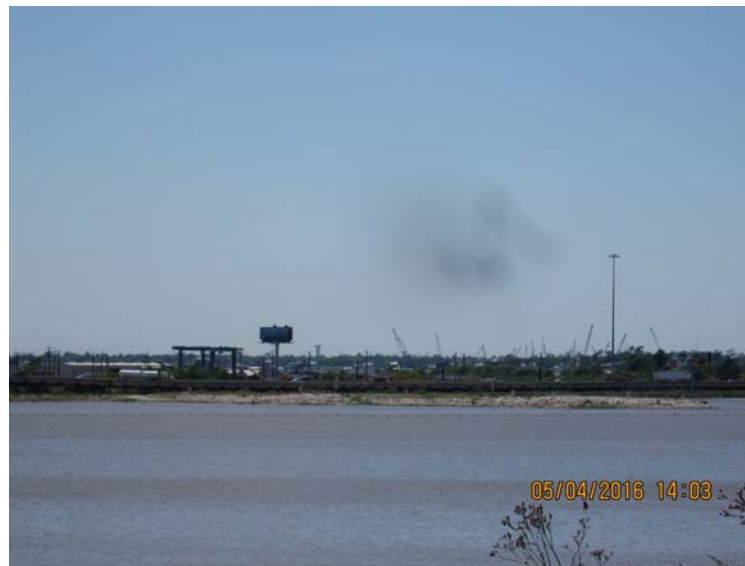
As part of the TCRA Site activities related to the quarterly inspection, additional permanent warning buoys were installed around the perimeter of the armored cap. The buoys were installed as outlined in the letter from Respondents’ Project Coordinator dated February 16, 2016 (Anchor QEA 2016a). Mobilization began on April 27, 2016, and installation was completed on April 31, 2016. The installation was scheduled for the week of April 18, 2016, but was delayed due to the heavy rain fall that week. Photographs 25 through 28 in Appendix A show the installed permanent buoy system.

Photograph 25: Buoy System (view east)

Photograph 26: Buoy System (view north)

Photograph 27: Buoy System (view south and west)

Photograph 28: Buoy System (view south southwest and left of Photograph 27)
