SUBJECT: DESTRUCTIVE ANALYSIS OF 10 STEEL COUPONS REMOVED FROM RED HILL FUEL STORAGE TANK NO. 14, PURSUANT TO SECTION 5.3 OF THE ADMINISTRATIVE ORDER ON CONSENT STATEMENT OF WORK, RED HILL BULK FUEL STORAGE FACILITY, JOINT BASE PEARL HARBOR-HICKAM, OAHU, HAWAII

Destructive Analysis of 10 Steel Coupons Removed from Red Hill Fuel Storage Tank #14

REPORT No. 201801967

December 17, 2018

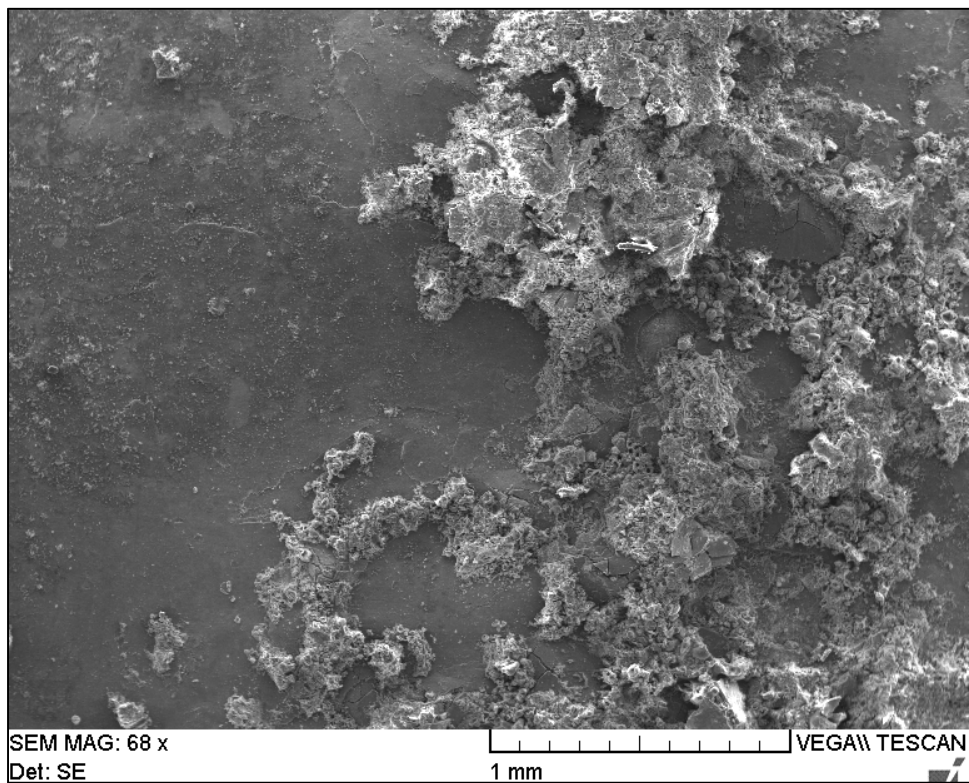
Figure 50. A representative SEM image of the specimen excised from Coupon 5 labeled as 5-1, prior to cleaning. No pits observed. (SEM, 40X)

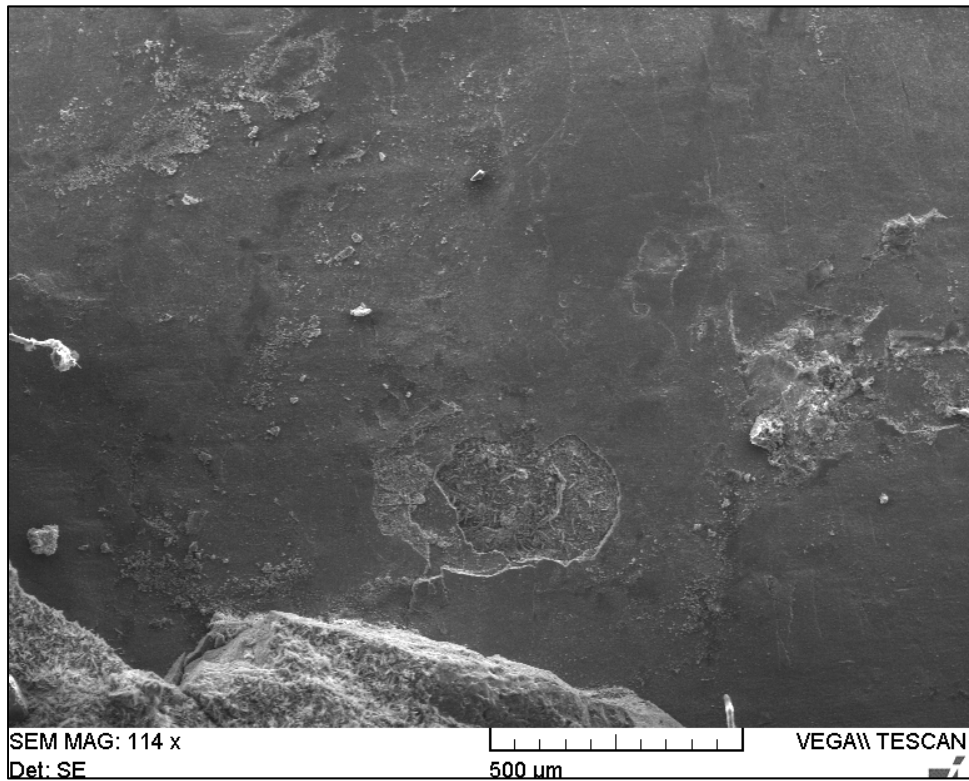
Figure 51. A representative SEM image of a pit on a specimen excised from Coupon 5 labeled as 5-2, prior to cleaning. (SEM, 67X)

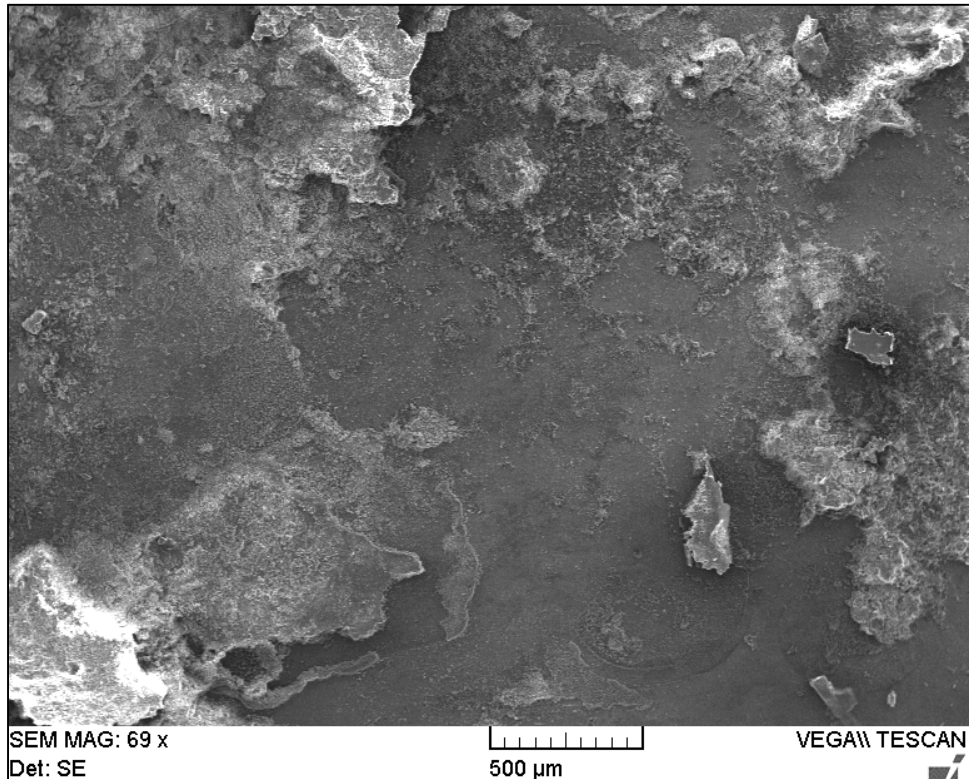
Figure 54. A representative SEM image the surface of a specimen excised from Coupon 6 labeled as 6-2, prior to cleaning. No pit was observed in this location. (SEM, 40X)

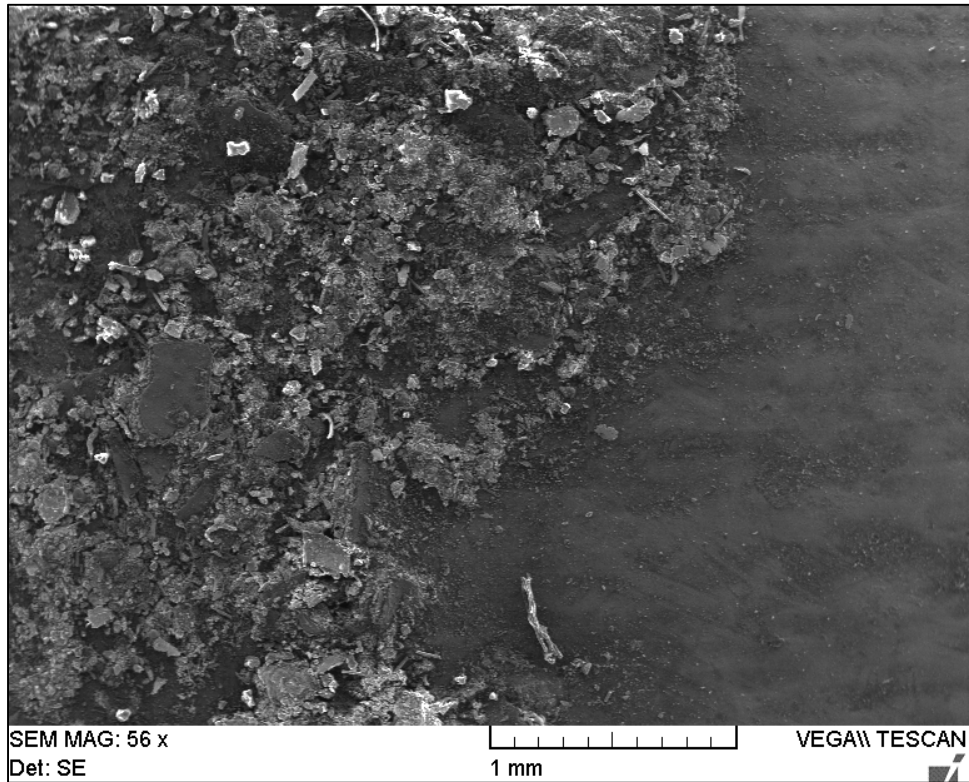
Figure 62. A representative SEM image of the surface of a specimen excised from Coupon 10 labeled as 10-1, prior to cleaning. No pit was observed in this location. (SEM, 33X)

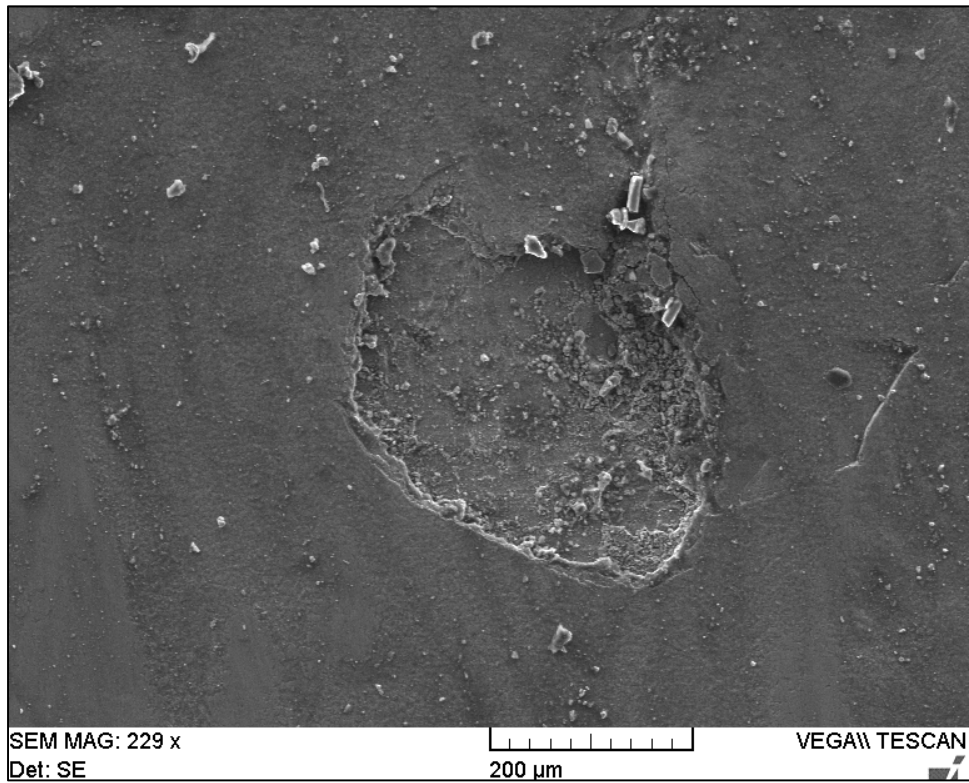
Figure 63. A representative SEM image of a pit on a specimen excised from Coupon 10 labeled as 10-2, prior to cleaning. (SEM, 135X)

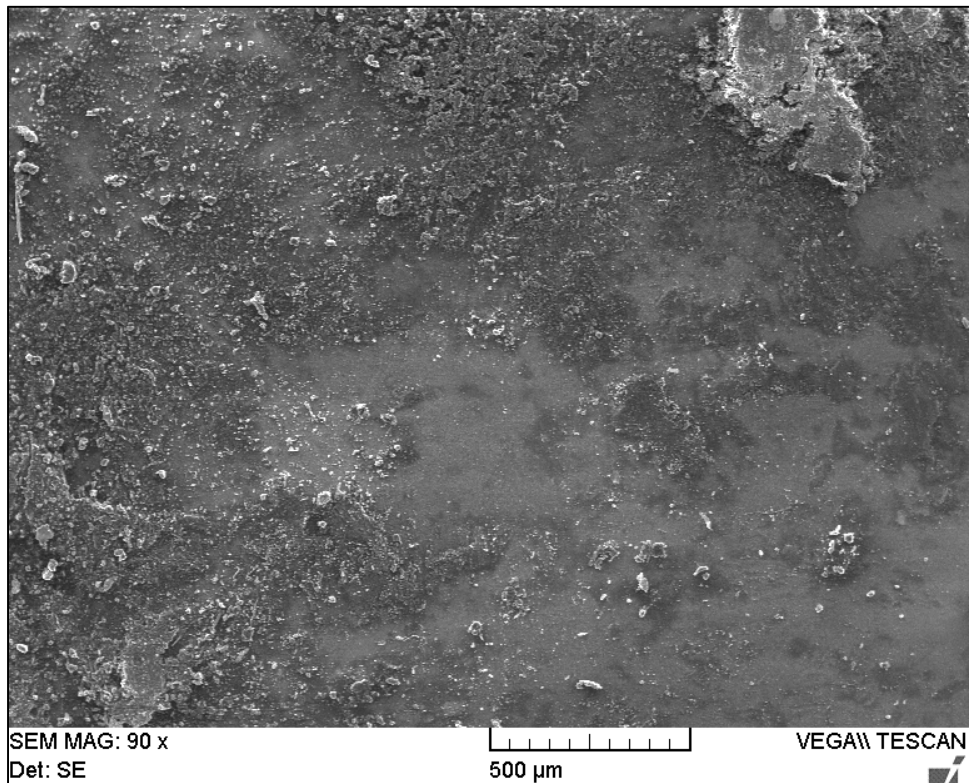
Figure 64. A representative SEM image of the surface on a specimen excised from Coupon 10 labeled as 10-3, prior to cleaning. No pit was observed in this location. (SEM, 53X)

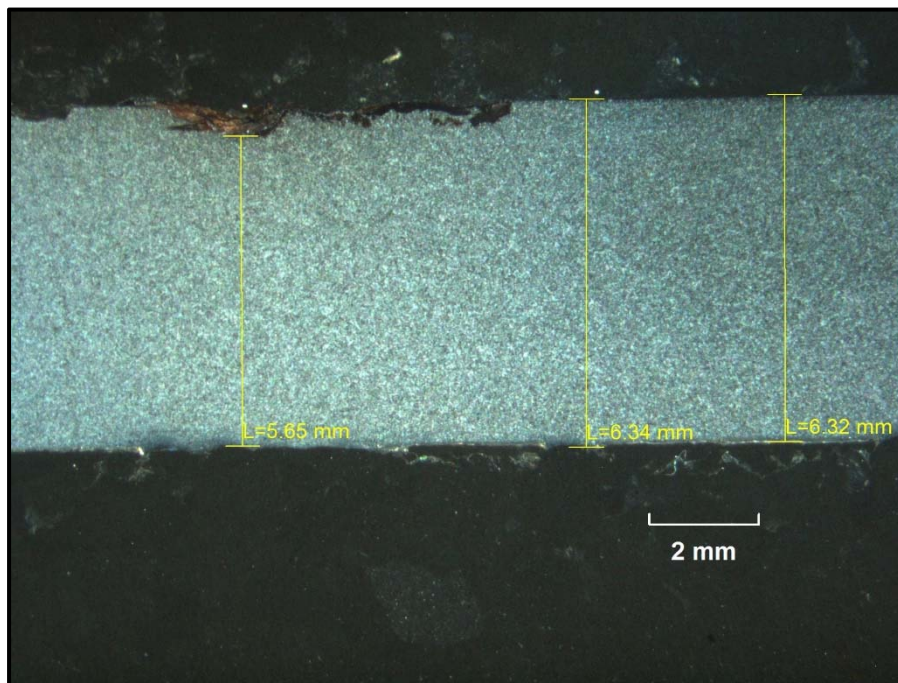
Figure 180. The prepared metallographic cross-section from Sample 1-1 is shown during examination with a stereomicroscope. The thickest location(s) are shown, as well as the thickness remaining underneath the deepest observed pit. (7X)

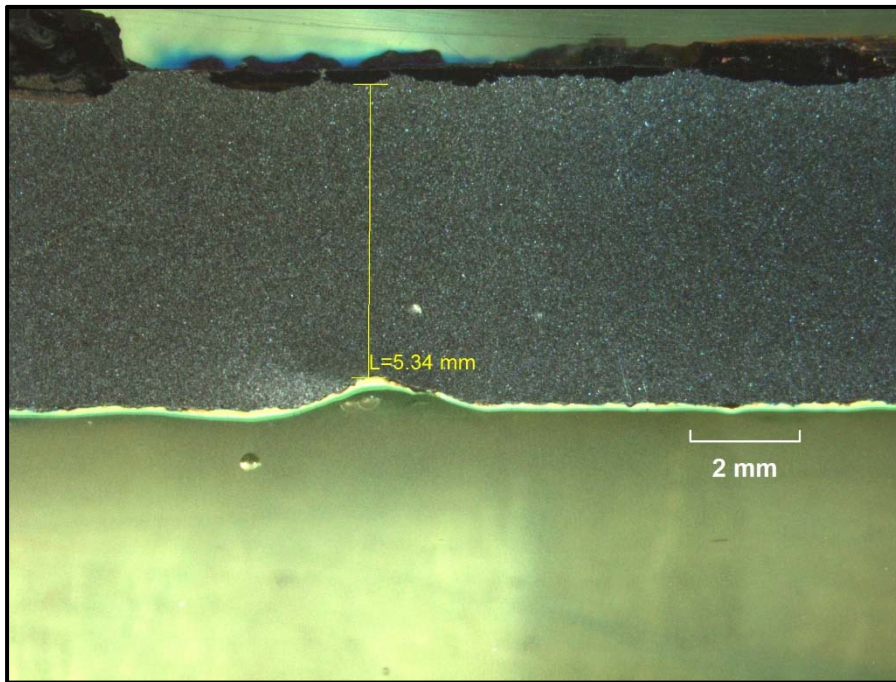
Figure 181. The prepared metallographic cross-section from Sample 1-3 is shown during examination with a stereomicroscope. The thickest remaining wall is shown. Note that the reduction in wall thickness was due to a depression on the painted face of the specimen. (7X)

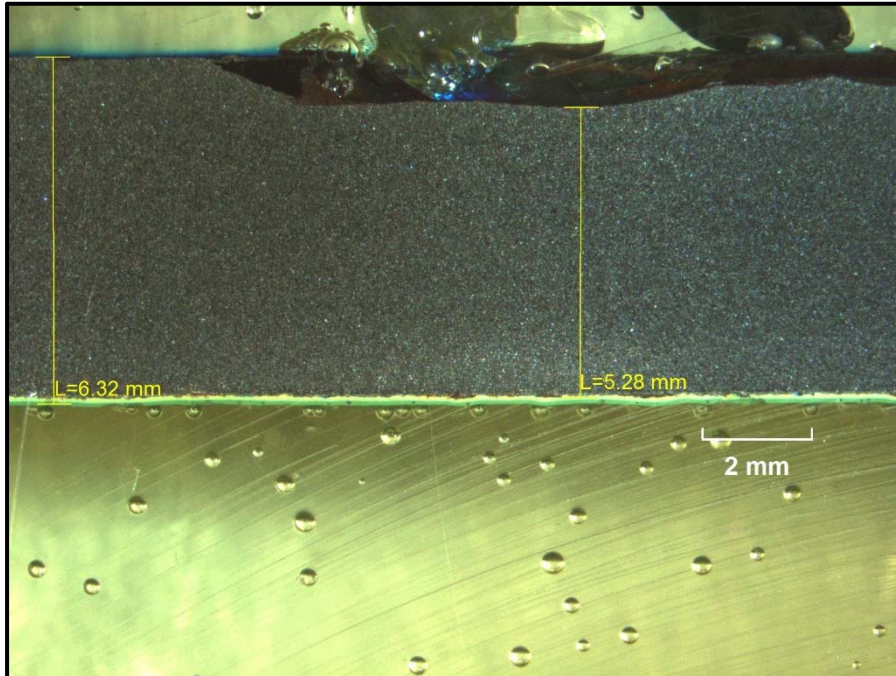
Figure 182. The prepared metallographic cross-section from Sample 1-4 is shown during examination with a stereomicroscope. The thickest location(s) are shown, as well as the thickness remaining underneath the deepest observed pit. (7X)

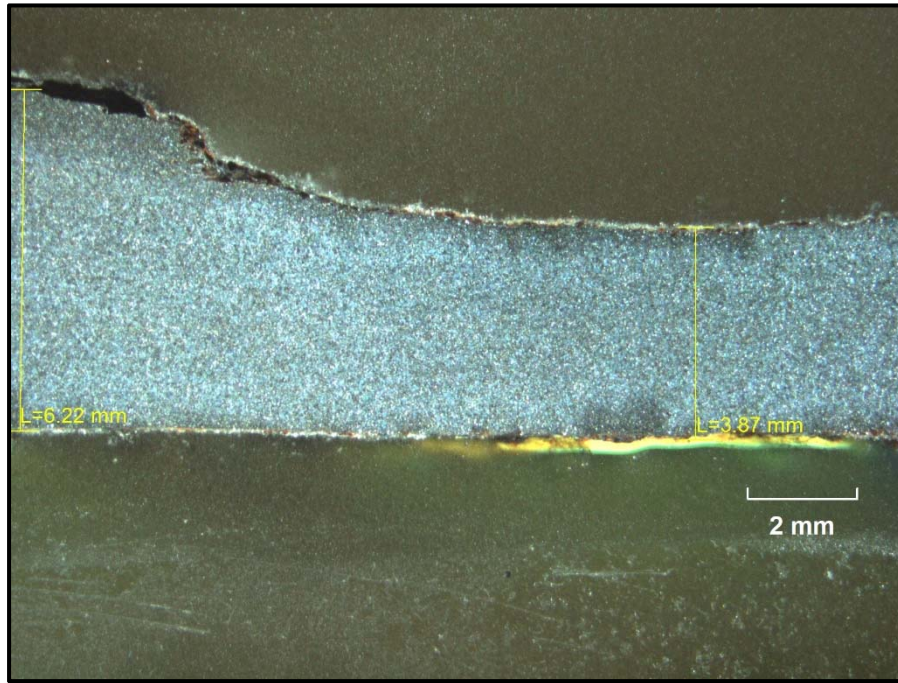
Figure 183. The prepared metallographic cross-section from Sample 2-1 is shown during examination with a stereomicroscope. The thickest location(s) are shown, as well as the thickness remaining underneath the deepest observed pit. (7X)

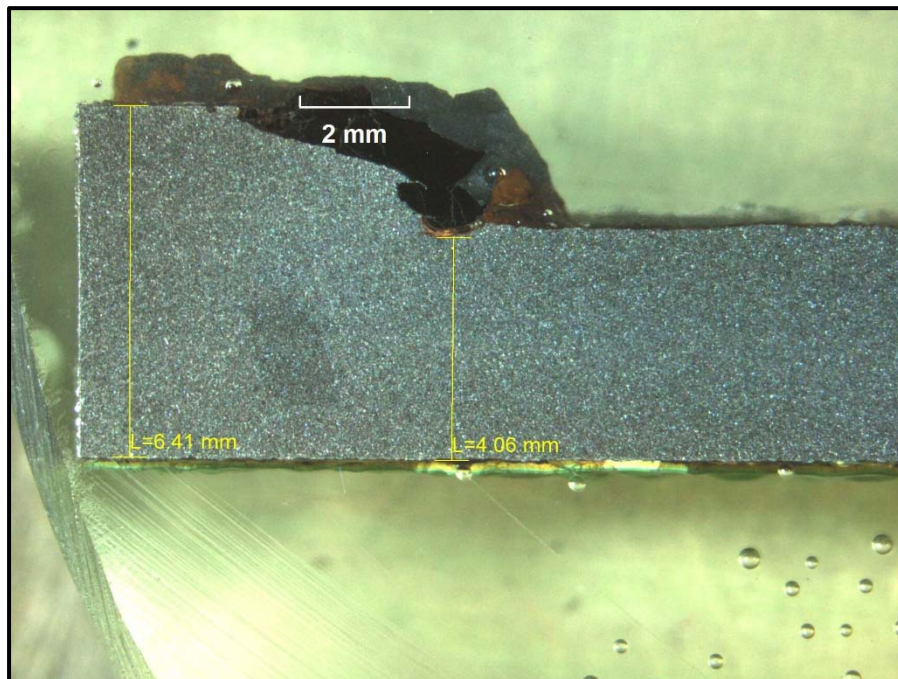
Figure 184. The prepared metallographic cross-section from Sample 2-2 is shown during examination with a stereomicroscope. The thickest location(s) are shown, as well as the thickness remaining underneath the deepest observed pit. (7X)

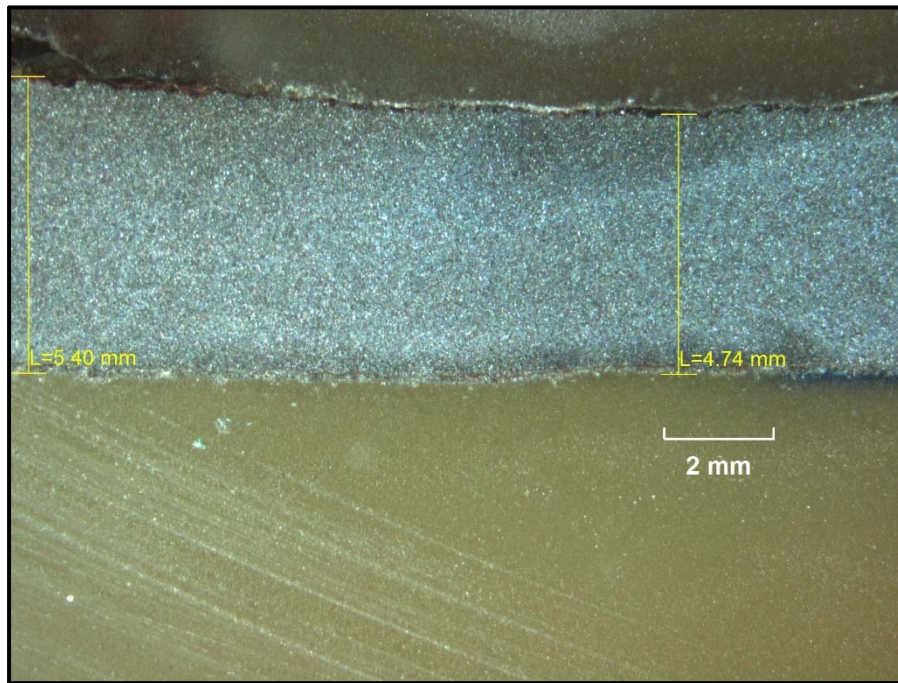
Figure 185. The prepared metallographic cross-section from Sample 2-3 is shown during examination with a stereomicroscope. The thickest location(s) are shown, as well as the thickness remaining underneath the deepest observed pit. (7X)

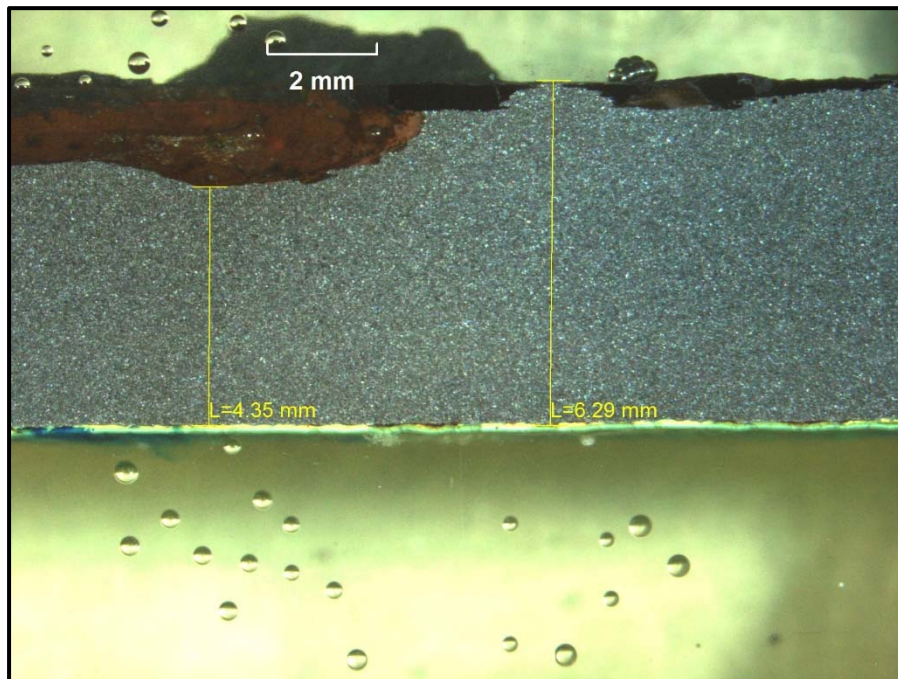
Figure 186. The prepared metallographic cross-section from Sample 3-1 is shown during examination with a stereomicroscope. The thickest location(s) are shown, as well as the thickness remaining underneath the deepest observed pit. (7X)

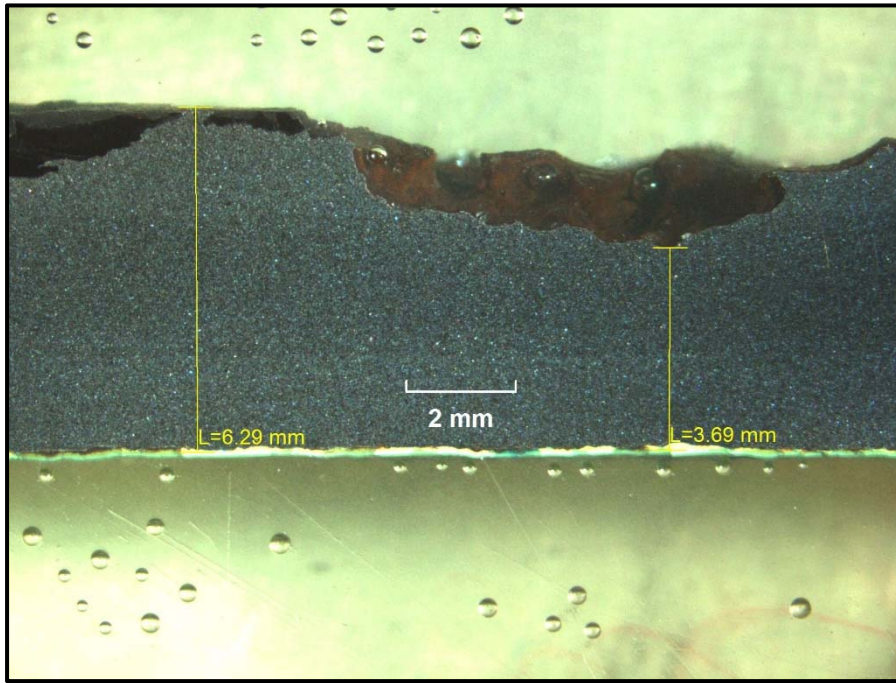
Figure 187. The prepared metallographic cross-section from Sample 3-2 is shown during examination with a stereomicroscope. The thickest location(s) are shown, as well as the thickness remaining underneath the deepest observed pit. (7X)

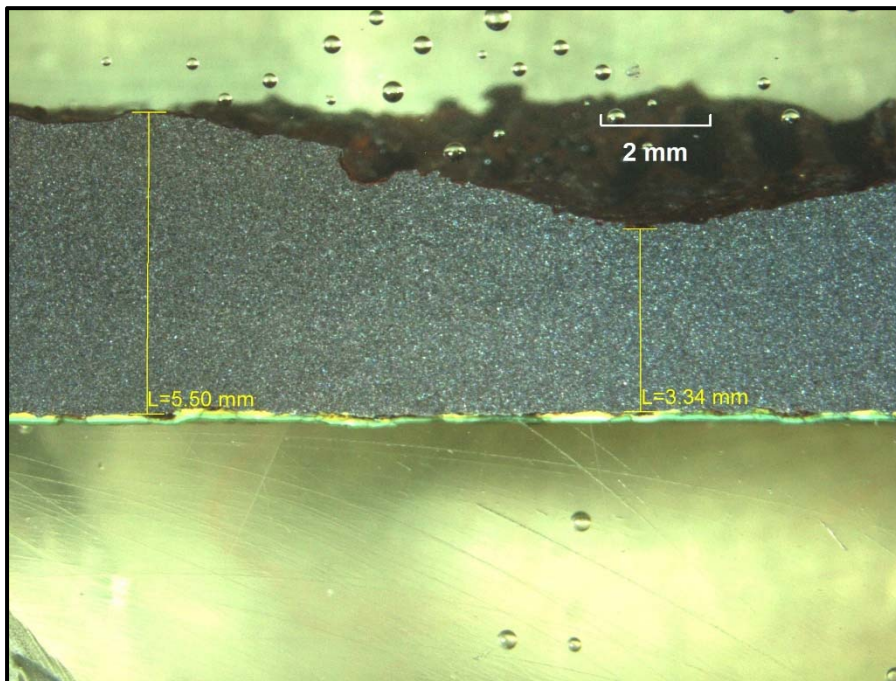
Figure 188. The prepared metallographic cross-section from Sample 3-3 is shown during examination with a stereomicroscope. The thickest location(s) are shown, as well as the thickness remaining underneath the deepest observed pit. (7X)

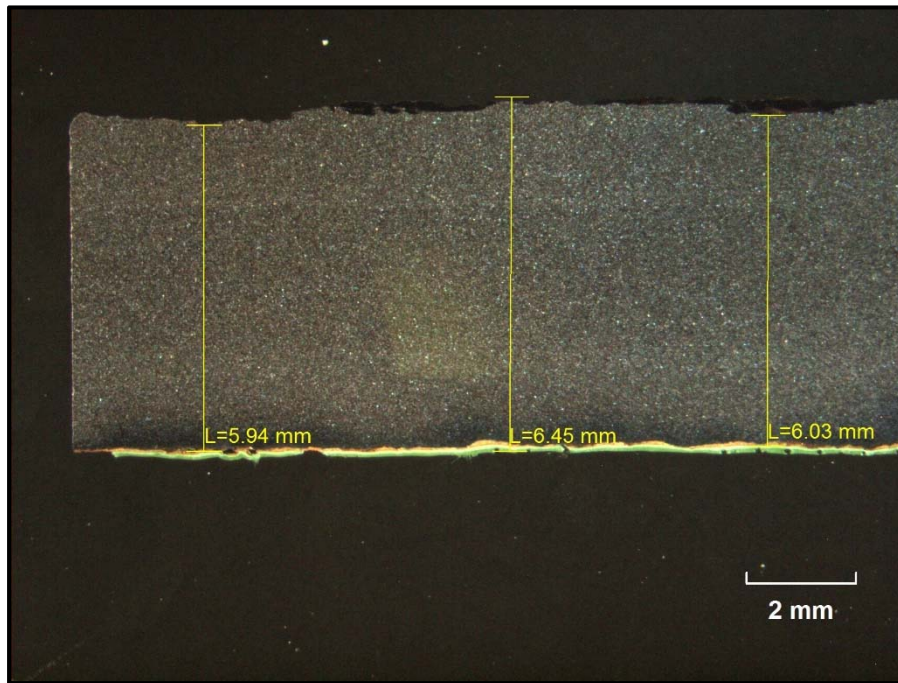
Figure 189. The prepared metallographic cross-section from Sample 3-4 is shown during examination with a stereomicroscope. The thickest location(s) are shown, as well as the thickness remaining underneath the deepest observed pit. (7X)

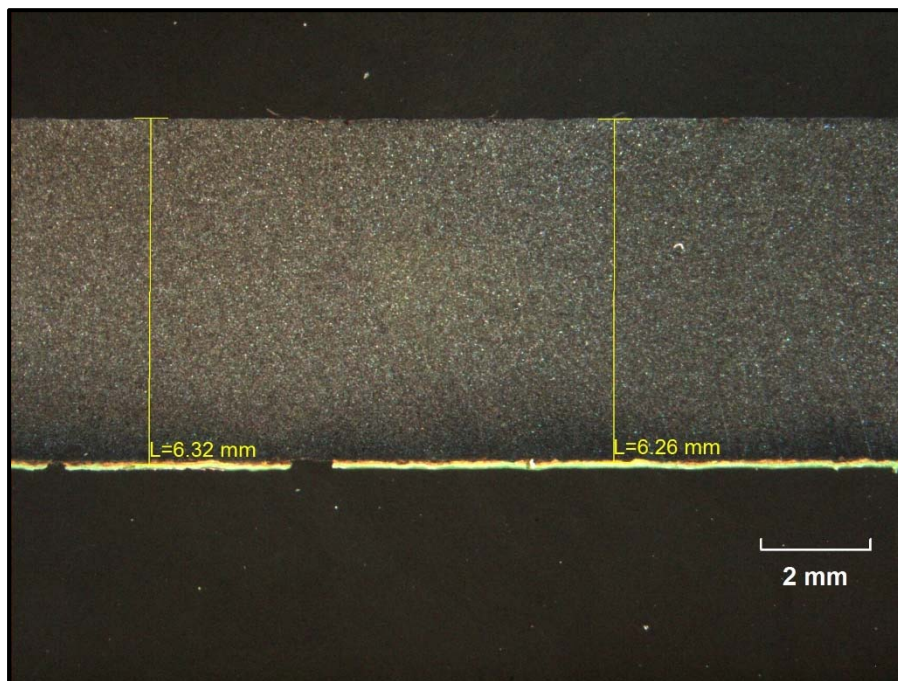
Figure 190. The prepared metallographic cross-section from Sample 5-1 is shown during examination with a stereomicroscope. No significant corrosion was observed. (7X)

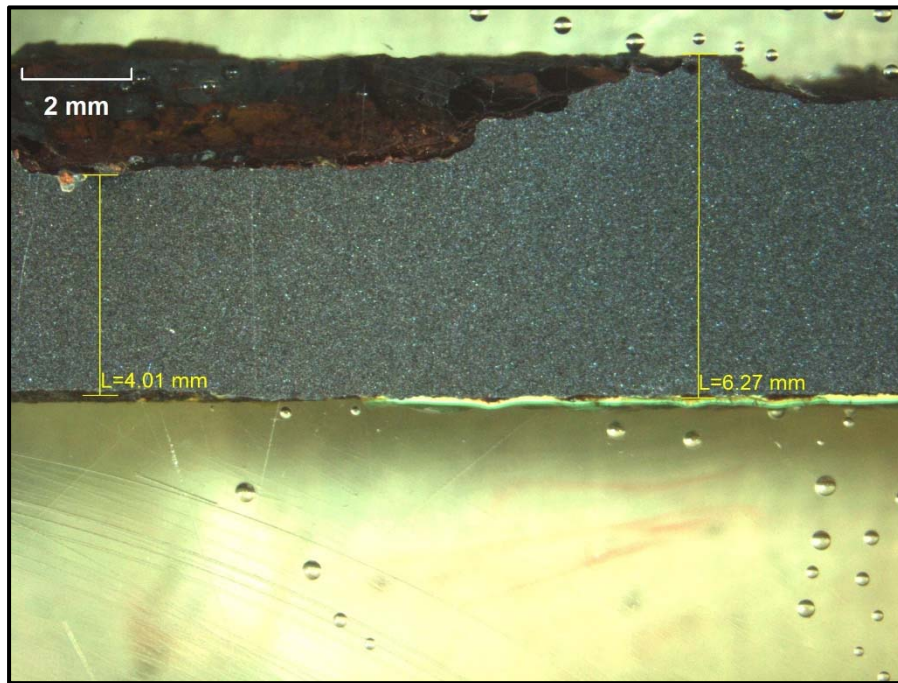
Figure 193. The prepared metallographic cross-section from Sample 6-1 is shown during examination with a stereomicroscope. The thickest location(s) are shown, as well as the thickness remaining underneath the deepest observed pit. (7X)

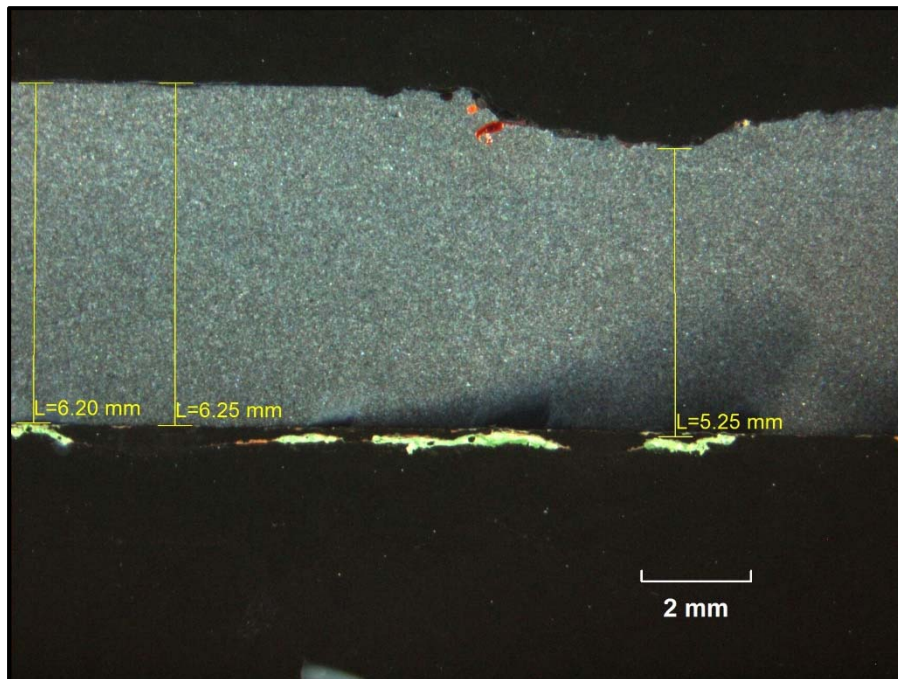
Figure 194. The prepared metallographic cross-section from Sample 6-2 is shown during examination with a stereomicroscope. The thickest location(s) are shown, as well as the thickness remaining underneath the deepest observed pit. (7X)

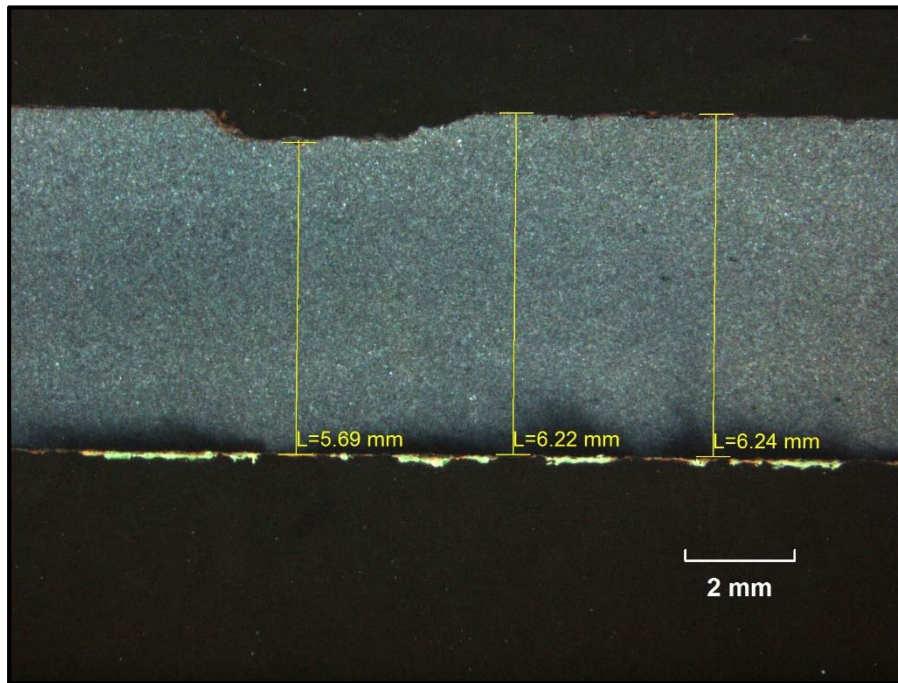
Figure 195. The prepared metallographic cross-section from Sample 6-3 is shown during examination with a stereomicroscope. The thickest location(s) are shown, as well as the thickness remaining underneath the deepest observed pit. (7X)

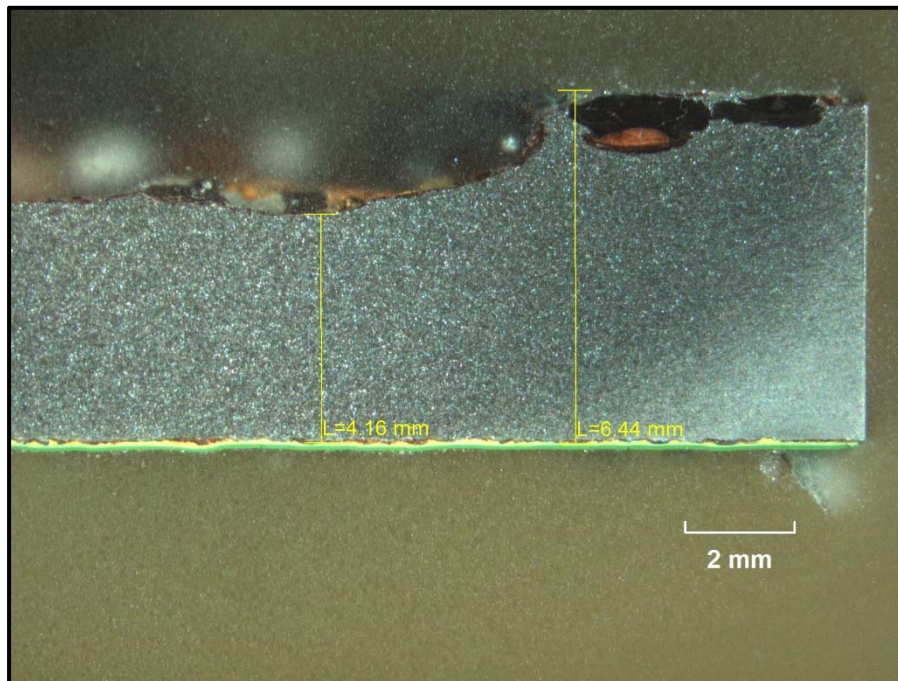
Figure 196. The prepared metallographic cross-section from Sample 7-1 is shown during examination with a stereomicroscope. The thickest location(s) are shown, as well as the thickness remaining underneath the deepest observed pit. (7X)

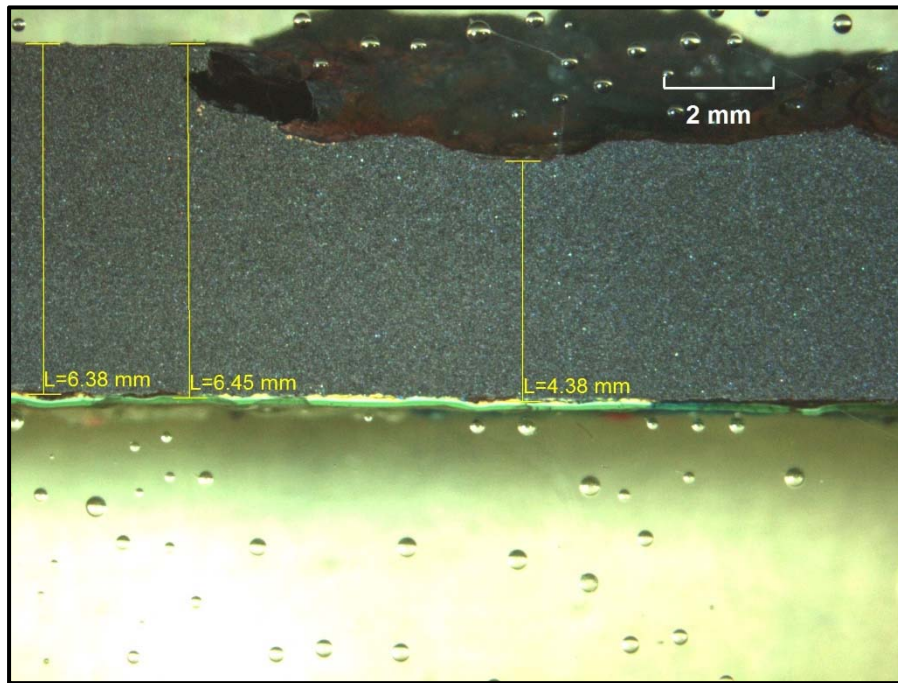
Figure 197. The prepared metallographic cross-section from Sample 7-3 is shown during examination with a stereomicroscope. The thickest location(s) are shown, as well as the thickness remaining underneath the deepest observed pit. (7X)

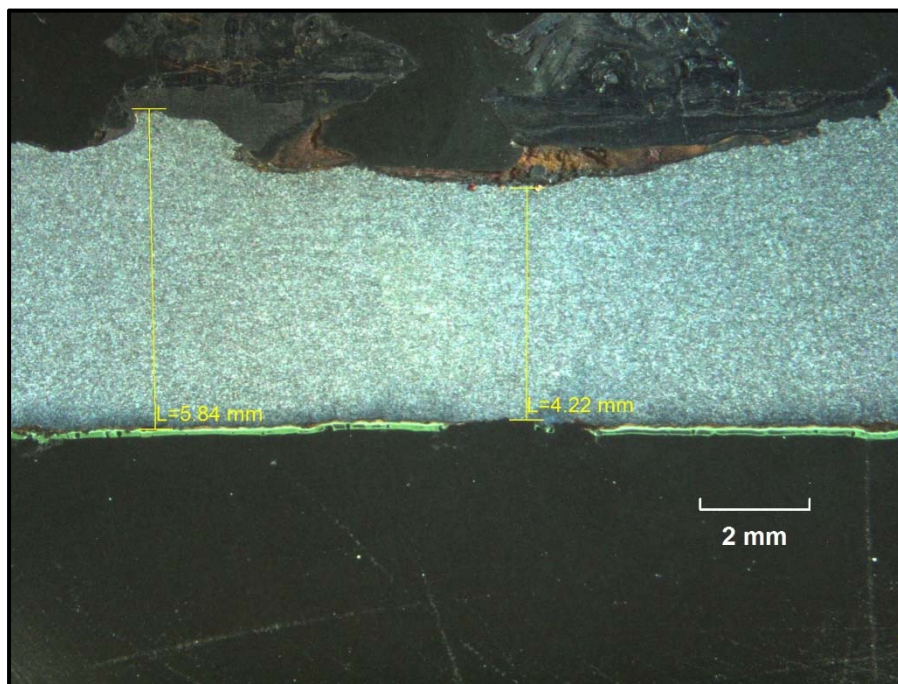
Figure 198. The prepared metallographic cross-section from Sample 7-4 is shown during examination with a stereomicroscope. The thickest location(s) are shown, as well as the thickness remaining underneath the deepest observed pit. (7X)

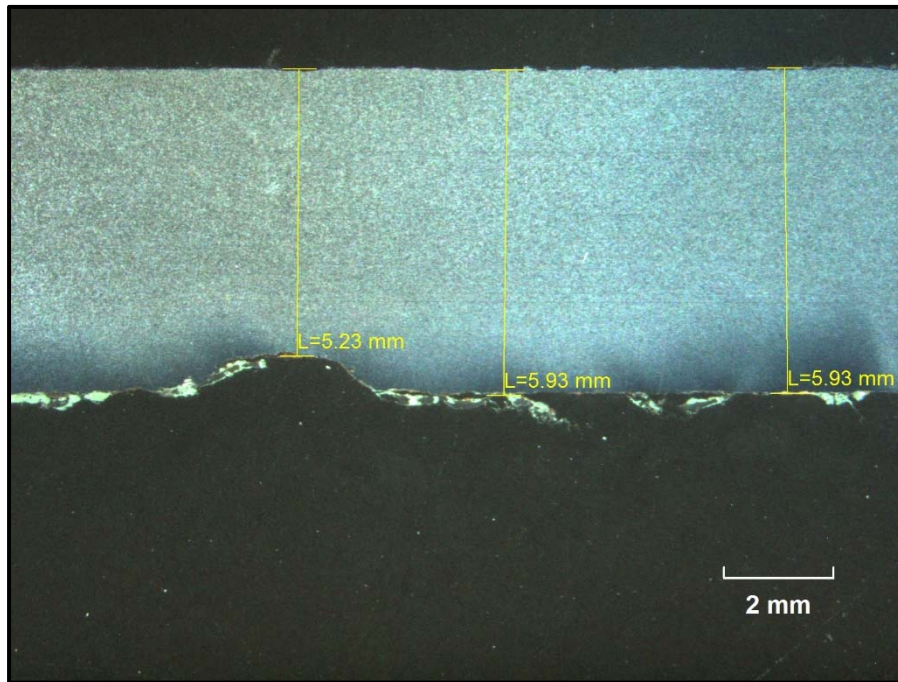
④ This is the weld-repaired plate section. Sample 8-3 exhibited a depression or pit on the painted surface.

Figure 199. The prepared metallographic cross-section from Sample 8-3 is shown during examination with a stereomicroscope. The thickest remaining wall is shown. Note that the reduction in wall thickness was due to a depression on the painted face of the specimen. (7X)

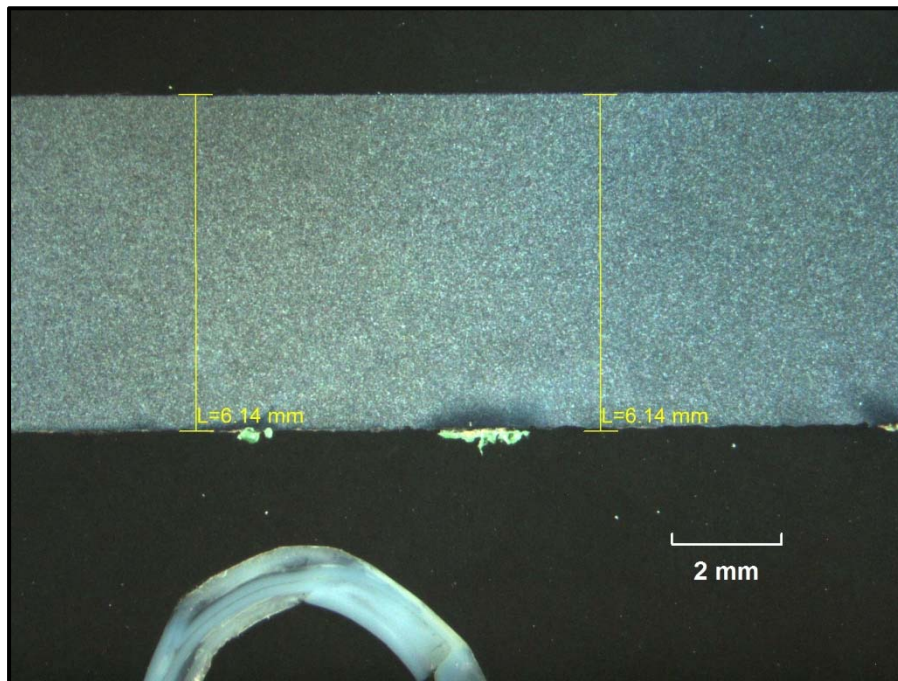
Figure 200. The prepared metallographic cross-section from Sample 10-1 is shown during examination with a stereomicroscope. The thickest location(s) are shown. No pitting was observed. (7X)

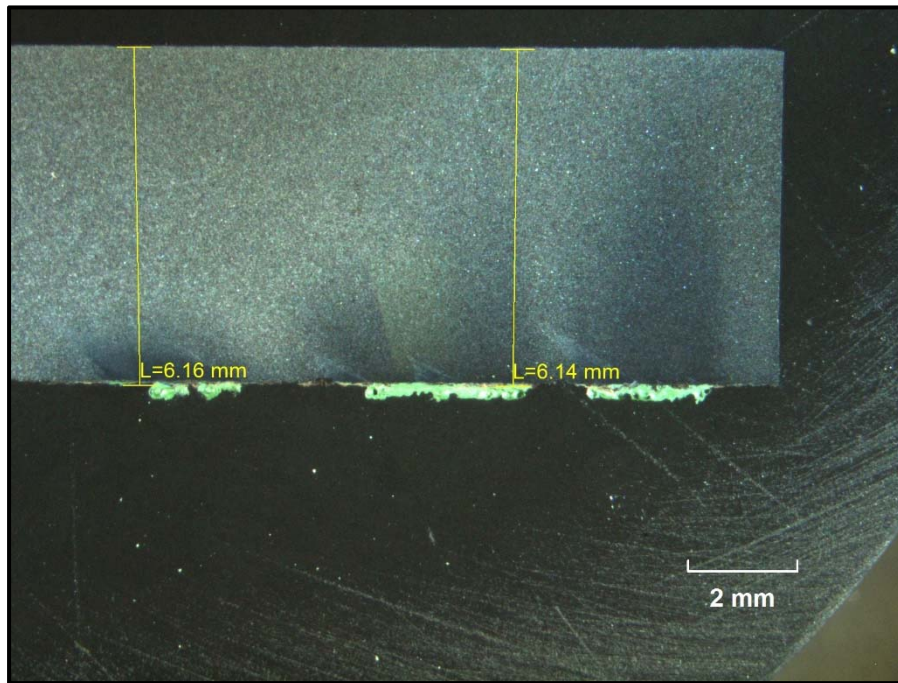
Figure 201. The prepared metallographic cross-section from Sample 10-2 is shown during examination with a stereomicroscope. The thickest location(s) are shown. No pitting was observed. (7X)

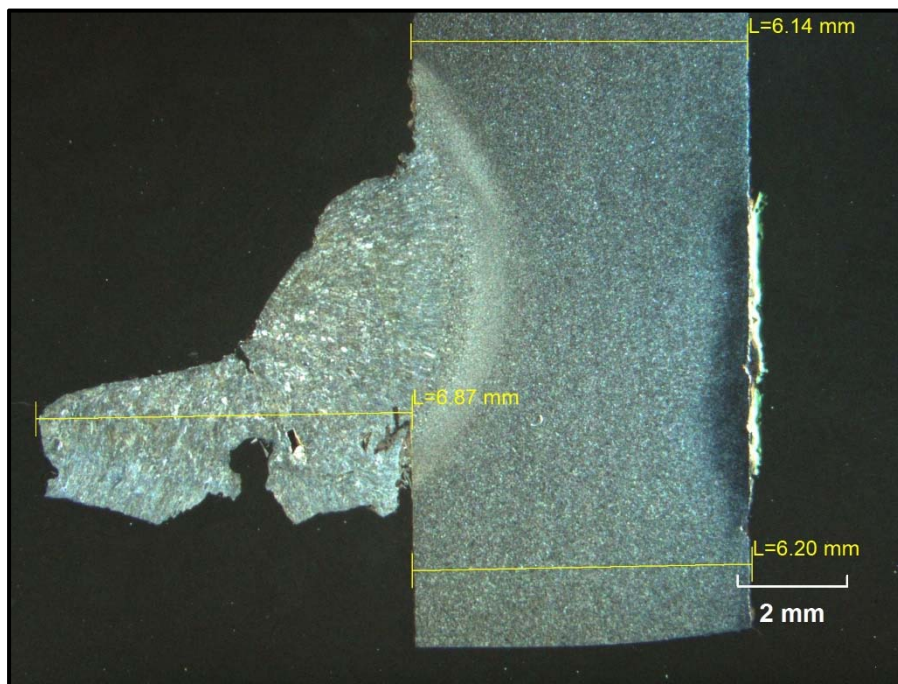
⑤ No pits observed. Suspected NDT inspection indication was a weld nugget on the interior surface of the coupon (thick area) on Sample 10-4.

Figure 202. The prepared metallographic cross-section from Sample 10-4 is shown during examination with a stereomicroscope. Image is rotated 90° from other images. The anomaly detected during NDE was likely the weld nugget on the interior surface of the coupon (left). No pitting or significant wall loss was observed. (7X)

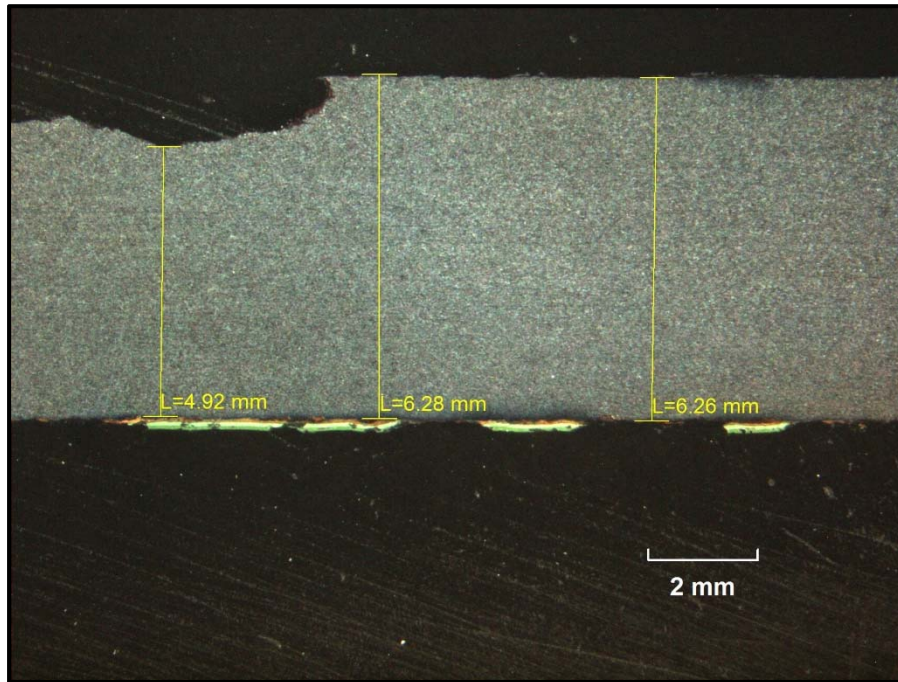
Figure 203. The prepared metallographic cross-section from Sample A1-1 is shown during examination with a stereomicroscope. The thickest location(s) are shown, as well as the thickness remaining underneath the deepest observed pit. (7X)

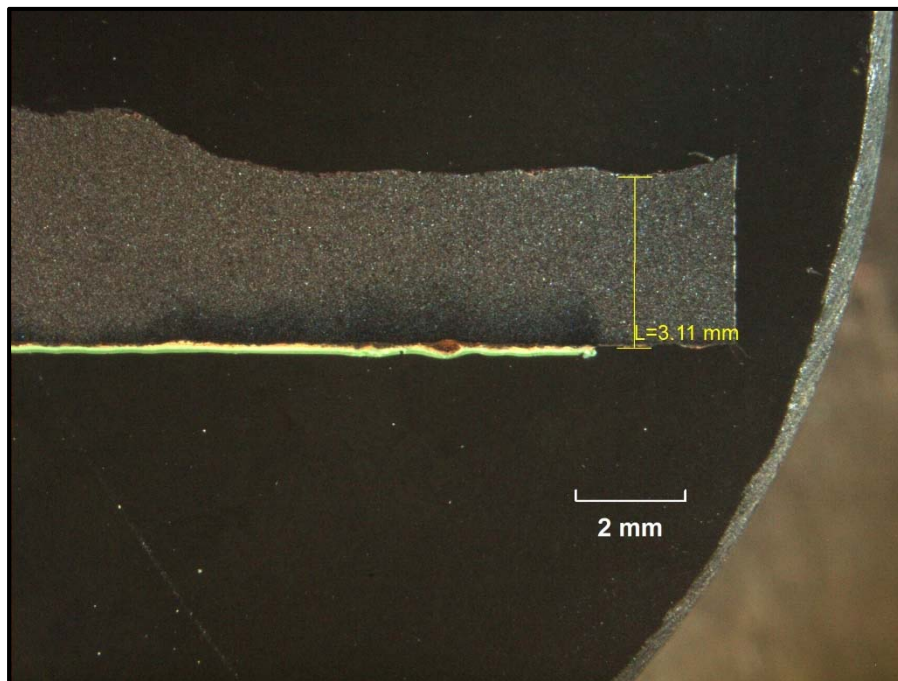
Figure 204. The prepared metallographic cross-section from Sample A1-4 is shown during examination with a stereomicroscope. The thickness remaining underneath the deepest observed pit is shown. (7X)

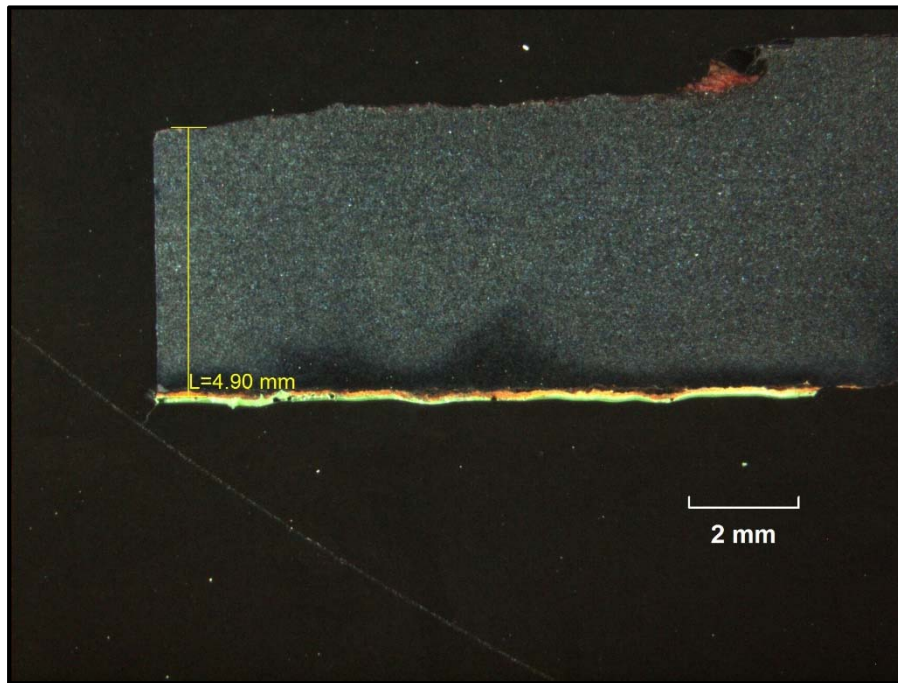
Figure 205. The prepared metallographic cross-section from Sample A1-5 is shown during examination with a stereomicroscope. The thickness remaining underneath the deepest observed pit is shown. (7X)

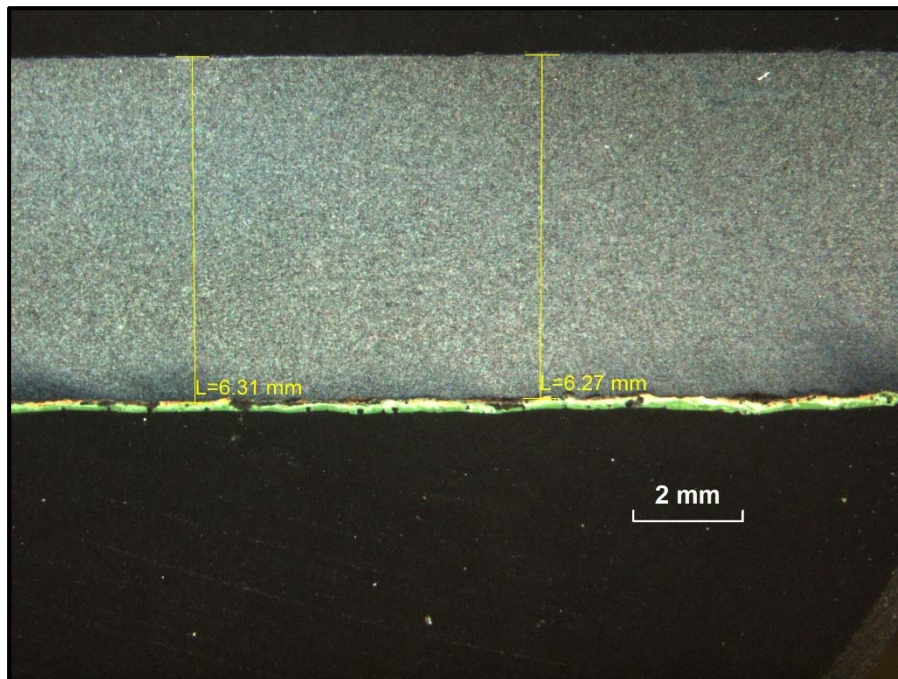
Figure 206. The prepared metallographic cross-section from Sample A2-3 is shown during examination with a stereomicroscope. No pitting was observed. (7X)

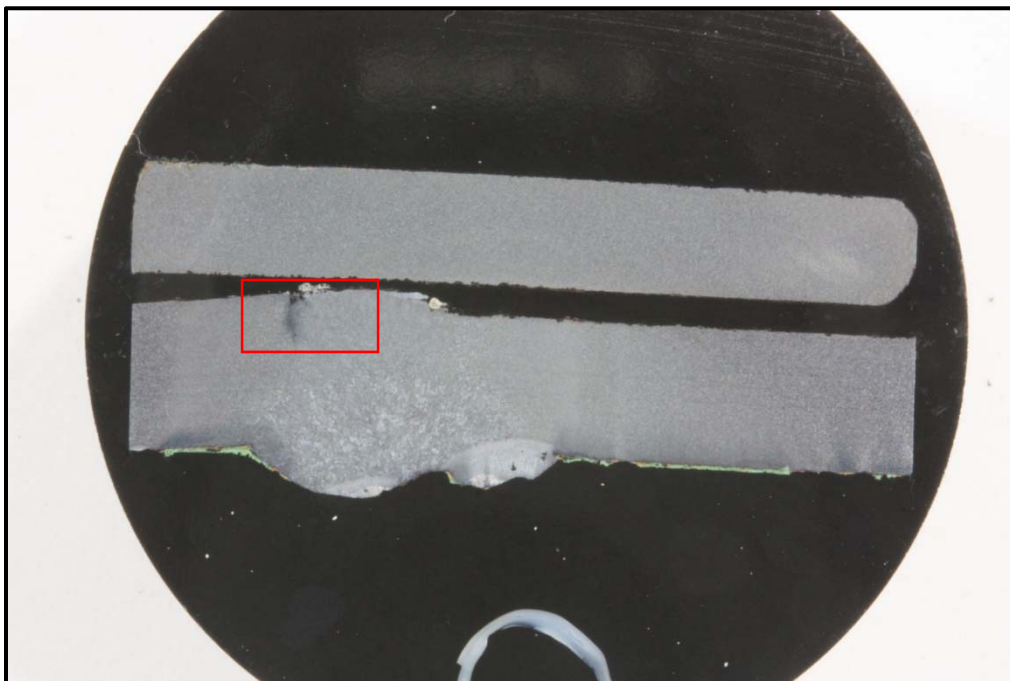
Coupon 8 exhibited what is presumed to be a prior weld repair and/or addition of a backing plate, where a patch was made on the tank wall. Representative images of the welds are presented as Figures 208 through 213. A full weld evaluation is outside the scope of this effort. The results are thus provided for information only.

Figure 208. The prepared metallographic cross-section through welded sample 8-1 is shown in an overall view. The painted exterior surface is along the bottom section. The area identified by the red box is shown in the next figure at higher magnification.
