SUBJECT: ADMINISTRATIVE ORDER ON CONSENT (AOC) STATEMENT OF WORK (SOW) SECTION 5 CORROSION AND METAL FATIGUE PRACTICES, DESTRUCTIVE TESTING RESULTS REPORT, RED HILL BULK FUEL STORAGE FACILITY (RED HILL), JOINT BASE PEARL HARBOR-HICKAM, OAHU, HAWAII

As identified in Red Hill Bulk Fuel Storage Facility Scope of Work for Destructive Testing Administrative Order on Consent (AOC) and Statement of Work (SOW) Section 5.3.2, the purpose of this effort is to verify the findings of the Corrosion and Metal Fatigue Practices Report, using destructive testing on at least one tank at the Facility.

In 2018, ten coupons were removed from Tank 14, so that a metallurgical and corrosion analysis of the coupons could be undertaken, with the primary aim of validating non-destructive examination (NDE) results. The steel coupons, concrete powder samples, and corrosion product were submitted to a certified third-party laboratory to perform this analysis.

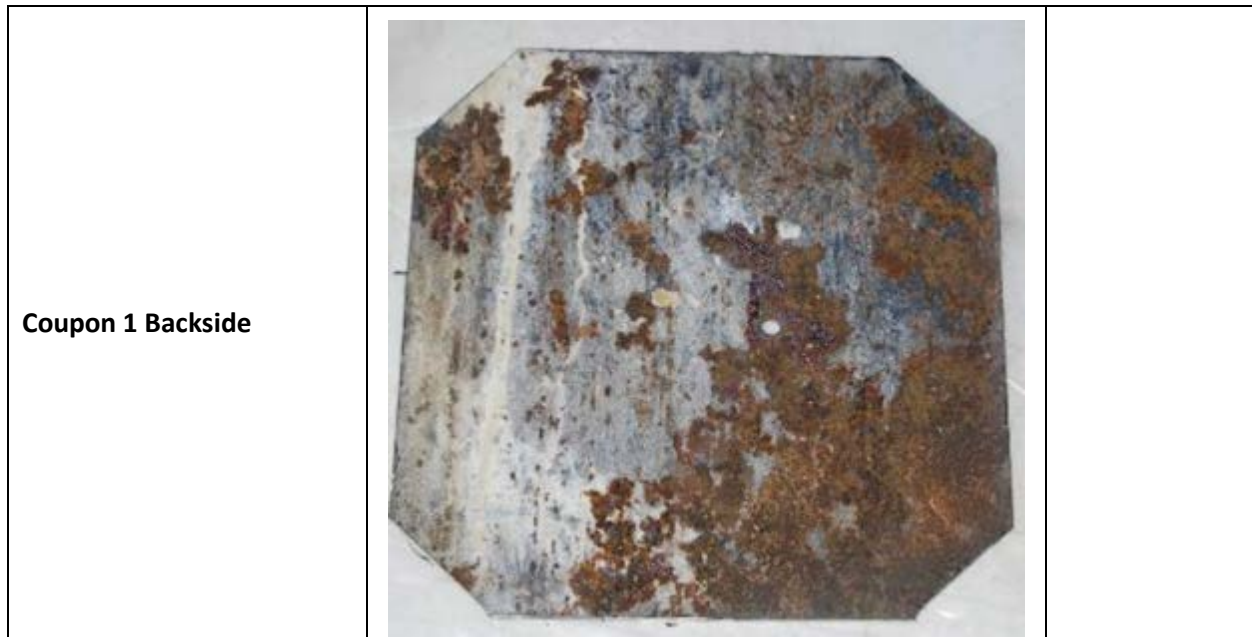
Table 3-1 Coupon 1 On-Site Condition Assessment

The concrete behind Coupon 1 was sound concrete with no cracks or delaminations. Table 3-1 contains the on-site concrete observations and test results.

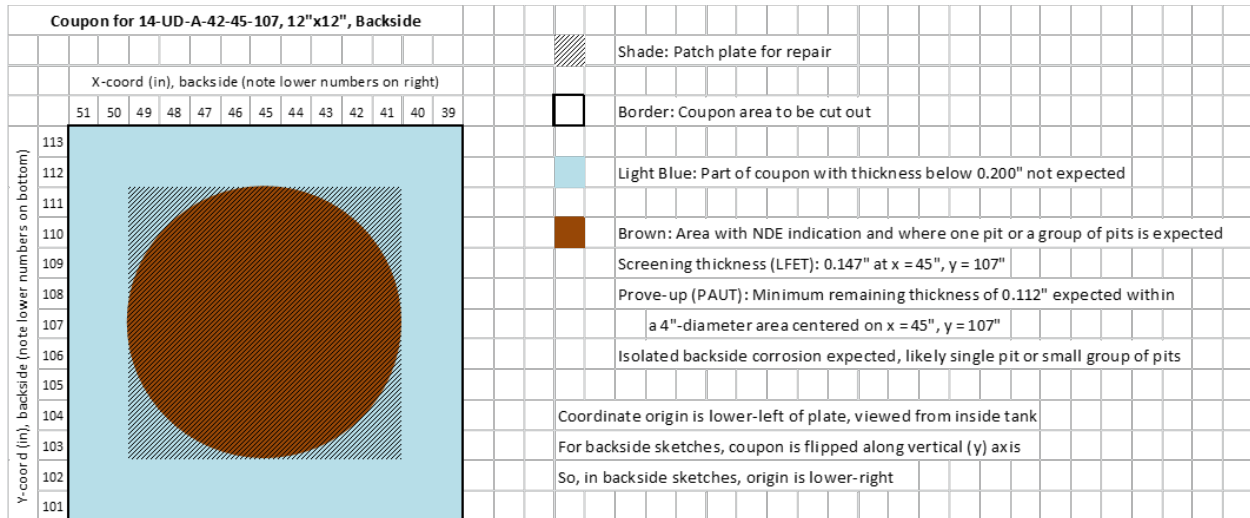
Figure 4-1 Expected Results from NDE Spreadsheet Data, Coupon 1

Destructive testing found pitting and minimum wall thickness of 0.208 inch. Remaining wall thickness greater than expected (208 mils vs. 112 mils). This deviation exceeded the 20 mils accuracy range for pitting.

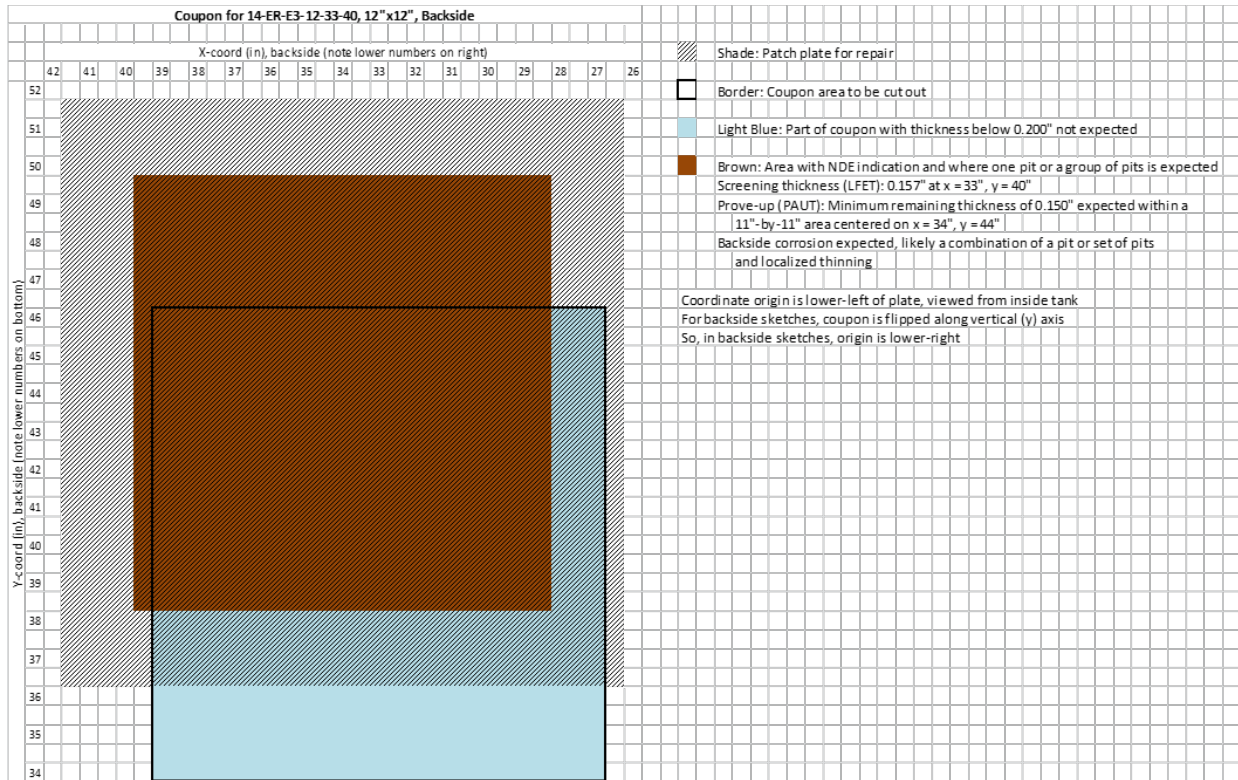
Figure 4-3 Expected Results from NDE Spreadsheet Data, Coupon 2

Remaining wall thickness as expected (152 mils vs. 150 mils). The LFET result fell within the 20 mils accuracy range for pitting.

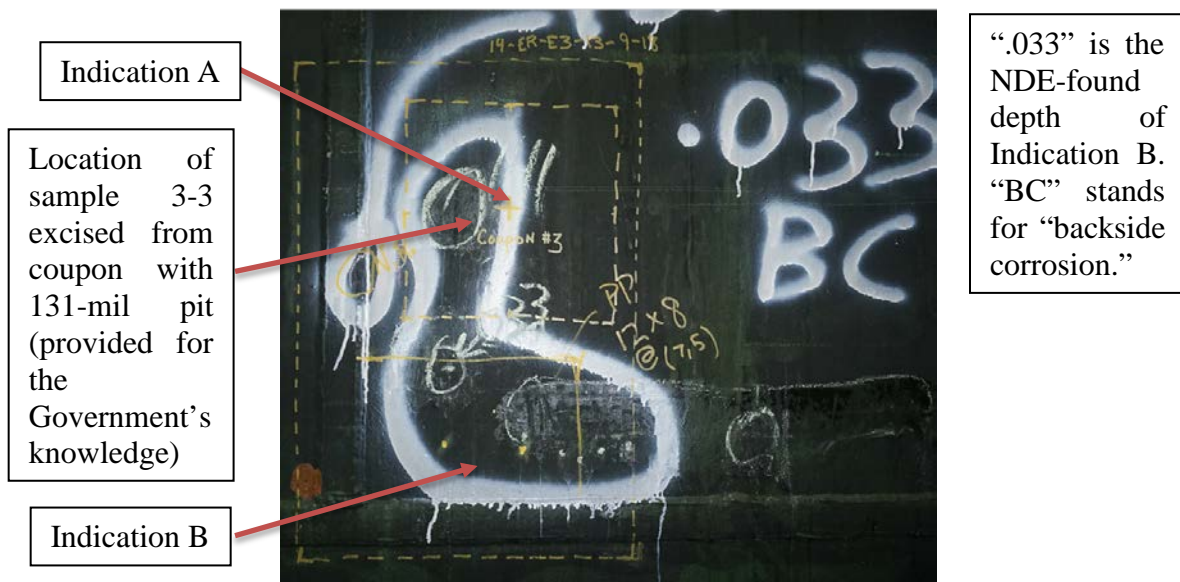
Figure 4-7 Location of Coupon 3 Prior to Removal

Laboratory results from Coupon 3 showed an area of remaining thickness of 131 mils, which is actionable. This thickness is within the layout area of Indication B.

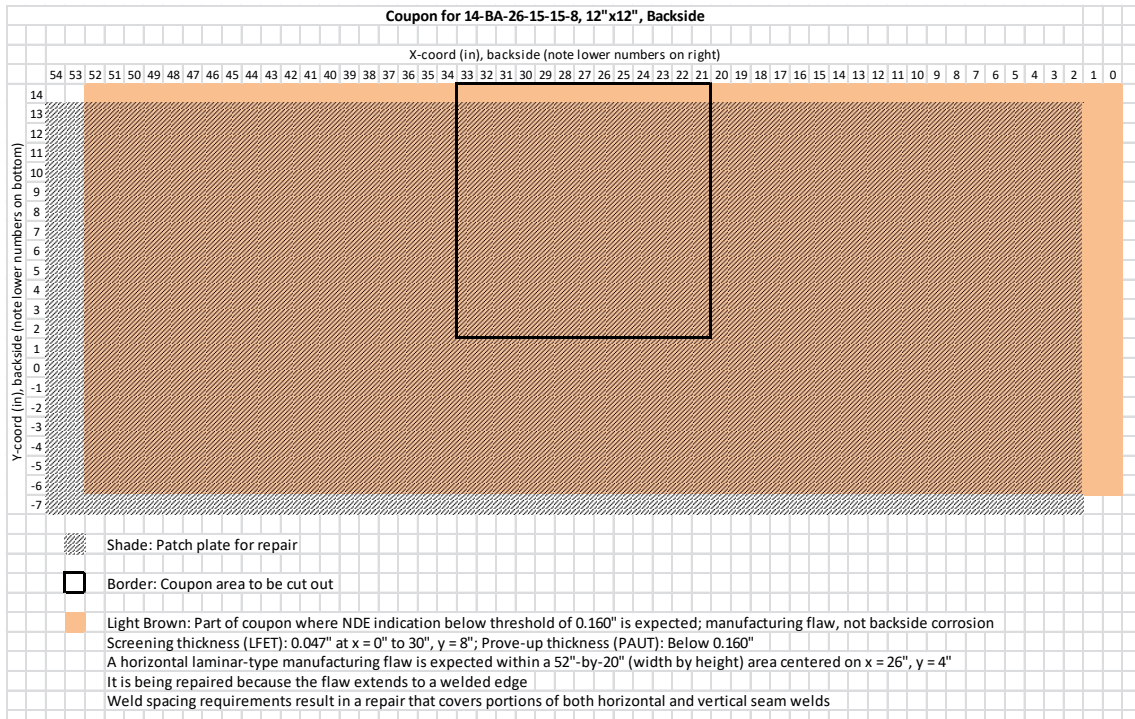
Figure 4-9 Expected Results from NDE Spreadsheet Data, Coupon 5

Destructive testing found pitting and minimum wall thickness of 0.224 inch. The remaining wall thickness was as expected.

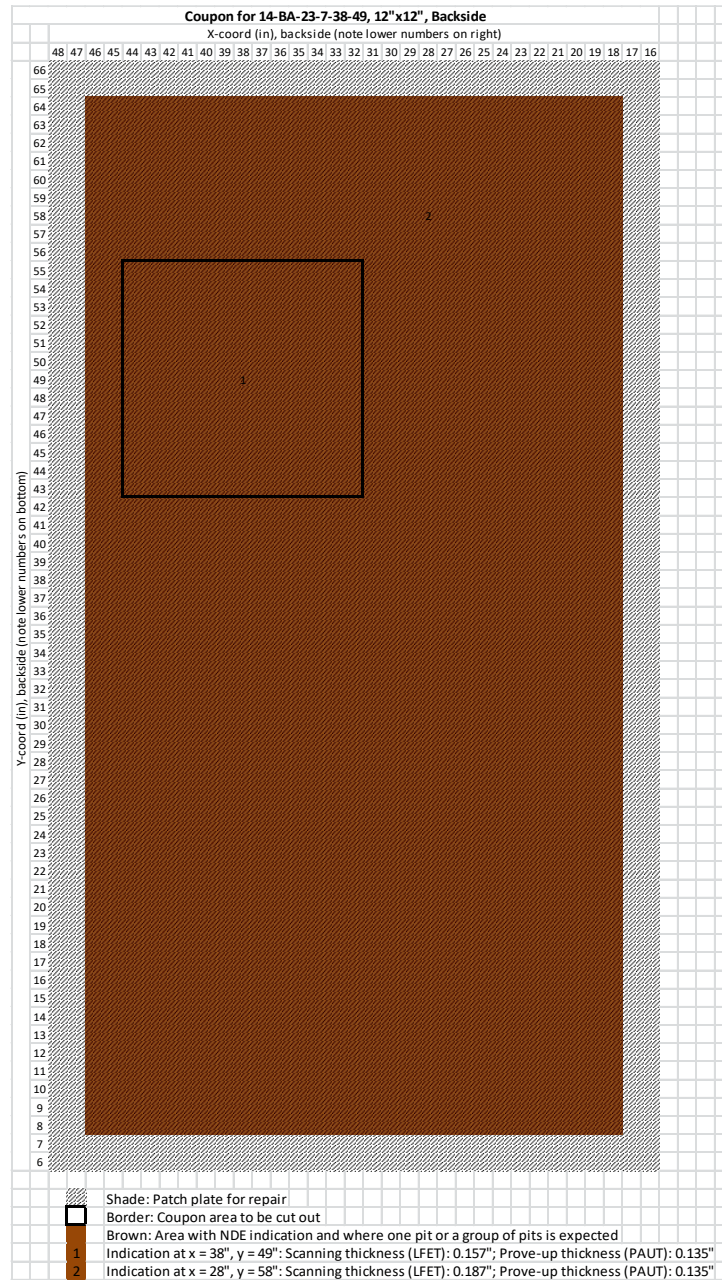
Figure 4-13 Expected Results from NDE Spreadsheet Data, Coupon 7

Destructive testing found pitting and a minimum wall thickness of 0.164 inch. The remaining wall thickness was within the 20-mil range for pitting but thicker than expected for the prove-up testing (164 mils vs. 135 mils).

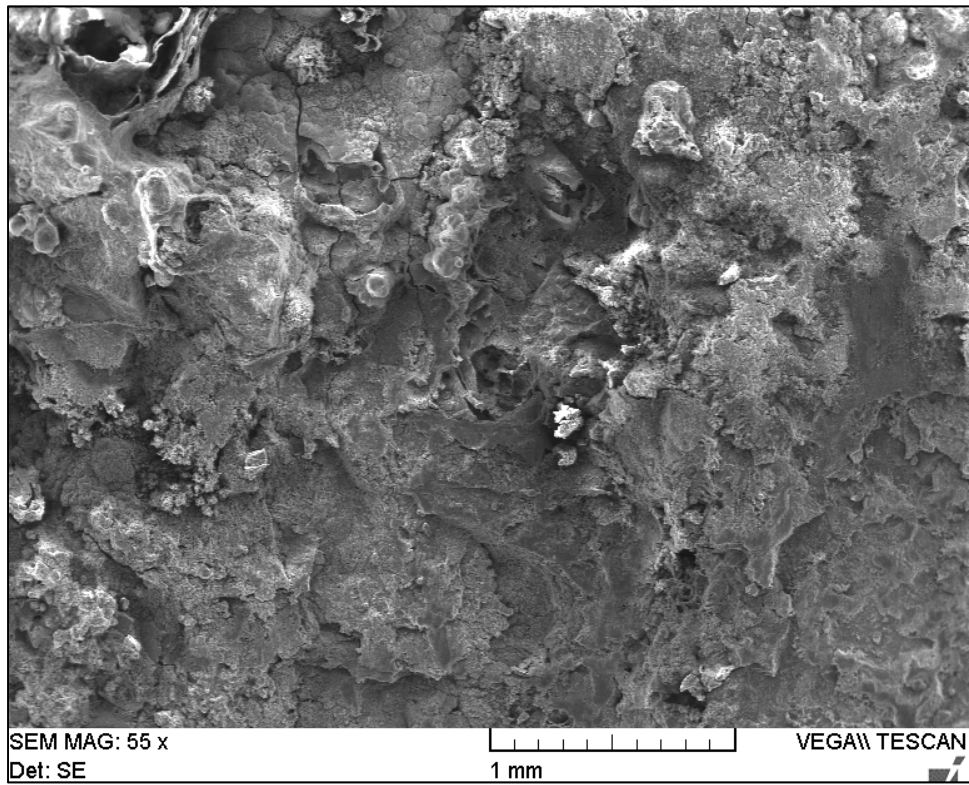
Figure 55. A representative SEM image of a pit on a specimen excised from Coupon 6 labeled as 6-3, prior to cleaning. (SEM, 32X)

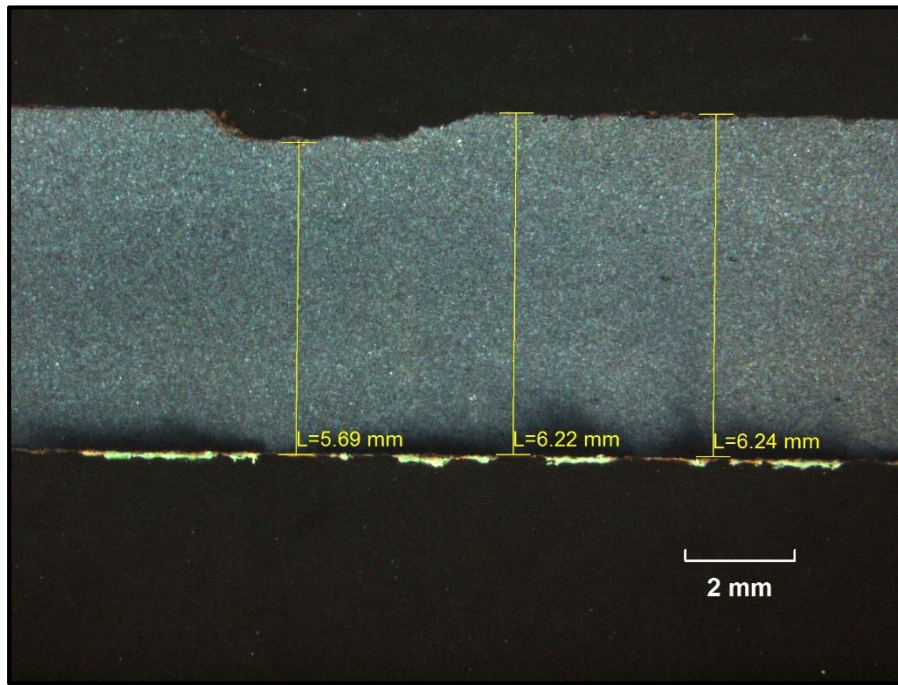
Figure 195. The prepared metallographic cross-section from Sample 6-3 is shown during examination with a stereomicroscope. The thickest location(s) are shown, as well as the thickness remaining underneath the deepest observed pit. (7X)

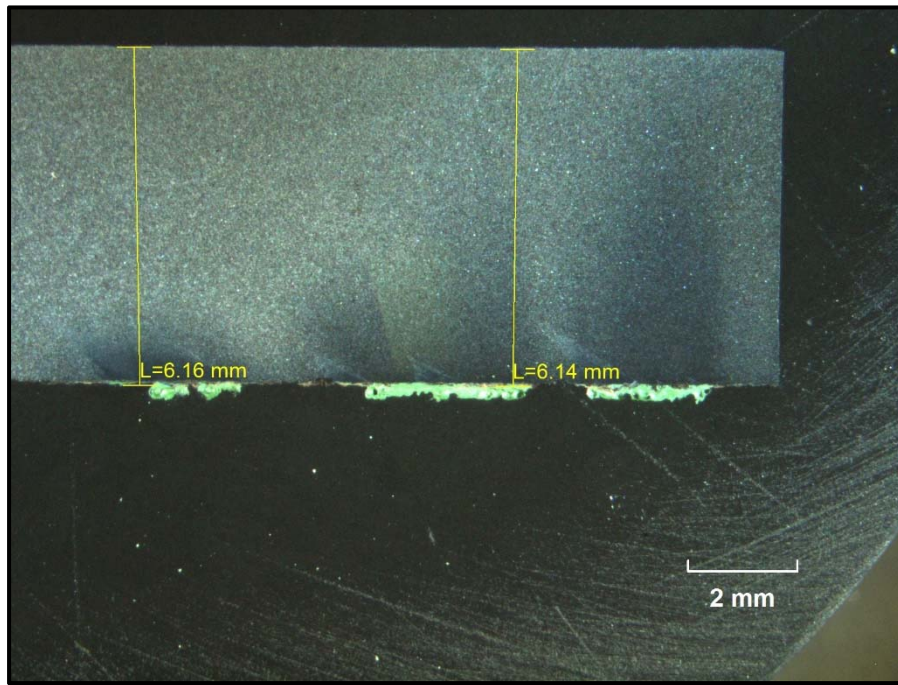
Figure 201. The prepared metallographic cross-section from Sample 10-2 is shown during examination with a stereomicroscope. The thickest location(s) are shown. No pitting was observed. (7X)

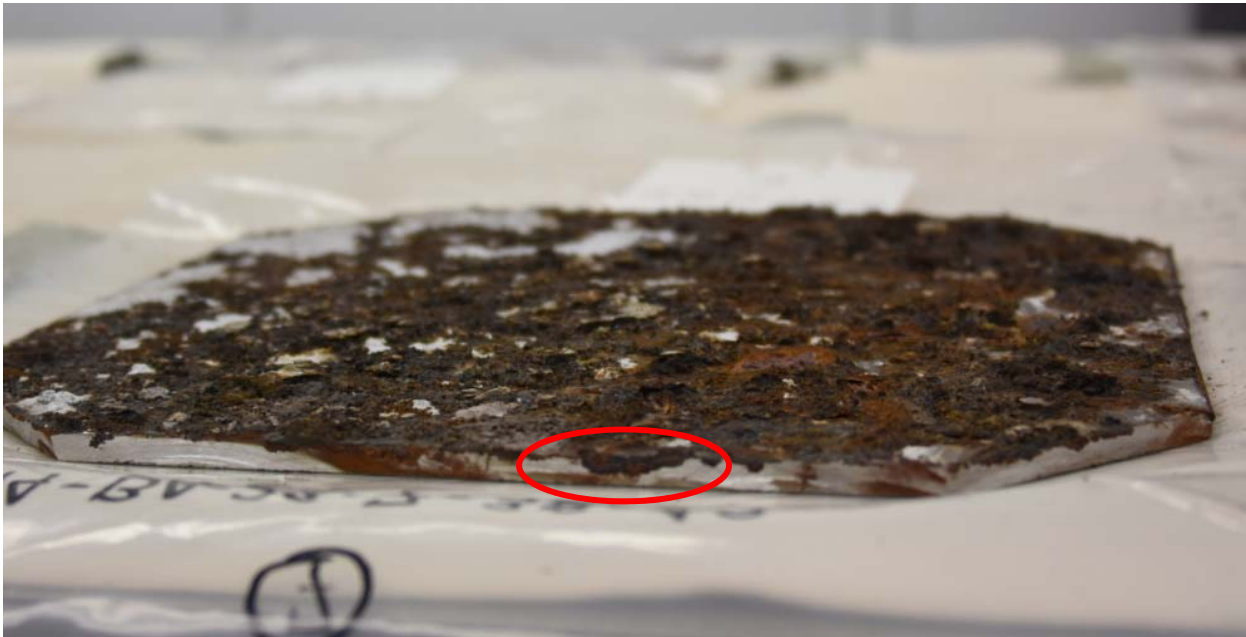
Figure A-1. Image provided by Robert Jamond on 3/20/19. This image was taken of the edge of Coupon #7 after extraction from Tank #14 and prior to shipping to IMR. The red circle identifies an area-of-concern identified prior to shipment of the coupon to IMR.

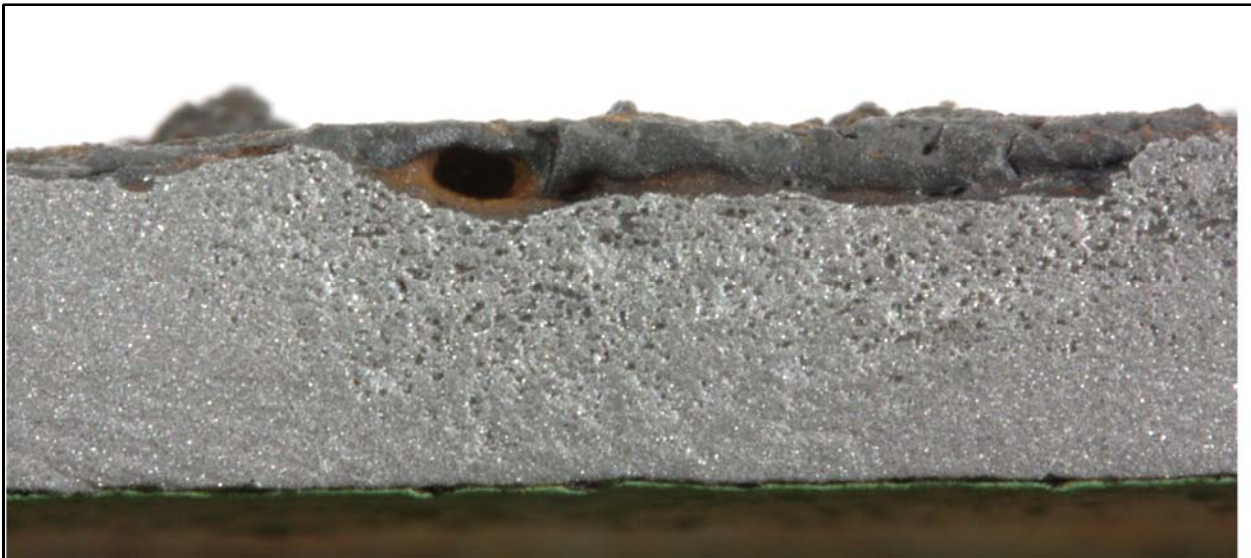
Figure A-4. Detail of the sandblasted edge on 3/20/19 in the same location as shown in the picture below. The sandblasting revealed that the feature was not a corrosion pit, as shiny metal was revealed when the red-colored staining was removed. There was an unusual appearance to the edge in this location, as though the sectioned edge had been superficially altered by heat associated with sectioning or some other post-sectioning reaction (atmospheric corrosion or corrosive media attack). That alteration gave the appearance of a deep corrosion pit.

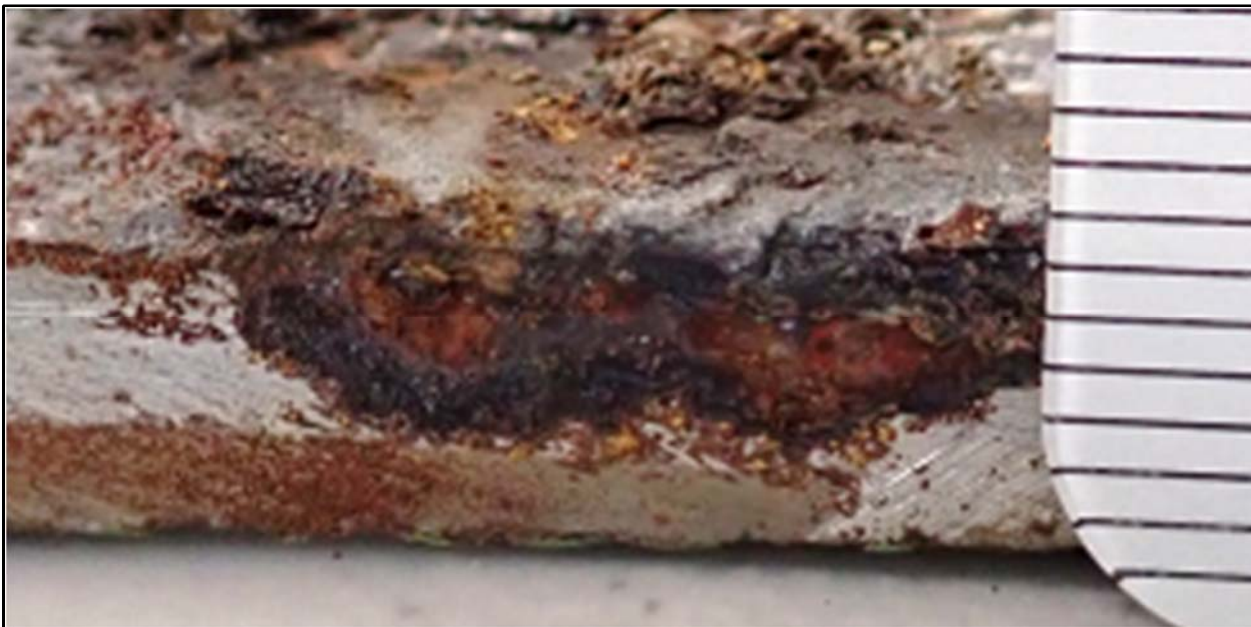
Figure A-5. The same area is shown in an image provided prior to shipping Coupon #7 to IMR (provided to IMR on March 13, 2019). What appeared to be a deep corrosion pit was actually rust-colored staining of the edge surface
