**Figure 1-1
Areas 3, 5, 7, & 11**

C & D Technologies, Inc.
200 West Main Street
Attica, Indiana

Figure 3-1
Proposed Exposure Barrier
Riverbank Area (CD-SB-59)

C & D TECHNOLOGIES
RIVERBANK CORRECTIVE MEASURES

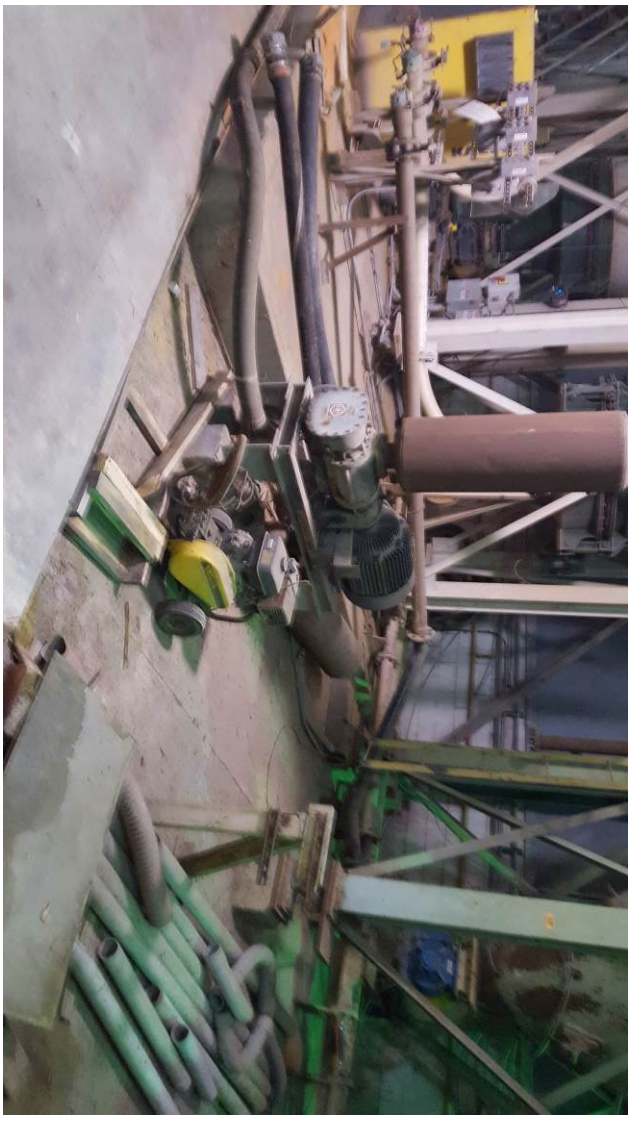
1

Representative concrete floor present in Area 3

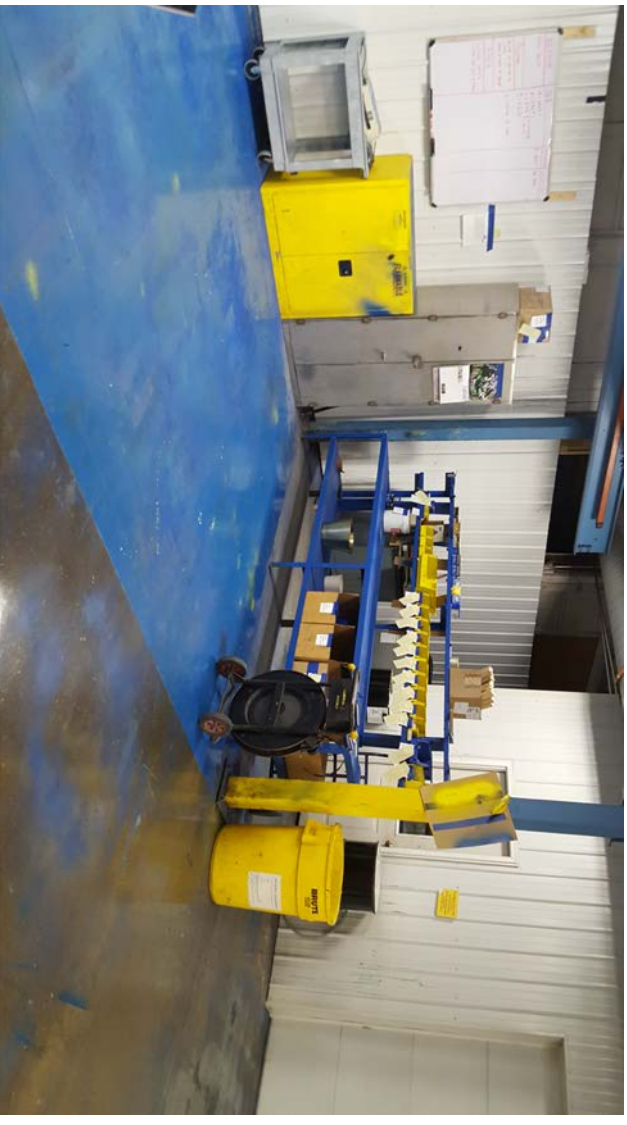
2

Representative concrete floor present in Area 7

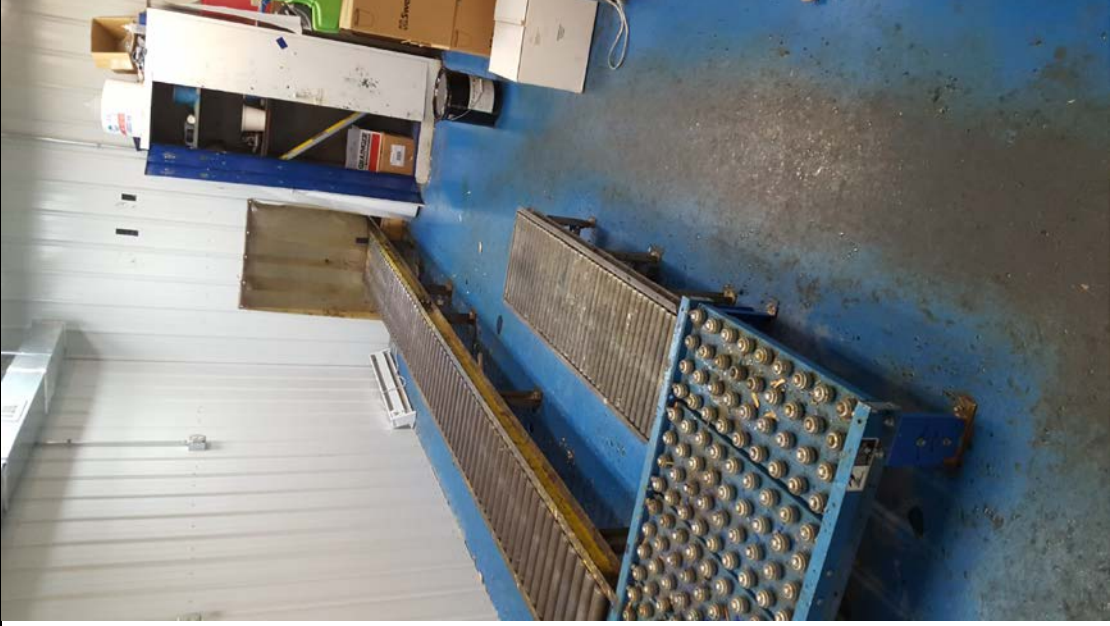
Photo No.
3

Representative
concrete floor present
in Area 7

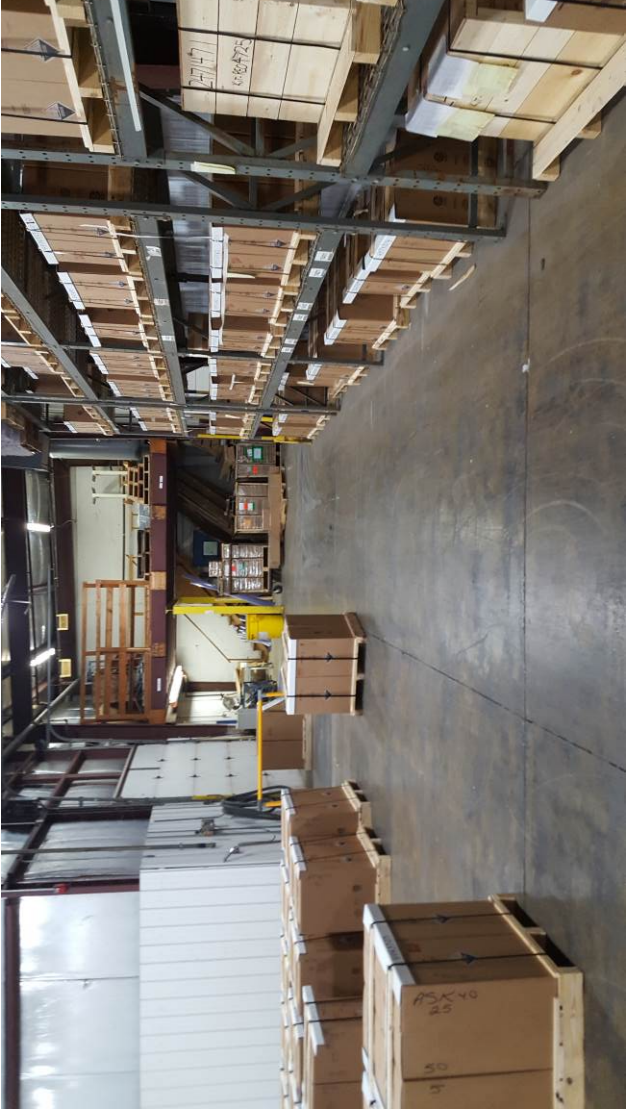
Direction Photo Taken:			
Description: Representative concrete floor present in Area 11

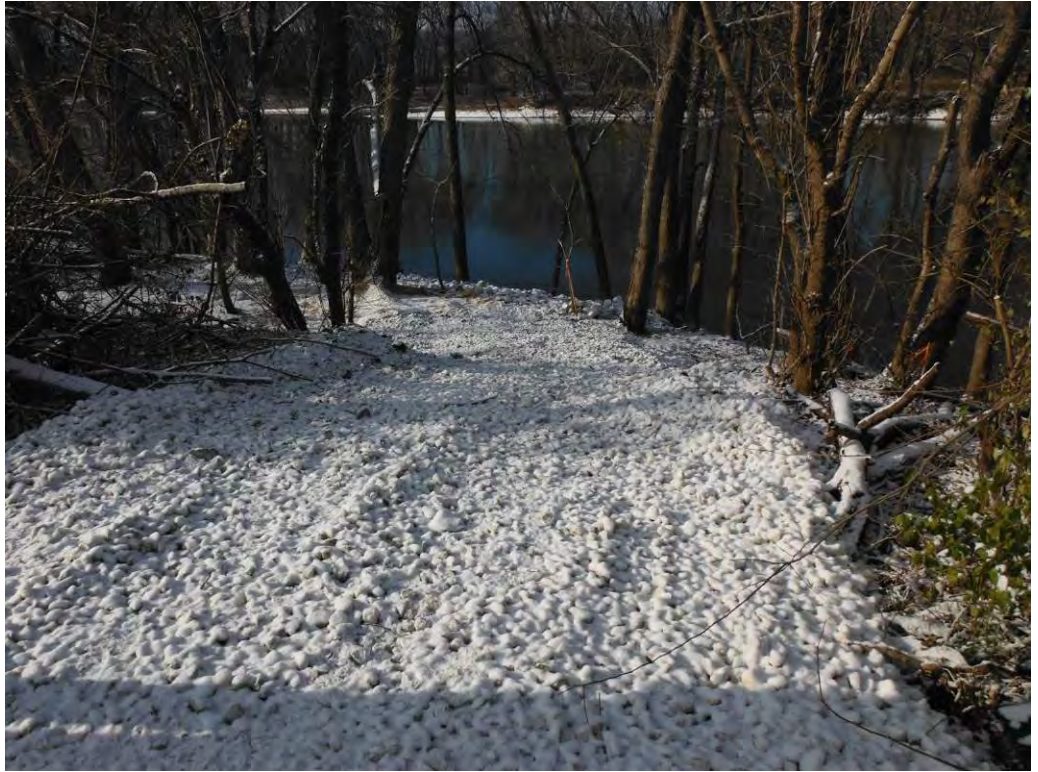
Photo No. 1	Date: 12/13/16
------------------------------	--------------------------

Description:
View east of work area from facility fence/access road.

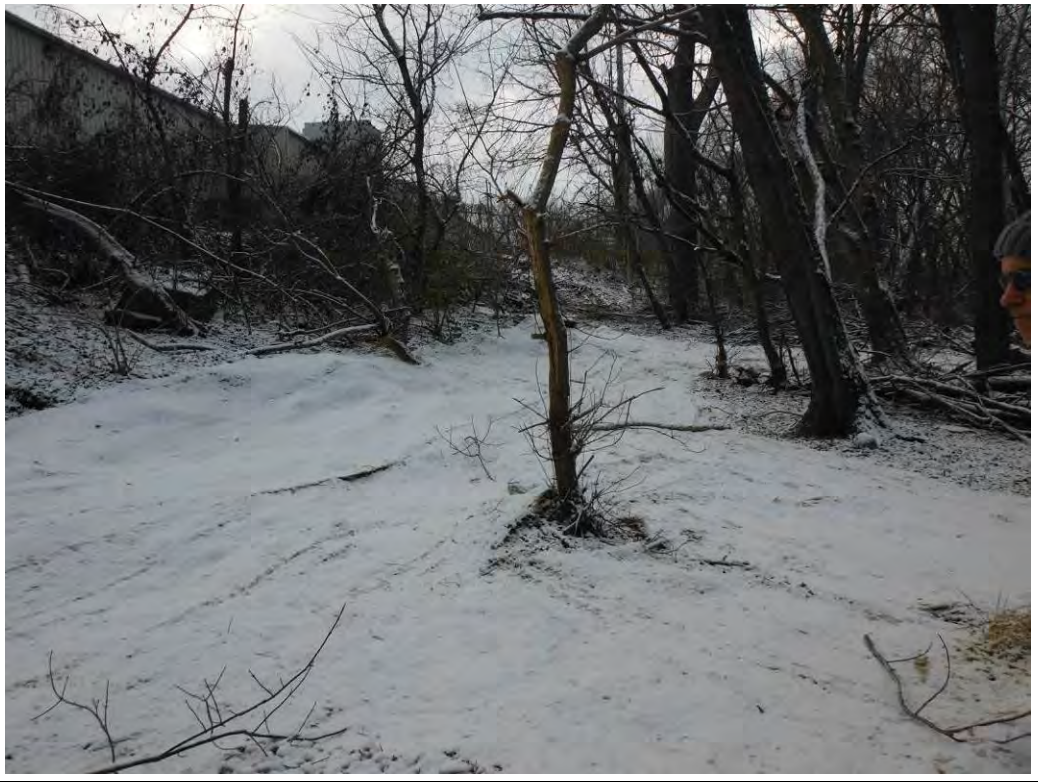
Photo No. 2	Date: 12/13/16
------------------------------	--------------------------

Description:
Previously disturbed area restored with fall mix and straw mat.

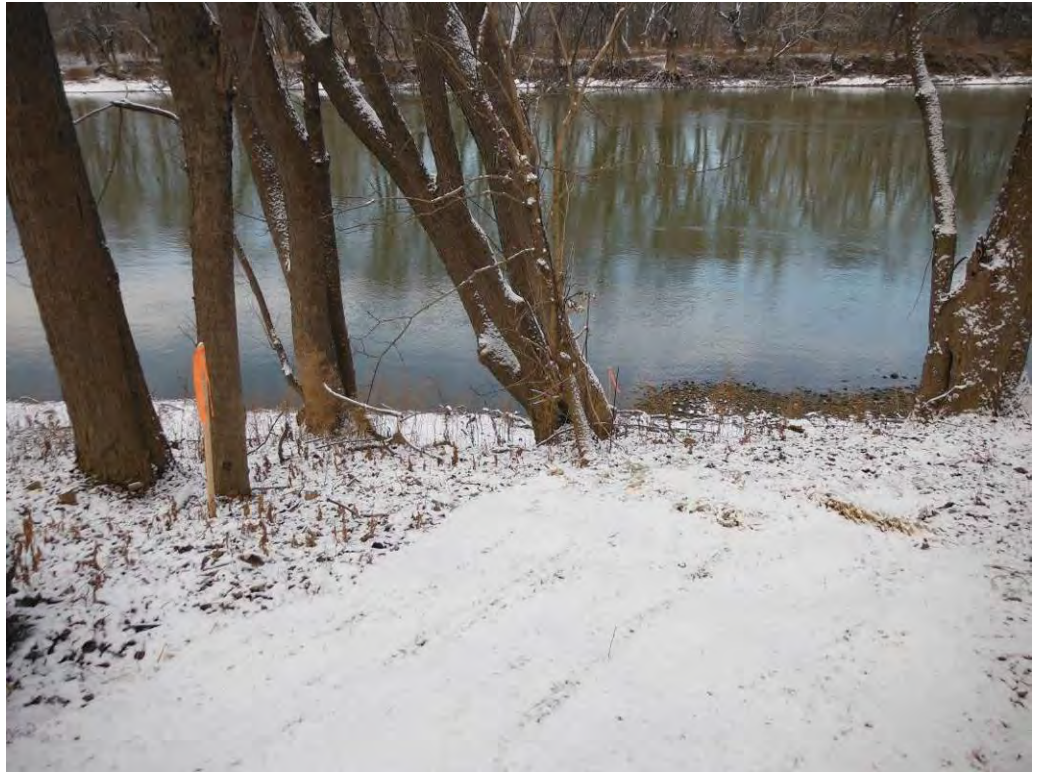
Photo No. 5	Date: 12/13/16
------------------------------	--------------------------

Description:
View west along southern boundary of surficial metal removal towards Wabash River.

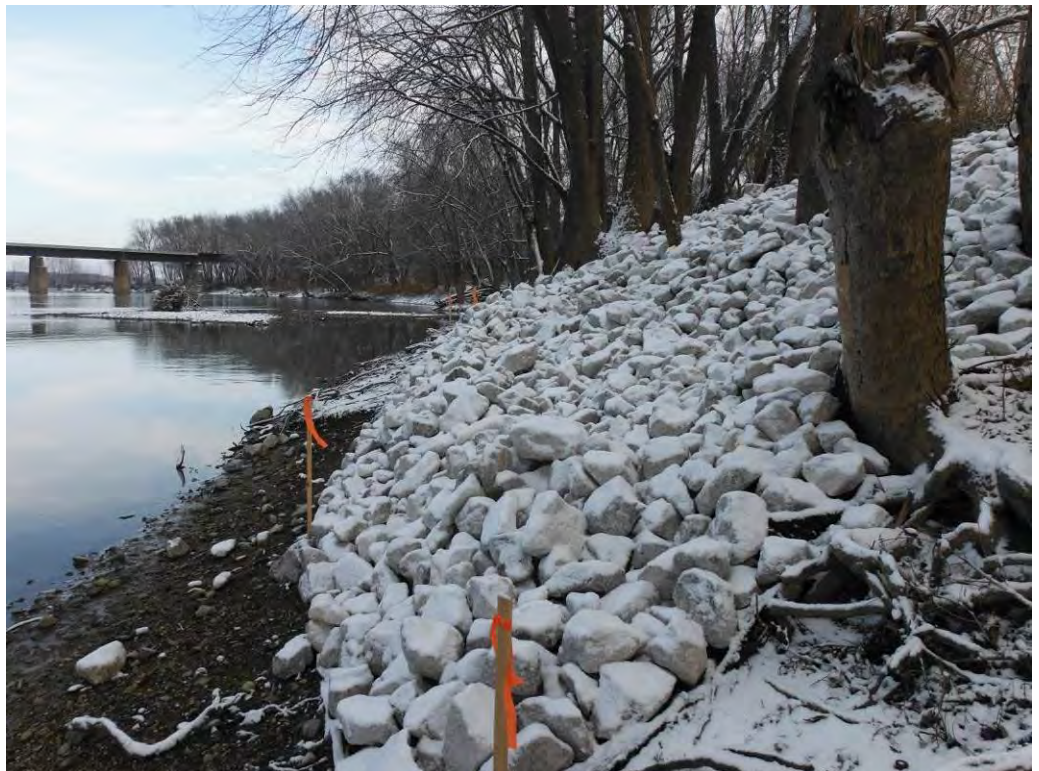
Photo No. 6	Date: 12/13/16
------------------------------	--------------------------

Description:
View north along lower eastern boundary of the exposure barrier. Survey markers represent exposure barrier boundaries.

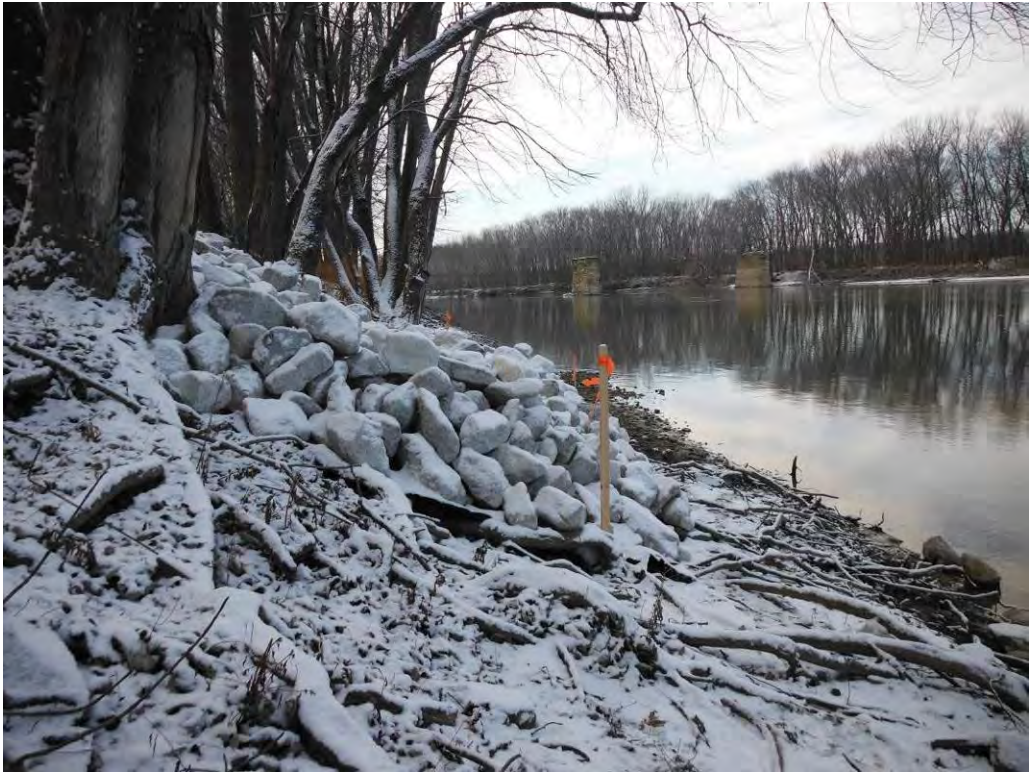
Direction Photo Taken: South			
Description: View south along western portion of the exposure barrier from the upstream side. Survey markers represent exposure barrier boundaries.

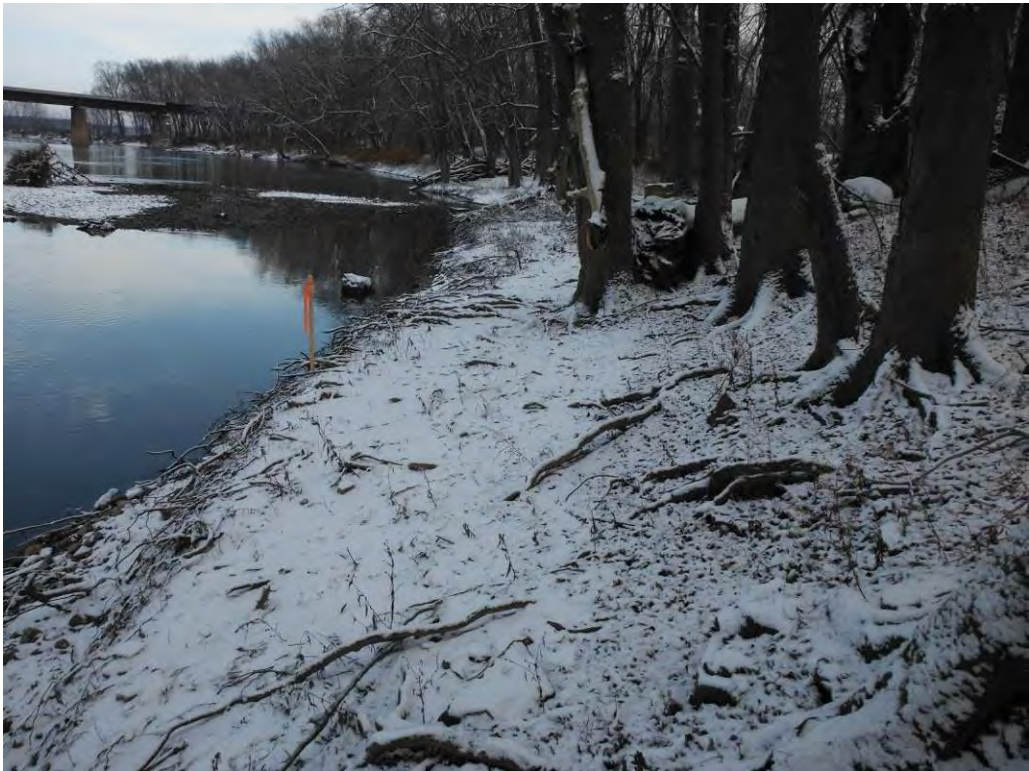
Photo No.: 10	Date: 12/13/16

Direction Photo Taken: North		
Description: View north from north end of exposure barrier towards northern boundary of the surficial metal removal area.
