**UNITED STATES ENVIRONMENTAL
PROTECTION AGENCY
REGION IX
75 Hawthorne Street
San Francisco, CA 94105**

**STATE OF HAWAII
DEPARTMENT OF HEALTH
P. O. BOX 3378
HONOLULU, HI 96801-3378**

Re: Response to Corrosion and Metal Fatigue Practices, Destructive Testing Results Report, Red Hill Bulk Fuel Storage Facility (Red Hill), Joint Base Pearl Harbor-Hickam, Oahu, Hawaii

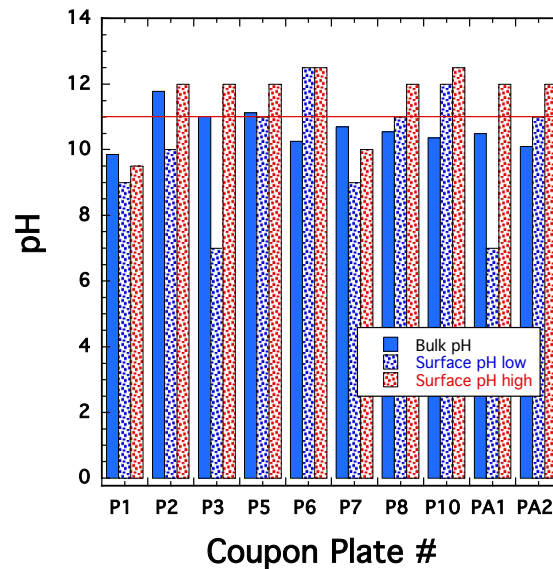
- i. Tables 15 and 16 of the Results Report Appendix A show measured pH is less than ($<$) 11 for concrete samples behind seven out of ten coupons, whereas pH for fresh concrete is around 13 or 14. When $\text{pH} < 11$, the concrete’s ability to protect steel from corrosion decreases and corrosion rates start to increase and accelerates as the pH levels drops.

Figure 1: Bulk and surface pH of concrete corresponding to the removed steel coupon plates. Bulk pH data and surface pH from DT Results Report [1].

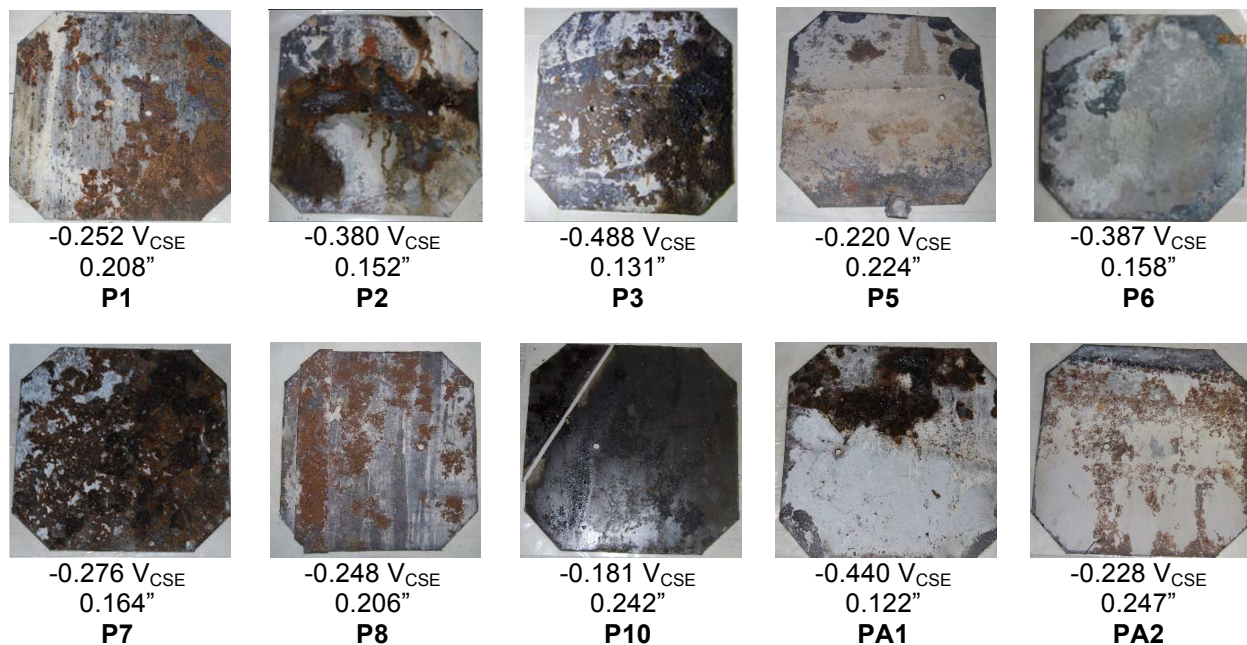
higher tendency to corrode), the lower the measured remaining plate thickness. Plates P5, P10, and PA2 corresponding to the three most positive corrosion potentials ($> -0.23 V_{CSE}$) showed no or only very light surface rust (Figure 6) [1]. Plates P1 and P8 (with potentials $\approx -0.25 V_{CSE}$) showed mostly mild surface rust (Figure 6) [1]; whereas, the remaining plates PA1, P2, P3, P6, and P7 (with potentials $< -0.27 V_{CSE}$) showed significantly more severe rusting (Figure 6) [1].

Generally, the formation of the visible red-brown rust (Figure 6) on plain-carbon steel indicates that the passivation in that local region has been lost. The gray regions of the plates (excluding the adhering concrete or grout) are regions where the steel is in the passive state (Figure 6). Passivation can be lost when the pH of the concrete drops below approximately pH 11 [7], or chloride (Cl) ions are present in sufficient concentration [4, 7]. The NACE Standard Practice SP0308-2008 [9] indicates that acid-soluble chlorides in excess of approximately 0.2 % (by weight of cement) can initiate corrosion of steel in concrete. The ion chromatography analyses of the concrete powder samples showed that the chloride concentration in the concrete ranged from 50 ppm (0.005 % by weight of cement) to 171 ppm (0.017 wt%), which is much lower than the threshold. The concentration of chlorides detected in the corrosion

Figure 6: The back side of the steel coupons, structure-to-electrolyte corrosion potentials (in V_{CSE}), and the minimum remaining thickness (in inches) that was measured for each plate. From DT Results Report [1]

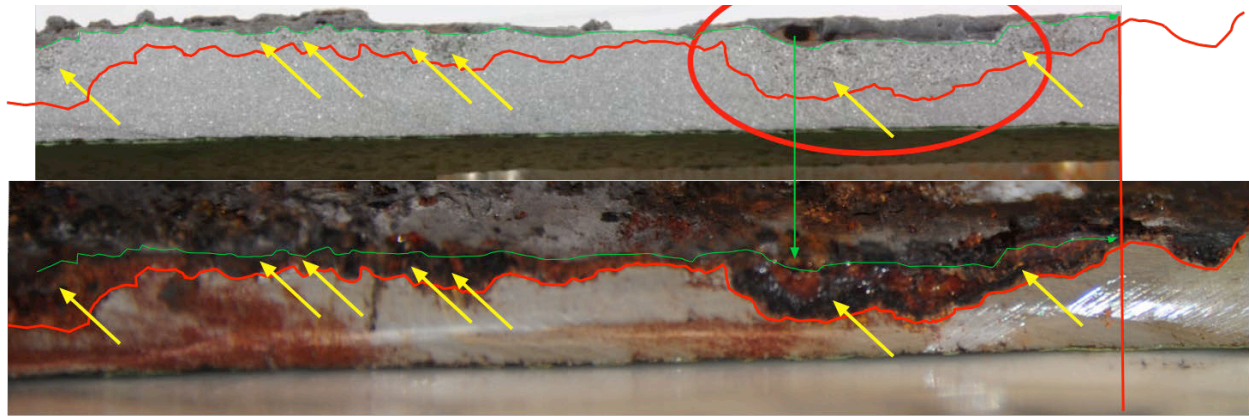
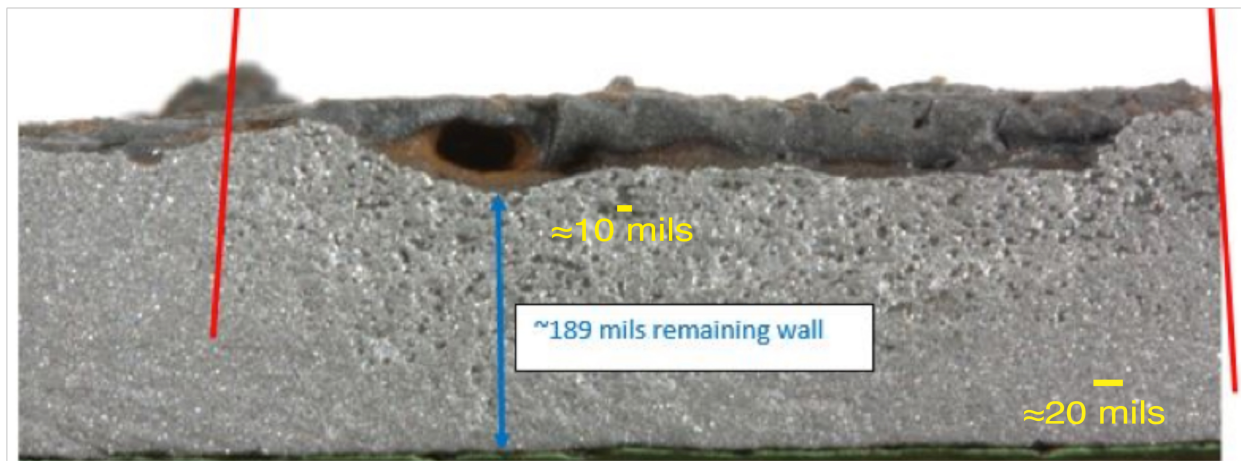
The electrolyte in the corrosion product at the corrosion front can become very corrosive due to acidification and accumulation of chlorides. This may have been observed on the cut edge of coupon plate P7 [11]. A photograph of the cut edge of plate P7 was taken on June 25, 2018 (bottom photo in Fig. 9a), approximately one week after coupon plate P7 was cut and removed from Tank 14. The image showed what was initially thought to be significant corrosion (dark brown rust) penetration into the thickness of the plate. To verify if the corrosion had actually penetrated into the plate, the edge of the specimen was cleaned by sandblasting [11] (approximately in March 2019, or six months after the coupon was extracted). The photo of the cleaned edge of coupon plate P7 was compared (Figure 9) to the photo of the un-cleaned edge. The demarcation between the cleaned steel plate and the free surface was highlighted with a thin green line (Figure 9a top), and the demarcation between the shiny cut edge of the corroded un-cleaned plate and the apparent corroded regions were highlighted with a thicker red line (Figure 9a bottom). Both lines were superposed on the cleaned and uncleaned plates (Figure 9a). The darker corroded regions on the edge of the uncleaned plate (Figure 9a bottom) corresponded to the areas that appeared to be porous (yellow arrows) on the cleaned plate (Figure 9a top and Figure 9b). The apparent porosity (Figure 9a top and Figure 9b) could be due to corrosion caused by corrosive electrolyte that leached out of the corrosion products onto the cut edge. Some of the pores appeared to be on the order of 5 to 10 mils in width (Figure 9b). If it is assumed that the pits are as deep as they are wide, the rate of corrosion would be on the order of (5 to 10 mils)/6 months or 10 to 20 mils/yr, which is much higher than passive corrosion rates. It is also recommended that the surface porosity be further investigated to verify whether the region is only superficially pitted or is actually porous.

Figure 9: Optical images (a) of cleaned (top) and uncleaned (bottom) edge of coupon plate P7. Magnified view (b) of the cleaned edge of coupon plate P7 showing pitted surface. Wavy red and green lines, yellow arrows, and 10 and 20 mils scale bars were superposed on original photos of the cleaned edge [11].

For moist concrete that is carbonated or contaminated by chlorides, the literature suggests that the corrosion rate can be of the order of 100 $\mu\text{m}/\text{yr}$ (4 mils/yr) [4]. The corrosion rate can be less if the moisture level decreases, but can also increase by an order of magnitude with heavy chloride contamination [4]. Since the corrosion rates are difficult to predict, historical corrosion data from all of the Red Hill tanks should be analyzed to help bracket realistic values. Additionally, if possible, active corrosion rates should be determined by measuring changes in the remaining wall thicknesses of known pit sites while tanks are out of service. This could be accomplished using, for example, ultrasonic testing.

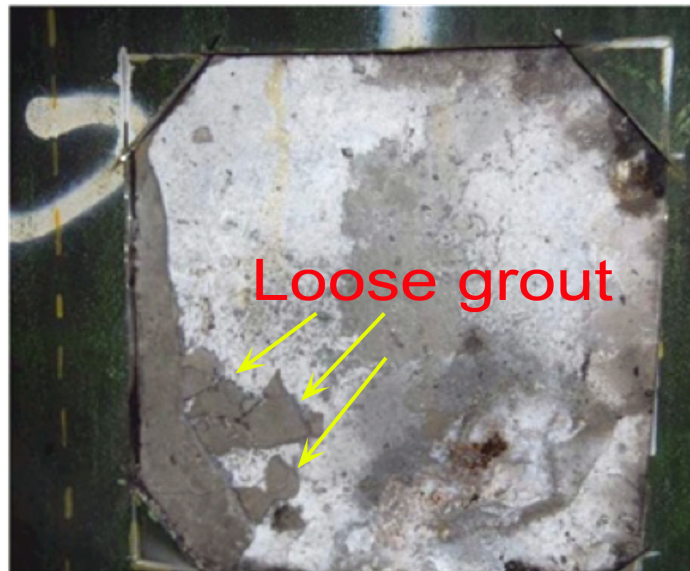
Since the grout was pressurized to 350 psi, it could have likely found its way to the steel-concrete interface from the concrete-Gunitite interface through any crevice or crack that may have formed. In one case, grout was found as far as 200 ft away from the tanks in an upper access tunnel [13]. The description of the tell-tale system, also indicates that crevices could exist between the tank wall and concrete layer [13]:

Figure 10: Loose grout behind coupon plate P6. From DT Results Report [1].

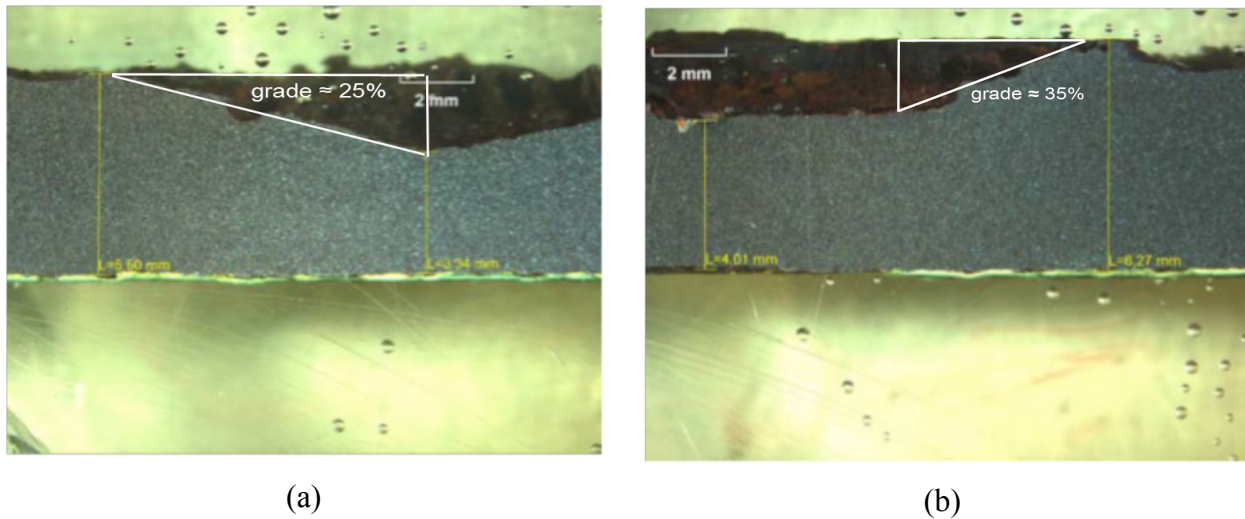
Figure 11: Cross section of coupon plate P3 (a) at the area of maximum wall loss (p. 18 of DT Results Report [1]) out of four sections examined, and cross section of coupon plate P6 (b) at area of maximum wall loss out of three sections examined (p. 24 of DT Results Report [1])

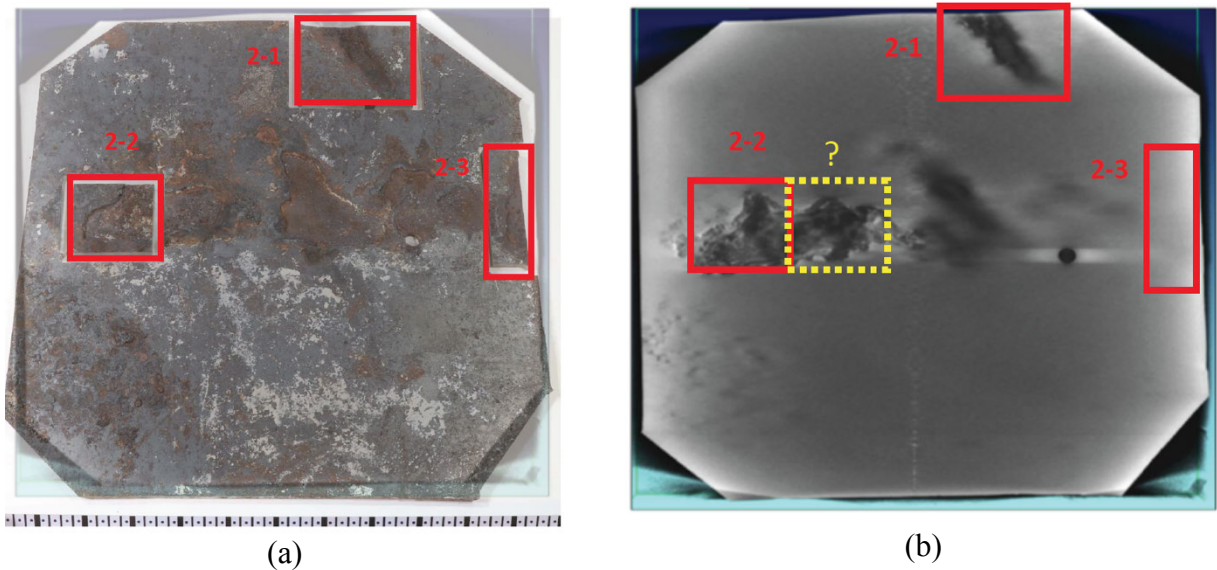
surface profile of the remaining steel substrate. The steel coupons were cleaned with a CO₂ dry ice blast, but all of the corrosion products were not removed; hence, the regions of the deepest pits would be difficult to determine. The three-dimensional profilometry data was not provided in the DT Results Report [1], but the results would likely not have characterized the bare steel substrate since the corrosion products were not thoroughly removed. X-ray computed tomography (CT) was used to aid in selecting the regions with the deepest pits, but in some cases, regions with potential deep pits were apparently not sampled (e.g., Figures 12, 13, and 14). The DT Results Report [1] did not describe if other methods were used to confirm the location of the deepest pits.

Figure 12: Coupon plate P2. Possible deep pit in yellow box region not sampled. Original images from DT Results Report [1].

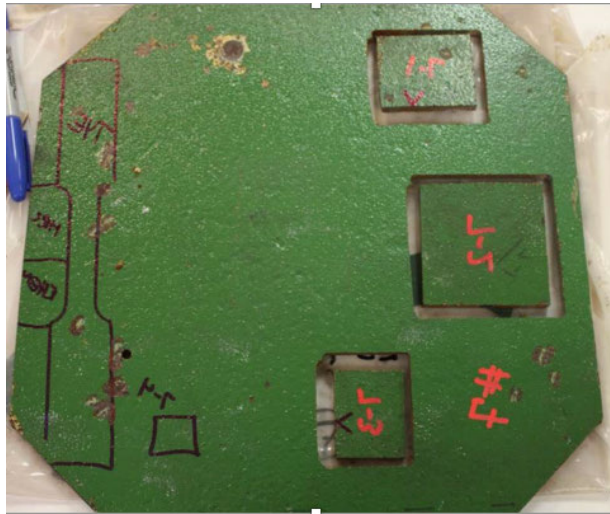
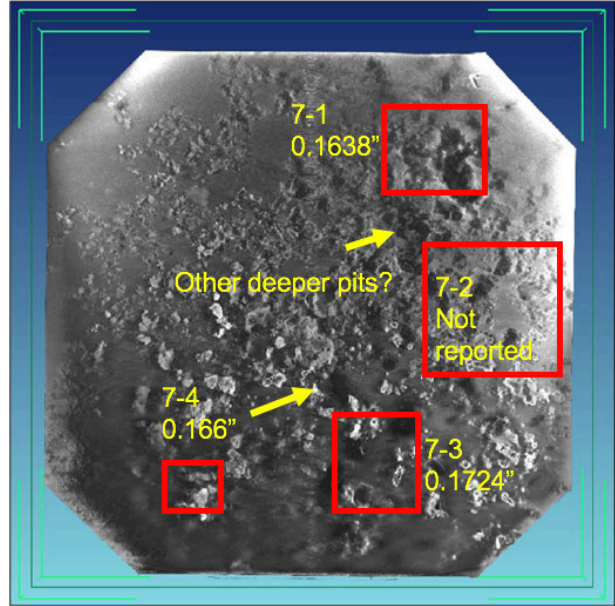
Figure 13: Coupon plate P7. Possible deep pits in region of yellow arrows not sampled. Original images from DT Results Report [1].

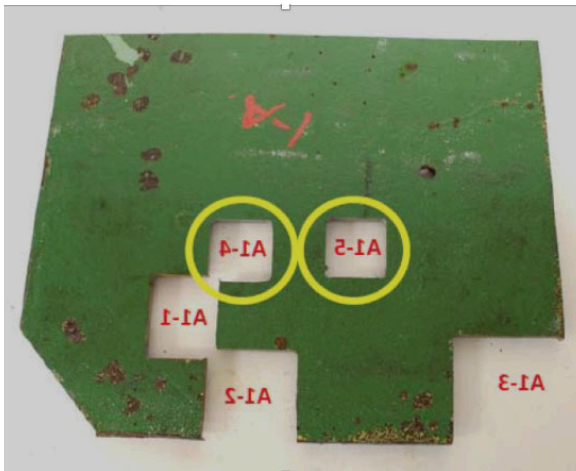
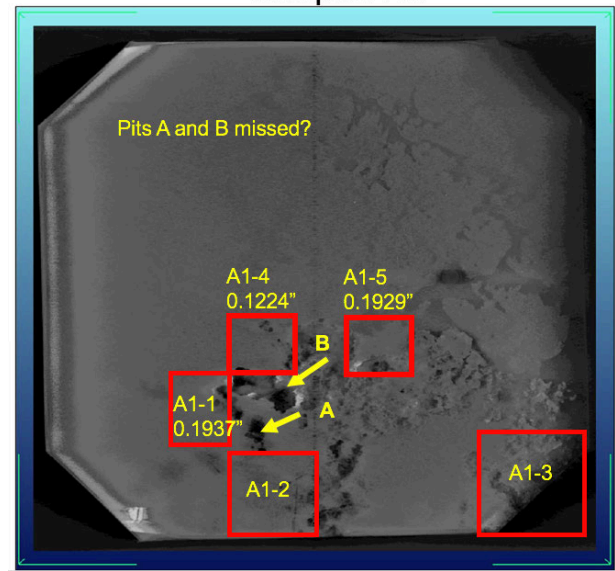
Figure 14: Coupon plate PA1. Possible deep pits in region of yellow arrows not sampled. Original images from DT Results Report [1].

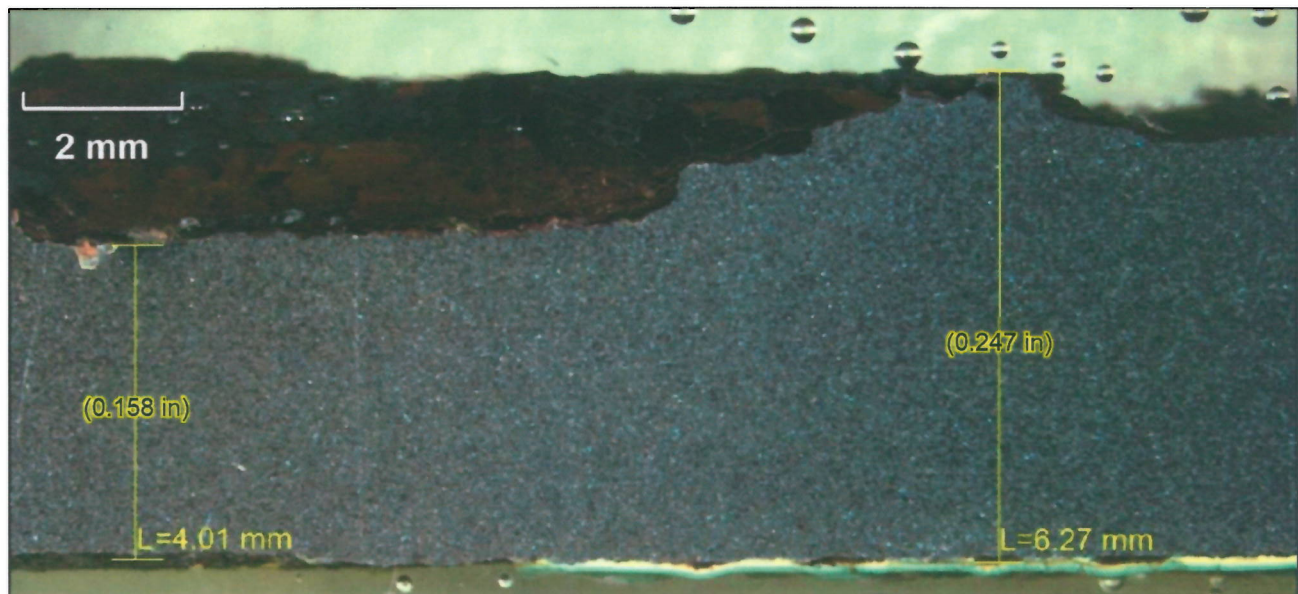
Figure 1 – Destructive Testing Cross-section from Sample 6-1

1. The larger, TesTex Falcon Mark II 2000 device should have been able to detect the pit in Coupon 6. According to the Navy this device has a probability of detection (POD) of 100% at 25% wall loss on pits with an aspect ratio of 3:1. The deepest pit in Coupon 6 amounted to ~37% wall loss and aspect ratio of greater than 3:1 (width to depth ratio). Figure 1 shows the cross-section through the deepest pit in Coupon 6 where the size and depth of the pit is obvious.
2. The smaller, TesTex TS-2000 device should have been able to detect the pit in Coupon 6 as the Navy stated this device can detect pits with a diameter of 1.57 mm. The width of the corrosion pit in Coupon 6 was much, much wider than 1.57 mm as is shown in Figure 1.

Second, the BWS believes Figure 1 clearly demonstrates this pit cannot be described as a “*pit of very small volume.*” This figure clearly shows a broad pit of considerable volume.

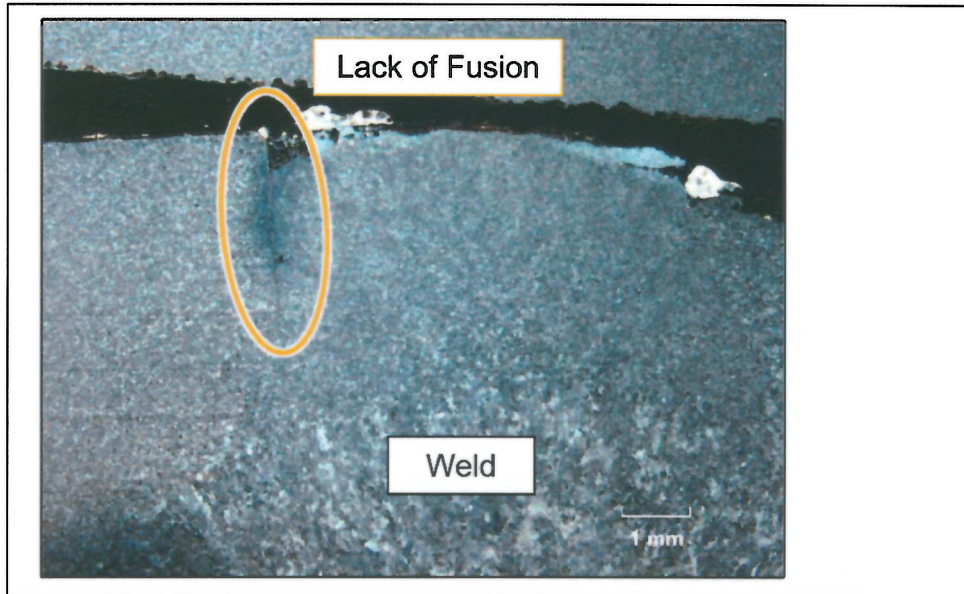
Figure 2 -- (Image from: IMR Test Labs. 2018)

4. The DT inspection did find weld defects. The one coupon that actually had a weld contained a linear defect that was found by destructive testing. This lack of fusion linear weld defect is shown below.

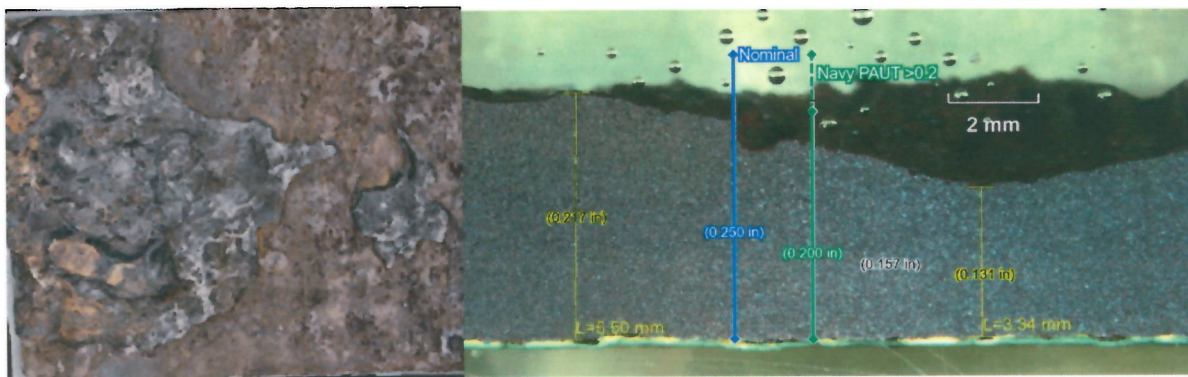
Figure 5 – Destructive Testing Cross-section from Sample 3-3.

A more graphic illustration of the error in the NDE methodology is shown in Figure 5. The image on the left-hand side of Figure 5 shows the extensive backside corrosion on Coupon 3. The right-hand side of Figure 5 shows the plate's reported thinnest area in cross-section after destructively testing. While it is unclear from the DT and IMR reports, this thinned region

(0.131-inch-thick) was presumably located by CT scanning of the entire coupon. The Navy NDE predicted that this area had little to no backside corrosion.

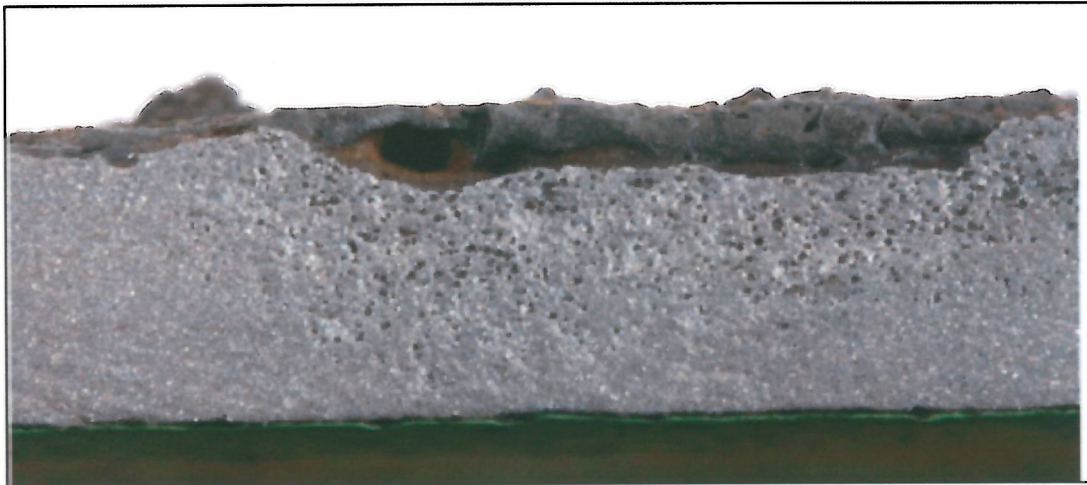
1. There was pitting observed as shown in their Figure A-4
2. It is not surprising that corrosion was not found as this area had been sandblasted.
3. The explanation that the area of concern "had been superficially altered by heat associated with sectioning or some other post-sectioning reaction (atmospheric corrosion or corrosive media attack)" is not credible. Atmospheric corrosion would be uniformly distributed along the cut surface, but the area of concern is localized. Secondly, the porosity is not consistent with heat associated with sectioning. Finally, we are unaware of any corrosive media used during coupon removal that could have locally attacked the edge in the area of concern.

Figure A-4. Detail of the sandblasted edge on 3/20/19 in the same location as shown in the picture below. The sandblasting revealed that the feature was not a corrosion pit, as shiny metal was revealed when the red-colored staining was removed. There was an unusual appearance to the edge in this location, as though the sectioned edge had been superficially altered by heat associated with sectioning or some other post-sectioning reaction (atmospheric corrosion or corrosive media attack). That alteration gave the appearance of a deep corrosion pit.

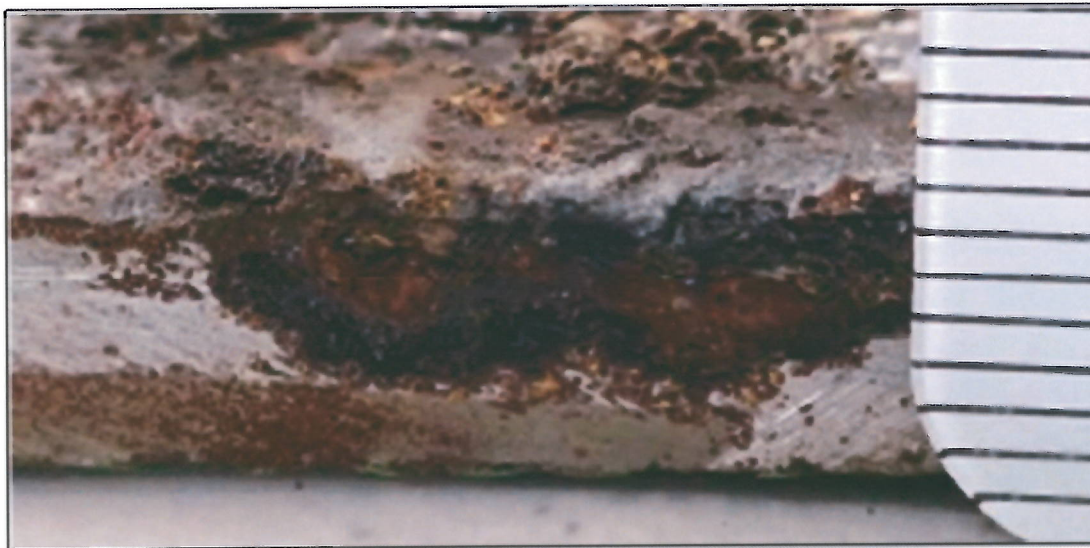
Figure A-5. The same area is shown in an image provided prior to shipping Coupon #7 to IMR (provided to IMR on March 13, 2019). What appeared to be a deep corrosion pit was actually rust-colored staining of the edge surface
