**PRL 96-21  
Emergency Repairs for Red Hill Tanks**

EMERGENCY REPAIRS FOR RED HILL TANKS

**Dames & Moore**  
Emergency Repairs For Red Hill Tanks at the Fleet Industrial & Supply Center  
Contract No. N62742-96-C-1356

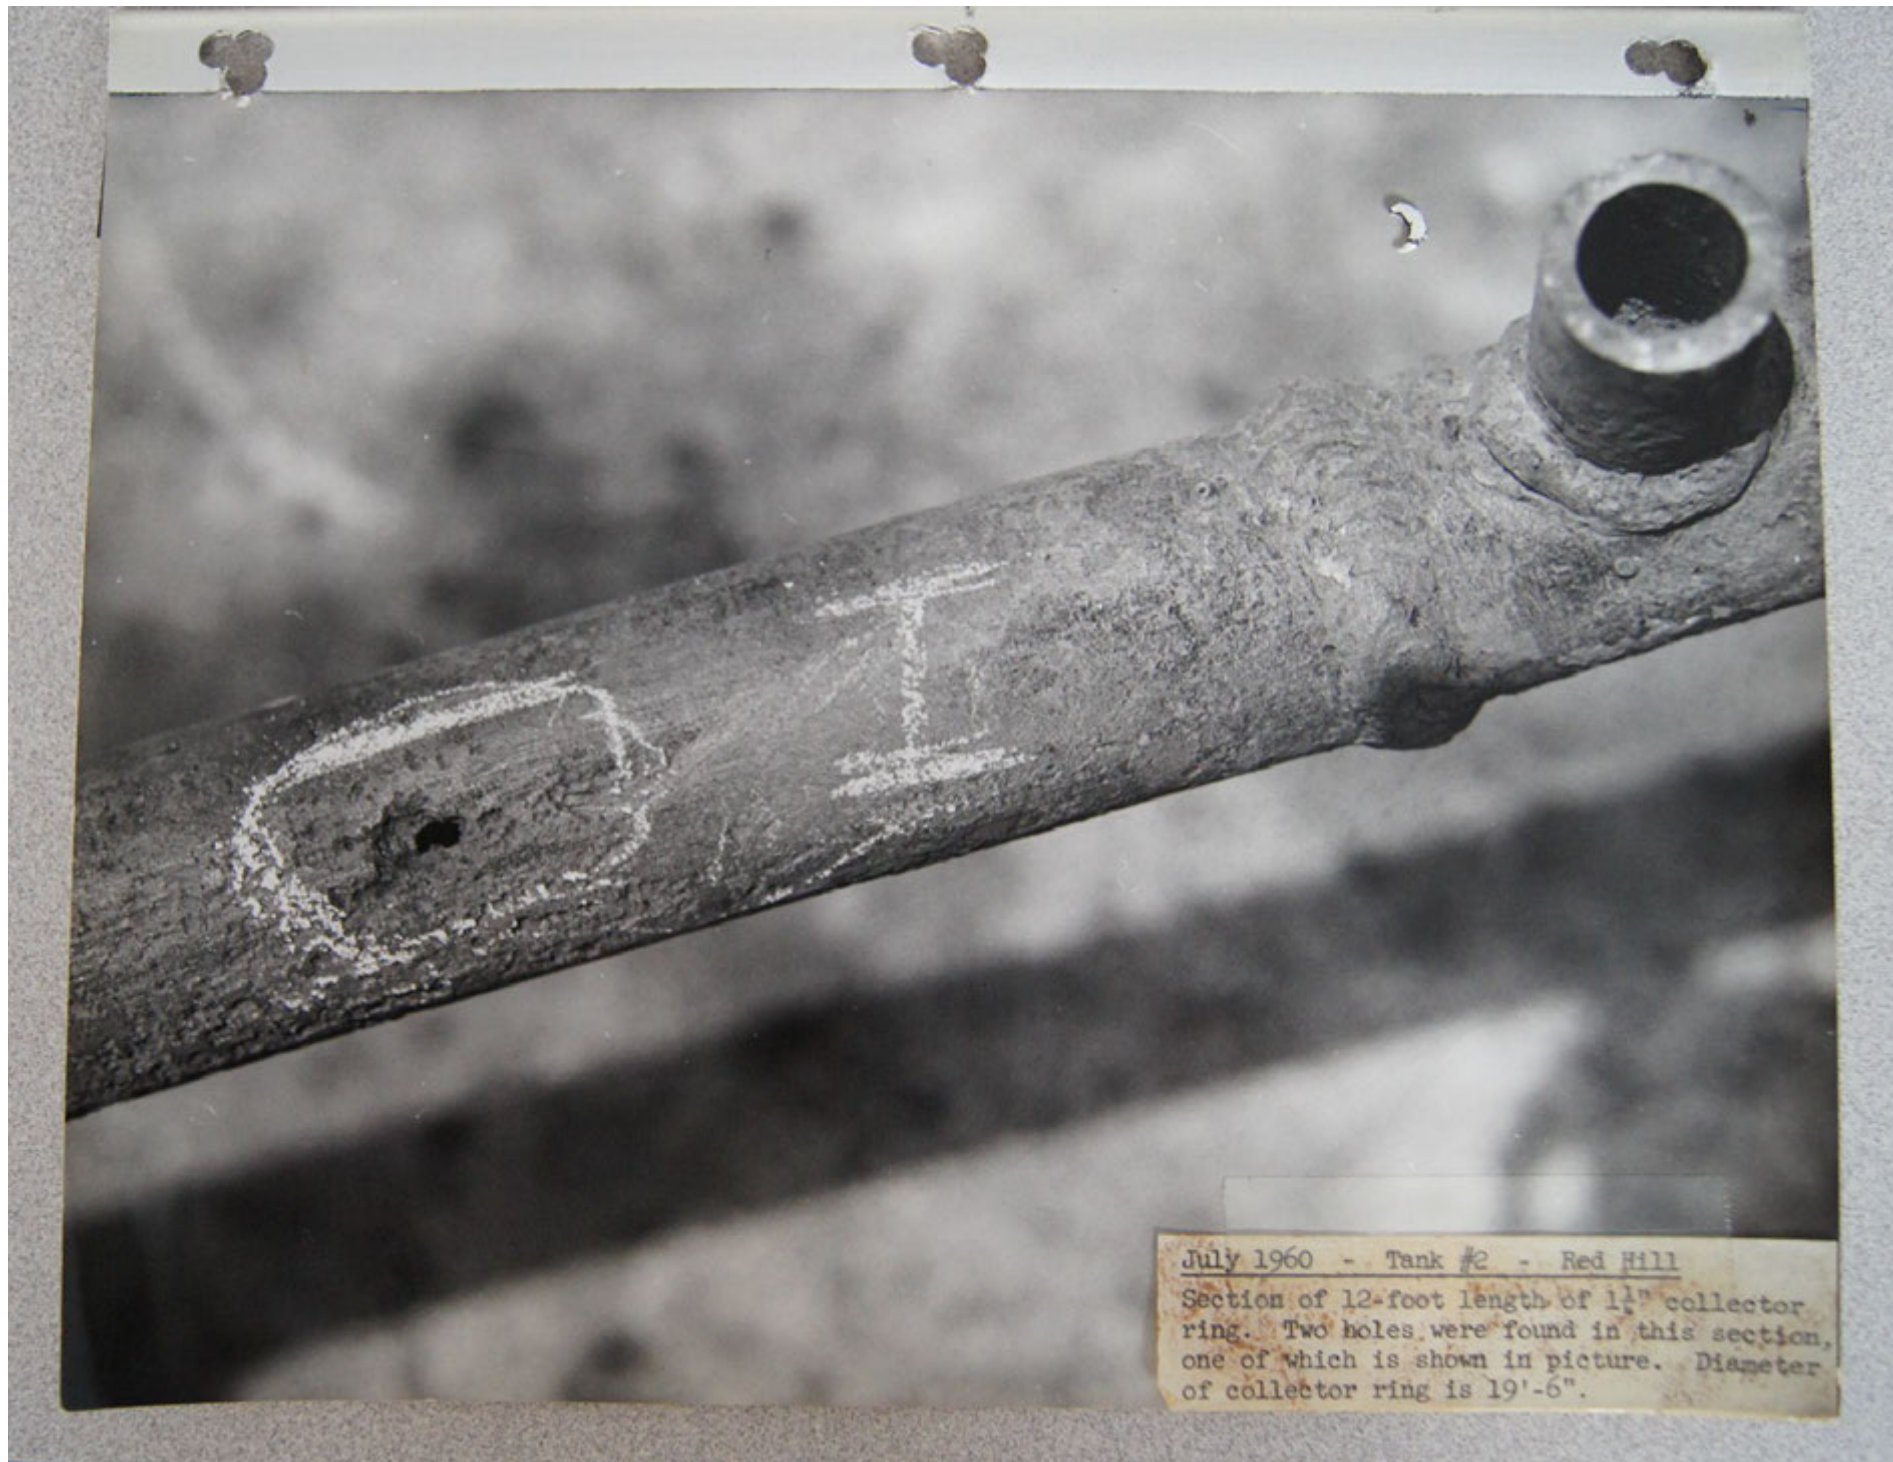
July 1960 - Tank #2 - Red Hill

Section of 12-foot length of 1 1/2" collector ring. Two holes were found in this section, one of which is shown in picture. Diameter of collector ring is 19'-6".

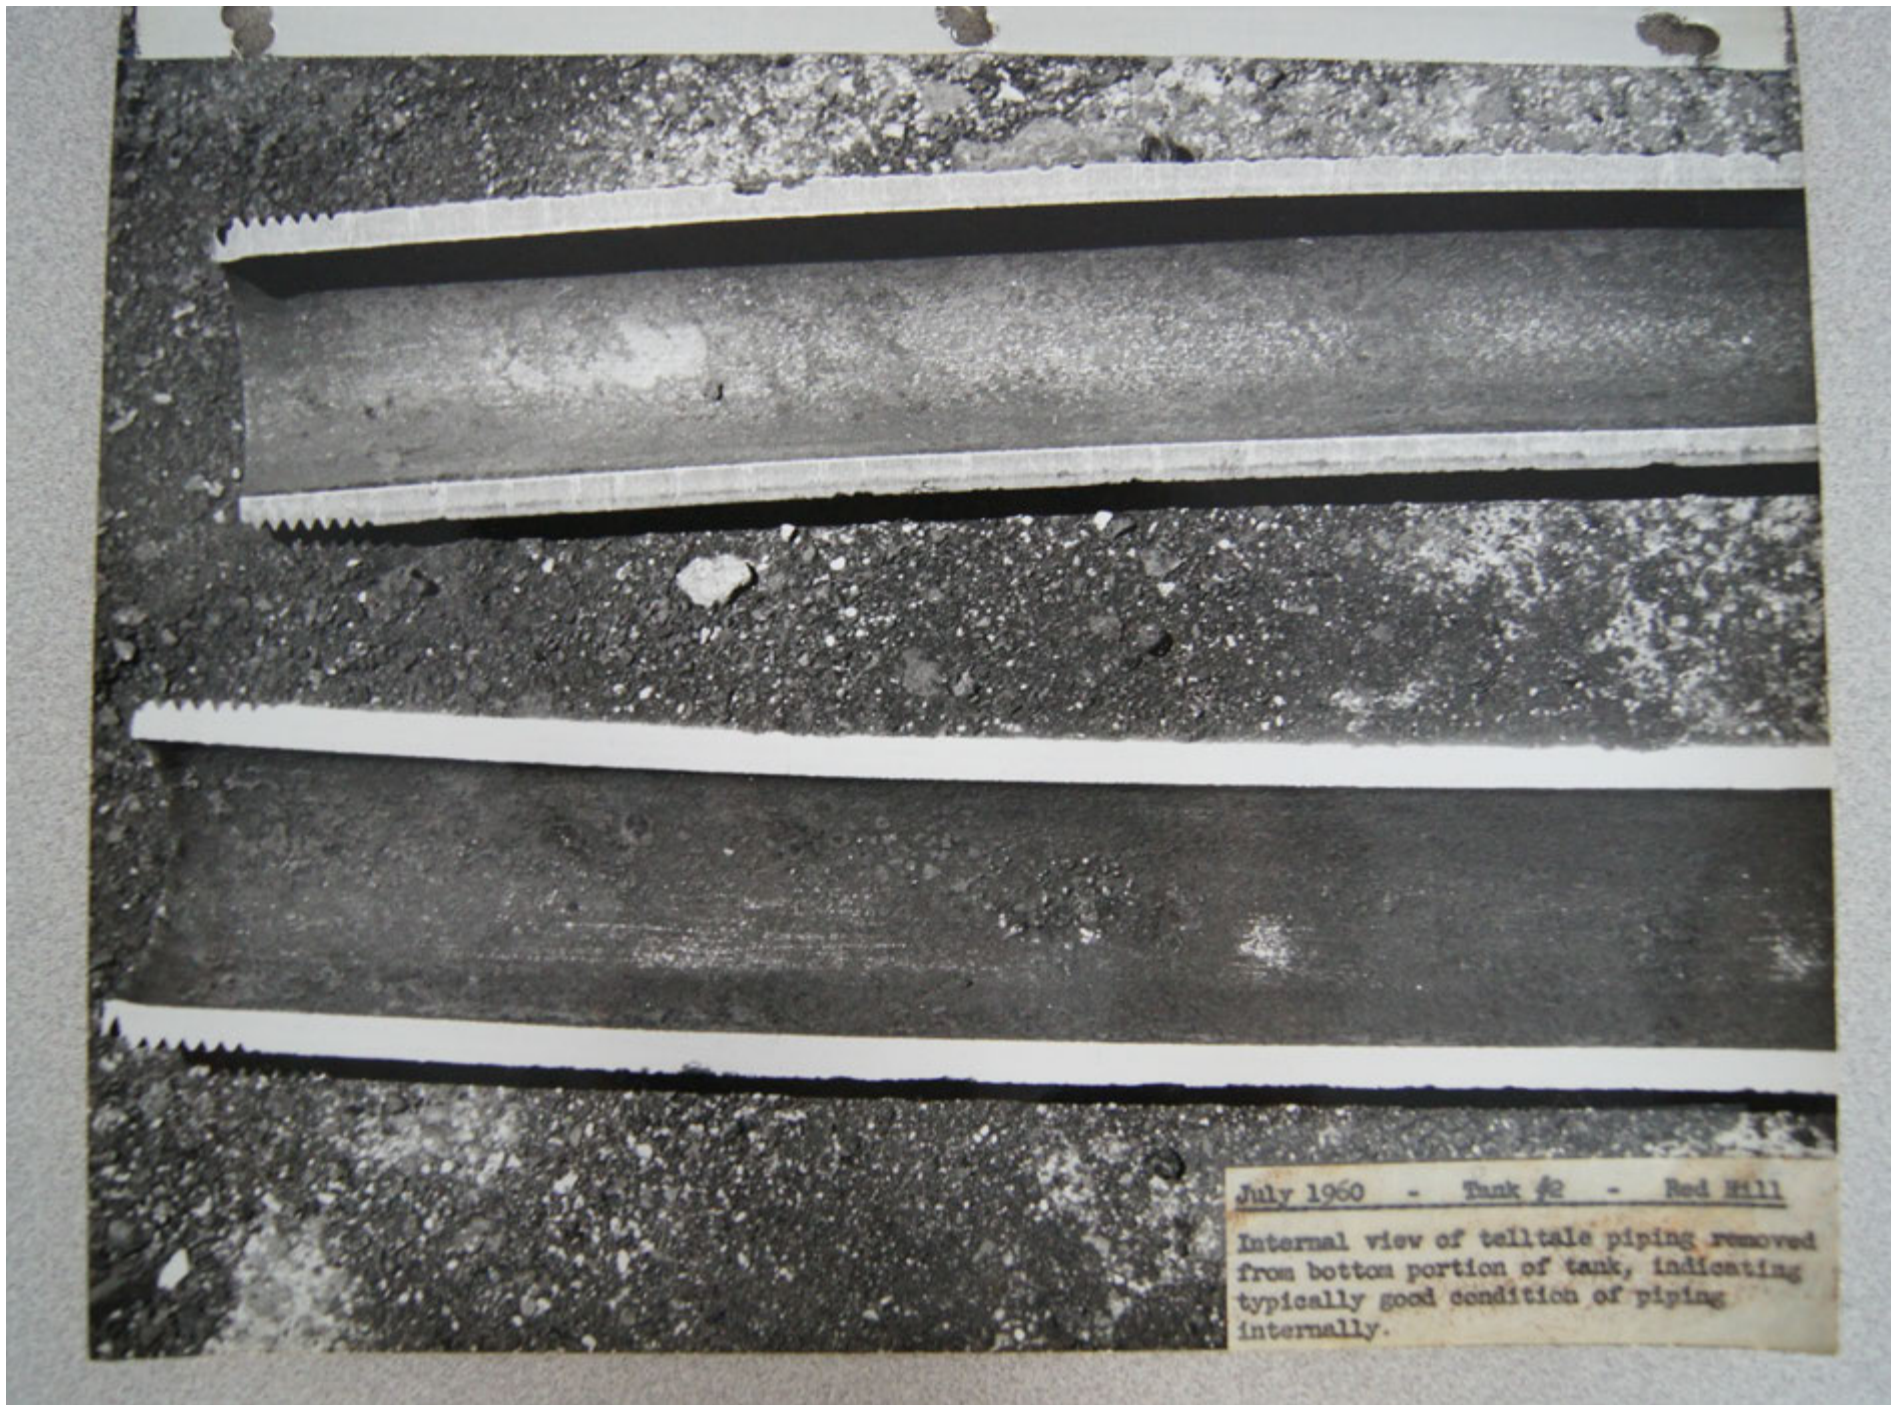
July 1960 - Tank #2 - Red Hill

Internal view of telltale piping removed  
from bottom portion of tank, indicating  
typically good condition of piping  
internally.

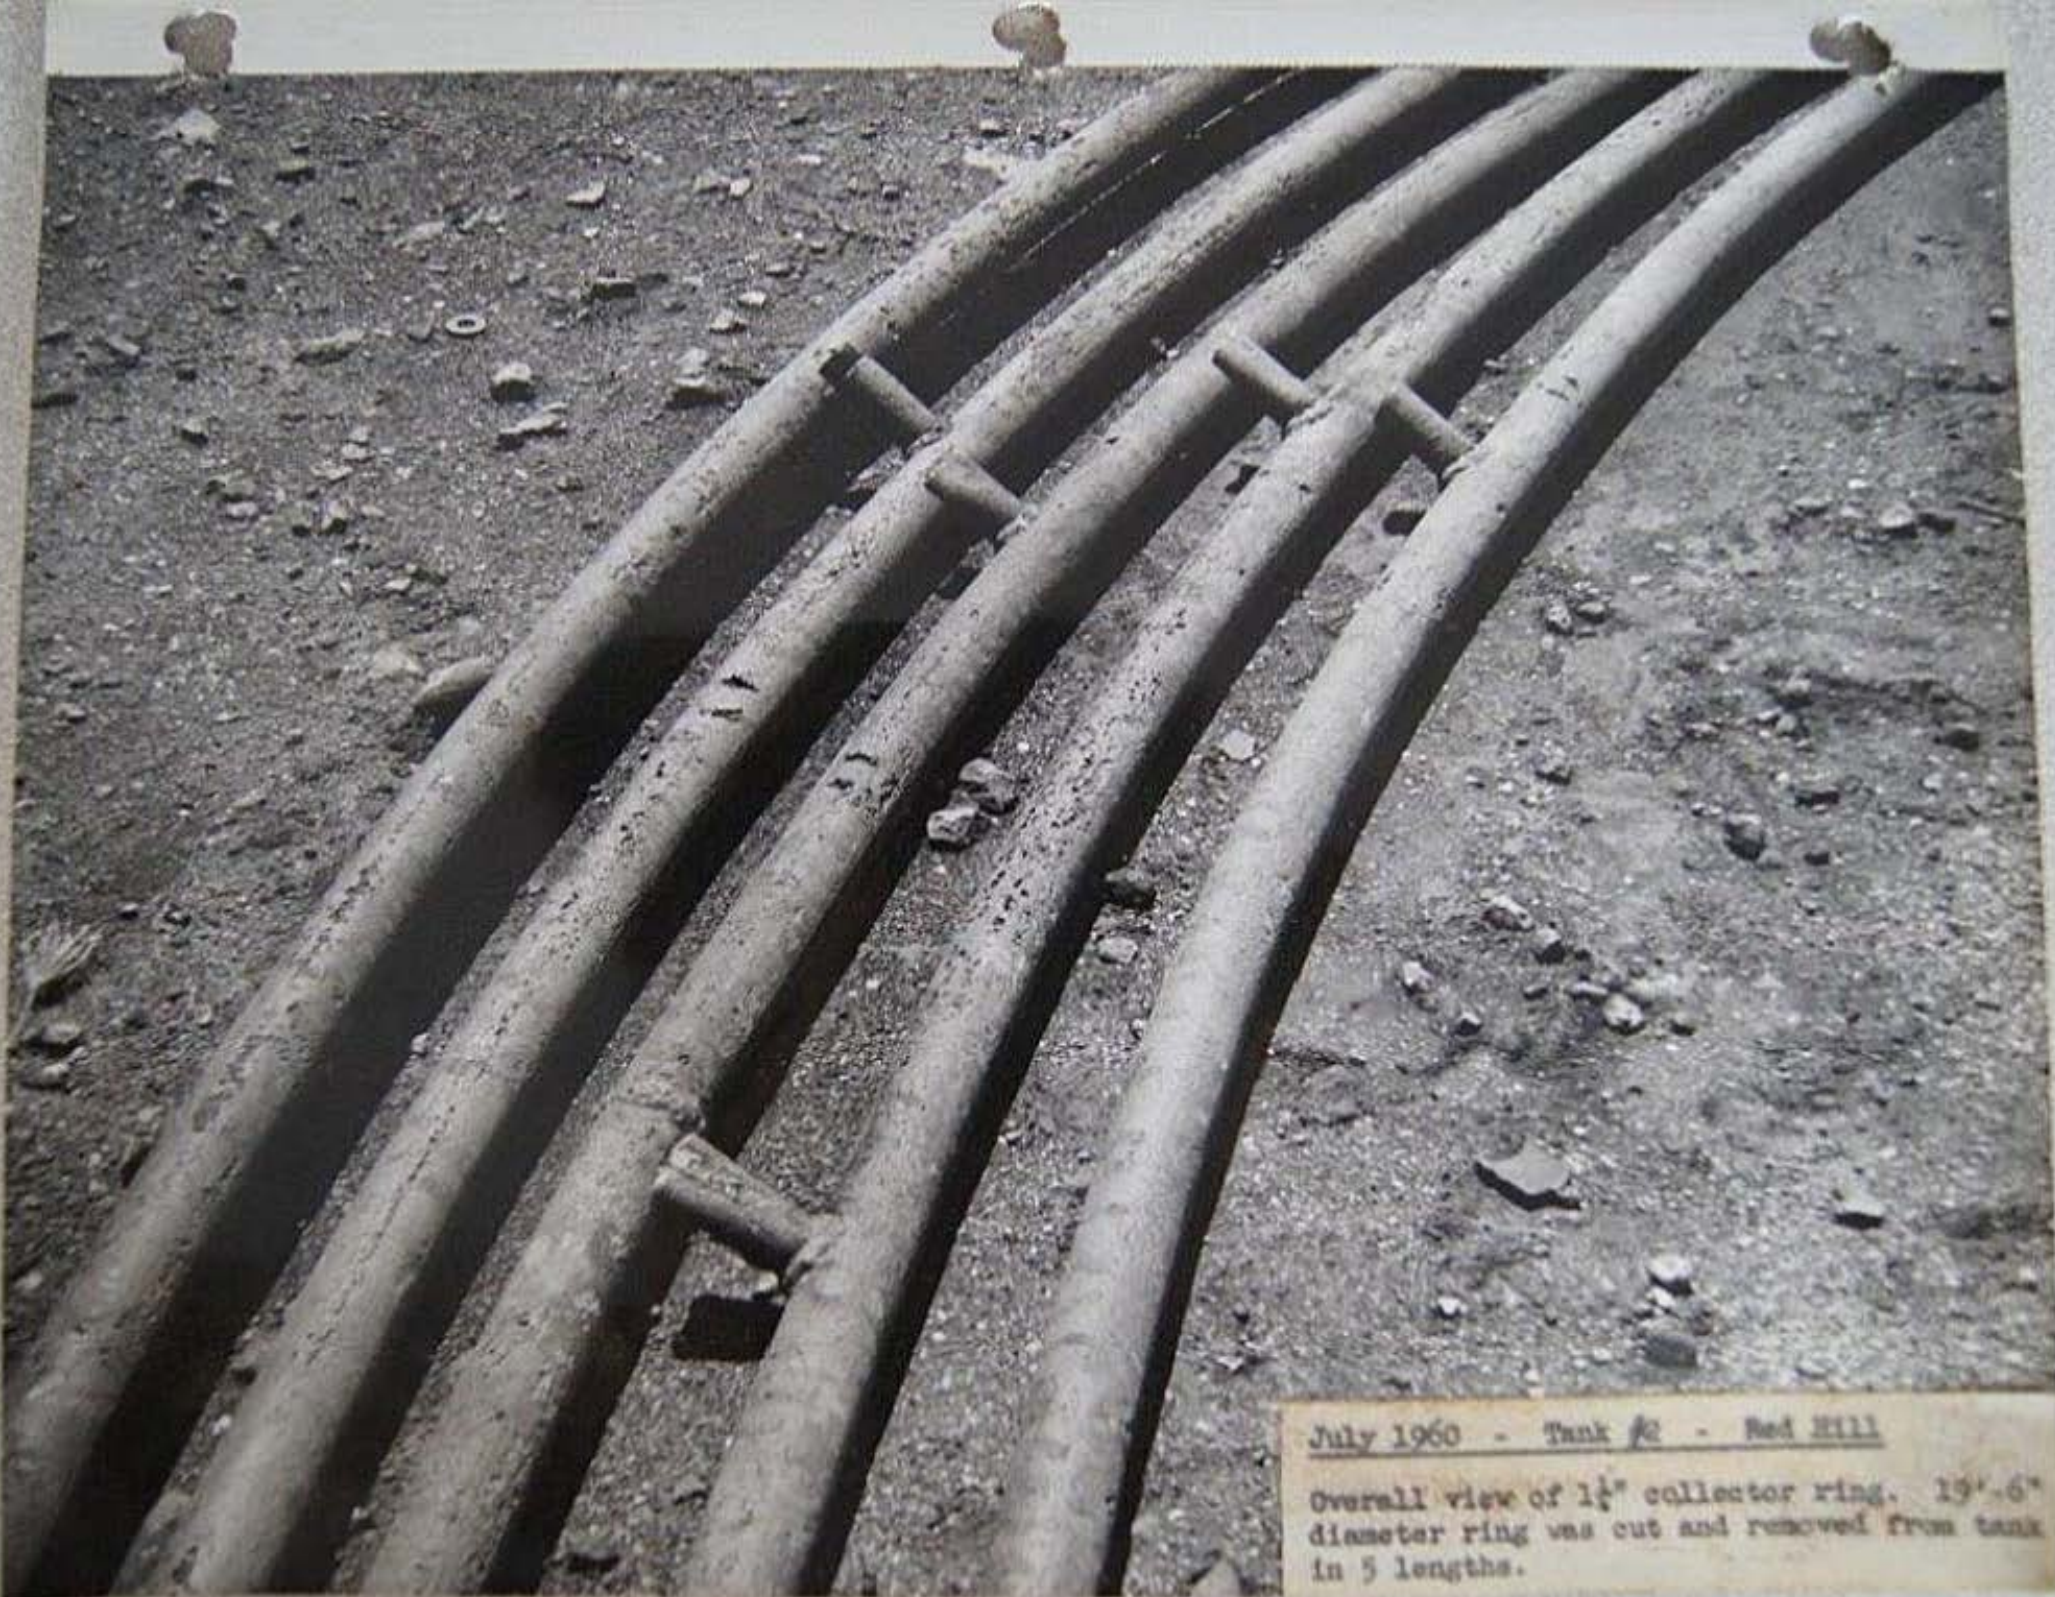
July 1960 - Tank #2 - Red Hill

Overall view of  $1\frac{1}{2}$ " collector ring. 19'-6" diameter ring was cut and removed from tank in 5 lengths.

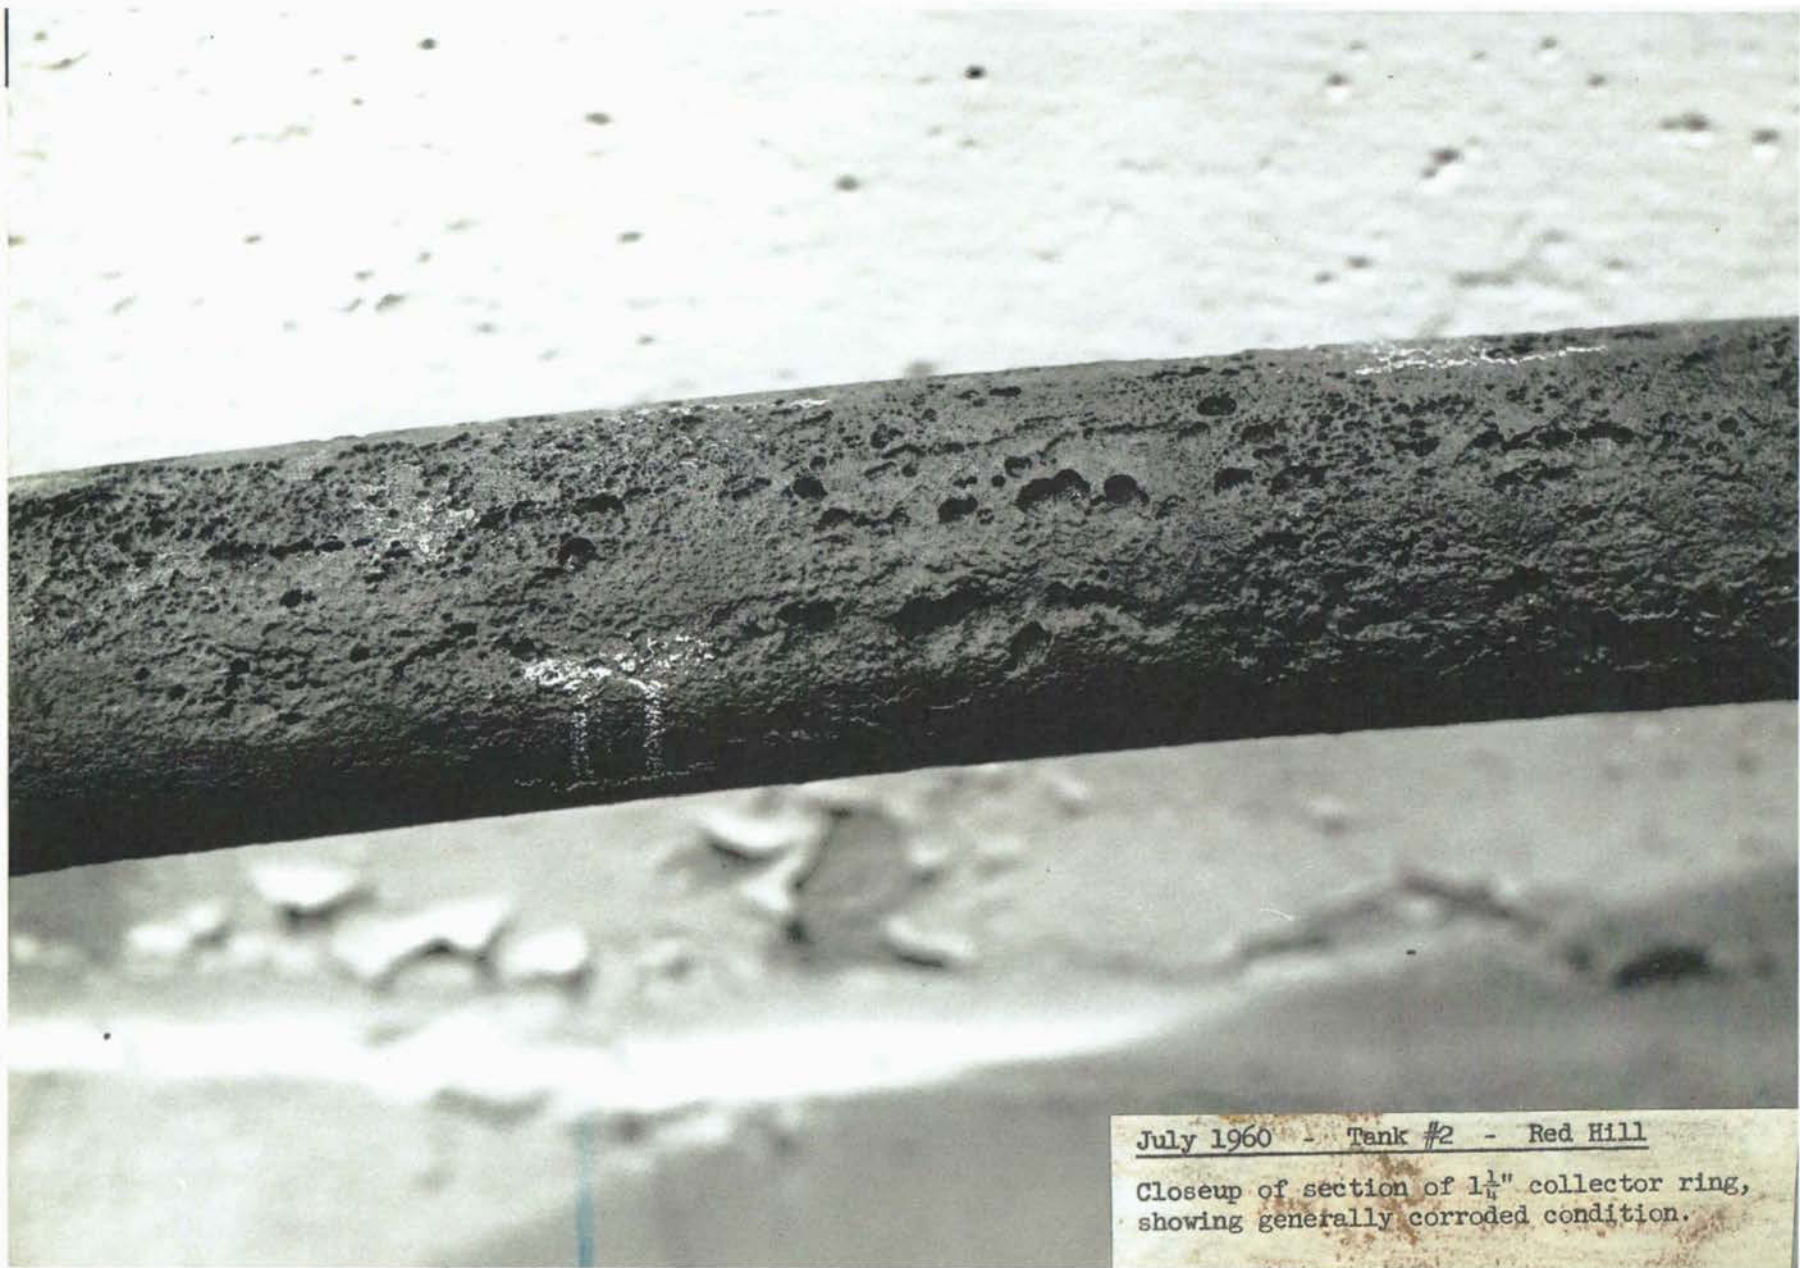
July 1960 - Tank #2 - Red Hill

Closeup of section of  $1\frac{1}{4}$ " collector ring,  
showing generally corroded condition.

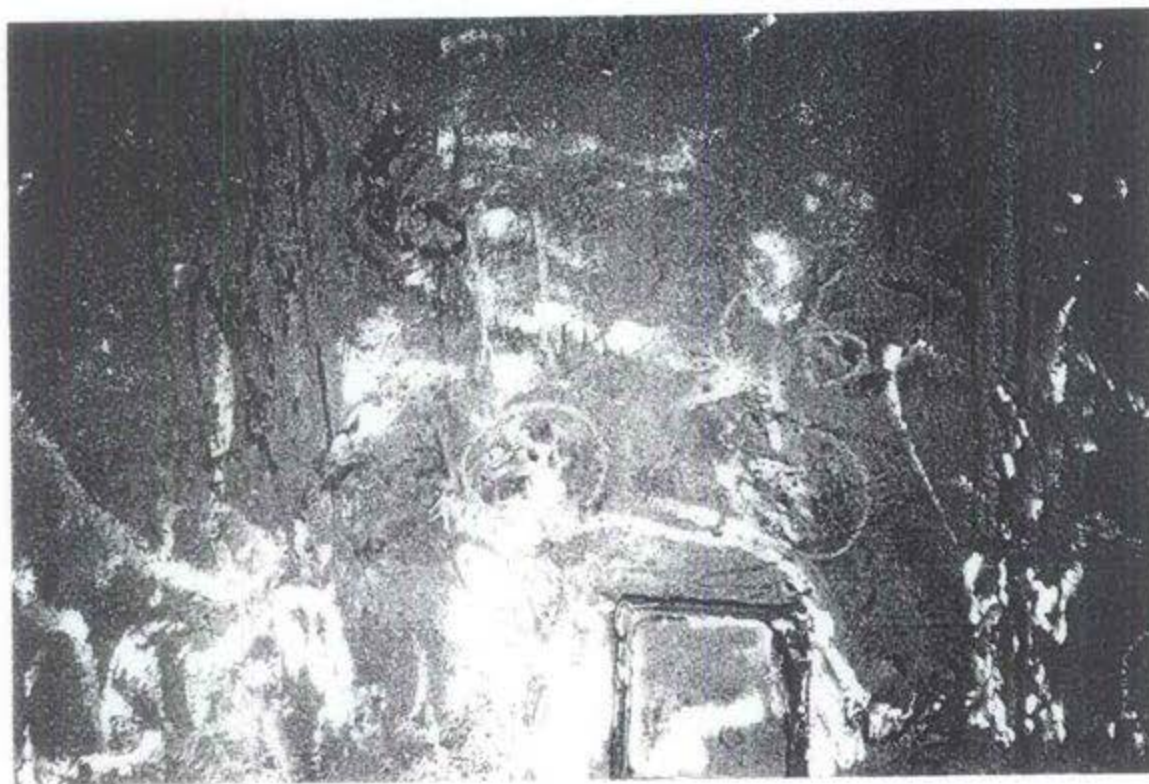
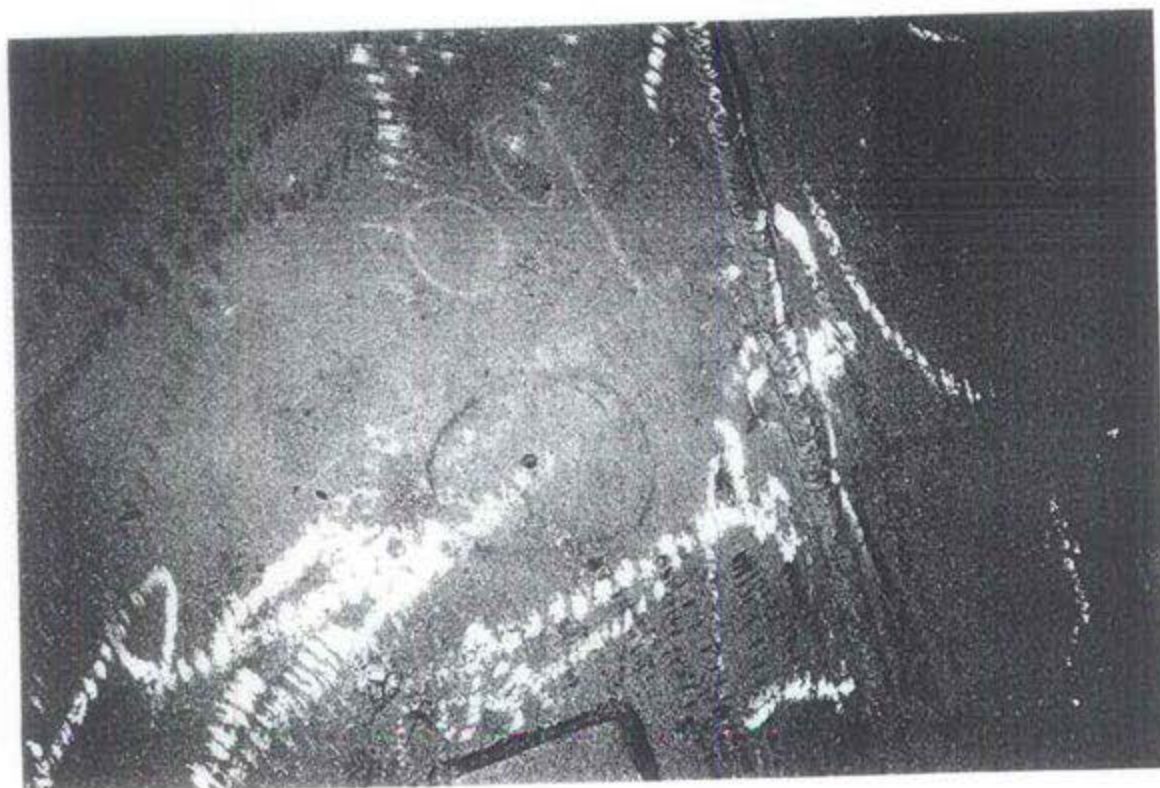
PICTURES SHOWING PITTING ON FIRST ASCENDING PLATES

- 3.0 Only pits over 0.06 inches deep were identified. Twenty pitted areas were identified and measured in the first ascending plates of the lower dome. The deepest pit recorded on the ascending plates was 0.12 inches. The metal thickness at the identified pits is greater than 0.10 and the scheduled repair by providing a welded patch plate over the pit is not applicable and no repair is necessary to maintain the integrity of the tank. (The method of repair specified by contract is provided on sheet M-9 of NAVFAC DWG. NO. 7927658, REPAIR TYPE 1.)

- 4.0 Pitting at the bottom of tank #16 was similar to #10 and did not require the scheduled repairs. However the sharp edges at the toe of pit caused problems with the coating application. To correct this problem on tank #10 Mid Atlantic Environmental advises smoothing the sharp edge mechanically or by applying primer coat with a stiff brush as proscribed by NAVFAC SPECIFICATION N62472-96-C-1356, Section 09970, 3.9.5, Application of Polyurethane Coating System, which states, "For blasted areas which are pitted, work the wash primer into the crevices, and pits with a stiff brush (100 mm brush cut 25mm long, for example)"

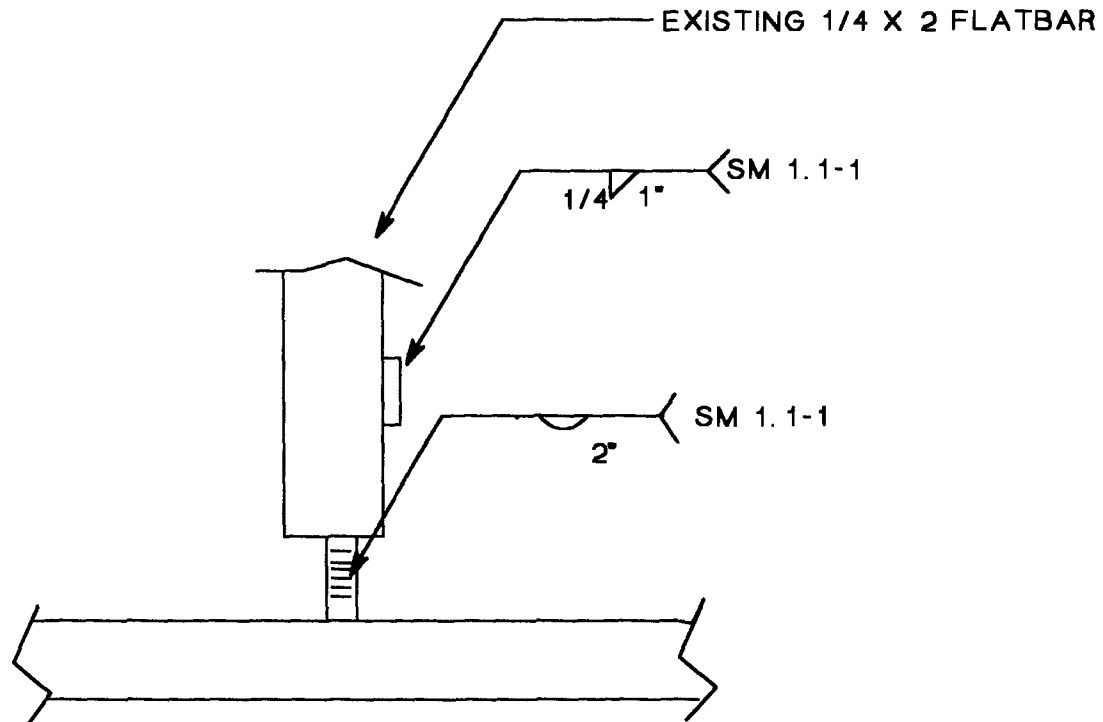
MID ATLANTIC ENVIRONMENTAL	
EMERGENCY REPAIRS FOR RED HILL TANKS	
Tank #7 AS BUILT DRAWINGS	
Repair No.: 002	File: 7r002
Upper Dome	Quadrant: D
Course: B	Plate: 22
Drawn by: Tom Kitchen	Date: 5/4/98

DEFECT INSPECTED 3/27/98 BY JF & TK

EXISTING 1/4 X 2 FLATBAR

TYPE 10 REPAIR

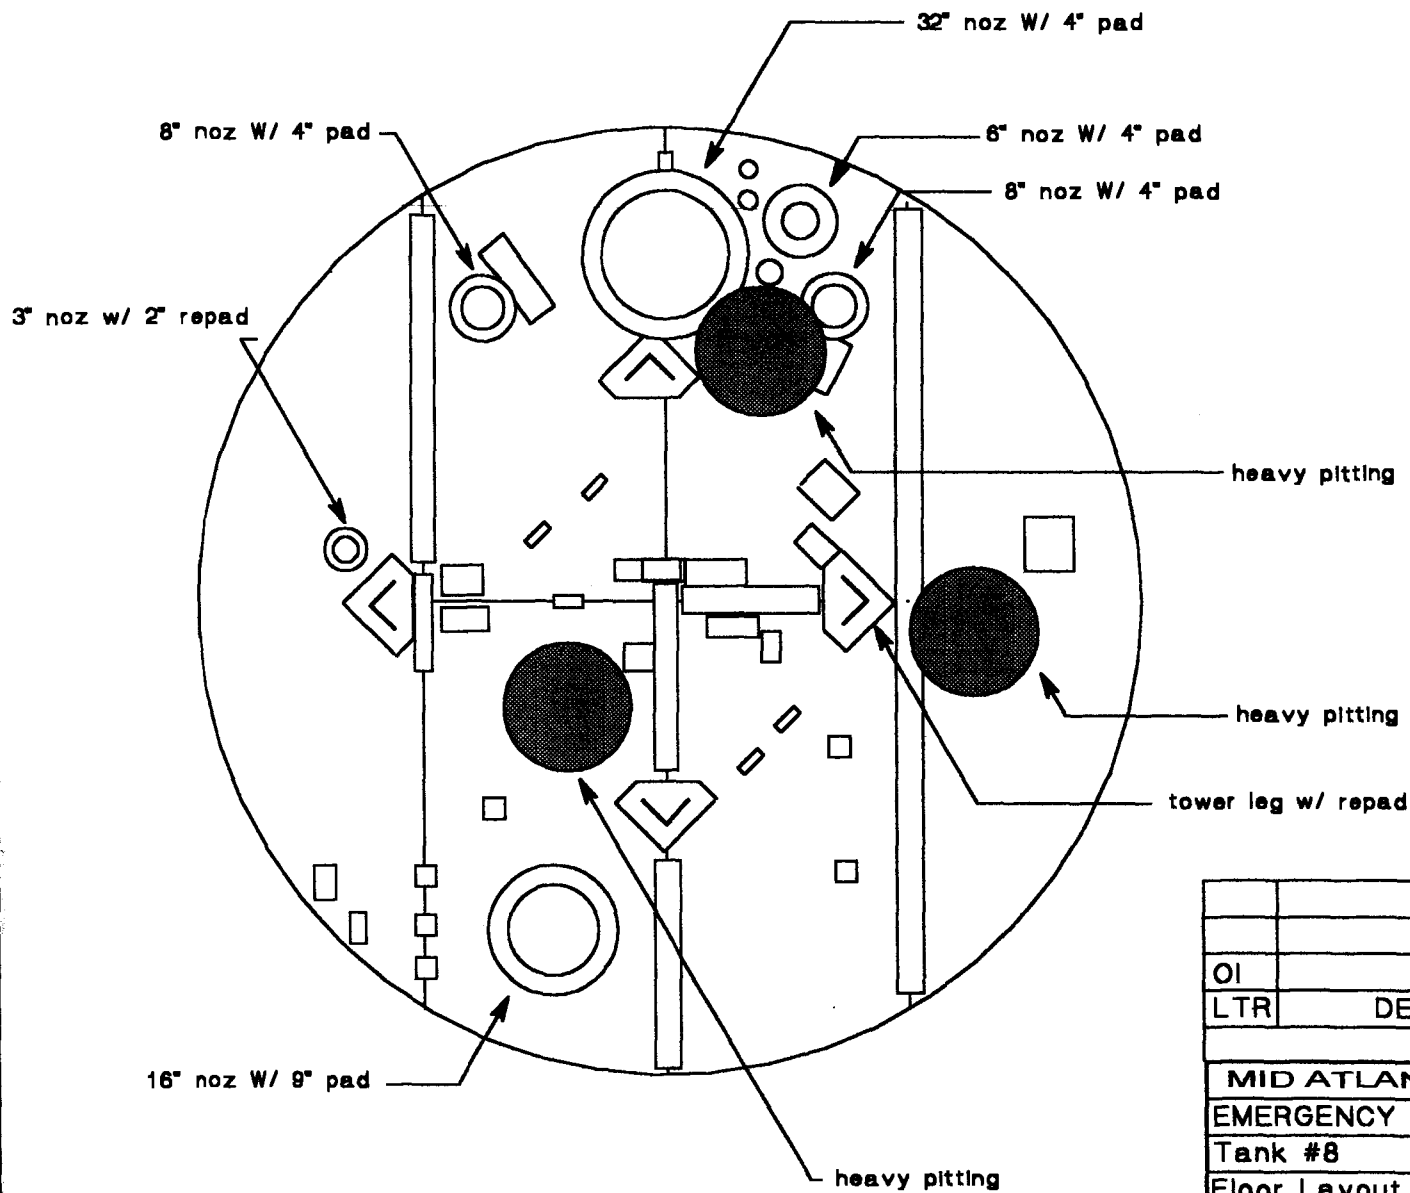
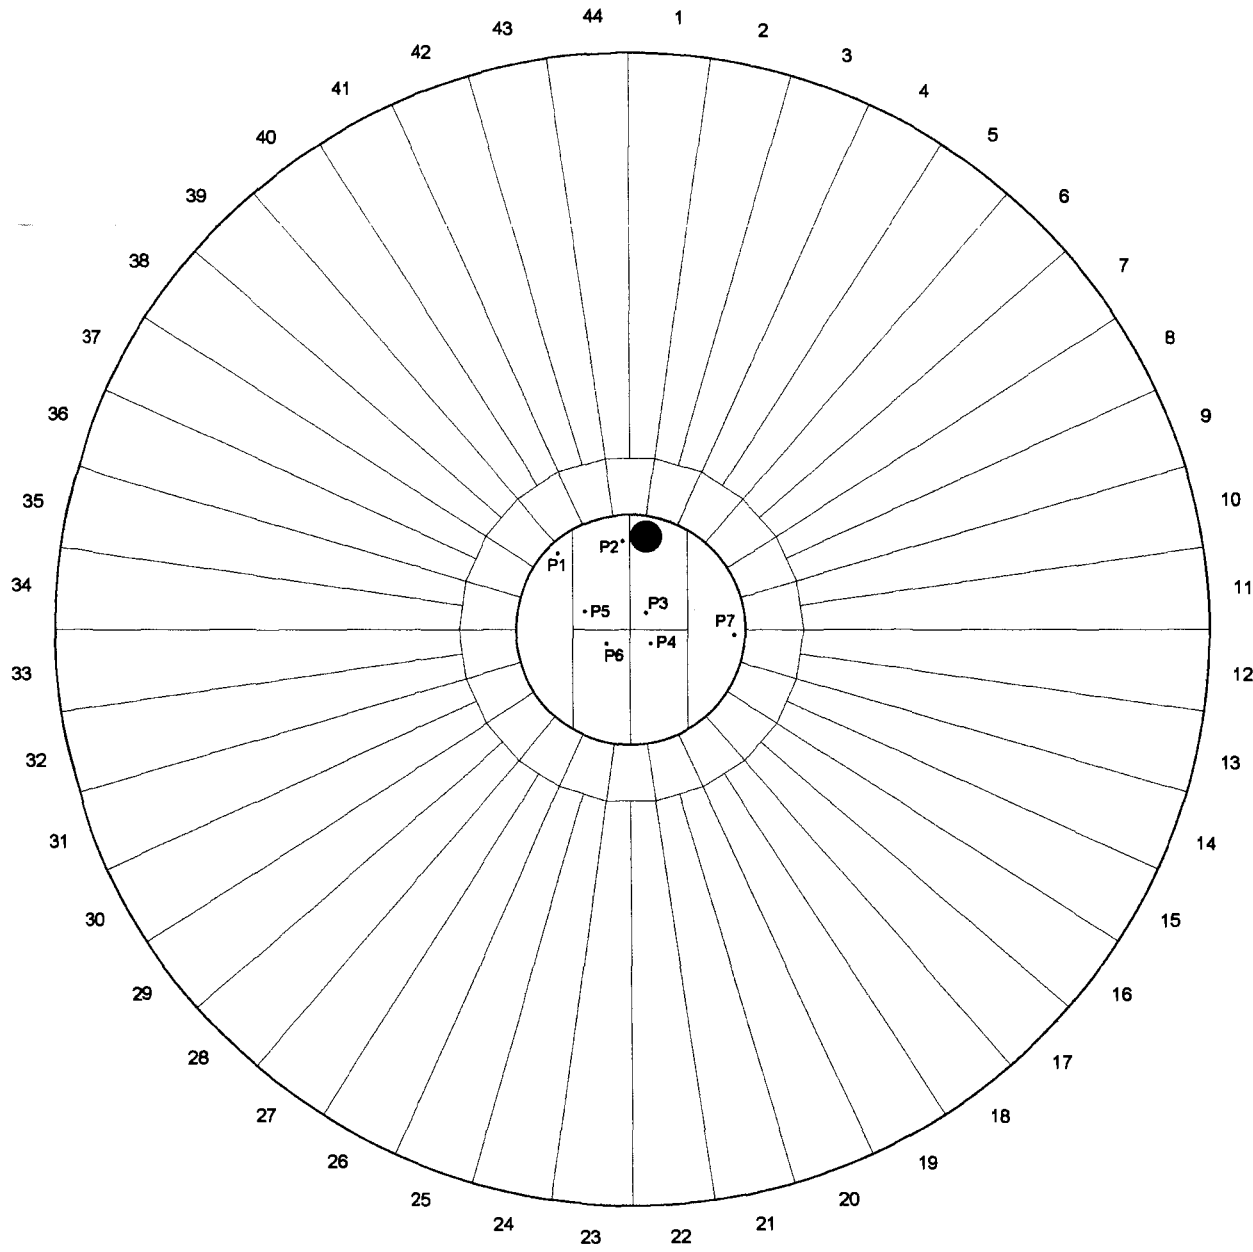
OI		TK	
LTR	DESCRIPTION	BY	DATE
REVISIONS			
MID ATLANTIC ENVIRONMENTAL			
EMERGENCY REPAIRS FOR RED HILL TANKS			
Tank #8			
Floor Layout		File: 8fillo	
Tank bottom			
Drawn By: T. Kitchen		Date: 7/20/98

Remarks/Legend: Pitting was general over 30% of bottom

- P1 = 0.15
- P2 = 0.11
- P3 = 0.09
- P4 = 0.12
- P5 = 0.09
- P6 = 0.09
- P7 = 0.12
