Project Title: CLEAN, INSPECT, AND REPAIR STORAGE TANKS 5 & 17
Location: PEARL NAVAL BASE – REDHILL COMPLEX, Pearl Harbor, HI
Task Order No.: N62583-09-D-0132/0003
WGS Project Number: 54118
Date: 18 Nov, 2010

**TANK 5 & 17 CLEANING, INSPECTION
AND REPAIRS PROJECT**

TANK 5 INSPECTION REPORT

**FINAL DRAFT TANK INSPECTION
& INTEGRITY REPORT**

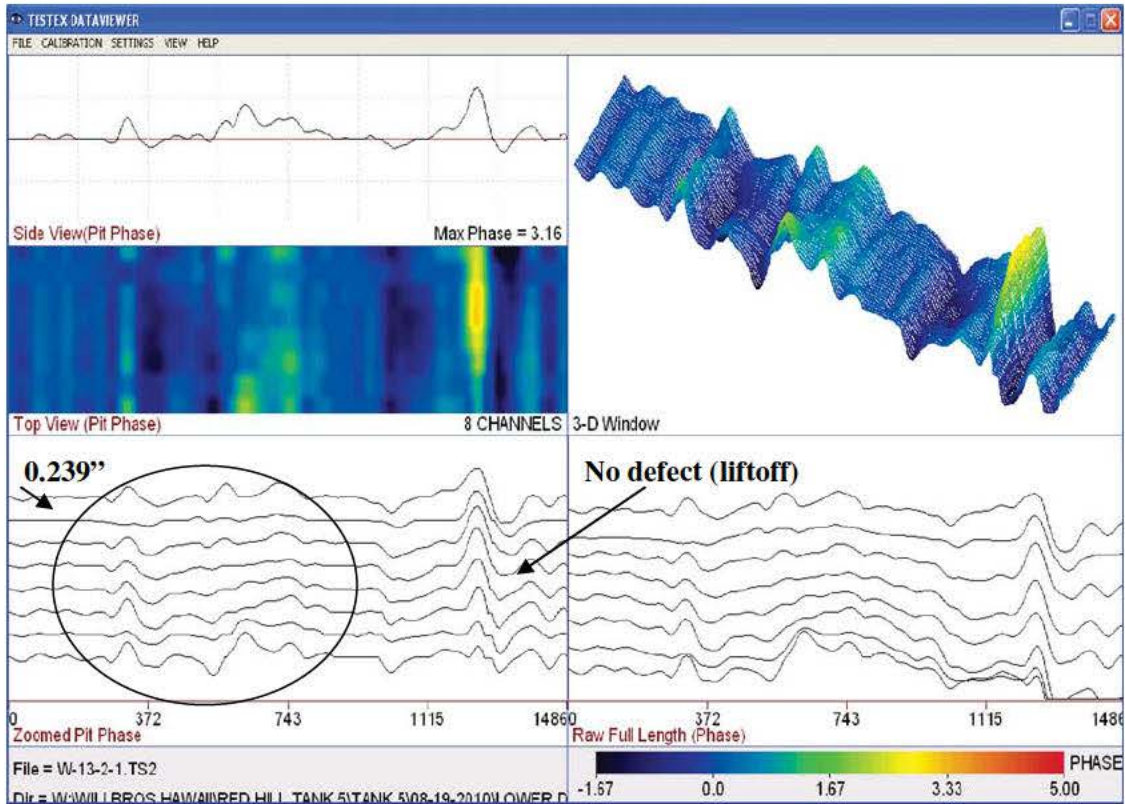
Flaw # 50: The Waveform above depicts an underside corrosion exhibiting 0.239" wall remaining

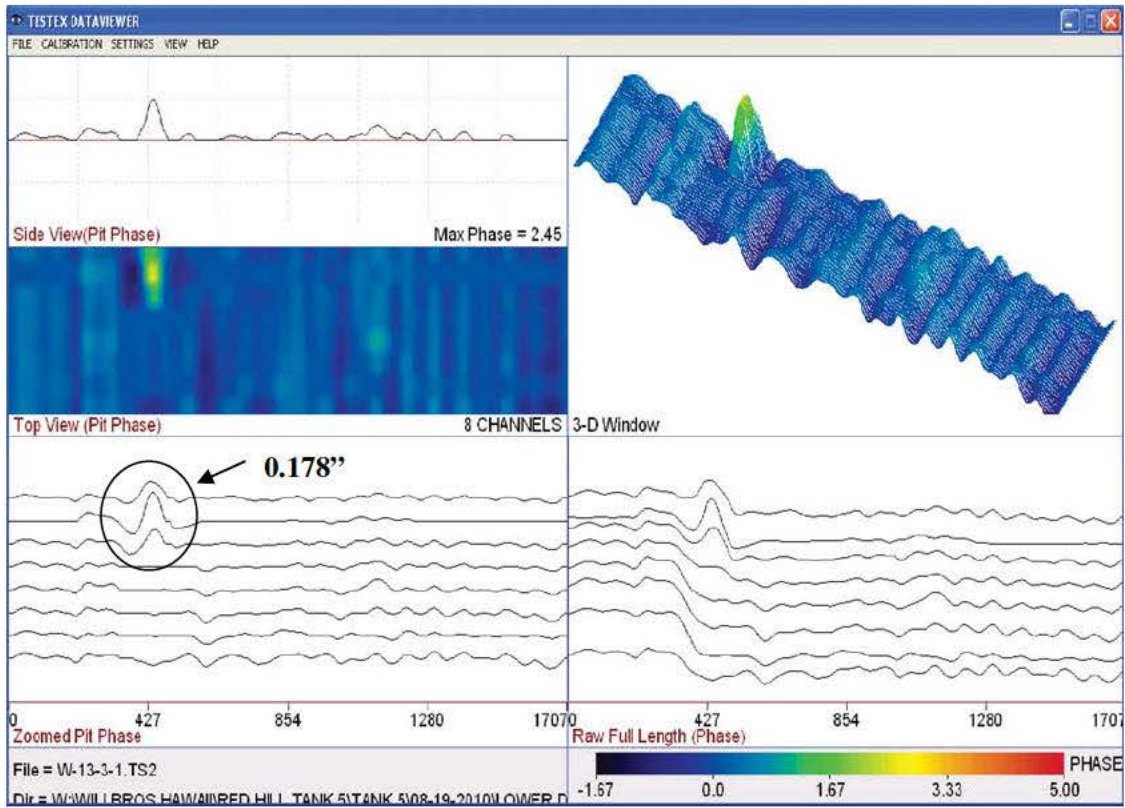
Flaw # 255: The Waveform above depicts an underside corrosion exhibiting 0.178" wall remaining

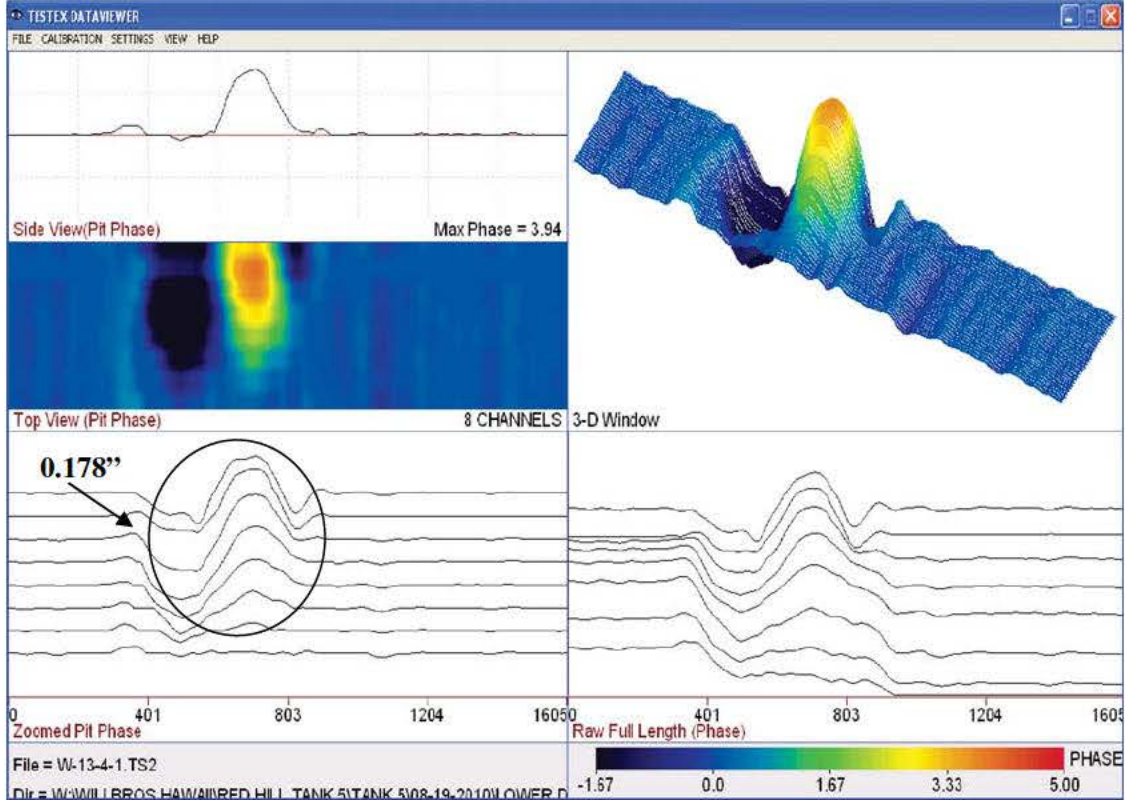
Flaw # 243: The Waveform above depicts an underside corrosion exhibiting 0.178" wall remaining

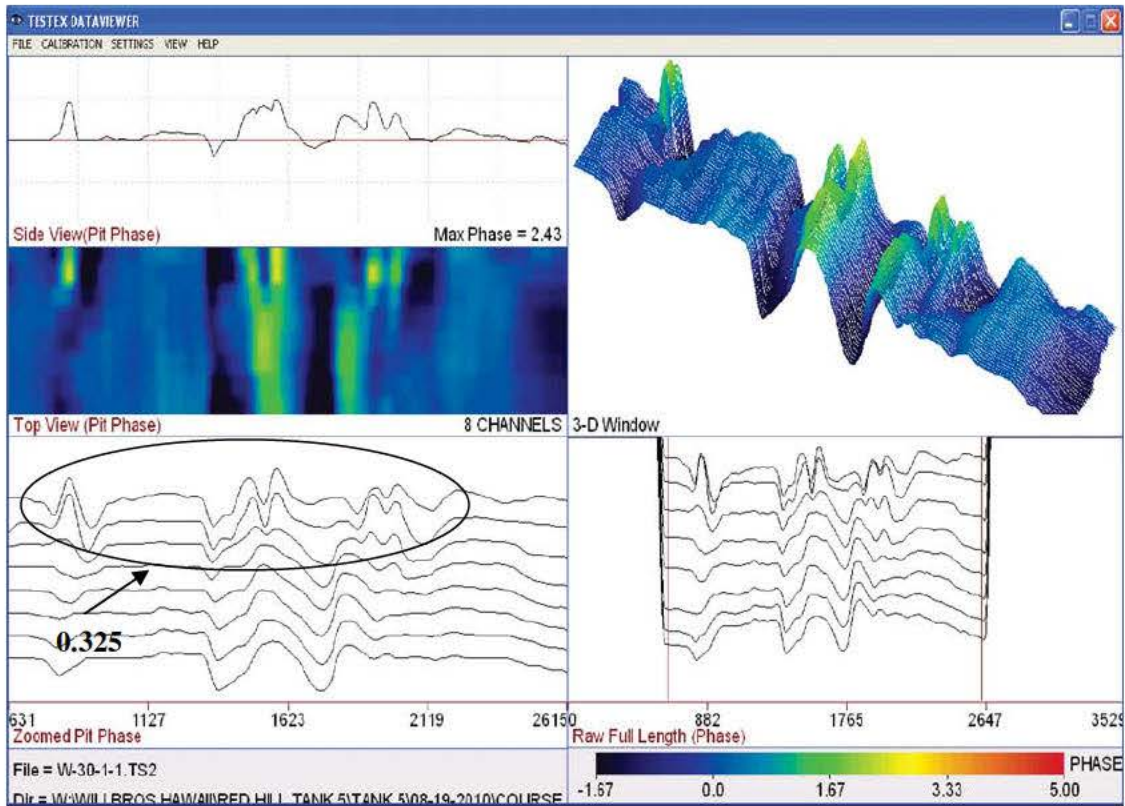
Flaw # 232: The Waveform above depicts an underside corrosion exhibiting 0.235" wall remaining

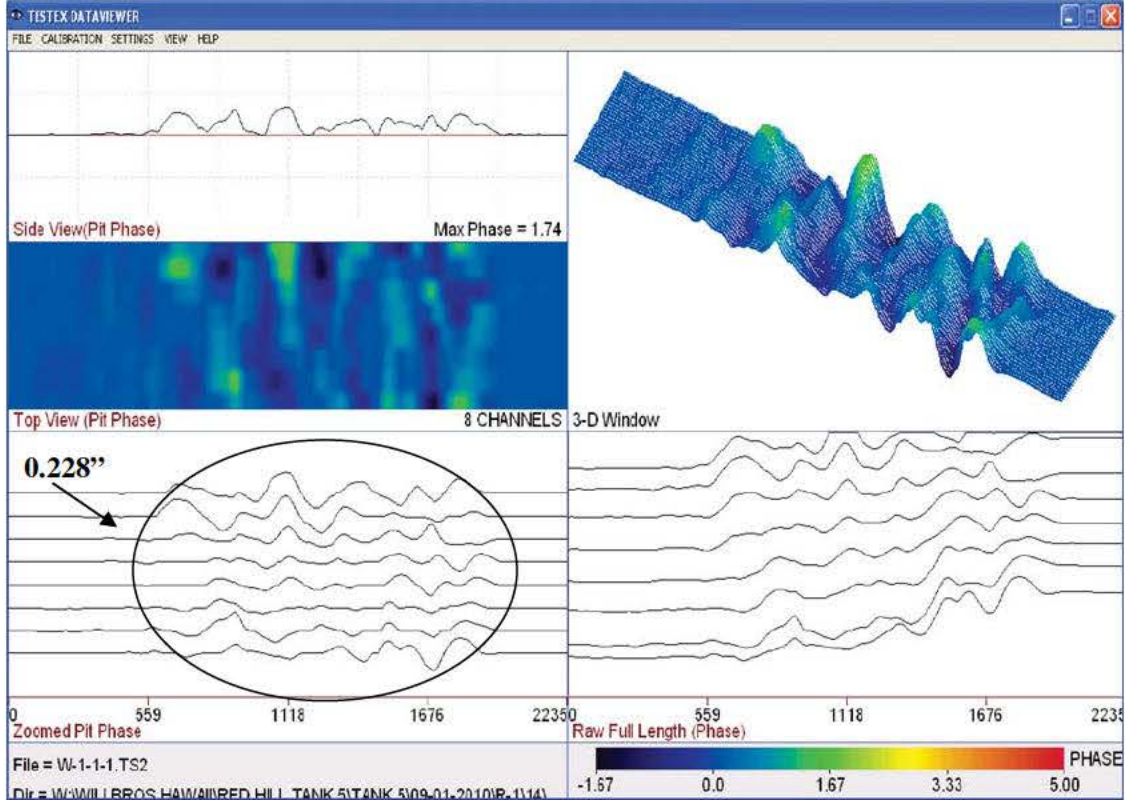
Flaw # 34: The Waveform above depicts an underside corrosion exhibiting 0.228" wall remaining

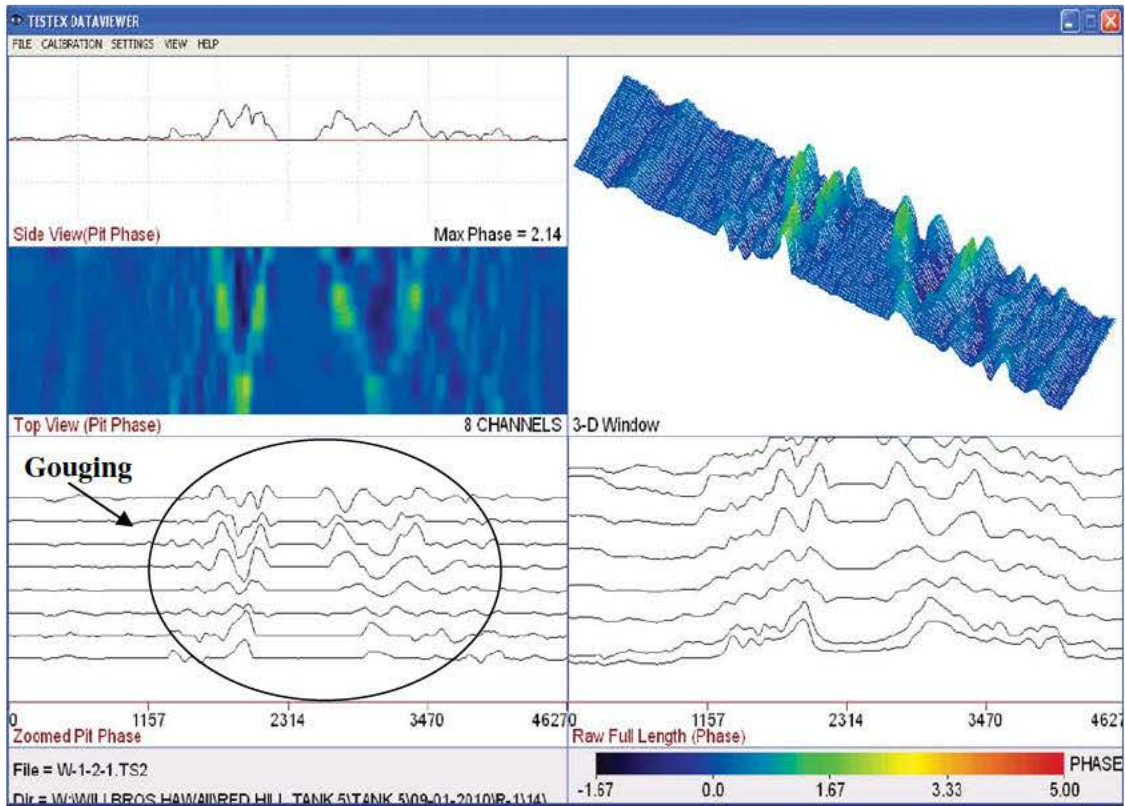
Flaw # 242: The Waveform above depicts surface side gouging 0.30" deep.

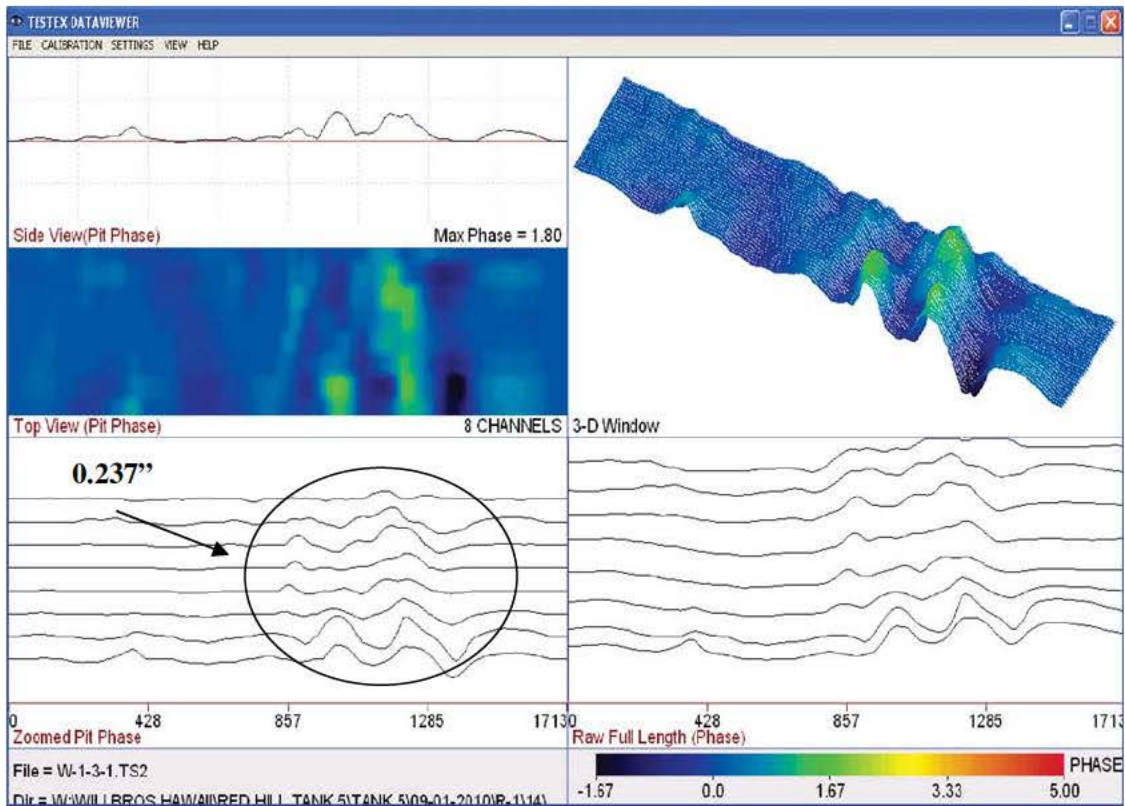
Flaw # 128: The Waveform above depicts an underside corrosion exhibiting 0.237" wall remaining.

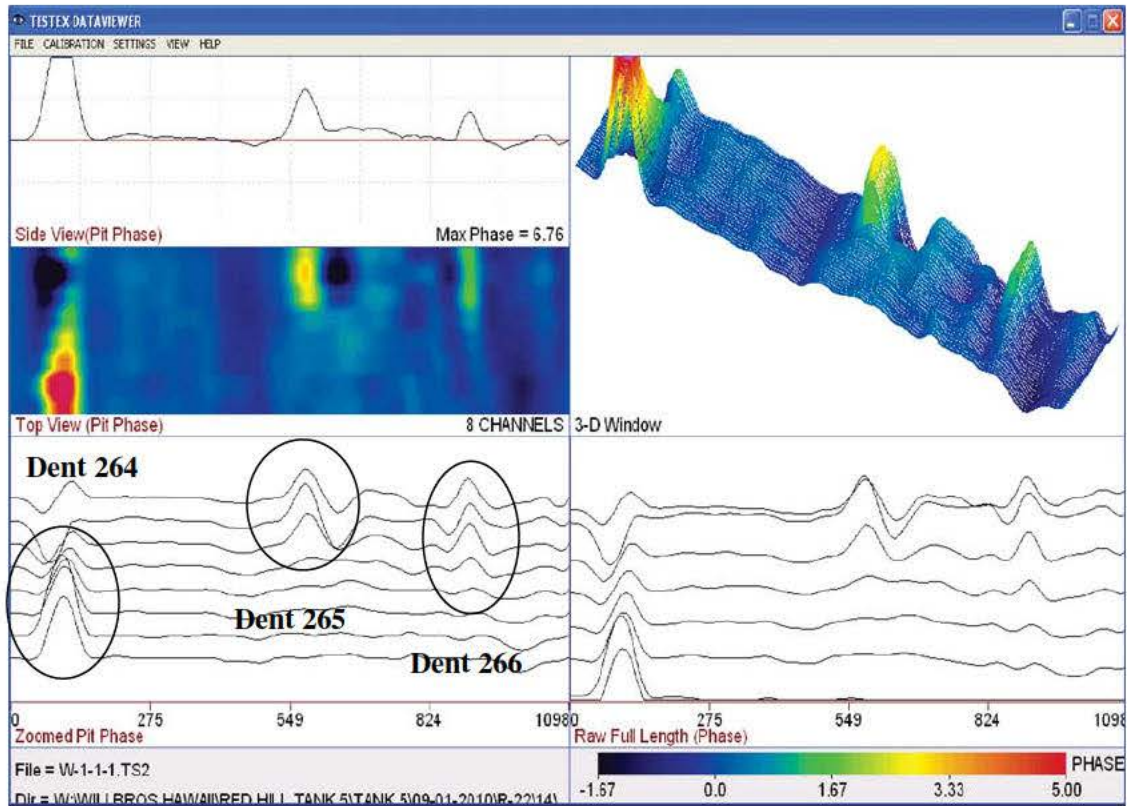
Flaw # 264, 265, and 266: The Waveform above depicts dents that are between 0.200" - 0.240" deep.

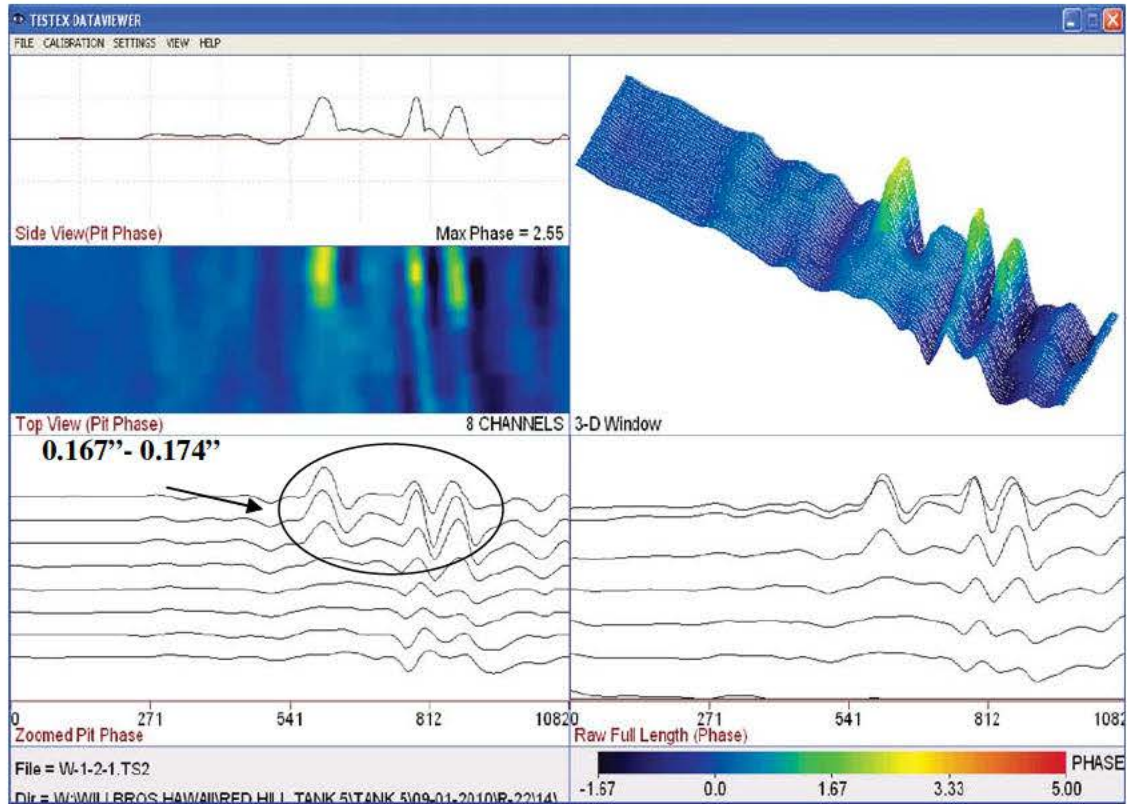
Flaw # 101 and 102: The Waveform above depicts an underside corrosion exhibiting 0.174" and 0.167" wall remaining.

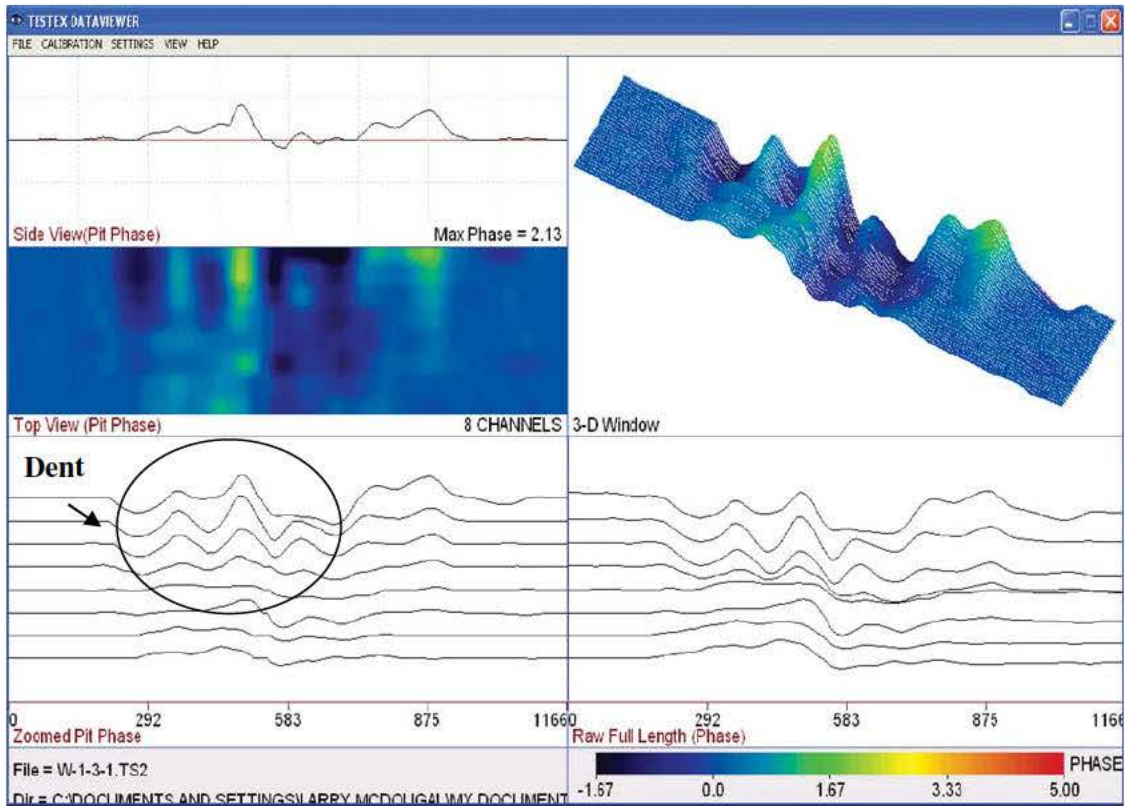
Flaw # 343: The Waveform above depicts a dent 0.250" deep.

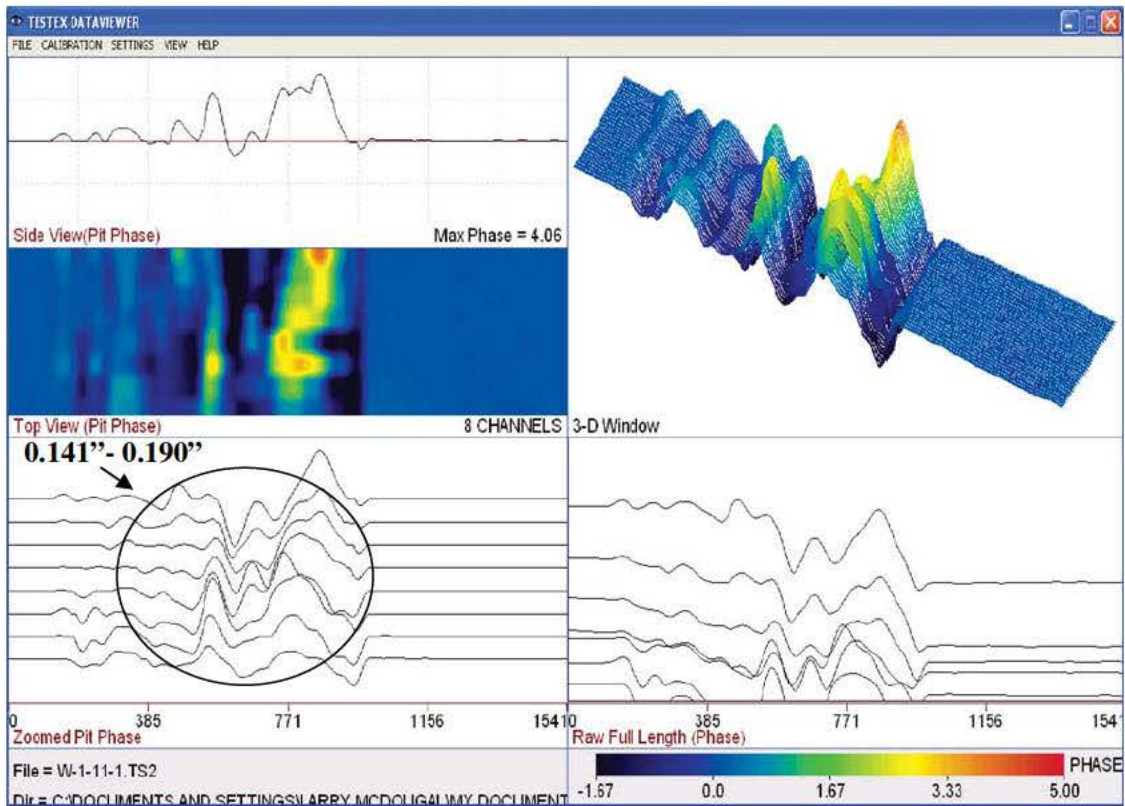
Flaw # 274: The Waveform above depicts an underside corrosion exhibiting 0.141" to 0.190" wall remaining.

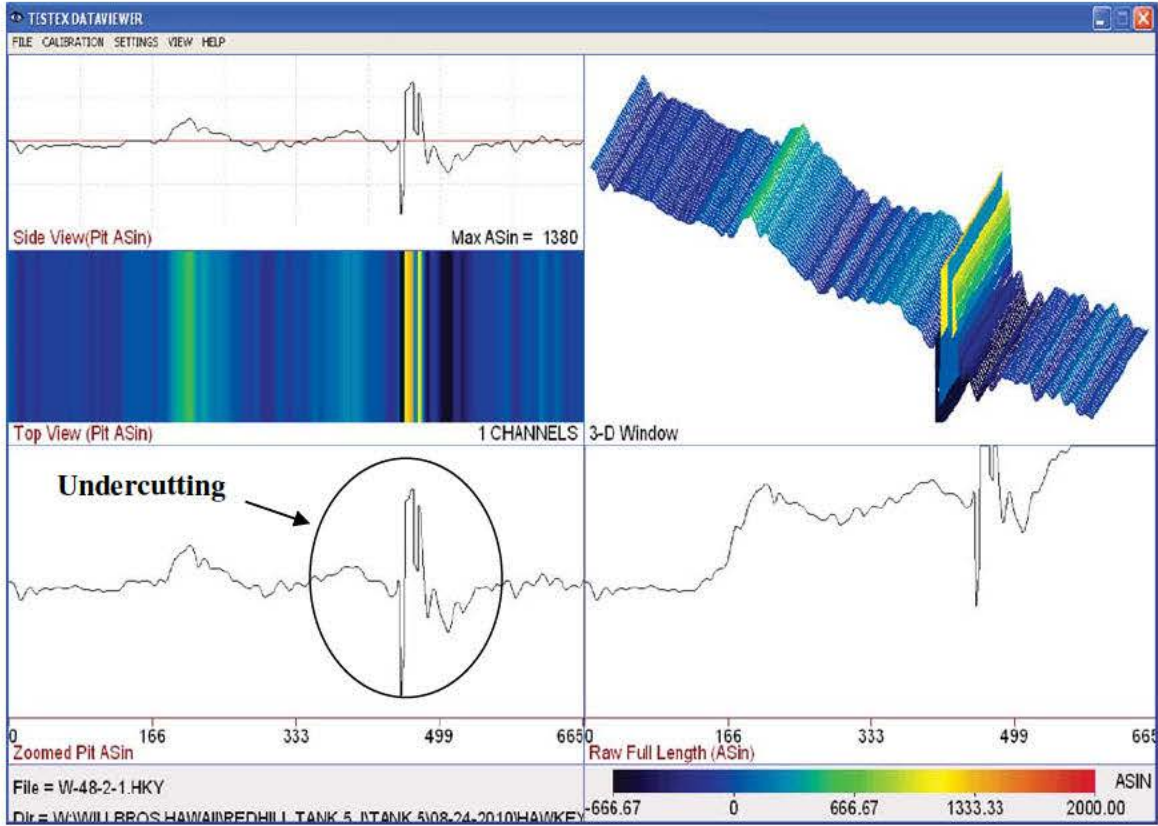
Flaw # 67A: The waveform above depicts undercutting in the weld 0.125" deep, 5" long.

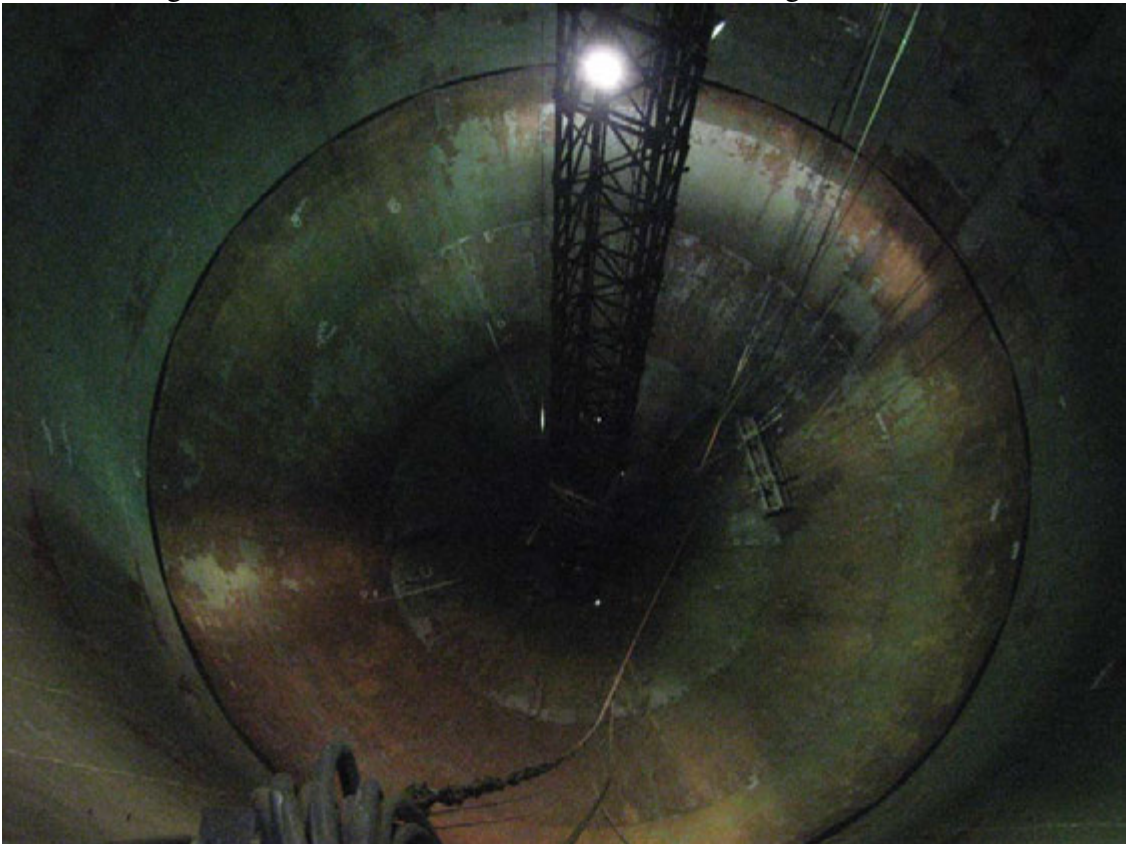
Lower dome view from above showing extensive coating failure.
