**Beazer East, Inc.**

**Former Koppers Wood-Treating Site – Carbondale, Illinois**

**Soil Removal and Surface Cover Remediation Project**

**Weekly Report #16: 2/1/21 – 2/7/21**

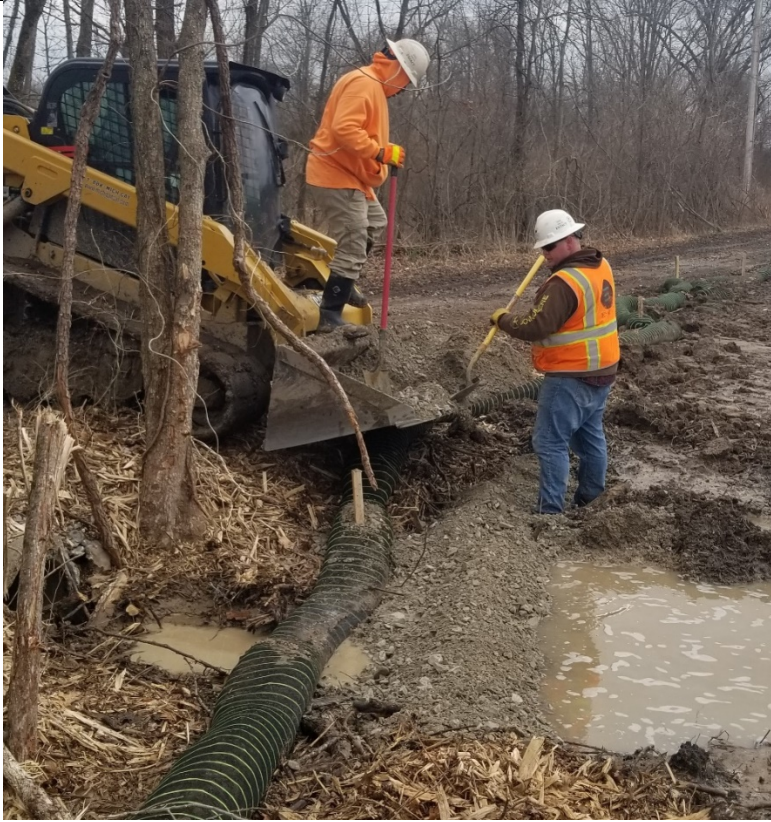
<b>Picture Number</b>	<b>1</b>

<b>Date</b>	2/2	
<b>Direction</b>	S	
<b>Description:</b> Installation of small rock check dam at inlet of culvert on eastern border of Soil Removal Area 4.		
<b>Picture Number</b>	<b>2</b>

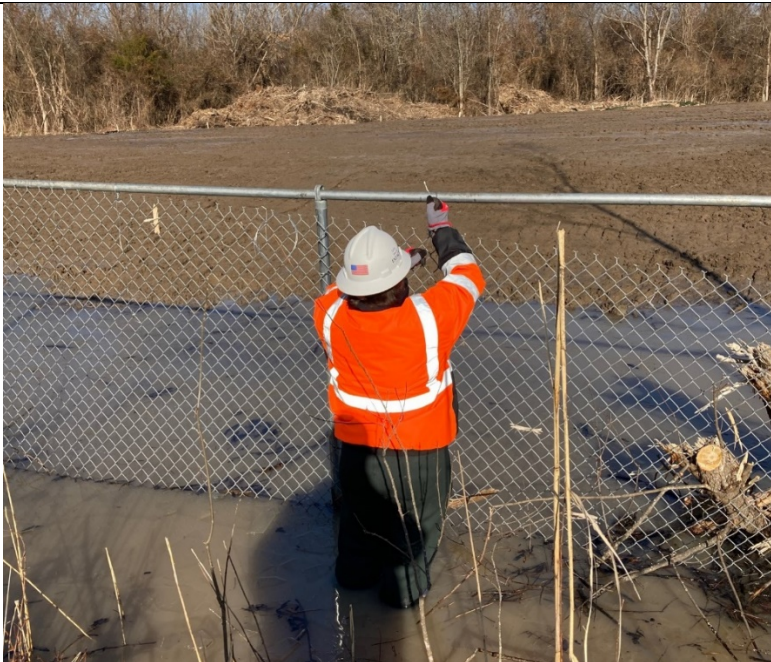
<b>Date</b>	2/3	
<b>Direction</b>	N	
<b>Description:</b> Repair of damaged fence along southern border of Surface Cover Area 2.
