Navajo Abandoned Uranium Mine Site Screen Report

Section 32 AUM Site

Navajo AUM Eastern Region

Weston Solutions, Inc.

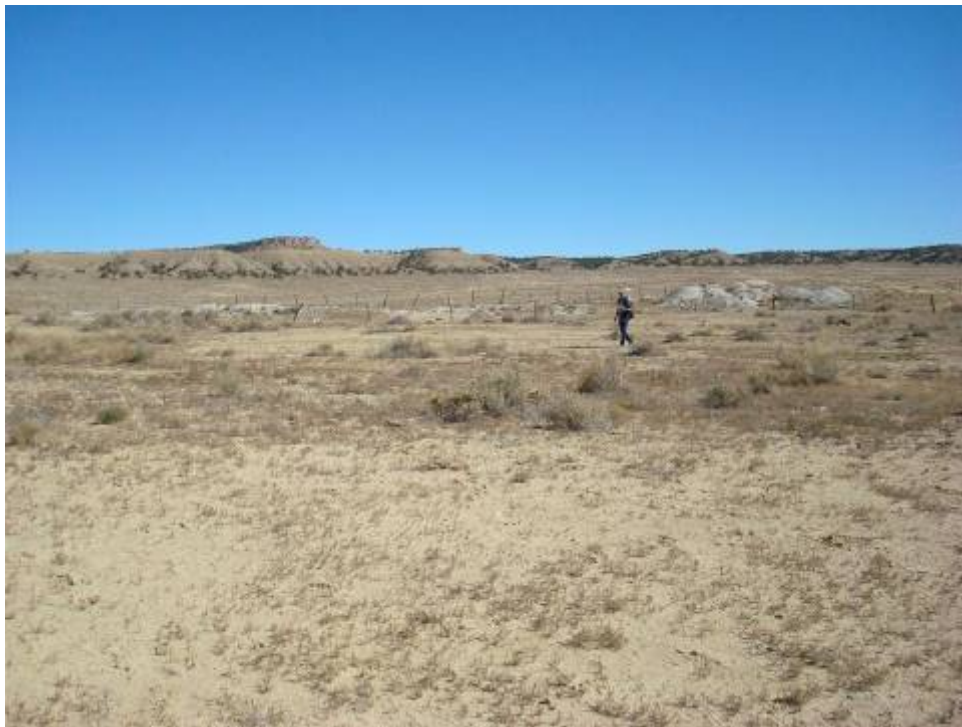
Photo 2. Section 32 Mine site, towards the south east.
waste piles in background are located on adjoining Section 33 Mine site

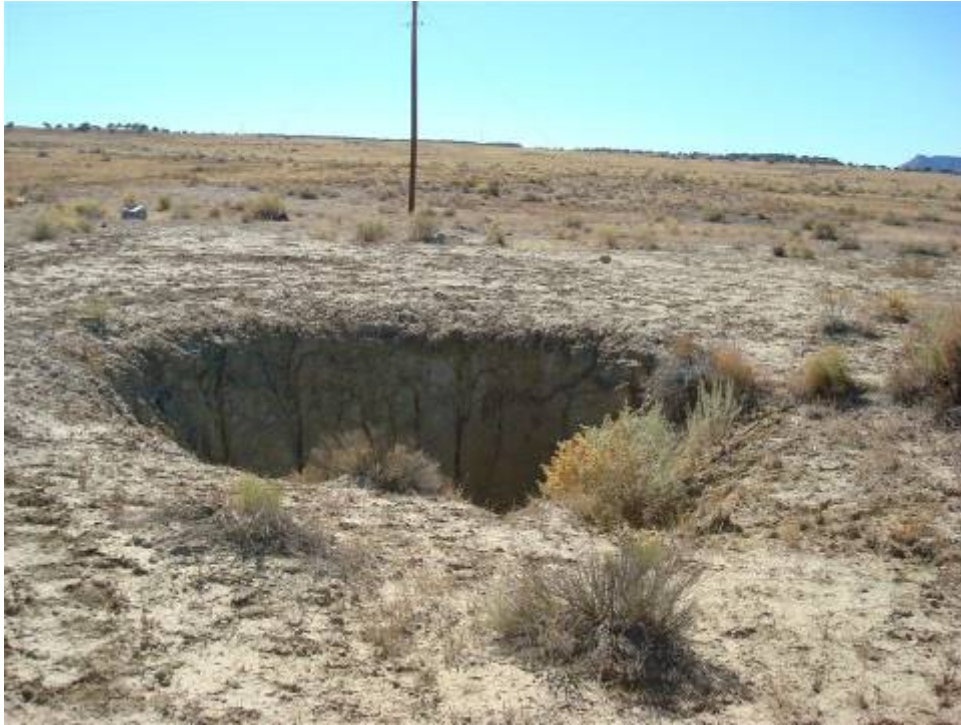
Reclamation status of the mine sites are currently unknown. No visible signs of reclamation were observed. A deep shaft is located at the southeastern portion of the site is unfenced. No waste piles or other mine features were observed during the site visit.

Photo 3. Section 32 Mine site, unsecured open shaft located in south east portion of site

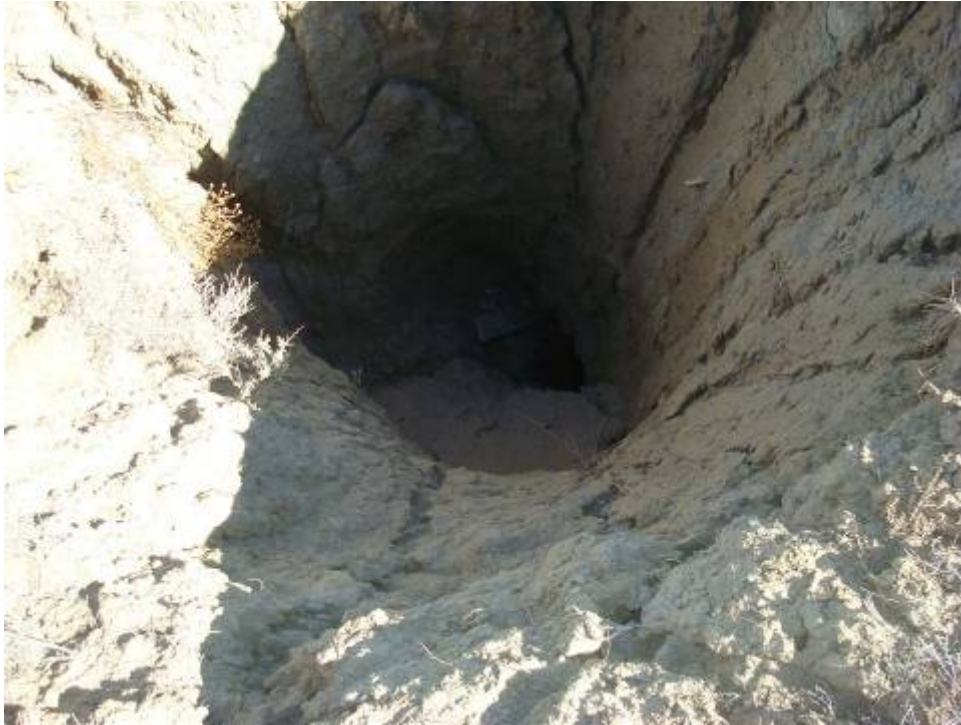
Photo 4. Section 32 Mine site, interior of open shaft

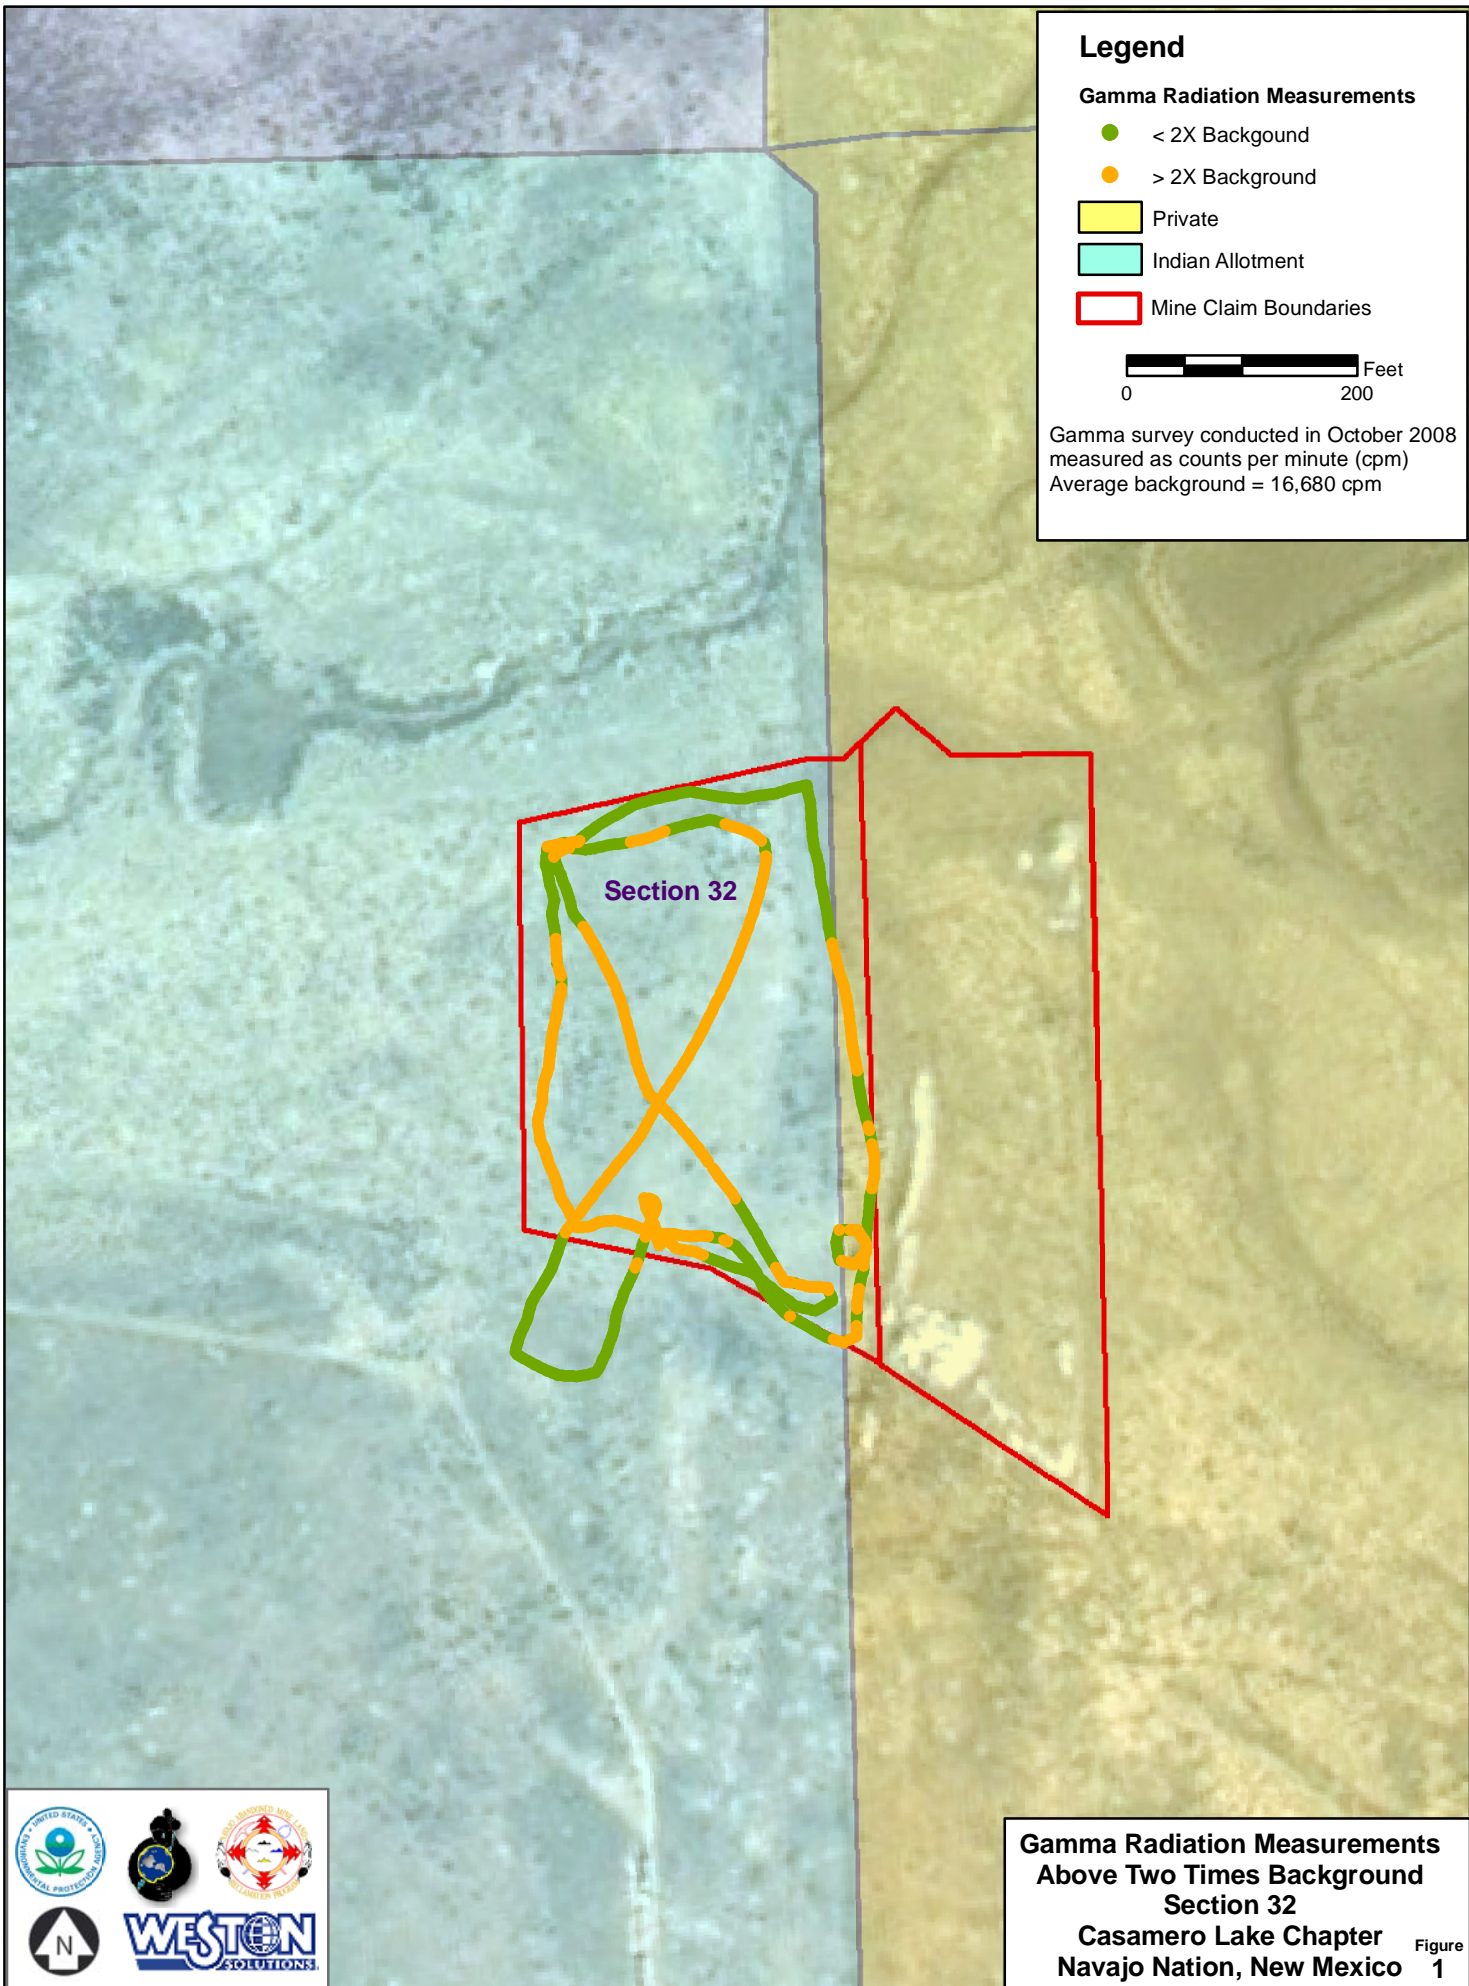
Gamma Radiation Measurements Above Two Times Background Section 32 Casamero Lake Chapter Navajo Nation, New Mexico

A total of 1,146 gamma radiation measurements were collected from mine sites, ranging from 10,689 cpm to 180,367 cpm. The measurements are represented in Figures 1 and 2.

Gamma survey conducted in October 2008
 measured as counts per minute (cpm)
 Average background = 16,680 cpm
