Subject: March 31, 2021 – April 1, 2021 CSO Inspection Report

**Purpose:** City of East St. Louis CSO Inspection

**Facility:** City of East St. Louis, IL

**Dates of Inspection:** March 31, 2021 – April 1, 2021

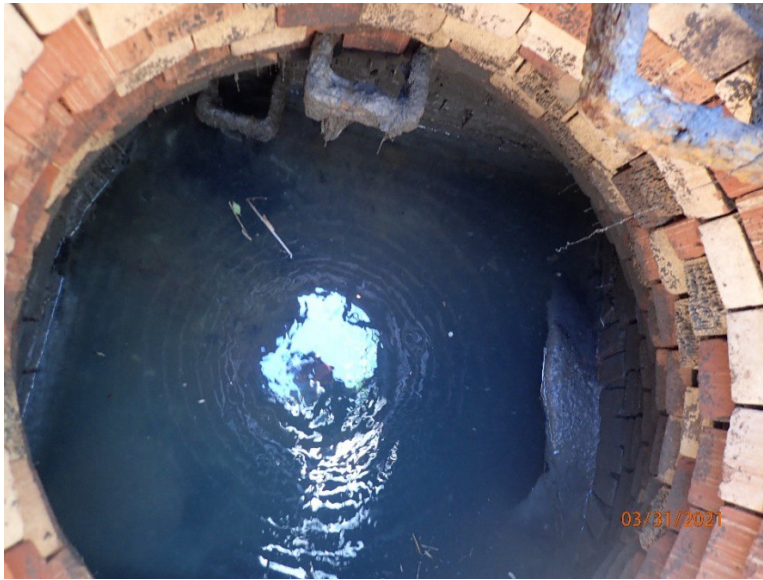
1: P3310004

Description: Looking down into the manhole that is the second manhole downstream of the flow from Centreville on 82<sup>nd</sup> Street. The manhole had standing water which was clear. There was some flow movement, but the level of the water did not recede.

Location: Manhole #15 in East St. Louis. Northwest of intersection of North 82<sup>nd</sup> Street and Ridge Avenue.

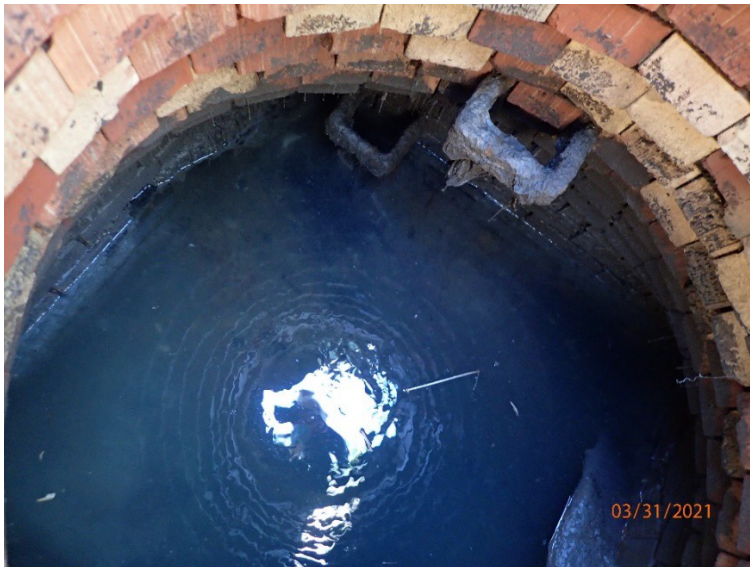
2: P3310005

Description: There was standing water with some flow into and out of manhole #15.

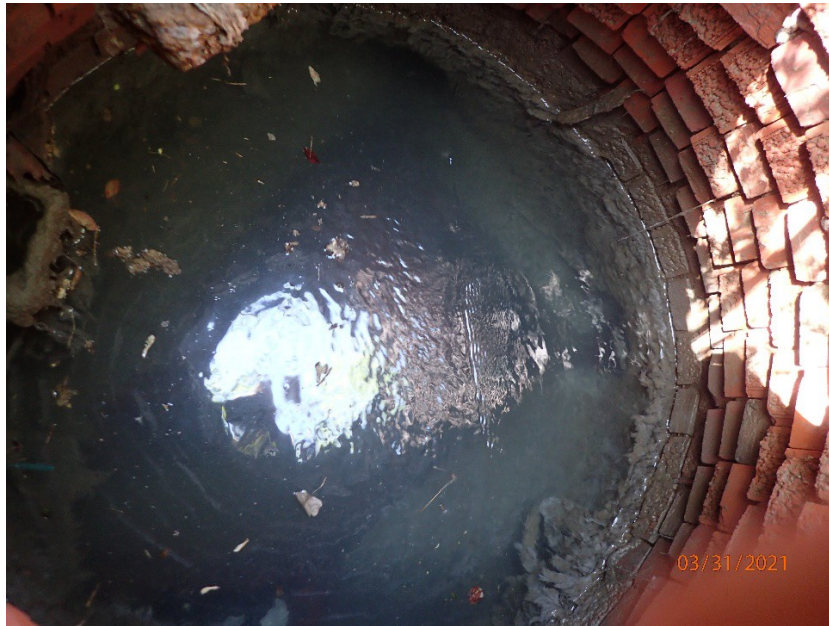
3: P3310007

Description: There was standing water in the first manhole downstream of Centreville in the East St. Louis collection system. There was some flow in and out, but the level of water did not recede.

Location: Manhole #42, southeast of North 82<sup>nd</sup> Street and Ridge Avenue.

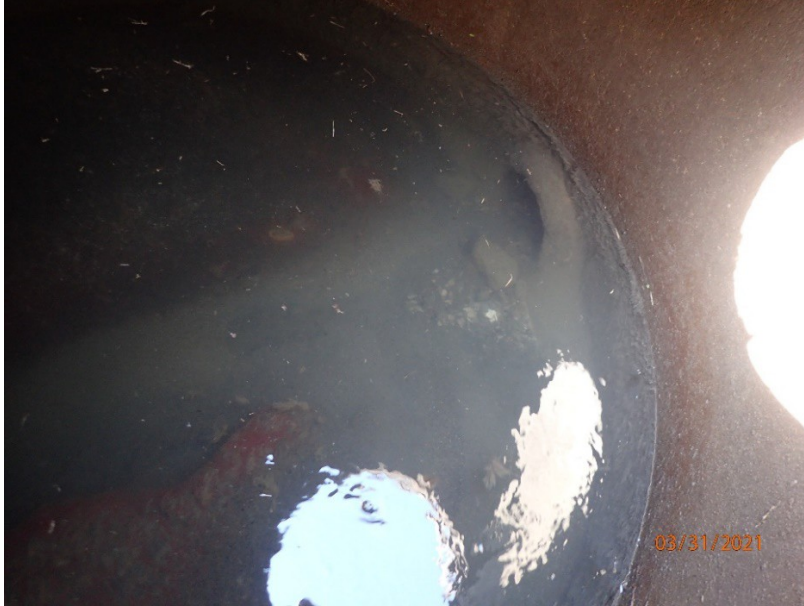
4: P3310008

Mr. Swanson and Mr. Stith then opened the last manhole in the City of Centreville's collection system on 82<sup>nd</sup> Street. This manhole had standing water in it also. IEPA inspector, Mr. Stitely, advised Mr. Swanson and Mr. Stith to continue to open manholes along this sewer line and find one that is not holding water. Mr. Stitely advised them to jet the line upstream of the first manhole that was not holding water to potentially break up any blockage in the sewer line that was preventing water from flowing freely. Mr. Swanson stated that they would try to perform this task the following day.

Description: The last manhole for the Centreville collection system before it flowed into the East St. Louis collection system had standing water in it.

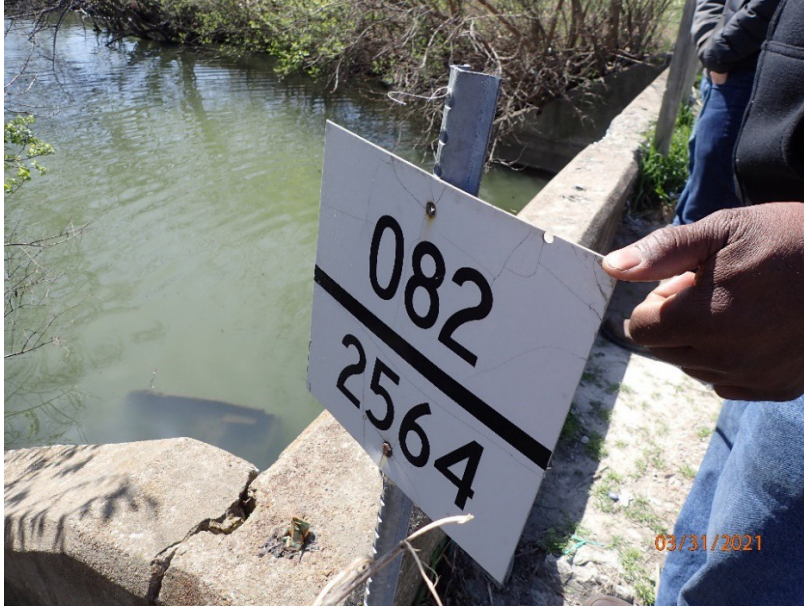
5: P3310009

The EPA inspection team then drove to observe Outfall 003 that discharges into the Frank Holten State Park Lake. Outfall 003 is listed in the Permit as a CSO discharge location at 47<sup>th</sup> Street and Lake Drive and the receiving water is the Frank Holten State Park Lake. There was no signage posted at the discharge location that would let the public know that the three pipes could contain sanitary waste. There were fishing lines and bobs hanging from the vegetation along the banks of the lake which is evidence that people fish off the bridge. The only signage contained some numbers with no description of their meaning.

Description: The sign marking at East St. Louis' Outfall 003, which flows to the Frank Holten State Park Lake.

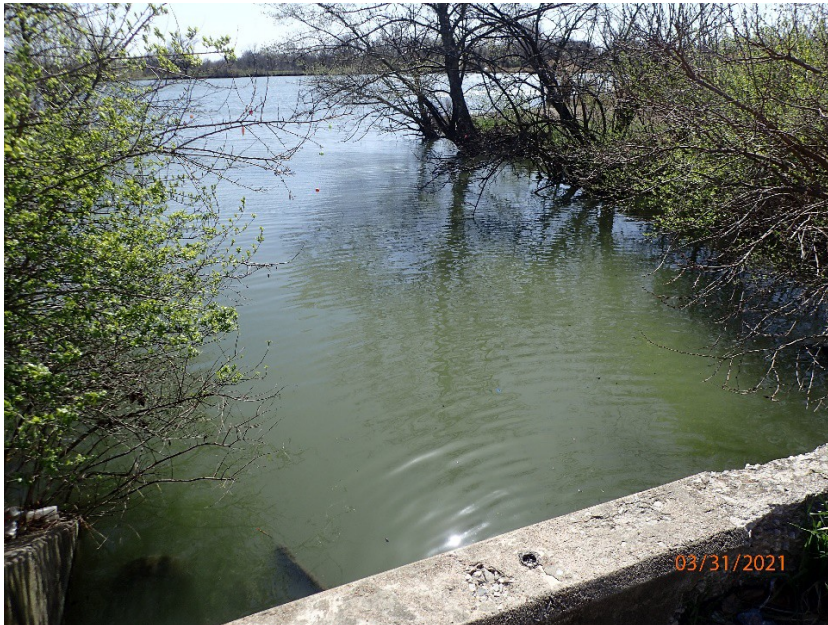
6: P3310010

Description: East St. Louis' Outfall 003 flows into the Frank Holten State Park Lake.

Mr. Swanson and Mr. Stith stated they did not know that the location where the three pipes (constituting Outfall 003) discharged to the Frank Holten State Park Lake were a CSO location for East St. Louis. Outfall 003 is located in the City of Centreville, but just south of the East St. Louis City boundary. They noted that there was a storm water pump station just to the northeast on North 47<sup>th</sup> Street near the East St. Louis Senior High School. EPA and the City personnel drove to the pump station.

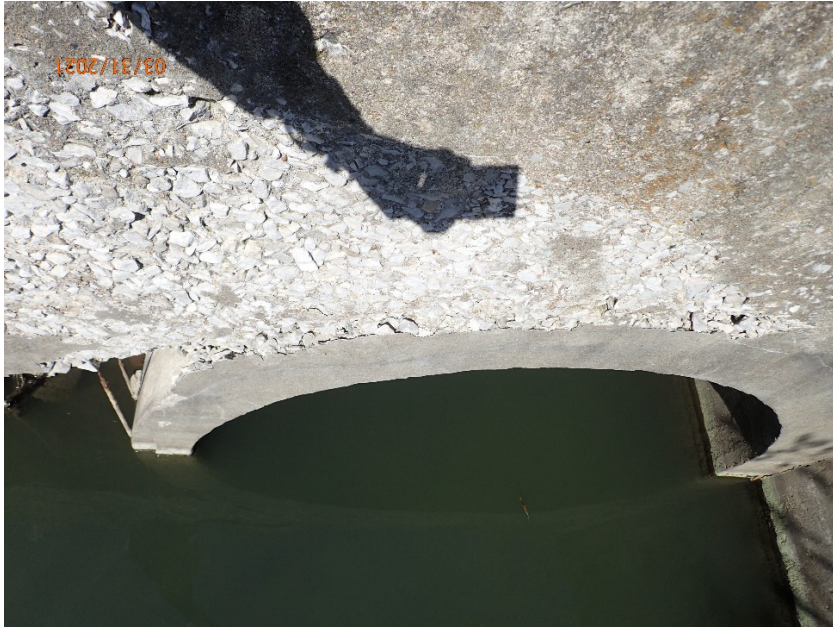
7: P3310011

Description: Looking down at one of the three pipes that make up Outfall 003.

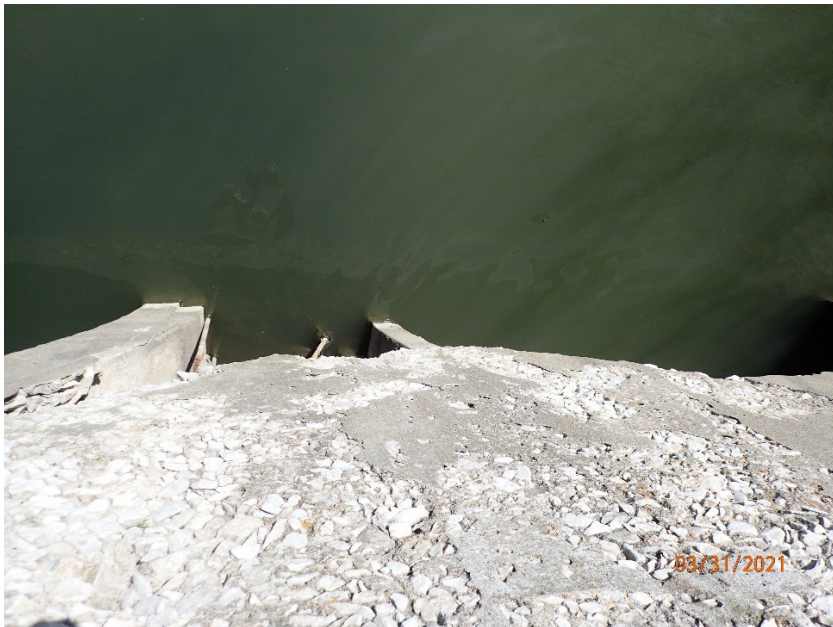
8: P3310012

Description: Looking down at Outfall 003 from above.

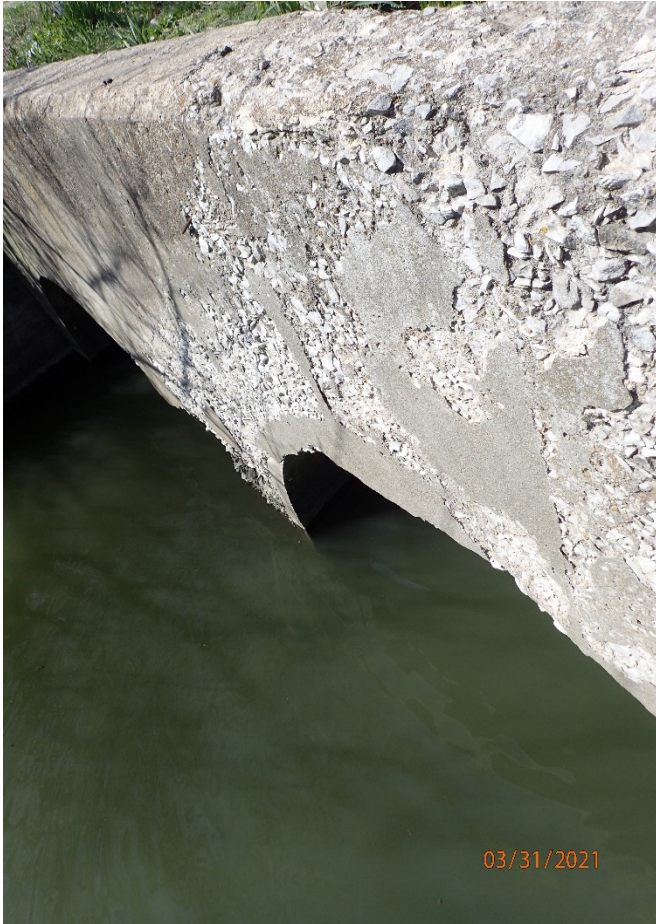
9: P3310013

Description: Looking down at one of the three pipes that make up Outfall 003.

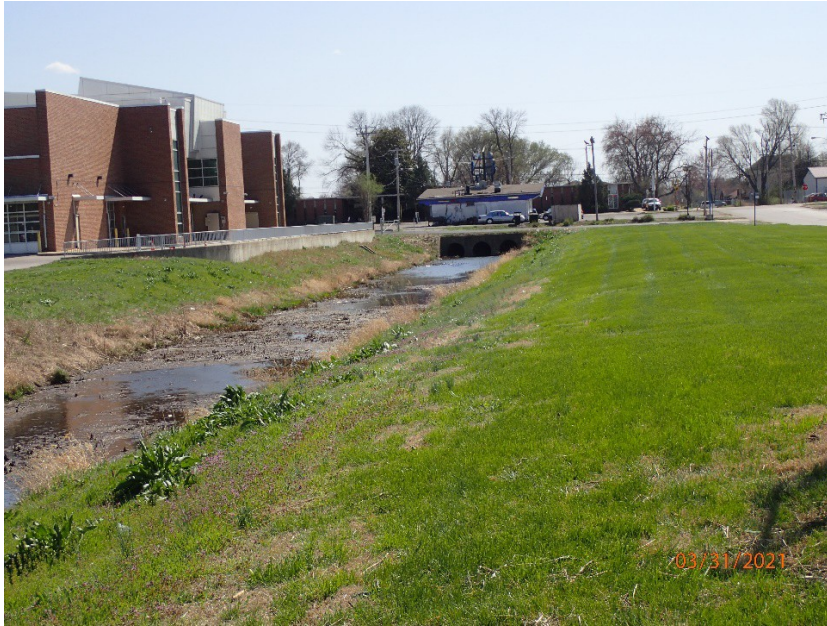
10: P3310014

Description: The ditch next to the pump station on North 47<sup>th</sup> Street north of State Street. Flow from the ditch flows south toward State Street.

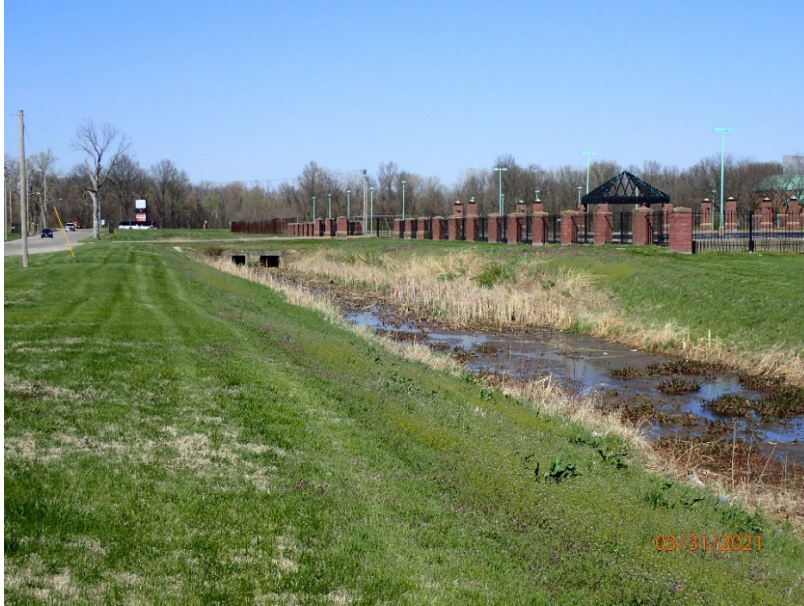
11: P3310015

Description: The ditch next to the pump station on North 47<sup>th</sup> Street north of State Street. Flow from the ditch flows south toward State Street.

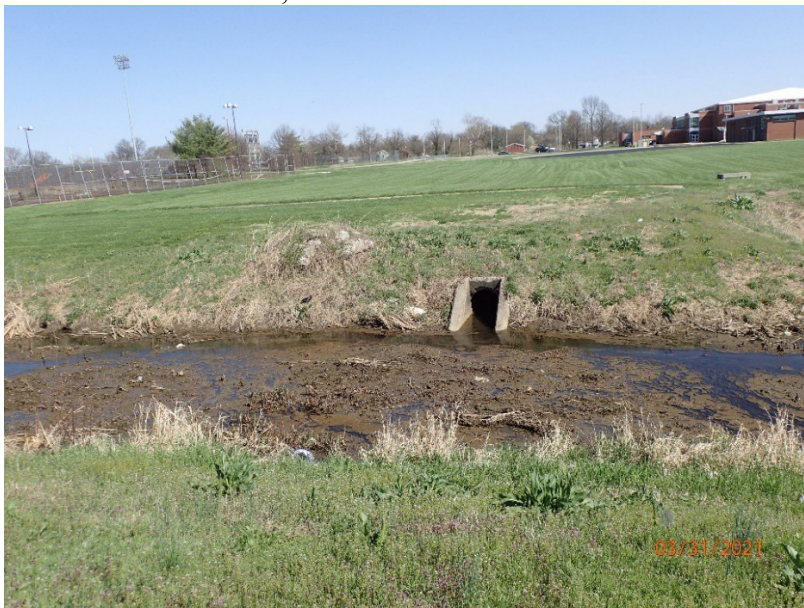
12: P3310016

Description: There are outlets on the east side of the ditch. There was no flow coming from the outlets on the day of the inspection and Mr. Swanson did not know where the flow would originate.

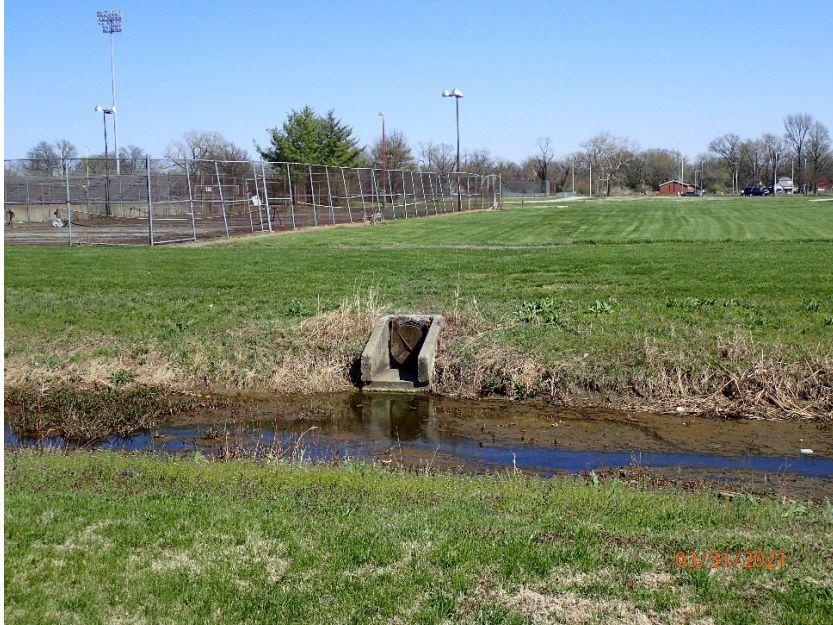
13: P3310017

Description: One of the outlets to the ditch has a backflow cover on the pipe. There was no flow coming from the outlets on the day of the inspection and Mr. Swanson did not know where the flow would originate.

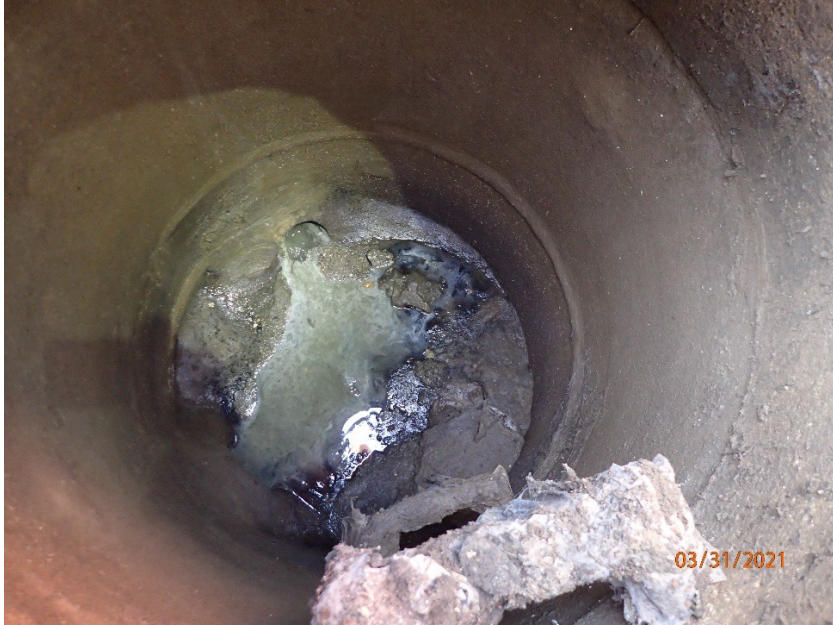
14: P3310018

EPA then continued to the remaining two sewer lines that connect the sanitary waste from the City of Centreville to the collection system in East St. Louis. The first manhole downstream from the City of Centreville along 63<sup>rd</sup> Street was flowing and had very low flow. The water was not clear and contained sanitary waste.

Description: The manhole at 63<sup>rd</sup> Street.

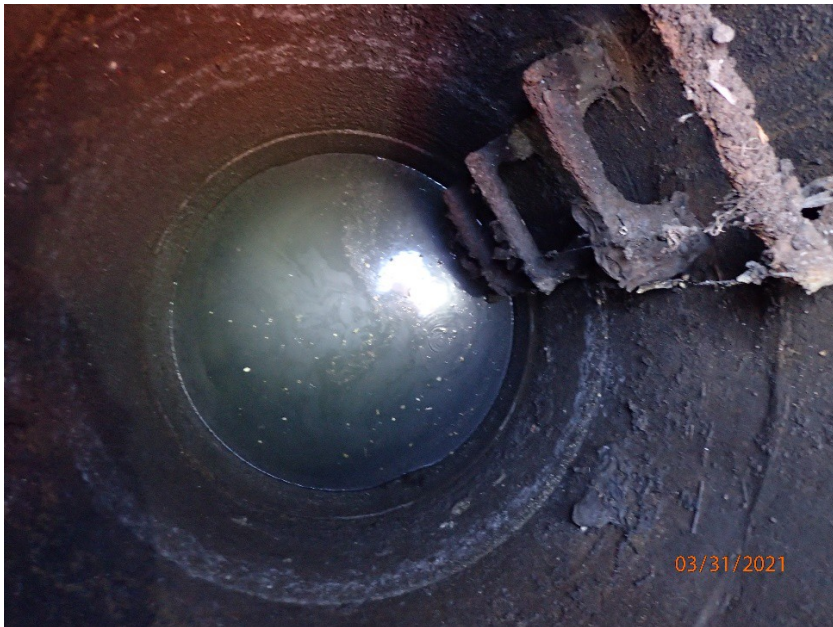
15: P3310019

The first manhole downstream from the City of Centreville along 73<sup>rd</sup> Street had standing water in it, but the water level was low. There did not appear to be any flow coming in or going out.

Description: The manhole at 73<sup>rd</sup> Street.

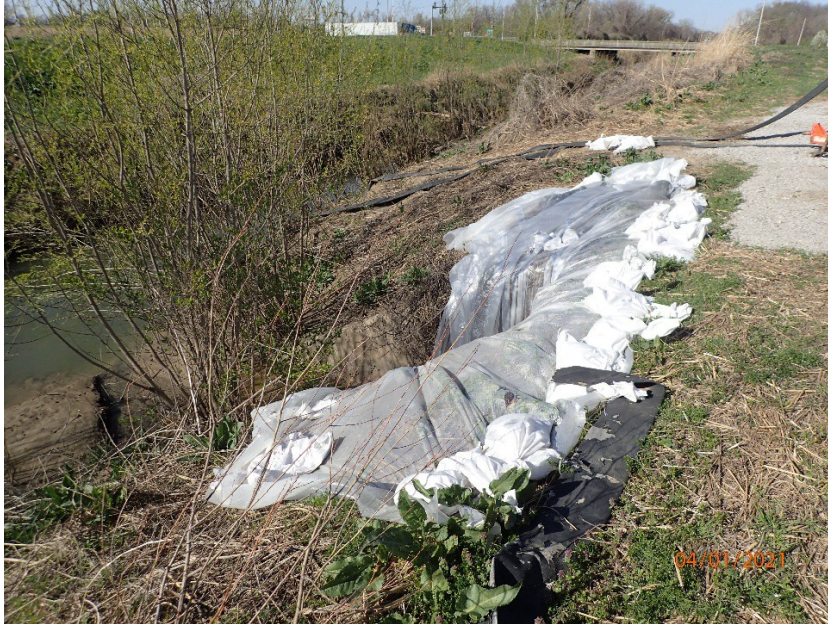
16: P4010023

At 4:30 P.M. on April 1, 2021, the EPA inspectors stopped at the East St. Louis storm water pump station at 68<sup>th</sup> Street and State Street. This pump station was not functioning and was in disrepair. There were no pumps on top of the pump housing in the pump station. There were two

Description: Large storm water outfall has been sandbagged and poly lined.

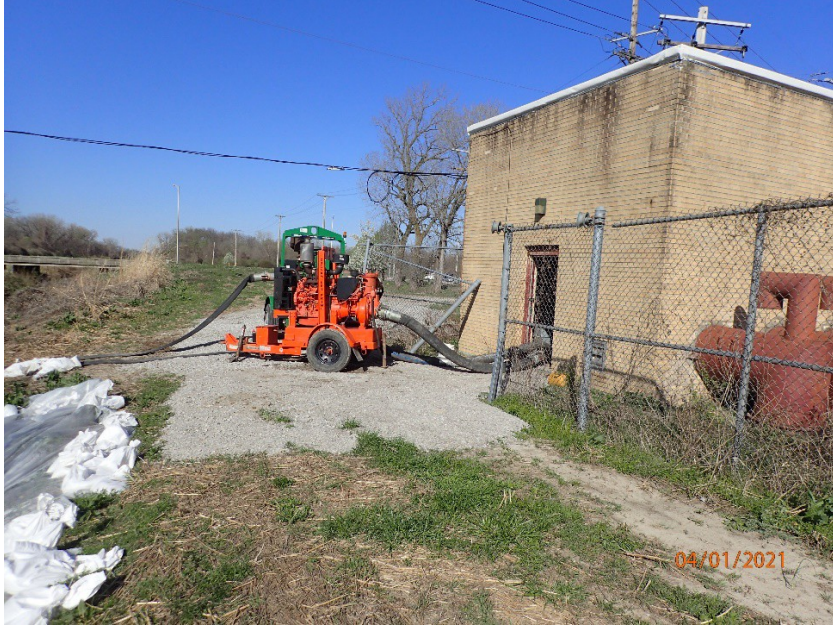
17: P4010024

bypass pumps outside the pump station for pumping the storm water from deep wet wells to a waterway that flowed southwest and south to Harding Ditch. Plastic sheeting was being held in place by sandpaper above the outfall pipe. The pump station building was unlocked and open to the public. There was no cover on the deep open wet wells. EPA also observed a deep manhole to the northeast of the building that had no sewer cover. EPA inspectors left the pump station at approximately 4:40 P.M.

Description: Storm water pump station is being bypassed.

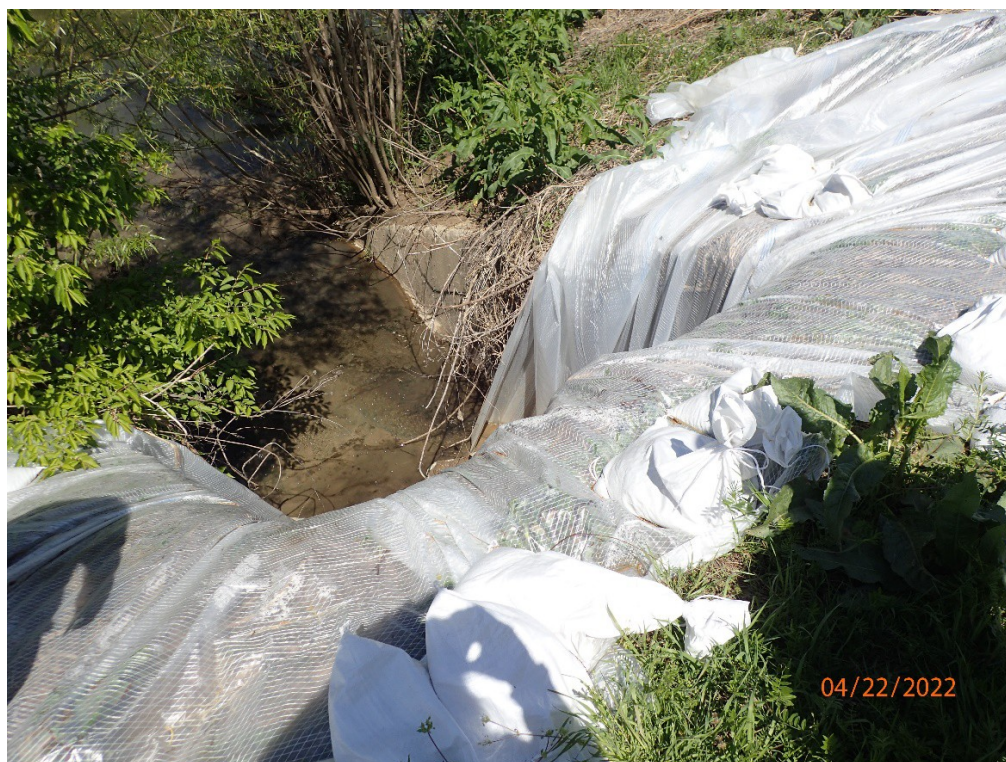
P4220019.JPG

Description: Plastic Sheeting to prevent flow from entering the outlet pipe is held in place by sandbags.

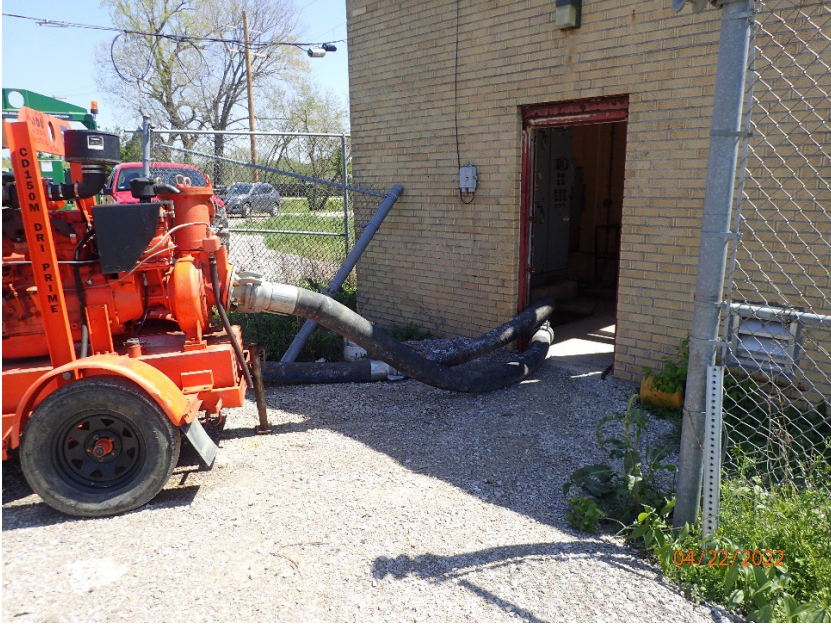
P4220020.JPG

Description: Pump station is being bypassed. Gate cannot be closed and pump station door is open.

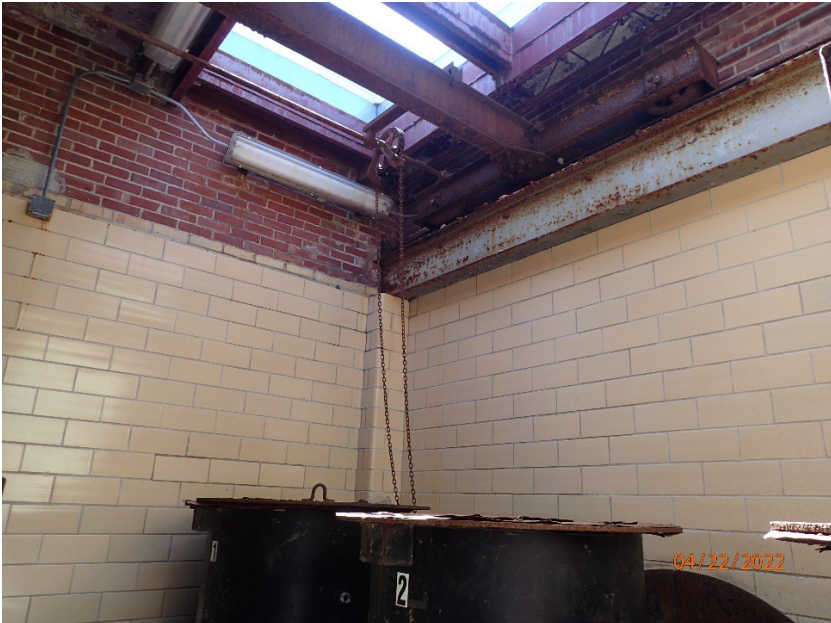
P4220021.JPG

Description: Roof is damaged and open to the elements.

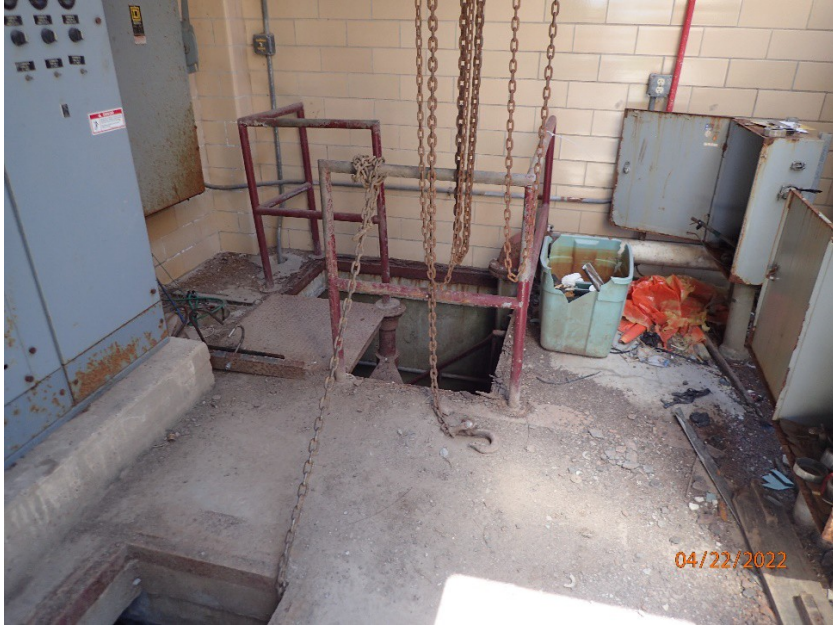
P4220022.JPG

Description: Wet well is open to the public.

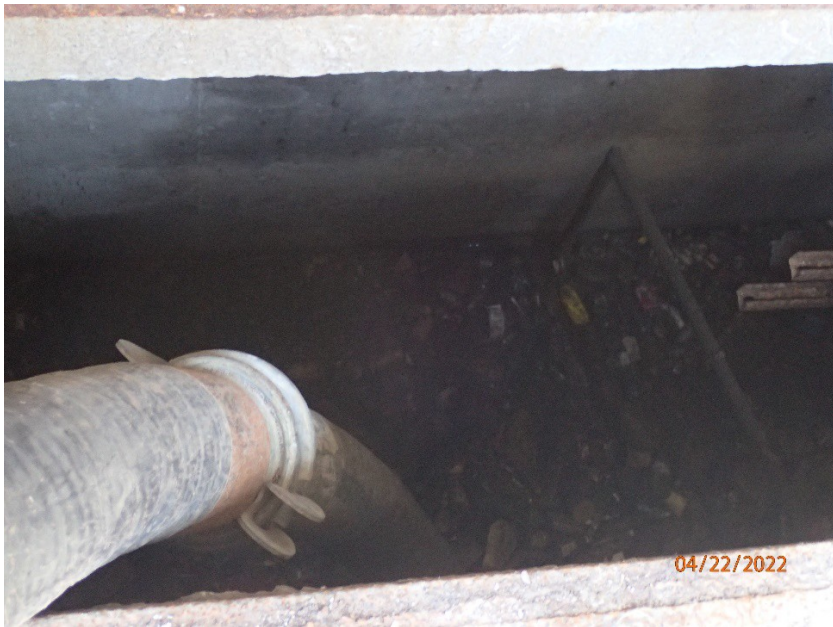
P4220023.JPG

Description: Wet well is not covered and is open to the public.

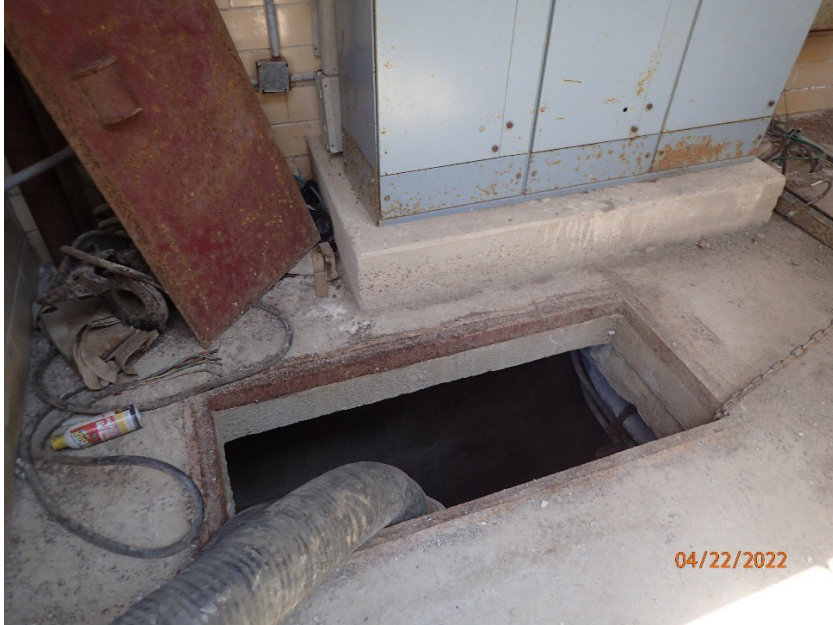
P4220024.JPG

Description: Wet well is not covered and is open to the public.

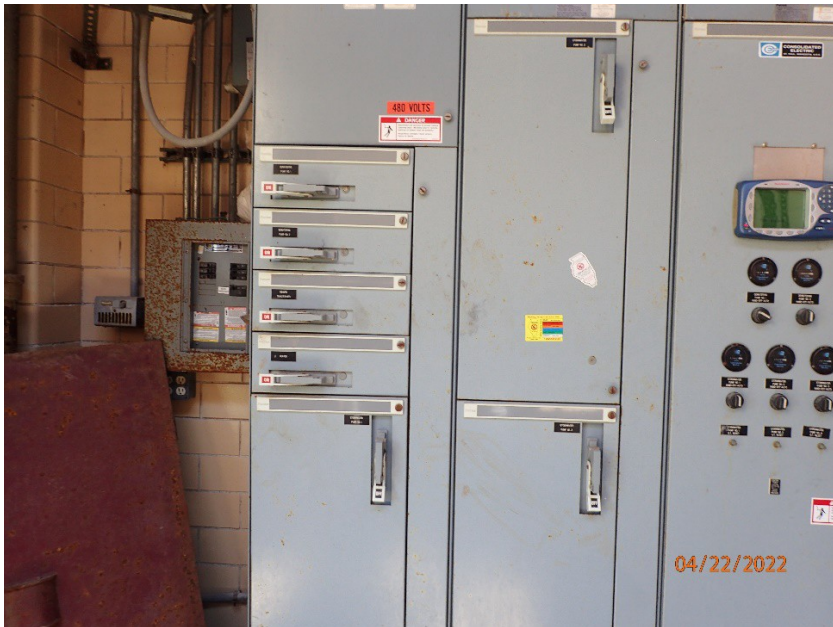
P4220025.JPG

Description: There is still power going to the pump station.

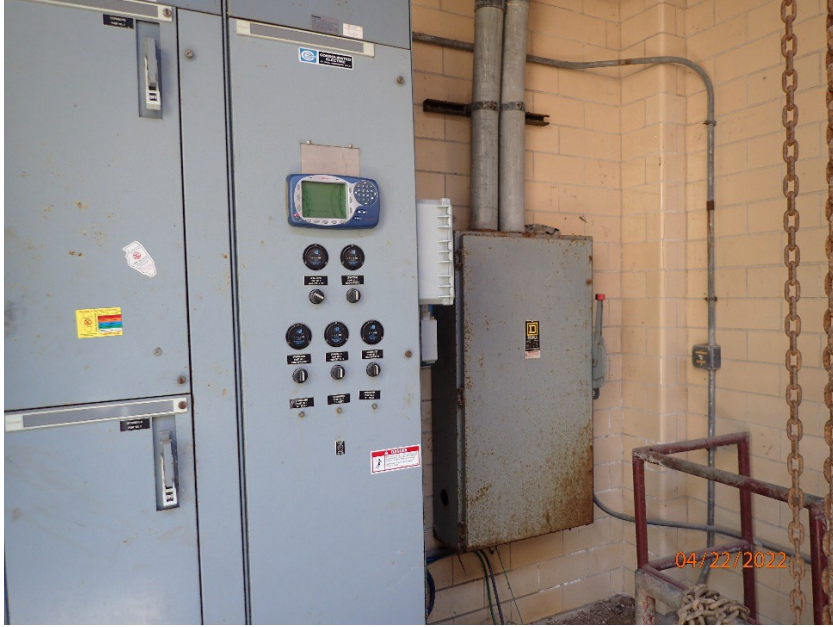
P4220026.JPG

Description: Electric feed is still on.
